# INITIAL FIRE SAFETY INSPECTION REPORT

**Factory Name: Aleya Apparels Ltd.**

**RSC ID: 24087**

**Address: 244, Singair Road, Hemayetpur, Savar**

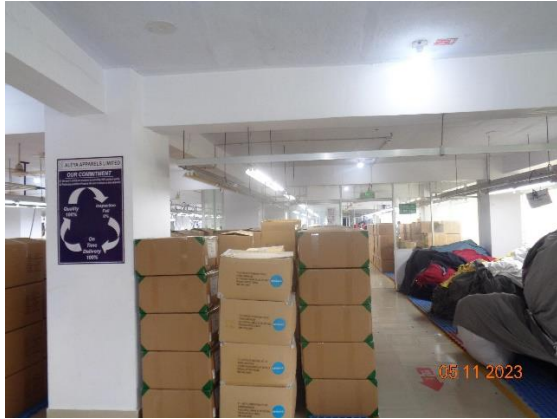
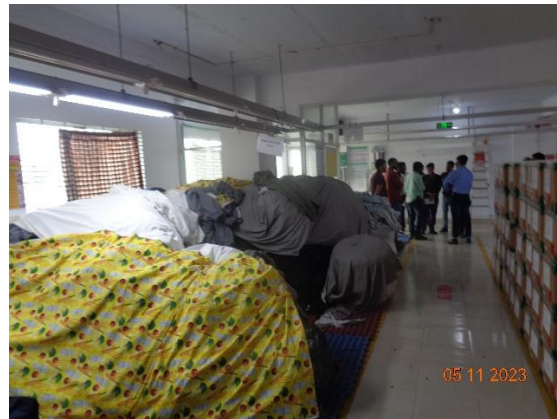
SI No.	Category	Findings	Required Action	Remediation Time Frame
F-1	Fire Rated Construction	Areas used for combustible storage open to the factory are not separated by fire rated construction on 1st floor in Building-3.	<p>Separate the dedicated storage rooms by minimum 1-hr fire-rated construction. Provide 0.75 hr. fire rated door and seal all penetrations and openings by 1 hr. fire rated fire rated barrier construction.</p> <p>Where separate storage rooms are not feasible, provide defined storage areas and limit the storage arrangement as follows: - Maximum height of 2.45m (8ft.) , maximum area of 23m<sup>2</sup> (250 ft<sup>2</sup>) and 3m (10ft.) clear distance from adjacent another unenclosed combustible storage.</p> <p>- If the building/floor is sprinkler protected: maximum height of 3.66m (12ft.) and maximum area of 93m<sup>2</sup> (1000 ft<sup>2</sup>) and 3m (10ft.) clear distance from adjacent another unenclosed combustible storage.</p>	Within 3 Months

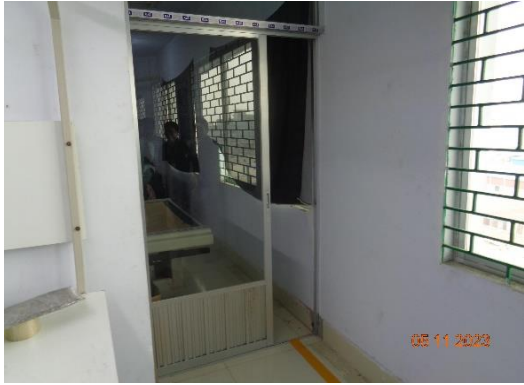
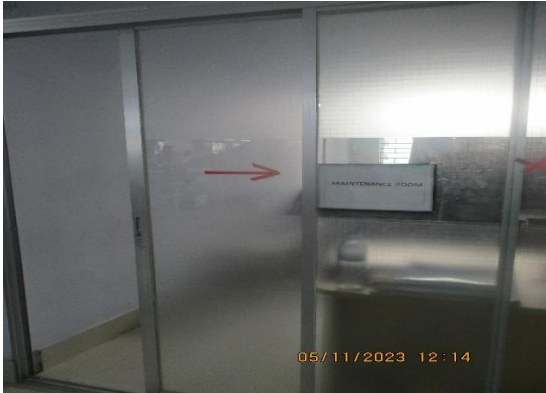
F-2	Means of Egress	Non- compliant sliding door located at several locations at the Building.	Replace all gates and doors along the means of egress with side-hinged, swinging egress doors in accordance with RSC standard 6.8.1.	Within 1 Month

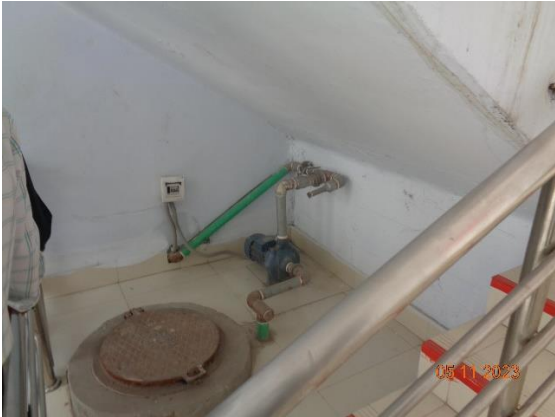
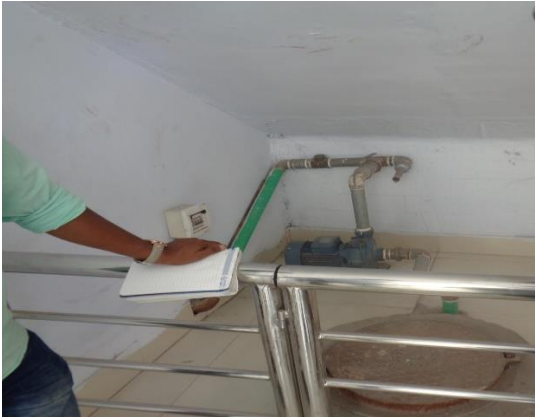
F-3	Means of Egress	<p>Water pump (domestic use) located at exit stair enclosure without separated by fire-rated construction.</p> <p>Location: <b>Building-3, Stair-1 Ground floor.</b></p>	<p>The exit stair enclosure shall be provided with a minimum of 2- hr. fire resistance rating for buildings 4 or more stories</p>	<p>Within 3 Months</p>
<div style="display: flex; justify-content: space-around;">

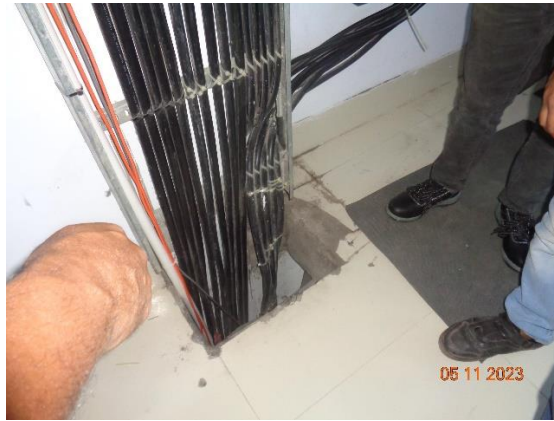
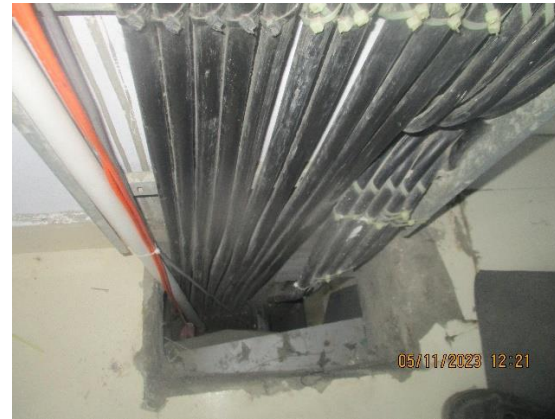
</div>				
F-4	Fire Rated Construction	<p>Unsealed penetrations and openings are located in the fire-rated floor/ceiling assemblies.</p> <p>Location: <b>Building-3, Ground floor &amp; First floor.</b></p>	<p>Provide a minimum 2-hr fire rated shaft to separate the utility risers from each floor level or seal all penetrations and openings in floors/ceiling assemblies by 3-hr fire rated listed/certified materials. The installation of such fire rated materials shall be following certified design.</p>	<p>Within 3 Months</p>

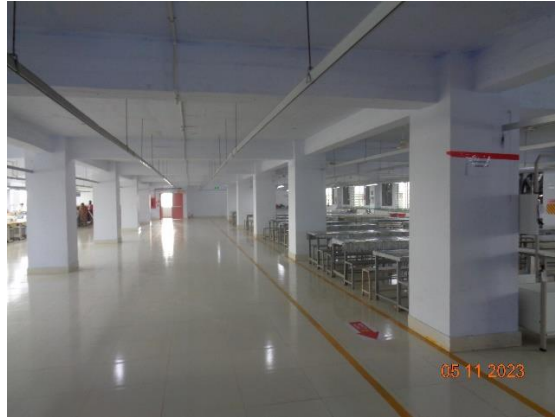
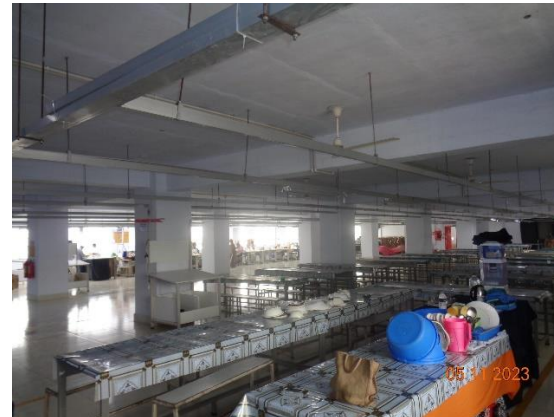
F-5	Fire-Rated Construction	<p>The dining area is not separated from Production floor area by fire rated construction.</p> <p>Location: <b>Building-3, 4th floor.</b></p>	<p>Canteen shall be separated from production area by minimum 3 Hr. rated separation. Seal and/or protect all openings to maintain the required fire separation.</p> <p>Also provide at least two means of exits leading directly to the street or leading to a corridor or open space having access to exits in two independent and different direction.</p>	Within 3 Months
-----	-------------------------	---	---	-----------------

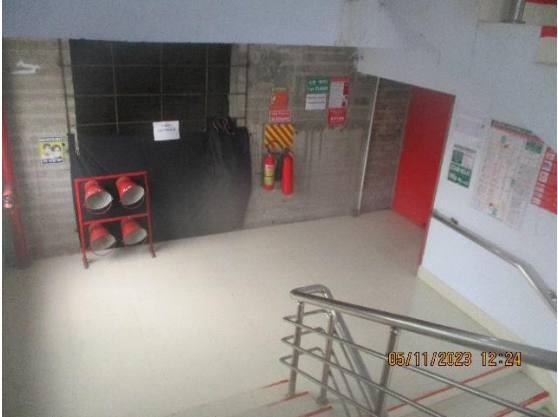
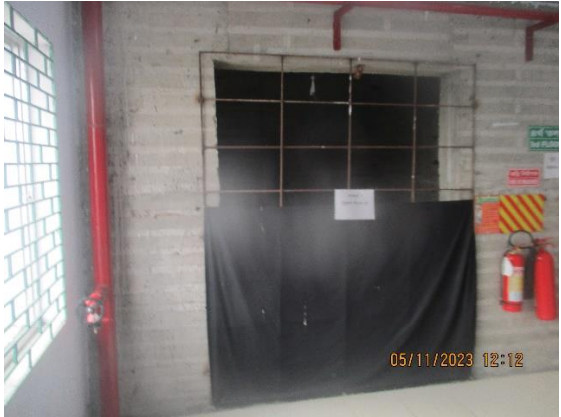
F-6	Fire Rated Construction	<p>Elevator shafts are directly open into the exit stair for stair-1 &amp; 2.</p> <p>Location: <b>Building-C</b></p>	<p>In new and interim construction, an exit stairway shall not be built around a lift shaft unless both of them are located in a smoke proof enclosure and made of a material with fire resistance rating required for the type of construction of smoke proof enclosure as per RSC-6.14.3. So, separate the stair enclosure from elevator shaft throughout the building.</p> <p>There is a variety of opening protective types i.e., fire rated lift landing doors, fire doors, fire rated curtain combination for both heat &amp; smoke control with integration with fire alarm control panel.</p>	Within 3 Months

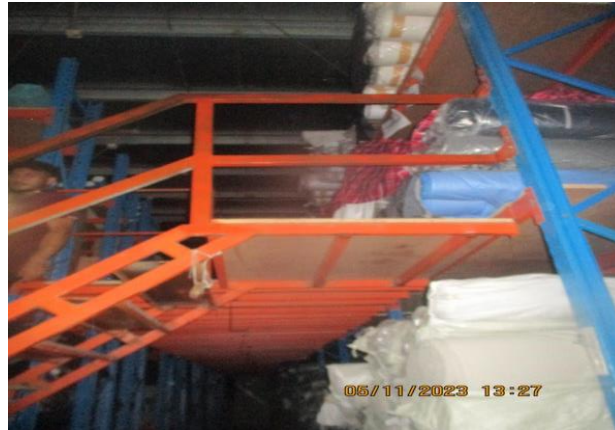
F-7	Fire Rated Construction	<p>Catwalk has been constructed on High rack storage and the area of the intermediate deck creates a full floor where the size of the deck is more than 33% of the total floor area and requires fire rated separation.</p> <p>Location: Building 1-Ground Floor (Bonded warehouse).</p>	<p>Remove the catwalk of the intermediate deck. Or , Maintain fire separation (3hr for type 1) between floor to floor as per BNBC 2006 Table 3.3.1. Provide required fire rating on the structural elements by following Table-3.2.4, 3.1.9 &amp; Table 4.4.1 of the RSC Technical Guidelines Standard or Table 3.3.1 of BNBC-2006. Consult a qualified fire protection engineer to design the rated construction barriers in between two floors and in structural members. Factory shall submit all required product datasheet, installation design along with design philosophy to RSC for review prior to installation on site.</p>	Within 6 Months

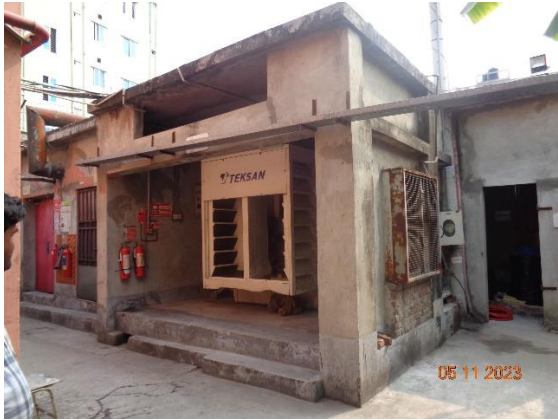
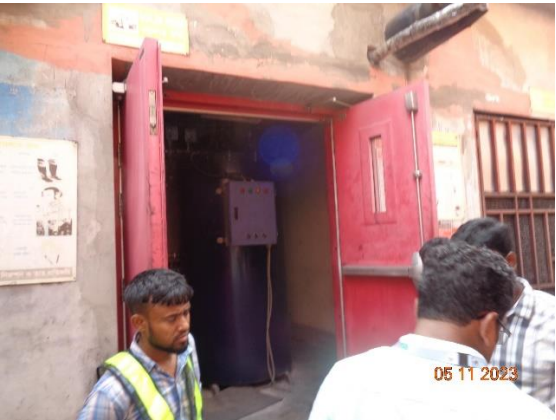
F-8	Fire Rated Construction	<p>The boiler and Generator rooms are not separated by fire rated construction due to openings, non-rated doors, and penetrations.</p> <p>Location: <b>Building-2 (Ground floor)</b></p>	<p>Separate the boiler rooms by a minimum 1-hr fire-rated construction for non-high rise. Seal and/or protect all openings to maintain the required fire separations.</p> <p>Separate the generator room by a minimum 2-hr fire-rated construction. Seal and/or protect all openings to maintain the required fire separations.</p>	Within 3 Months
<div style="display: flex; justify-content: space-around;">

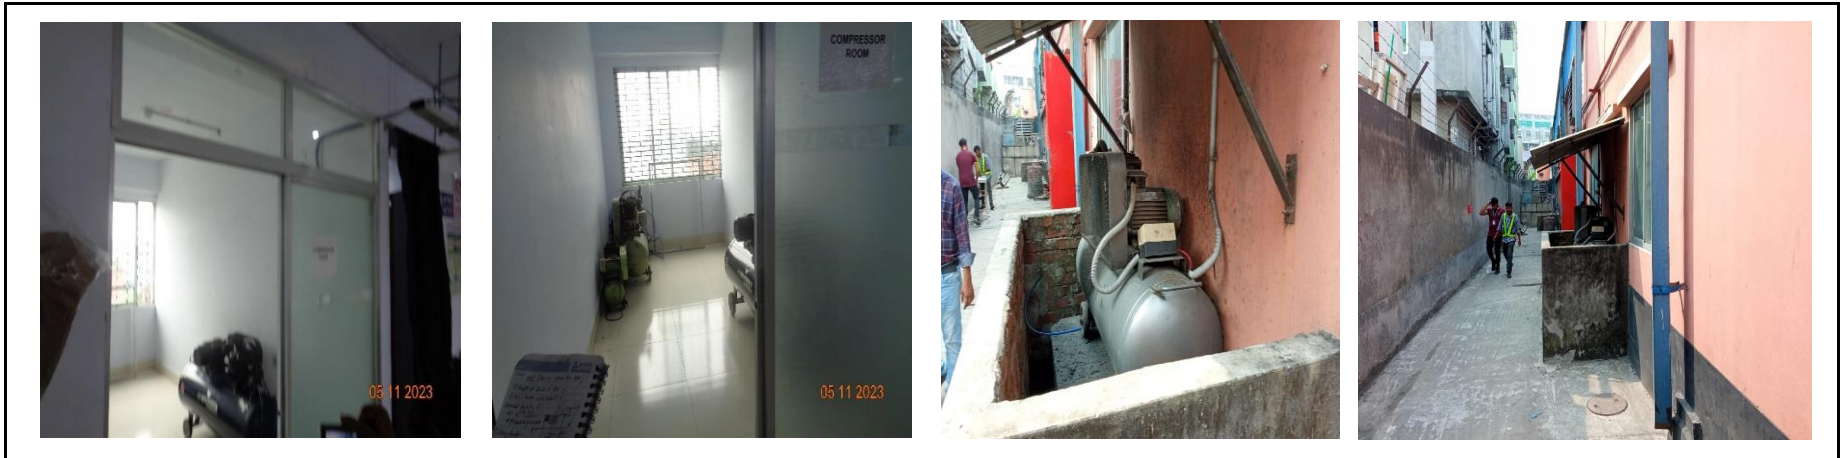
</div>				
F-9	Fire Rated Construction	<p>The Compressor rooms are not separated by fire rated construction due to openings, non-rated doors, and penetrations.</p> <p>Location: <b>Building-3 (1st Floor) &amp; Southside of Building-01.</b></p>	<p>Separate the compressor rooms by a minimum 2-hr fire-rated construction from storage occupancy.</p> <p>Seal and/or protect all openings to maintain the required fire separations.</p>	Within 3 Months

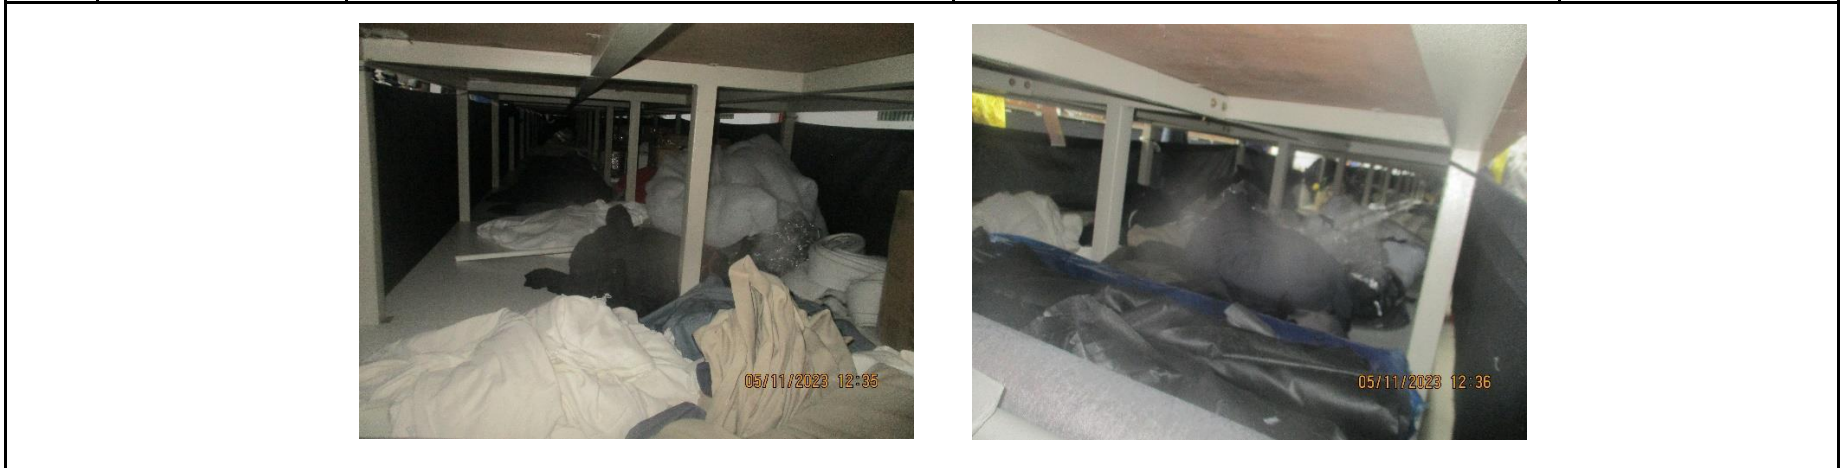
F-10	Fire Rated Construction	Underneath of Cutting table areas used for combustible storage open to the factory are not separated by fire rated construction on Ground floor in Building-3.	Remove all combustibles stored underneath the cutting tables at the noted locations.	Within 2 Months
------	-------------------------	--	--	-----------------

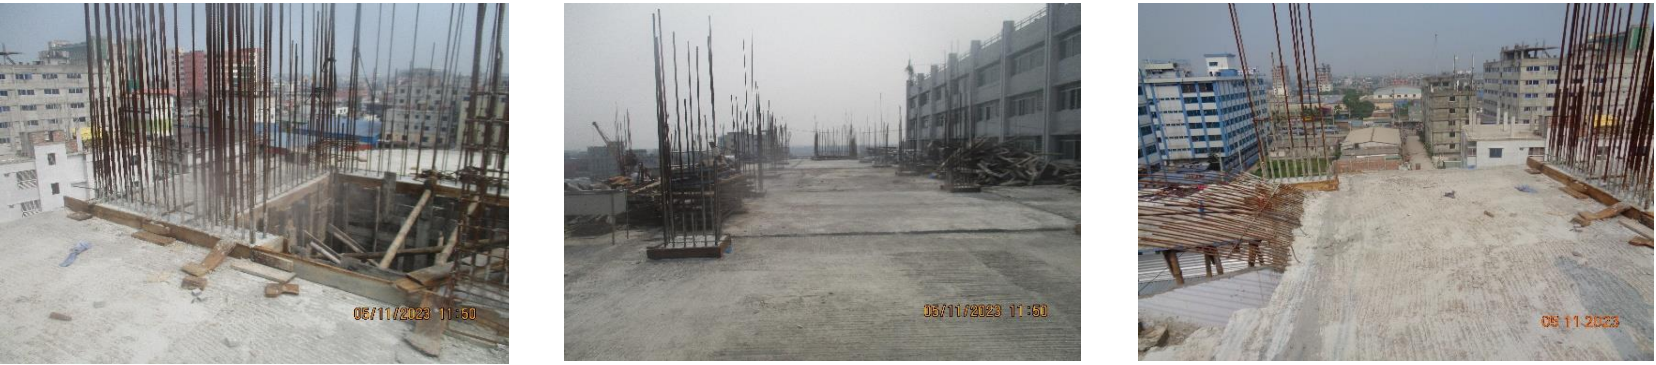
F-11	Means of Egress	Parapet or Guardrail not provided on rooftop	All occupiable roofs shall be provided with parapets or guards with a minimum height of 1067 mm (42 in.).	Within 2 Months

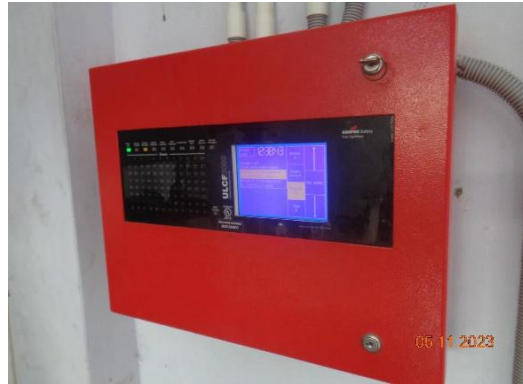
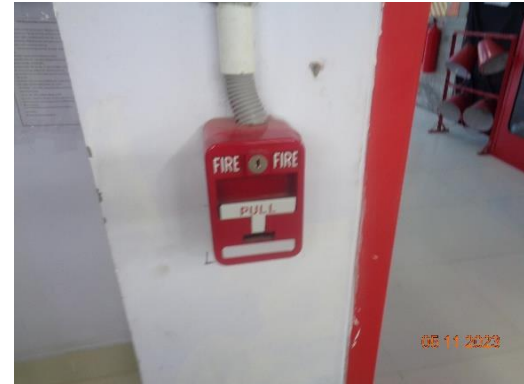
F-12	Fire Alarm & Detection System (FADS)	<p>The fire alarm and detection system installation requires detailed review to confirm compliance with NFPA 72 and RSC standard.</p> <p><b>Location: All building.</b></p>	Submit as-built drawings, testing records, equipment certification and other relevant documentation to the RSC for review and approval/acceptance test.	Design Review within 2 months and installation within 4 months.

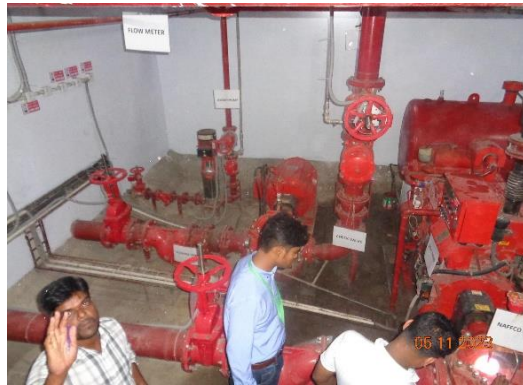
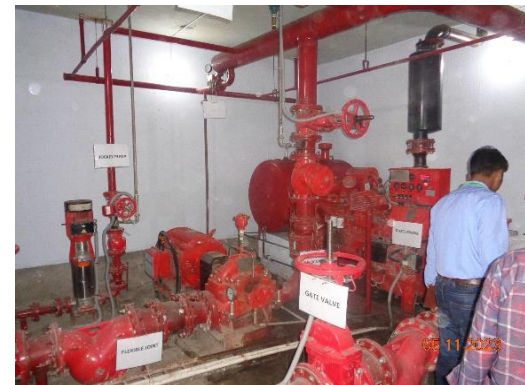
F-15	Inspection Testing and Maintenance of Fire Suppression System (Standpipe) (ITM)	Inspection, testing and maintenance of the standpipe system is not found in accordance with NFPA 25.	Inspect, test and maintain the standpipe system and keep written records on-site, in accordance with NFPA 25.	Within 1 Month after installation.
F-16	Inspection Testing and Maintenance of Fire Suppression System (Pump) (ITM)	Inspection, testing and maintenance of the fire pump system is not in accordance with NFPA 20.	Inspect, test and maintain the fire pump system and keep written records on-site, in accordance with NFPA 20 and RSC standards.	Within 1 Month after installation.
