# INITIAL FIRE SAFETY INSPECTION REPORT

**Concorde Garments Limited (Extension)**

**RSC ID: 24620**

**Plot-M/3, Road-5, Section-7, Pallabi, Mirpur, Dhaka-1216.**

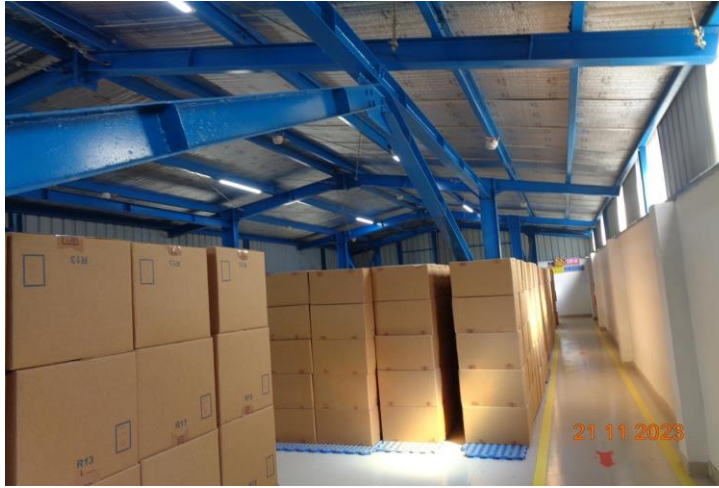
| SI No. | Category | Findings | Required Action | Remediation Time Frame |
|---|---|---|---|---|
| F-1 | Fire Rated Construction | The main structural elements of the the shed at 3rd floor of Utility Building are constructed by steel which is non-rated and were found in exposed condition without any fire protection. (Interim Structure). | Interim building shall be type-1 or type-2 construction as per Table 3.2.4 of BNBC-2006. Provide required fire rating on the structural elements by following Section 4.4 and Table 4.4.1 of the RSC Technical Guidelines Standard or Table 3.3.1 and Table 4.1.1 from BNBC Part 4. Consult a qualified fire protection engineer to design the rated construction barriers in between two floors and in structural members. | Within 6 months |

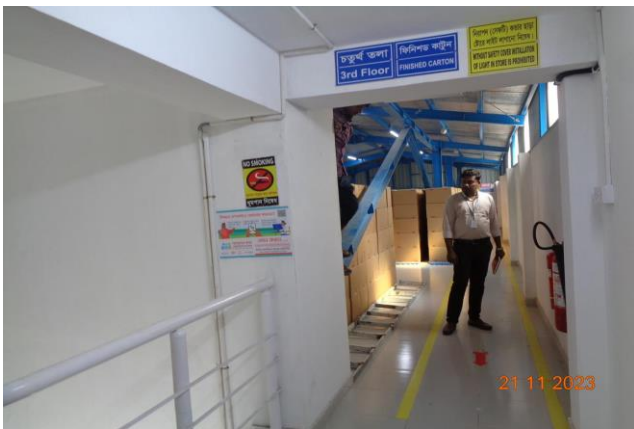
| F-2 | Fire Rated Construction | Finished goods store discharge directly into the exit stair enclosures. <b>Location:</b> 3rd floor of Utility Building. | Openings from exit enclosure to storage room, generator and hazard spaces shall be provided with a vestibule with fire rated construction and openings. Provide a 1.5 hr. fire rated door on the exit stair side and a 1-hr. fire rated door on the Store, generator, substation room side. Ensure that the fire rating of the vestibule construction matches that of the exit stair enclosure. | Within 3 months |

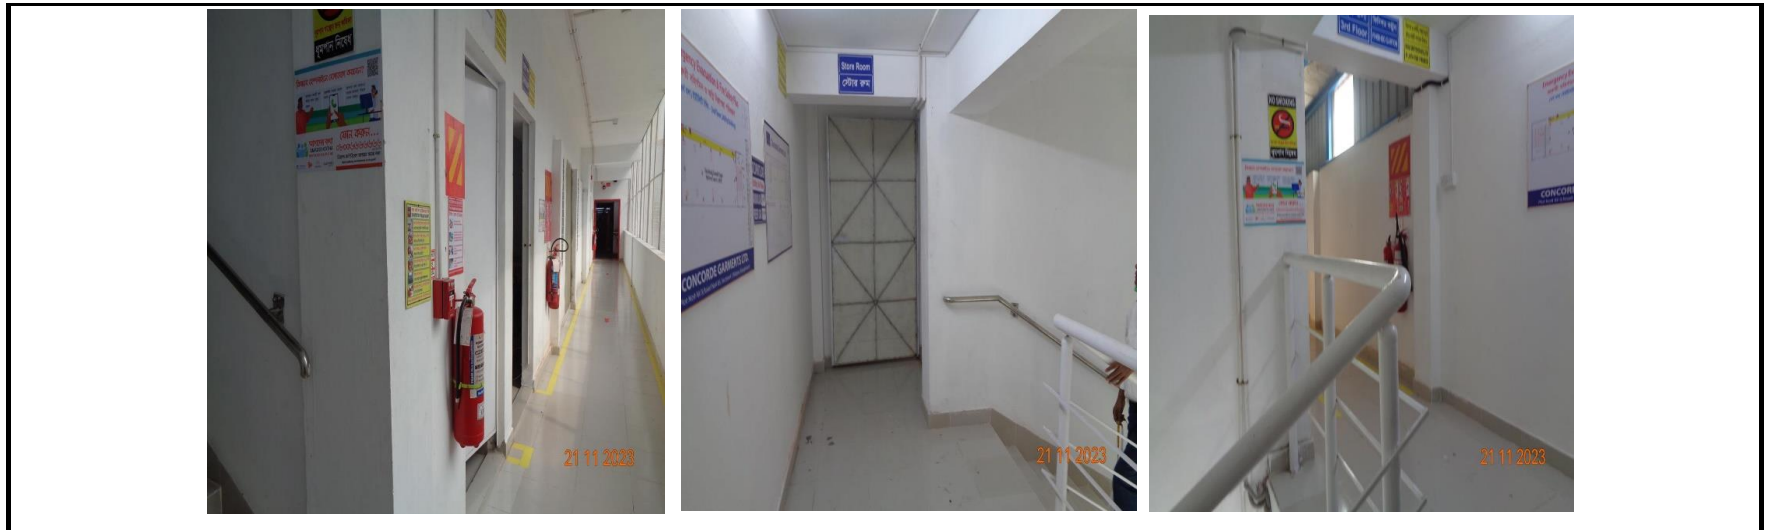
| F-3 | Fire Rated Construction | The exit stairs are not separated from work areas, other spaces by fire-rated construction due to non rated openings. | <p>Provide minimum 2-hr rated fire wall and 1.5-hr fire rated doors for buildings that are 4 or more stories and minimum 1-hr rated fire wall and 0.75-hr fire rated doors for buildings that are less than 4 stories. Seal all unprotected openings to separate the exit stairs from work areas and other building spaces on all floor levels.</p> <p>Ensure that the fire doors are self-closing and positive latching and that they are provided with fire exit (panic) hardware where serving production floors. If fire doors are required to be held open for functional reasons, provide automatic closing devices tied to the fire alarm system.</p> | Within 3 months |

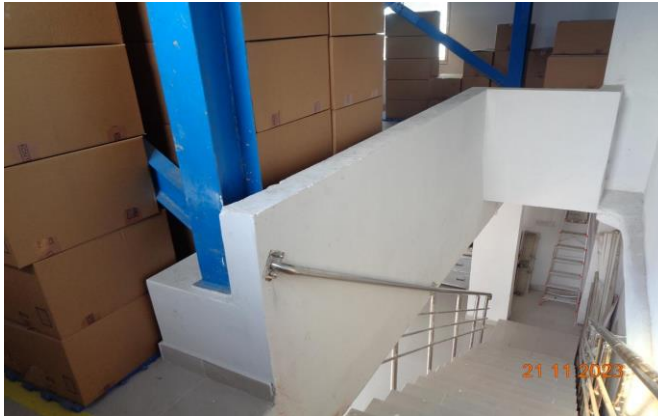
| F-4 | Fire Rated Construction | <p>Room used for combustible storage was not separated by fire rated construction.<br/> <b>Location:</b> 3rd floor of Utility Building.</p> | <p>Separate the dedicated storage rooms by minimum 1-hr fire-rated construction. Provide 0.75 hr. fire rated door and seal all penetrations and openings by 1 hr. fire rated barrier construction.</p> <p>Where separate storage rooms are not feasible, provide defined storage areas and limit the storage arrangement as follows:</p> <ul style="list-style-type: none"> <li>- Maximum height of 2.45m (8ft.) , maximum area of 23m2 (250 ft2) and 3m (10ft.) clear distance from adjacent another unenclosed combustible storage.</li> <li>- If the building/floor is sprinkler protected: maximum height of 3.66m (12ft.) and maximum area of 93m2 (1000 ft2).</li> <li>- In-process storage shall not exceed 10 percent of the building area of the story in which they occur.</li> </ul> <p>Separate areas of unenclosed combustible storage by a minimum clear distance of 3m.</p> | Within 3 months |

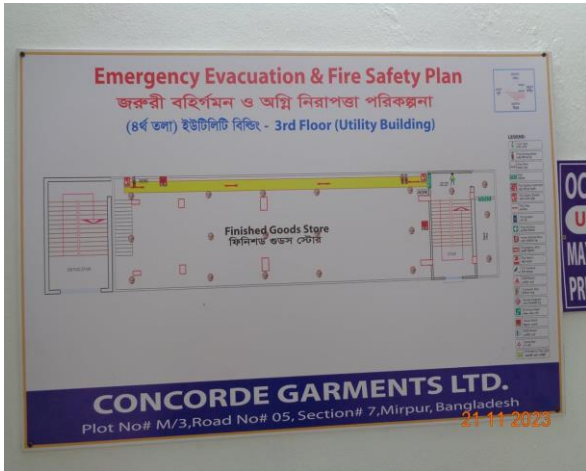
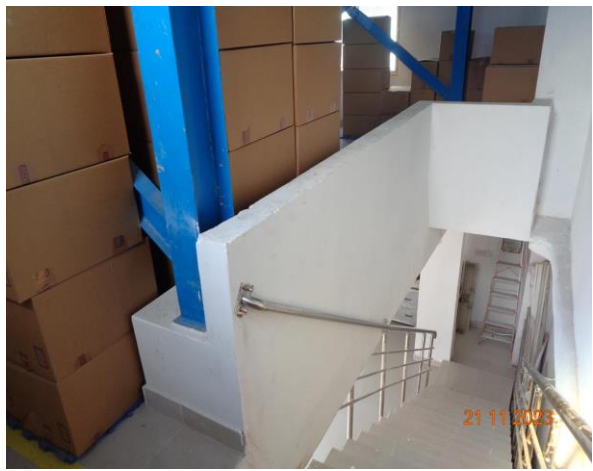
| F-5 | Means of Egress | Stair-2 of 3rd floor was internally discharged into 2nd floor without separation. | <p>Modify stair to discharge directly outside.</p> <p>Or</p> <p>Provide 2-hr fire-rated exit passageway leading directly outside (vestibules to separate any storage areas).</p> | Within 3 months |

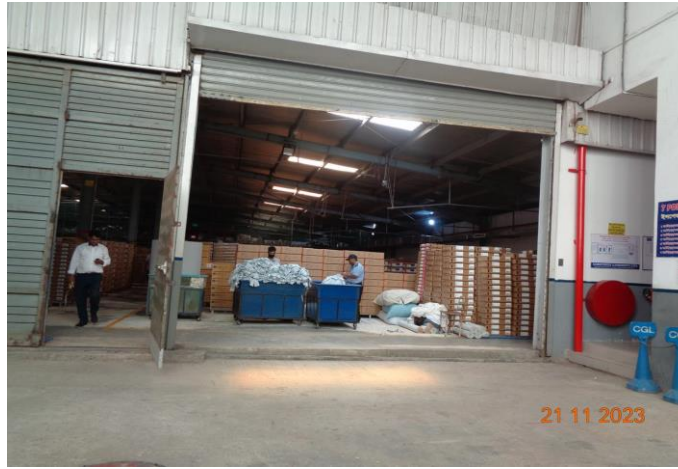
| F-6 | Means of Egress | The egress court (Stair-1 discharge path) is found unprotected. | <p>Seal all penetrations and openings along the discharge path, up to a height of 10 ft., to provide a minimum 1-hr fire separation.</p> <p>Alternatively, provide a second remote discharge path to the public way (only include this if feasible).</p> | Within 3 months |

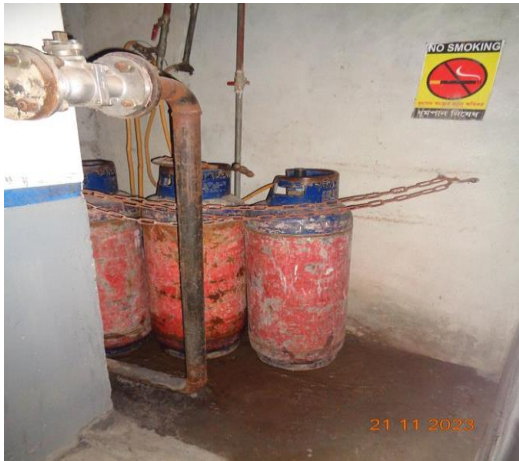
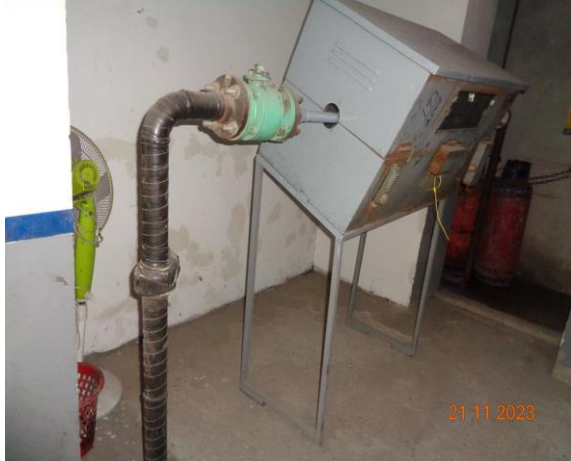
| F-7 | Fire Rated Construction | Liquefied or compressed gas cylinders are located within the factory. | <p>LPG/CNG cylinders are permitted to be stored in a separate dedicated building on the factory premises within its boundaries if the building meets the following conditions.</p> <ol style="list-style-type: none"> <li>1. The storage building must be at least 3 meters away from any other building and boundaries.</li> <li>2. The exterior walls of the building must have a fire resistance rating of 3 hours using noncombustible construction.</li> <li>3. Doors and other openings in the exterior walls must be protected with suitable closing devices having a fire protection rating of 3 hours.</li> <li>4. The building is to be used for no other purpose than the storage of LPG/CNG cylinders.</li> <li>5. The building must be mechanically ventilated to control the accumulation of flammable vapors.</li> <li>6. The installations must be approved and accepted by the requirements of the AHJ, Gas supply company regulations, manufacturers/supplier's instructions/guidance, CIOB and all other applicable agencies, codes and standards.</li> </ol> | Within 3 months |

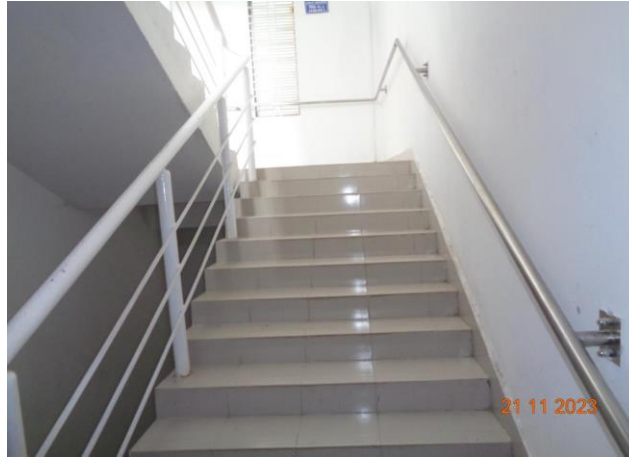
| F-9 | Means of Egress | The width of stair-1 is less than 60 in. | In interim construction, stairs shall have a minimum width of 1.5 m (60 in.) according to RSC Technical Guidelines (StandardV1.0) section 6.5.6.2.1. Provide minimum stair widths of 1.5 m (60 in). | Within 3 months |

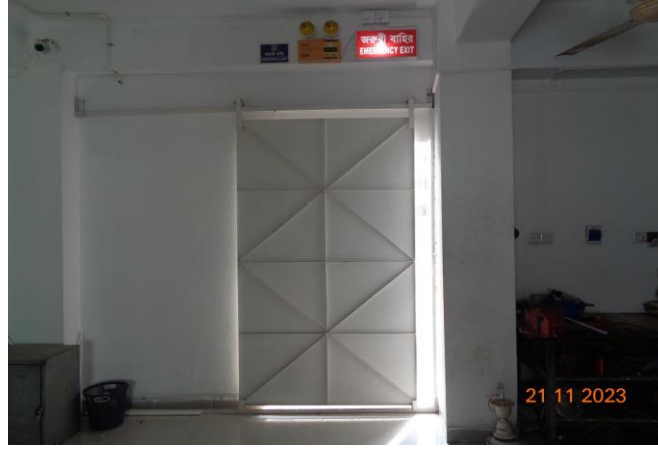
| F-10 | Means of Egress | Sliding doors are provided at building exits.<br><b>Location:</b> Electrical maintenance room, 2nd floor. | Replace all collapsible and sliding doors along the means of egress with side-hinged, swinging egress doors. | Within 1 month |

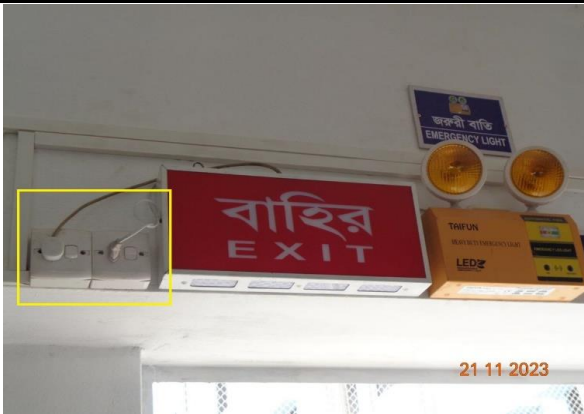
| F-12 | Egress Lighting | Manual on-off switch is provided for emergency lighting / exit signage units. | Remove manual on/off switches from emergency lighting / exit signage units to prevent them from being switched off. | Within 1 month |

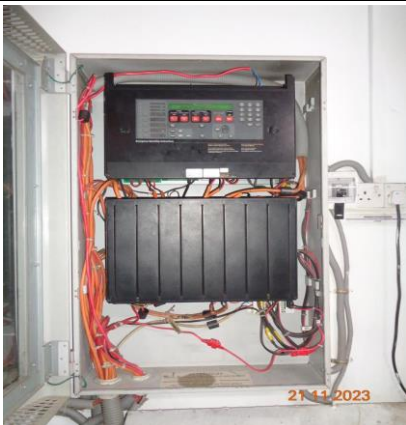
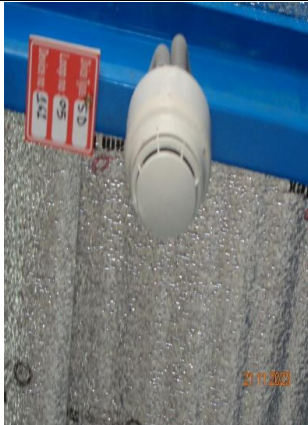
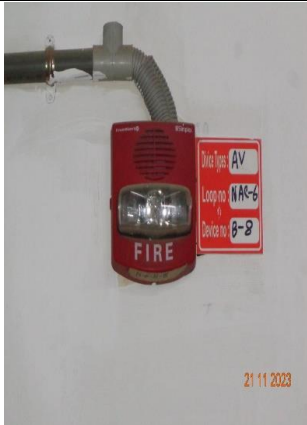
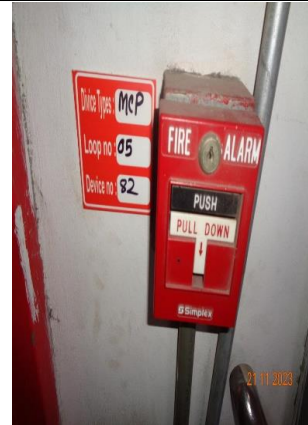
| F-14 | Fire Alarm & Detection System (FADS) | Automatic fire alarm & detection system installation requires detailed review to confirm compliance with NFPA 72 and RSC standards. | <p>Submit as-built drawings, testing records, equipment certification and other relevant documentation to the RSC for review.</p> <p>Once reviewed, install or modify the fire detection and alarm system (where required) throughout the building in accordance with RSC technical guidelines (standard) and NFPA 72. The factory management shall contact RSC to conduct the final acceptance testing after the installation, testing &amp; commissioning.</p> | Design Review within 2 months and modification within 3 months (If require). |
