INITIAL FIRE SAFETY INSPECTION REPORT

Bea-Con Knit Wear Limited (Factory-2) (Extension)

RSC ID: 24582

Fire Safety Inspection Report

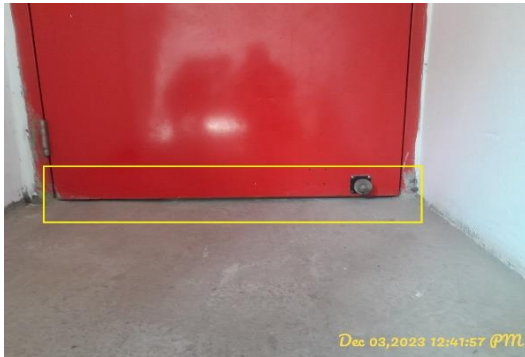
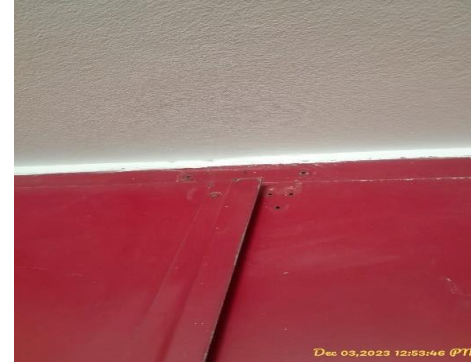
SI No.	Category	Findings	Required Action	Remediation Time Frame
F-1	Mean of Egress	<p>The exit stairs are not separated from [work areas, other spaces] on each floor by fire-rated construction due to non-functional fire doors & penetrations.</p> <p>Location: 3 storied Utility building</p>	<p>The exit stair enclosure shall be provided with a minimum of 1- hr. fire resistance rating with 60 minutes opening protection.</p> <p>The clearance under the bottom of a fire door shall be a maximum of 19mm.</p> <p>Ensure that the fire doors are self-closing and positive latching and that they are provided with fire exit (panic) hardware where serving production floors. If fire doors are required to be held open for functional reasons, provide automatic closing devices tied to the fire alarm system.</p>	Within 3 months

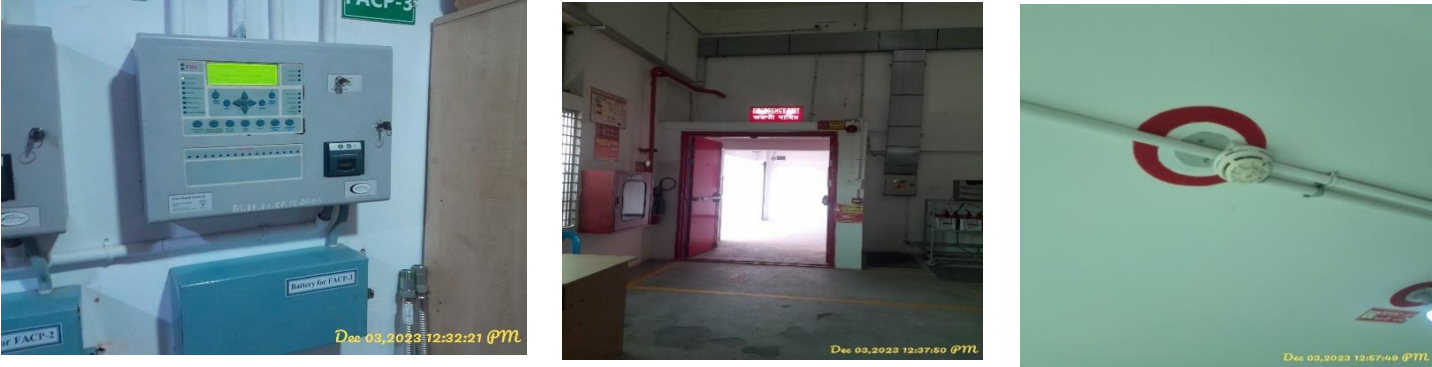
F-4	Fire Alarm & Detection System (FADS)	Addressable fire alarm & detection system installation requires detailed review to confirm compliance with NFPA 72 and RSC standard.	<p>Submit design, documents and calculations to RSC for review prior and based on the review modify the system if there is any.</p> <p>After installation the owner shall contact the RSC for witness of conducting the final acceptance testing of the fire detection & alarm system installation.</p> <p>Also inspect, test and maintain the fire alarm system, and keep written records on-site, in accordance with NFPA 72.</p>	Design Review within 1 month and modification within 3 months. (If required).

<p>The middle row contains three photographs. The first shows a grey fire alarm control panel with a digital display and various buttons, mounted on a wall. The second shows a red fire door with a 'FIRE DOOR' sign above it, set in a hallway. The third shows a white fire alarm detector mounted on a ceiling, with a red circular mark next to it.</p>

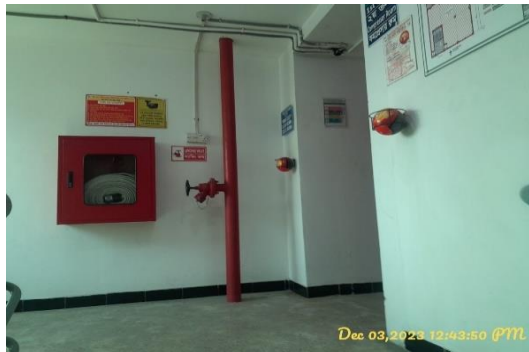
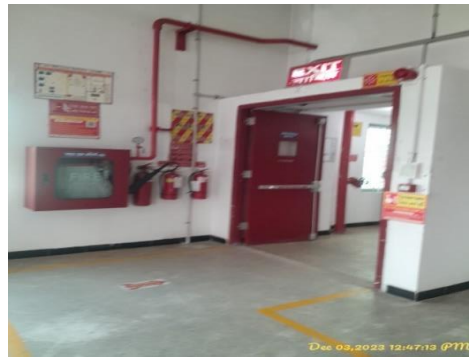
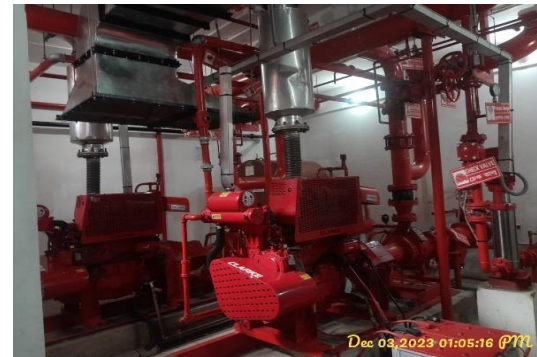
F-6	Fire Protection System(Standpipe)	Standpipe system installation requires detailed review to confirm compliance with NFPA- 14 , 20 ,22 & 24 or as per RSC standard.	<p>Submit the standpipe system drawing to RSC for review.</p> <p>Once the design is reviewed, install and modify the standpipe system throughout the building in accordance with review comment, RSC Standard and NFPA 14,20,22 and 24.</p> <p>After installation the owner shall conduct internal testing and commissioning and then contact the RSC for witness of final acceptance testing.</p>	Design Review within 1 month and modification within 3 months (If required).
-----	------------------------------------	--	--	--
