INITIAL FIRE SAFETY INSPECTION REPORT

Mark Sweater Ltd. (Extension)

RSC ID: 24775

Date: 24-Dec-2023

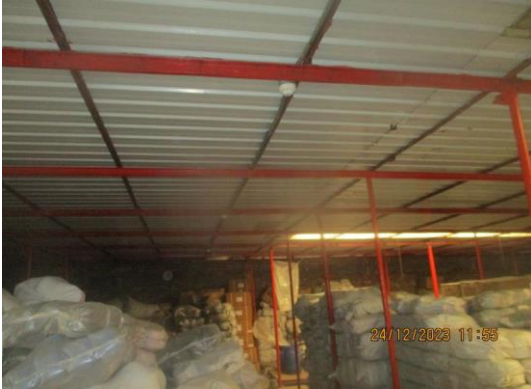
SI No.	Category	Findings	Required Action	Remediation Time Frame
F-1	Fire Rated Construction	<p>The main structural element of the building is constructed by steel element which is non-rated and were found in exposed condition without any fire protection.</p> <p>Location: Shed-1, Yarn & Wastage Shed (Single storied steel shed).</p>	<p>The building shall be type-I or II construction. So, provide require rating in the structural element of the building. Consult with a qualified fire protection engineer. BNBC 2006-Table 3.2.4.</p>	Within 6 months

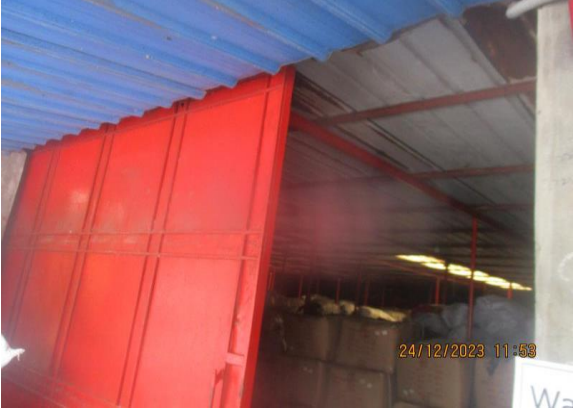
F-2	Means of Egress	<p>Collapsible gates/sliding doors/rolling shutter doors are provided at building exits and along egress routes.</p> <p>Location: Shed-1, Yarn & Wastage Shed.</p>	<p>Replace all collapsible gates/ sliding doors/ rolling shutter doors along the means of egress with side-hinged, swinging egress doors.</p> <p>If locks are required for security reasons, utilize specialized door locking features complying with NFPA101.</p>	Within 1 month.

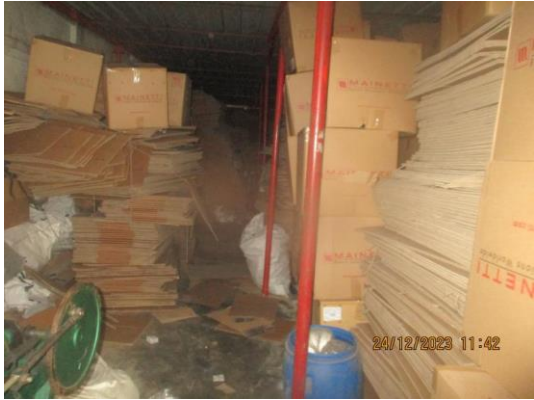
F-4	Means of Egress	<p>Aisles marking has not been provided on the floor properly.</p> <p>Location: Shed-1(Yarn & Wastage Shed).</p>	<p>Provide minimum aisle widths of 36 inch with proper marking & update on evacuation map.</p>	<p>Within 3 months</p>

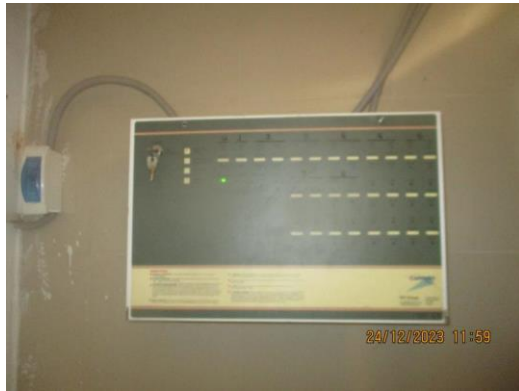
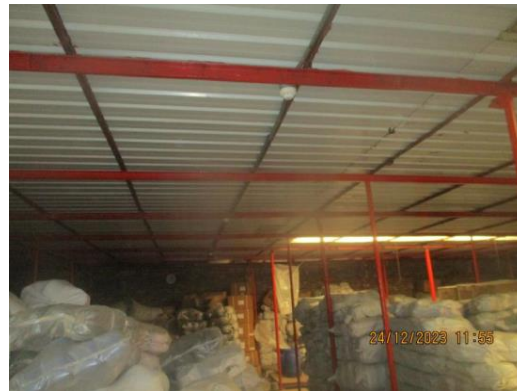
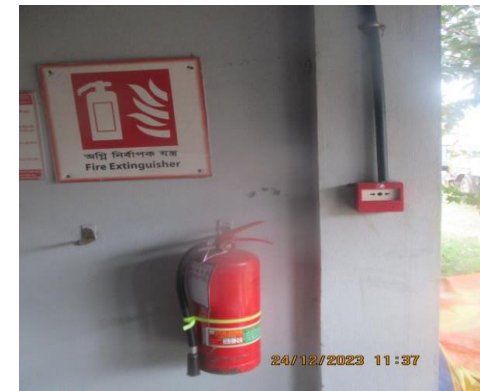
F-10	Fire Alarm & Detection system	The fire alarm & detection system is antiquated, not a listed system, and does not provide alarm and notification features consistent with acceptable standards.	Replace the fire alarm system with a new, listed addressable fire alarm system in accordance with NFPA 72.	Design Review within 2 months and installation within 4 months

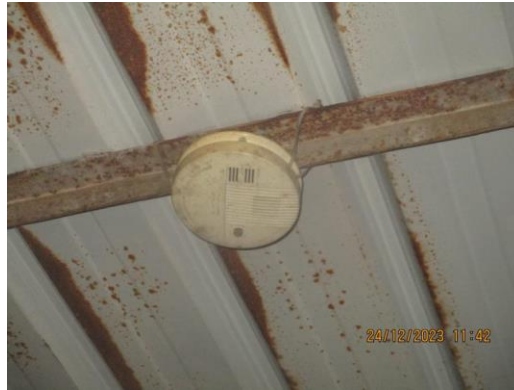
F-11	Fire Alarm & Detection system (ITM of FADS)	Inspection, testing and maintenance for the fire alarm system is not in accordance with NFPA 72 and The RSC Technical Guidelines (Standard).	Inspect, test and maintain the fire alarm system and keep written records on-site, in accordance with NFPA 72 and The RSC Technical Guidelines (Standard) and keep written records on-site	Within 1 month (after installation)
F-12	Fire Alarm & Detection system (Single station)	The building is equipped with single-station smoke alarms. Smoke alarm activation sounds only a local alarm and does not provide automatic fire alarm notification of occupant.	Remove single-station smoke alarms. Provide automatic smoke detection throughout the building, tied into the fire alarm system, in accordance with NFPA 72.	Design Review within 2 months and installation within 4 months
