# INITIAL FIRE SAFETY INSPECTION REPORT

**GLOBAL FIT (BANGLADESH) LIMITED**

**RSC ID: 24931**

# Fire Safety Inspection Report

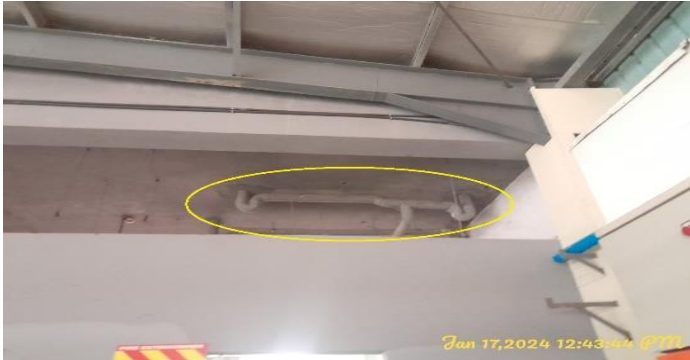
| Sl No. | Category | Findings | Required Action | Remediation Time Frame |
|---|---|---|---|---|
| F-1 | Fire rated Construction | <p>Unsealed penetrations and openings are located in the fire-rated floor/ceiling assemblies.</p> <p><b>Location: Ground Floor of Office building through PVC pipe of toilet.</b></p> | <p>Seal all penetrations and openings in floor/ceiling assemblies to maintain the fire separation at least by 2-hr. The used sealer shall be 3rd party certified and installation shall be as per manufacturer's datasheet.</p> <p>Or</p> <p>Provide a minimum 2-hr fire rated shaft to separate the utility risers from each floor if required.</p> | Within 3 months |

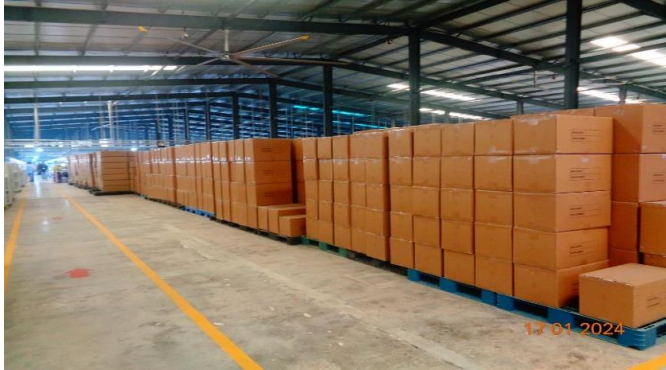
| F-2 | Fire rated construction | <p>Areas used for in-process storage of combustible materials are open to the surrounding occupancy.</p> <p><b>Location: Ground floor of Production shed.</b></p> | <p>Provide defined storage areas and limit the storage arrangement as follows:</p> <p>Maximum height of 2.45 m and maximum area of 23 m<sup>2</sup> and is separated by a minimum 3.0 m (10ft) from other storage areas and they do not exceed 10 percent of the building area of the story in which they occur. If sprinkler protected, Maximum height 12 ft (3.66 m) and maximum area of 1000 ft<sup>2</sup> (93 m<sup>2</sup>) and separated by a at least 25 ft (7.62 m) from other storage areas and does not constitute more than 10 percent of the building area or 4000 ft<sup>2</sup> (372 m<sup>2</sup>) of the sprinklered area, whichever is greater.</p> <p>or,</p> <p>Enclose the storage area from the surrounding occupancy with a minimum 1 hour fire rated construction.</p> | Within 3 months |

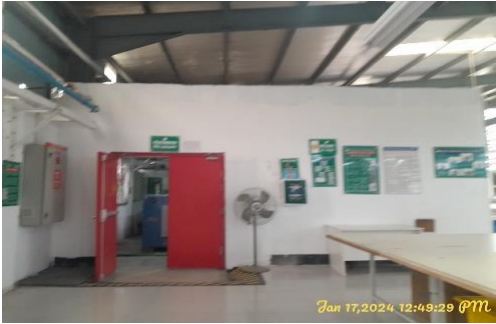
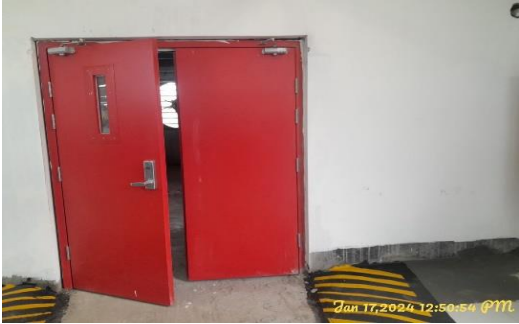
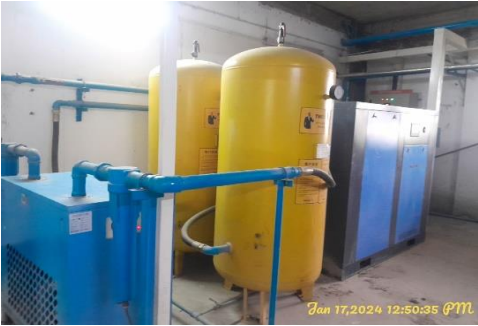
| F-3 | Fire Rated Construction | <p>Boiler room &amp; compressor room are not separated from production area due to non functional fire door.</p> <p><b>Location: Ground floor of main production shed.</b></p> | <p>Boiler &amp; compressor shall be separated from other occupancies by a minimum 1-hr fire rated construction (wall, floor, slab etc.). Seal all penetrations and openings (door, window etc.). If fire doors are required to be held open for functional reasons, provide automatic closing devices tied to the fire alarm system.</p> | Within 3 months |

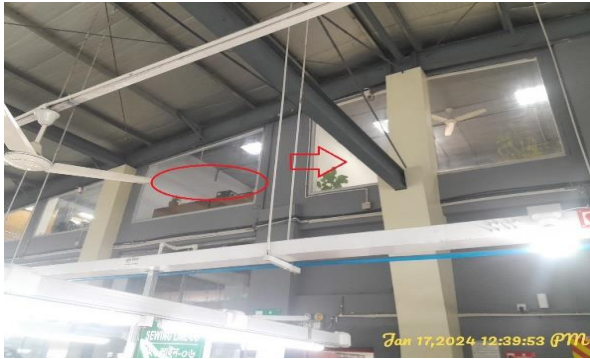
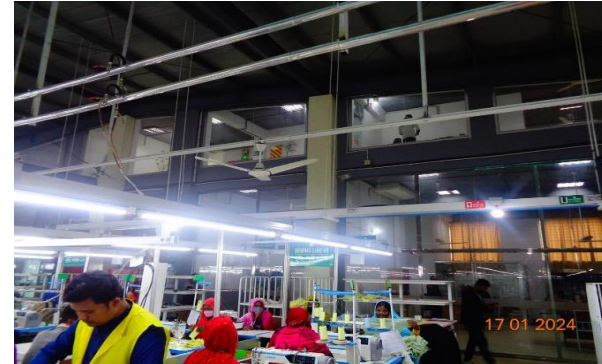
| F-4 | Fire Rated Construction | <p>First floor of three storied office building is not separated from main production shed.</p> | <p>Separate the three storied office building from main production shed by minimum 2-hr fire rated construction.</p> | Within 3 months |

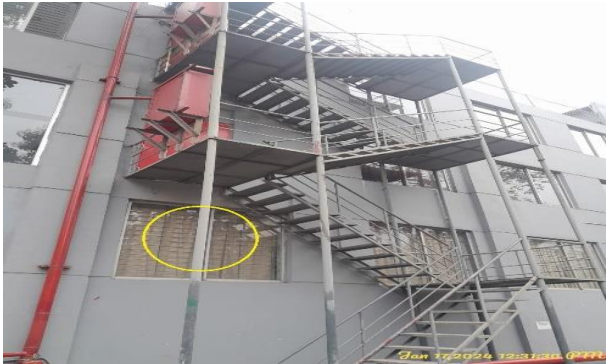
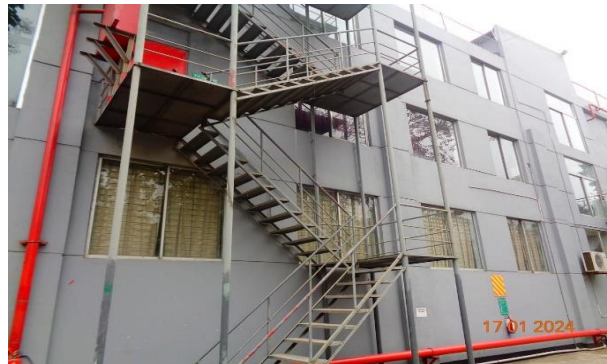
| F-5 | Fire rated Construction | <p>Exterior exit stairs are not properly separated from the building.</p> <p><b>Location: Exit stair-2 of three storied office building.</b></p> | <p>Exterior exit stairs shall be separated from the building with a rating requirement of [ 1 hr. fire rating for 3 or fewer stories and 2 hr. fire rating for 4 or more stories ]. The rating of the exterior wall shall extend 3.05 m (10 ft) beyond the ends of the stair structure.</p> | Within 3 months |

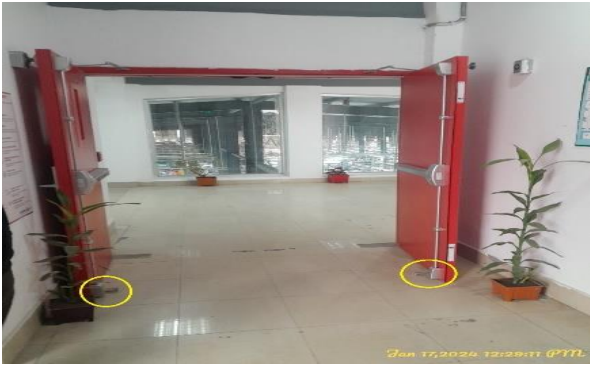
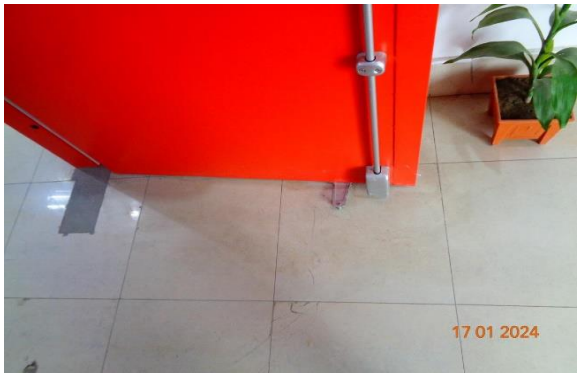
| F-6 | Fire rated Construction | <p>The exit stairs are not separated from [work areas, other spaces] on each floor by fire rated construction due to non-functional fire doors.</p> <p><b>Location: Office building</b></p> | <p>The exit stair enclosure shall be provided with a minimum of 1- hr. fire resistance rating with 60 minutes opening protection.</p> <p>The clearance under the bottom of a fire door shall be a maximum of 19mm.</p> <p>Ensure that the fire doors are self-closing and positive latching and that they are provided with fire exit (panic) hardware where serving production floors. If fire doors are required to be held open for functional reasons, provide automatic closing devices tied to the fire alarm system.</p> | Within 3 months |

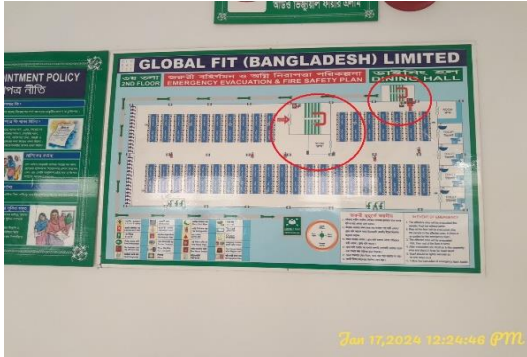
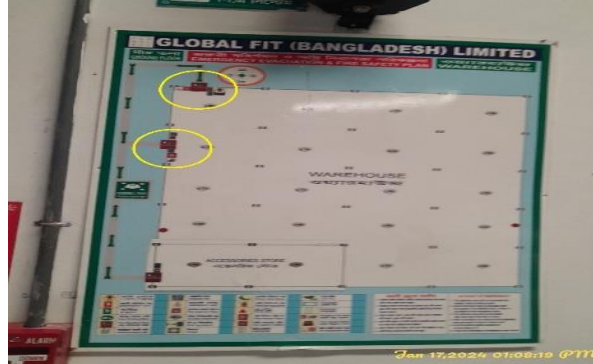
| F-7 | Mean of Egress | <p>Exits are not remotely located from each other such that a single fire event could compromise both exits.</p> <p><b>Location: Three storied office building &amp; single storied warehous shed.</b></p> | <p>Modify exit arrangement to meet RSC Technical Guideline (Standard) V1- 6.6.6.</p> <p>Or</p> <p>Provide additional exit(s) to meet RSC Technical Guideline (Standard) V1- 6.6.6.</p> | Within 3 months |

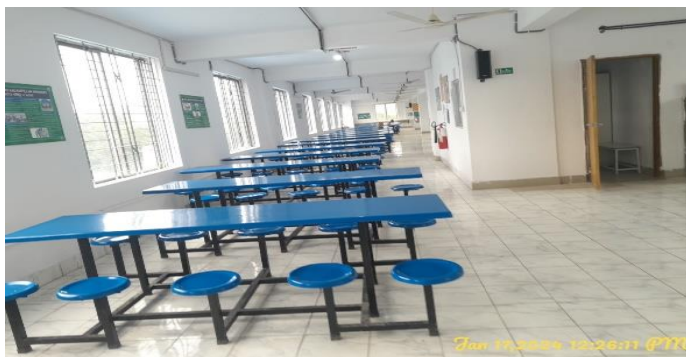
| F-8 | Mean of Egress | <p>Aisle mark are not provided at dining area at office building</p> | <p>Aisles shall be provided with a minimum unobstructed clear-width of 0.9 m (36 in.).</p> | Within 1 month |

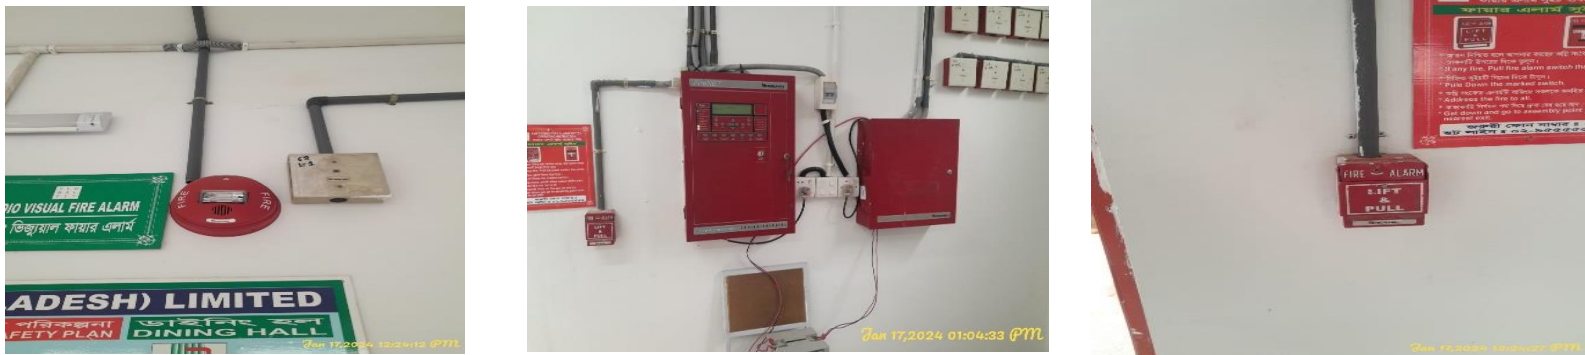
| F-15 | Fire Alarm & Detection System (FADS) | <p>Addressable fire alarm &amp; detection system installation requires detailed review to confirm compliance with NFPA 72 and RSC standard.</p> <p><b>Location: All buildings</b></p> | <p>Submit design, documents and calculations to RSC for review prior and based on the review modify the system if there is any.</p> <p>After installation the owner shall contact the RSC for witness of conducting the final acceptance testing of the fire detection &amp; alarm system installation.</p> <p>Also inspect, test and maintain the fire alarm system, and keep written records on-site, in accordance with NFPA 72.</p> | Design Review within 1 month and modification within 3 months (If require). |
