# **FIRE SAFETY INSPECTION REPORT**

## **CROWN FASHION AND SWEATER INDUSTRY, LTD. PLOT NO. 781-782, VOGRA**

**ACCORD**  
on Fire and Building Safety in Bangladesh

March 16, 2014

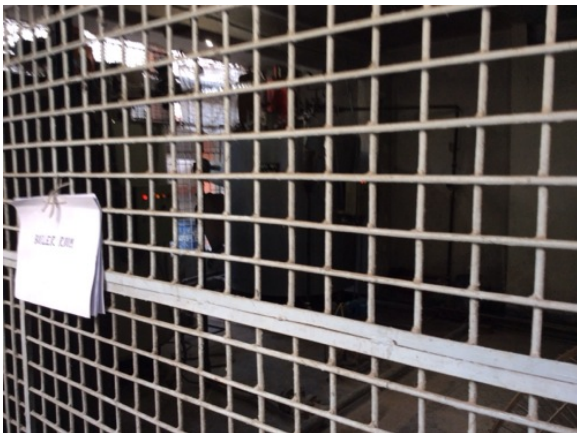
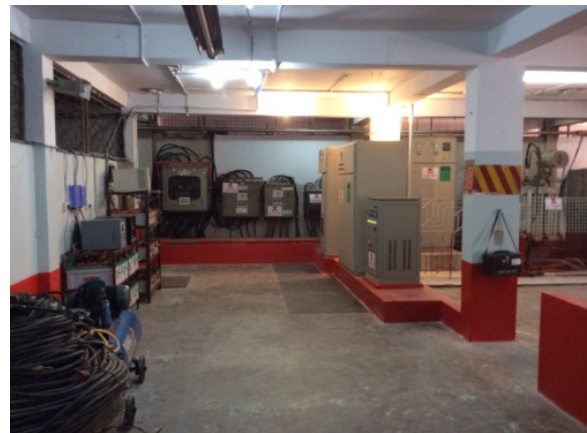
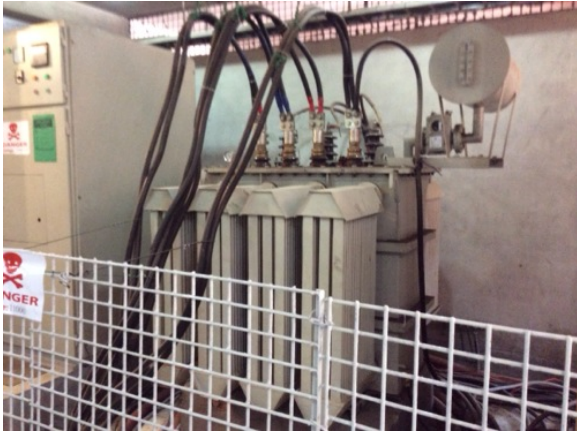
| No. | Category | Finding | Recommendation | Remediation Timeframe |
|---|---|---|---|---|
| F-1 | Fire Rated Construction | The boiler / generator / transformer rooms were not separated by fire-rated construction (openings, non-rated doors, penetrations).<br><br>Ground floor. | Separate the boiler / generator / transformer rooms by a minimum 2-hr fire-rated construction. Seal and/or protected all openings to maintain the required fire separations | Within 3 months |

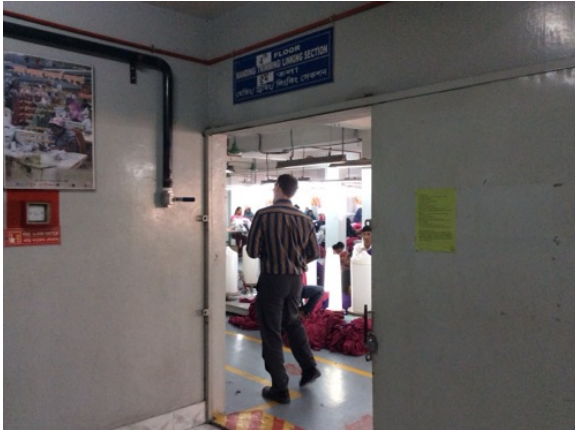
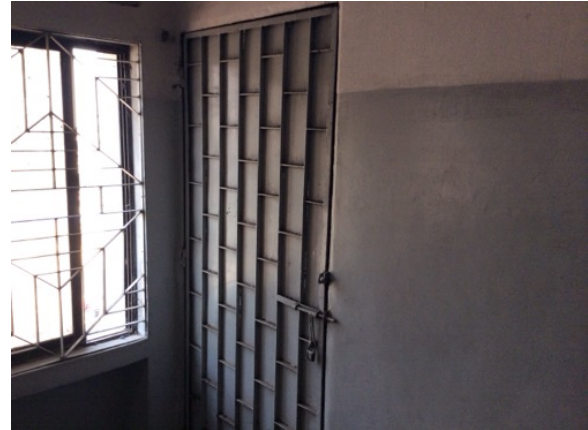
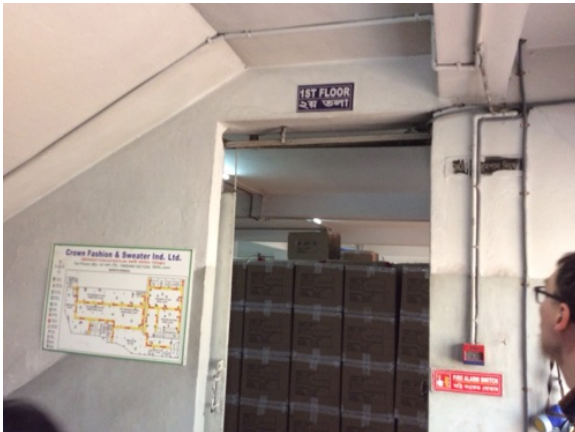
| F-2 | Fire Rated Construction | The exit stairs are not separated from work areas, and other spaces on each floor by fire-rated construction. | <p>Provide minimum 1.5-hr fire rated doors and seal all unprotected openings to separate the exit stairs from work areas and other building spaces on all floor levels. Ensure that the fire doors are self-closing and positive latching and that they are provided with fire exit (panic) hardware where serving production floors.</p> <p>If fire doors are required to be held open for functional reasons, provide automatic-closing devices tied to the fire alarm system.</p> | Within 3 months |

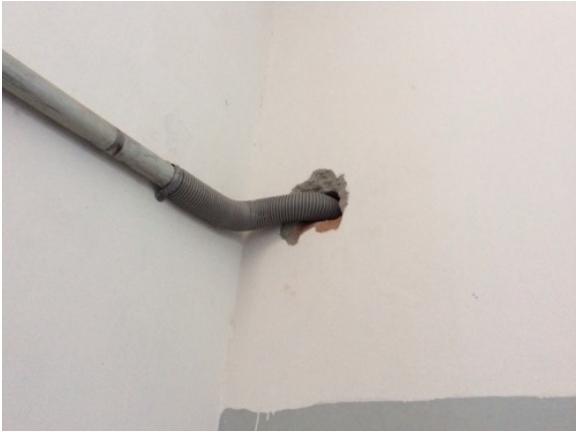
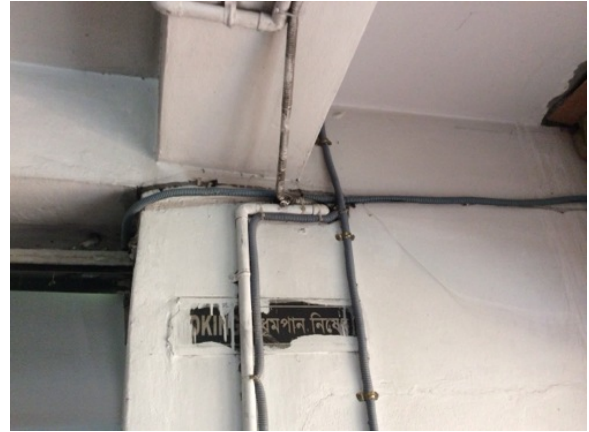
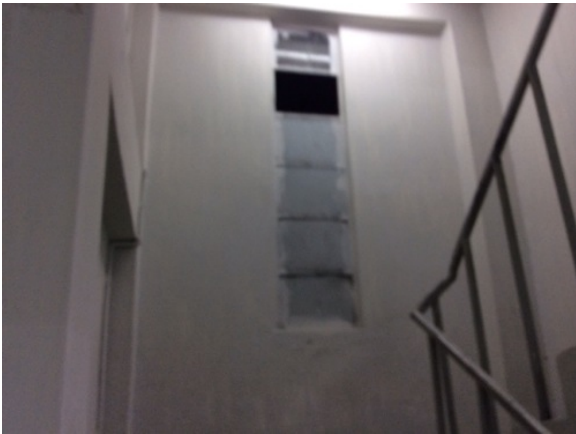
| F-3 | Fire Rated Construction | Unsealed penetrations and openings are located in exit stair enclosures. | Seal all penetrations and openings in exit stair enclosure walls to maintain the fire separation. | Within 3 months |

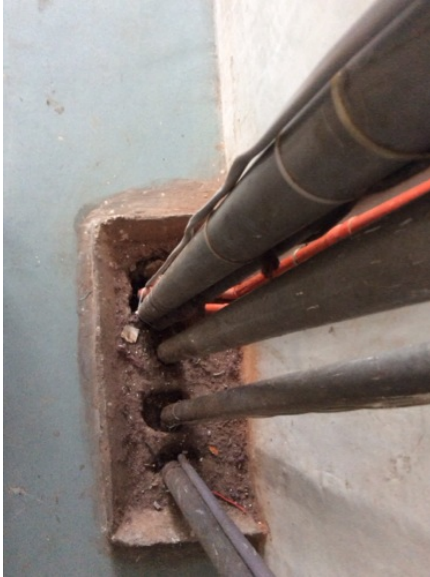
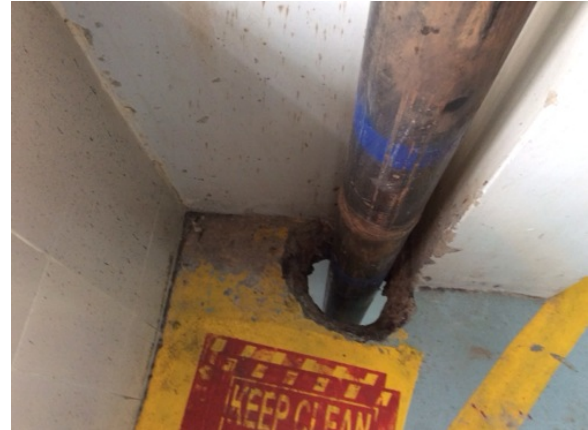
| F-4 | Fire Rated Construction | Unsealed penetrations and openings are located in the fire-rated floor/ceiling assemblies. | Provide a minimum 2-hr fire-rated shaft to separate the utility risers from each floor level.<br><br>Seal all penetrations and openings in floor/ceiling assemblies to maintain the fire separation. | Within 3 months |

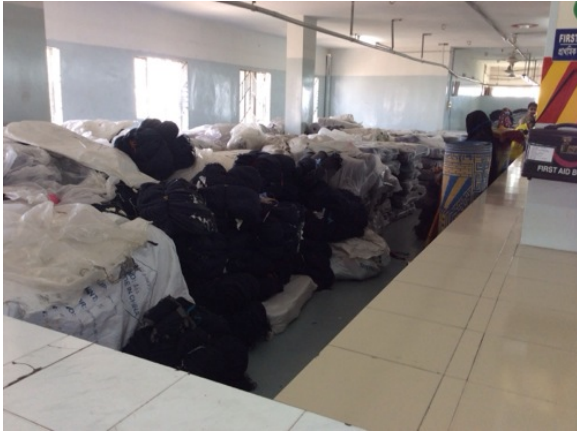
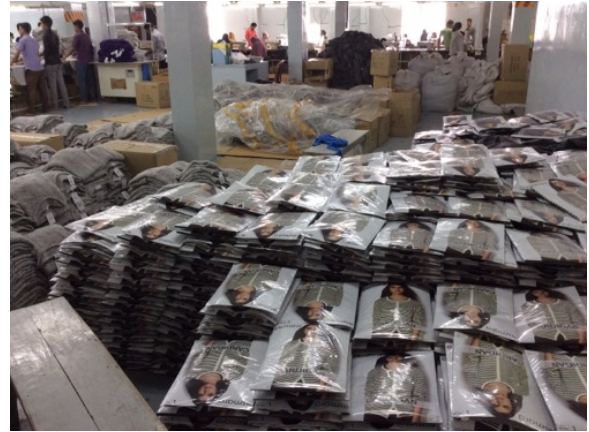
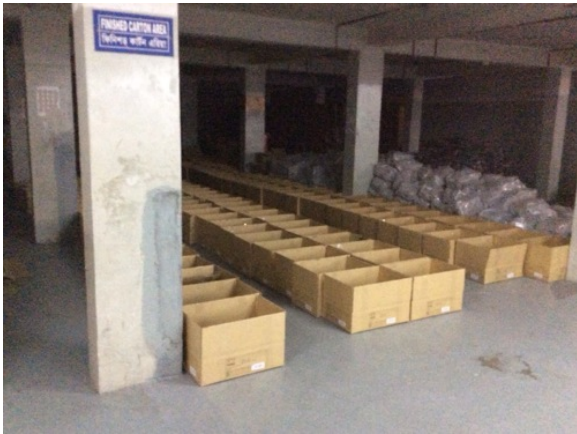
| F-5 | Fire Rated Construction | <p>Areas used for combustible storage are not separated by fire-rated construction.</p> <p>Throughout building.</p> | <p>Provide dedicated storage rooms separated by minimum 1-hr fire-rated construction.</p> <p>Where separate storage rooms are not feasible, provide defined storage areas and limit the storage arrangement as follows:</p> <ul style="list-style-type: none"> <li>- Maximum height of 2.4m and maximum area of 23m<sup>2</sup></li> <li>- If sprinkler protected: maximum height of 3.66m and maximum area of 93m<sup>2</sup></li> </ul> <p>Separate areas of unenclosed combustible storage by a minimum clear distance of 3m.</p> | Within 3 months |

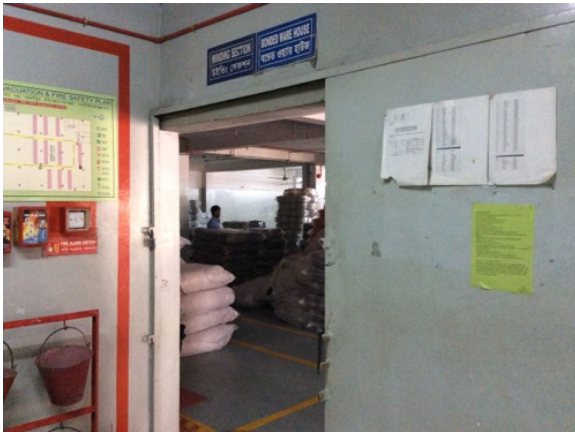
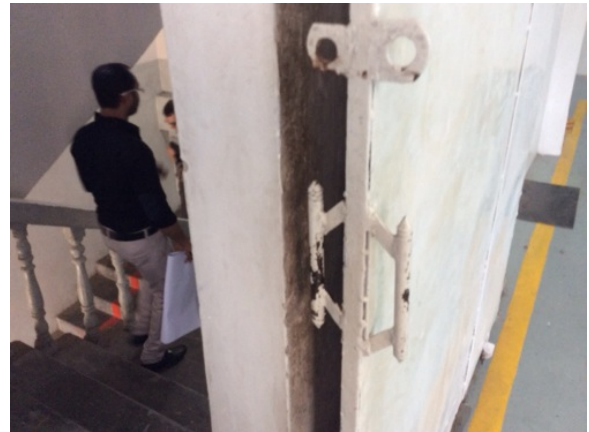
| F-6 | Egress | <p>Egress doors / gates with locking features are provided at building exits, and exit stairs.</p> <p>Pad locks on doors were unlocked and open at time of inspection.</p> | <p>Remove locking features from all egress doors / gates.</p> <p>If locks are required for security reasons, utilize special door locking features complying with NFPA 101.</p> | Immediate |

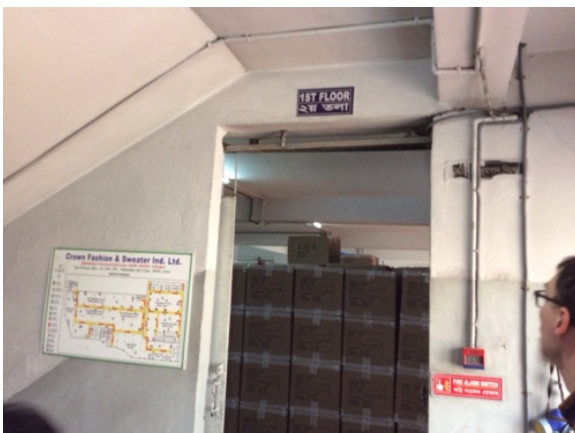
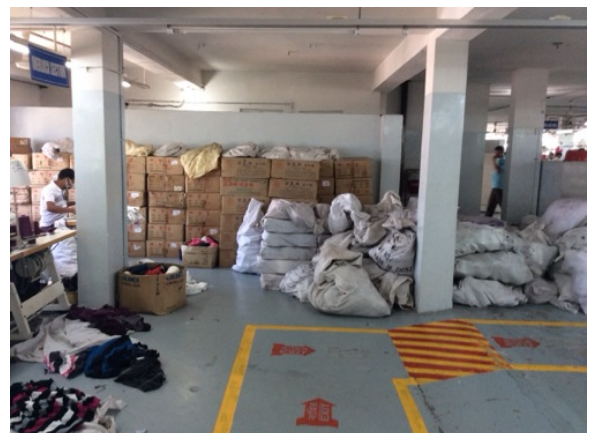
| F-7 | Egress | Storage was located in the egress path. | Keep egress paths and stairs clear of storage. | Immediate |
| | | Several locations throughout building. | | |

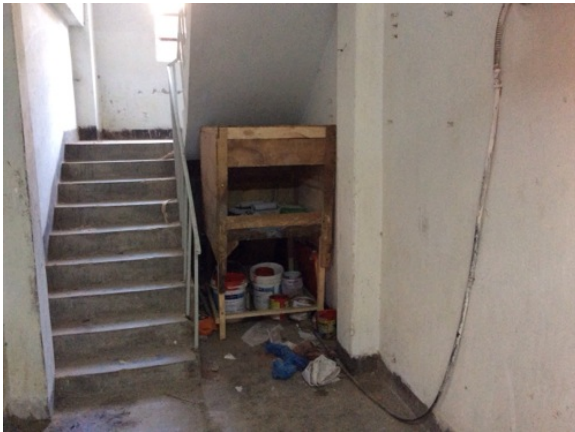
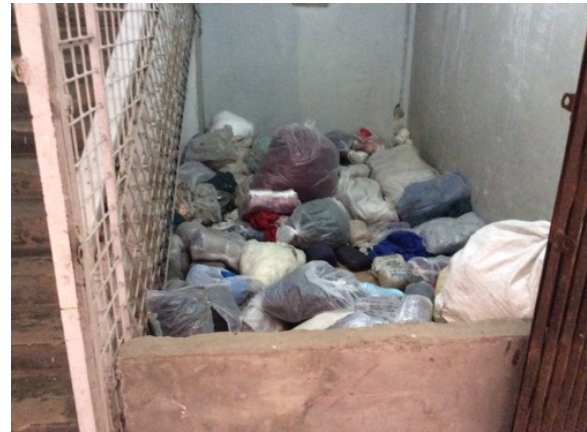
| F-8 | Egress | Storage was located in the exit stair. | Remove all storage from exit stairs and egress paths. | Immediate |
| | | Several locations. | | |

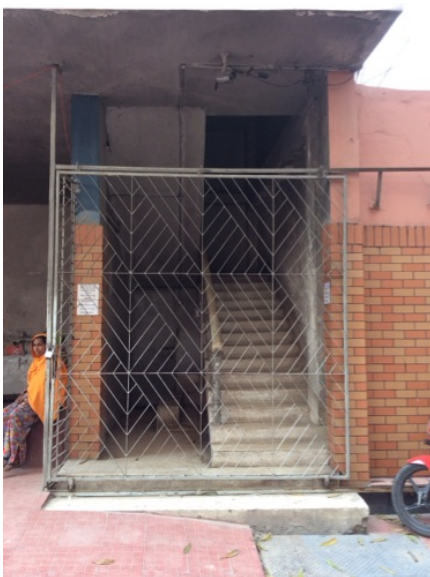
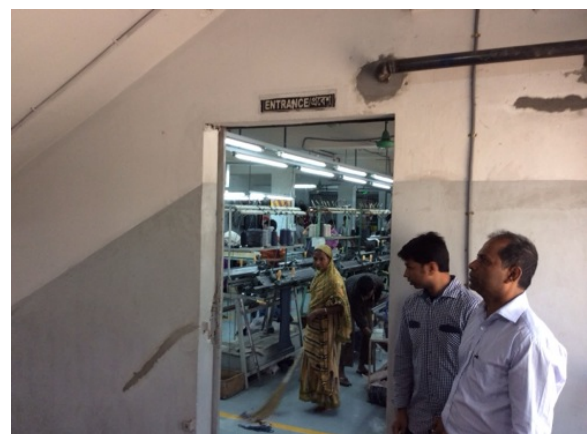
| F-9 | Egress | Collapsible gates / sliding doors are provided at building exits, and exit stairs. | Replace all gates / sliding doors along the means of egress with side-hinged, swinging egress doors. | Within 1 month |

| | | Throughout building. | If locks are required for security reasons, utilize special door locking features complying with NFPA 101. | |

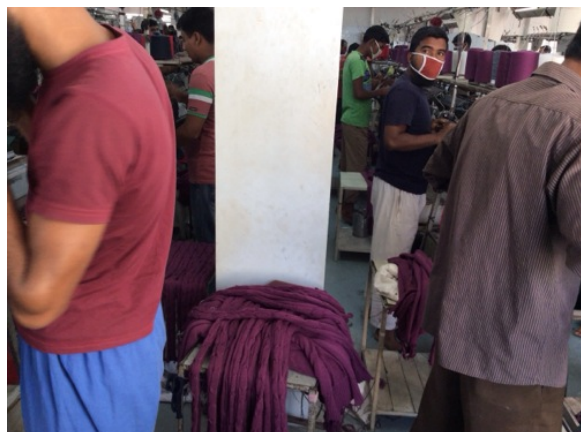
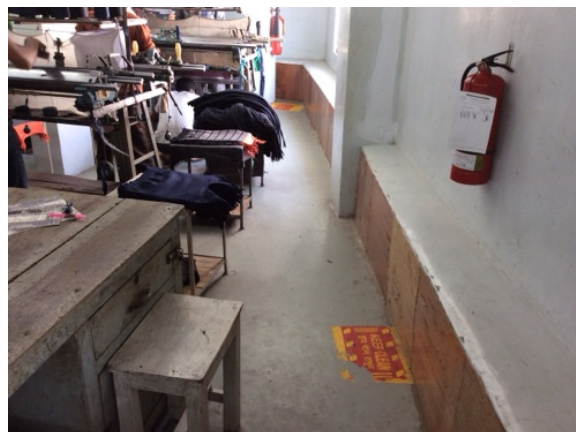
| F-10 | Egress | The width of egress aisles is less than 36-in.<br><br>Throughout building. | Provide minimum aisle widths of 36-in. | Within 3 months |

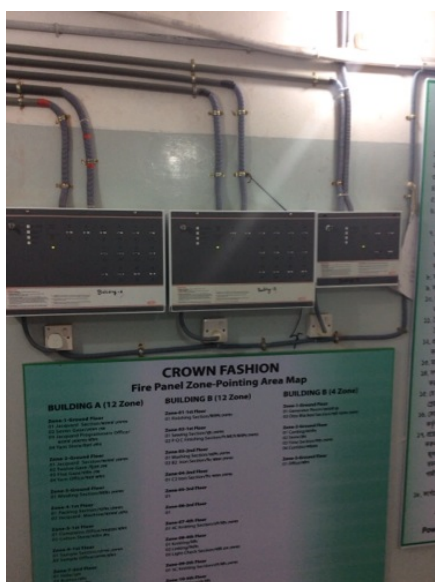
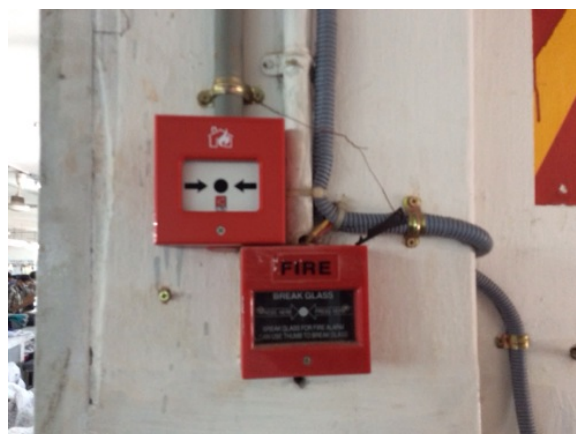
| F-13 | Fire Protection | The fire alarm system is antiquated, not a listed system, and does not provide alarm and notification features consistent with acceptable standards. | Replace the fire alarm system with a new, listed addressable fire alarm system in accordance with NFPA 72. | Design within 4 months, install within 9 months |
