# INITIAL FIRE SAFETY INSPECTION REPORT

**Tanzila Textile Ltd. (Extension)**

**RSC ID: 24938**

**Date: 22 Jan 2024**

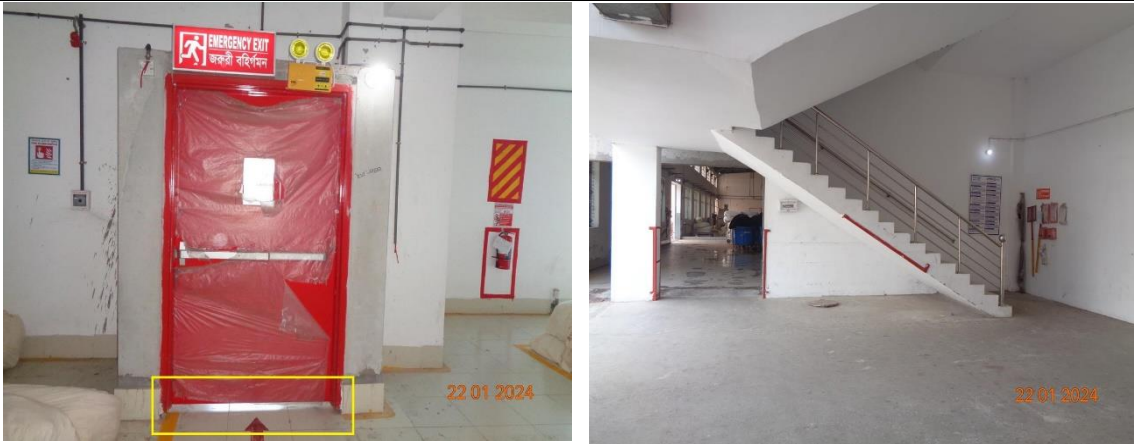
| SI No. | Category | Findings | Required Action | Remediation Time Frame |
|---|---|---|---|---|
| F-1 | Fire Rated Construction | Exit stairs are not separated from work areas & other spaces on each floor by fire-rated construction due to unprotected openings. Fire door has been installed but gap below door was more than 19 mm. <b>Location:</b> Store building. | <p>Separate the exit stairs from work areas and other building spaces on all floor levels by minimum 2- hr fire-rated construction. Provide minimum 1.5- hr fire rated doors and seal all unprotected openings and penetrations to maintain the fire separation.</p> <p>Ensure that all fire doors are self-closing and positive latching, and are provided with fire exit (panic) hardware where serving production floors or assembly occupancies.</p> <p>If fire doors are required to be held open for functional reasons, provide automatic-closing devices tied to the fire alarm system.</p> <p>Once fire doors are installed, every door in a stair enclosure serving more than 5 stories shall be provided with re-entry unless it meets RSC 6.8.3.1.</p> | Within 3 months |

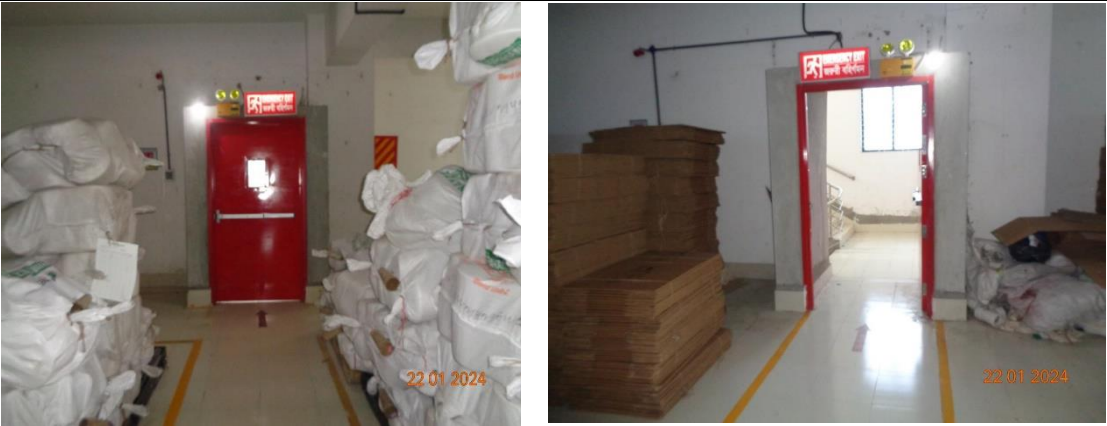
| F-2 | Fire Rated Construction | Room used for combustible storage discharge directly into the exit stair enclosures. <b>Location:</b> Ground, 2nd, 3rd, 4th & 5th floor of Store Building. | Openings from exit enclosure to storage room, generator and hazard spaces shall be provided with a vestibule with fire rated construction and openings. Provide a 1.5 hr. fire rated door on the exit stair side and a 1-hr. fire rated door on the store, generator, substation room side. Ensure that the fire rating of the vestibule construction matches that of the exit stair enclosure. | Within 3 months |

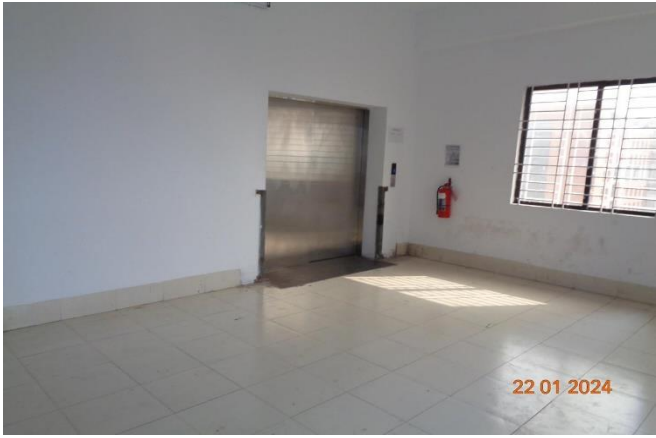
| F-3 | Fire Rated Construction | Elevator shafts are directly open into south exit stair enclosure and inside the floor at Store Building. | <p>For interim construction, elevators shall not open into an exit enclosure as per RSC Standard-6.14.3.</p> <p>So, provide a minimum 2-hr fire rated shaft to separate the lift from each floor and exit stair enclosure.</p> <p>Or, Modify the elevator and stair enclosure arrangement in a way to satisfy RSC standard 6.14.3.</p> | Within 3 months |

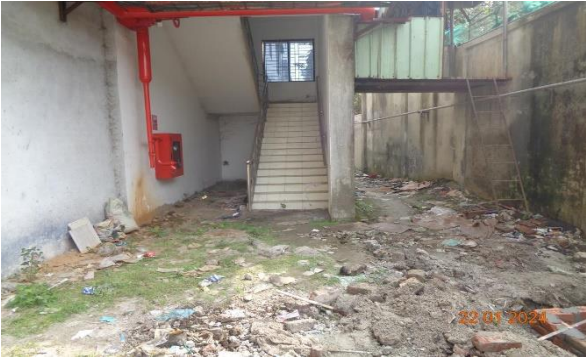
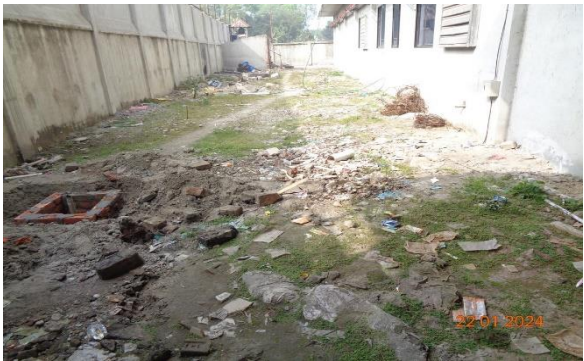
| F-4 | Means of egress | The west side exit discharge path of Store Building is not even and smooth. | Level the exit discharge path to ensure smooth and safe evacuation. | Within 1 month |

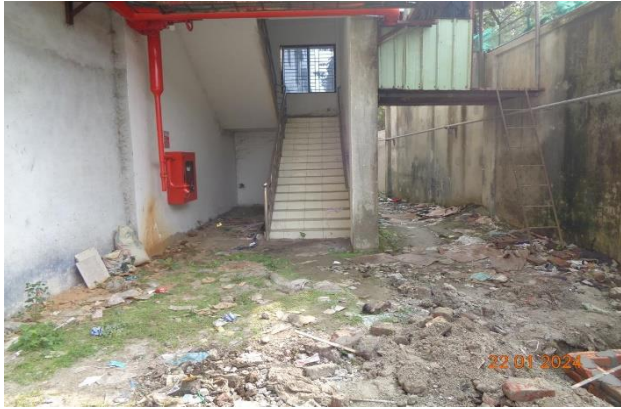
| F-5 | Means of Egress | The width of west stair is found (48 in) less than 60 in. | In interim construction, stairs shall have a minimum width of 1.5 m (60 in.) according to RSC Technical Guidelines (StandardV1.0) section 6.5.6.2.1. Provide minimum stair widths of 1.5 m (60 in). | Within 3 months |

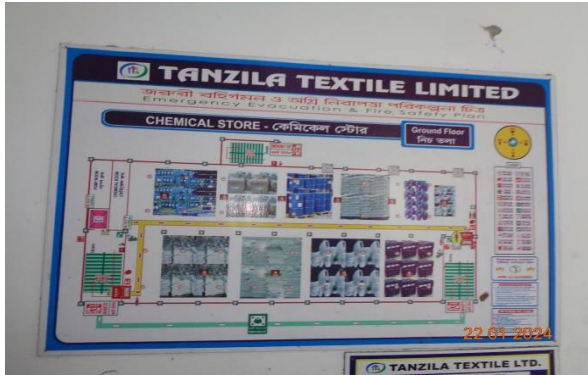
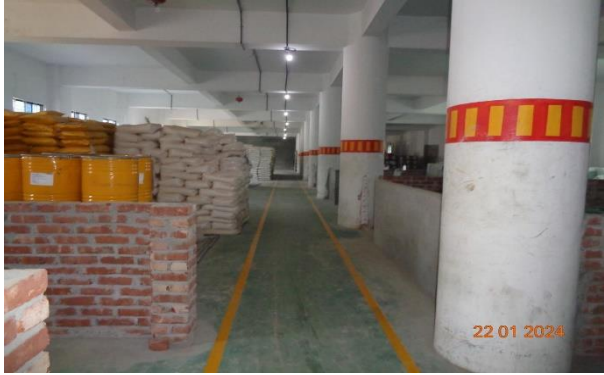
| F-6 | Means of Egress | Common path of egress travel for chemical store exceeds 8m (25ft).<br><b>Location:</b> Ground floor, Store Building. | Reconfigure the egress arrangement to reduce the maximum common path of travel for Group J (high hazard) occupancies to not more than 8m (25ft). | Within 3 months |

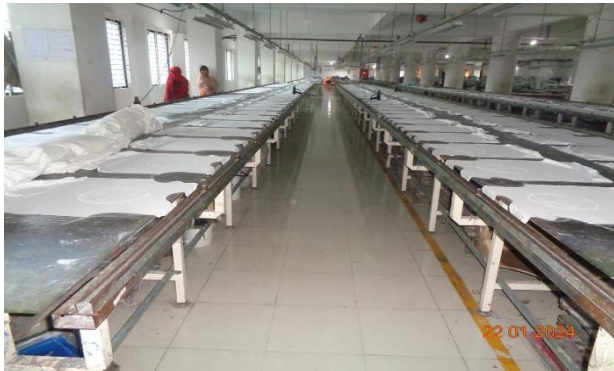
| F-7 | Means of Egress | Aisles marking was missing in 1st floor printing section. | Aisles shall be free and unobstructed and clearly marked with a minimum clear-width of 0.9 m (36 in.). | Within 1 month |

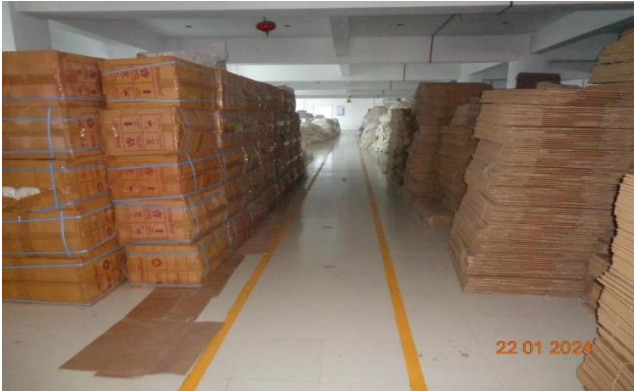
| F-10 | Egress Lighting | Based on the number and location of emergency lights observed, adequate illumination levels are not anticipated along egress routes. | Test the emergency lighting system on each floor and provide additional emergency fixtures to provide adequate illumination along the means of egress. Provide a minimum illumination of 10 lux at the floor level within exit stairs and exit discharge paths and minimum 2.5 lux along exit access aisles. | Within 1 month |

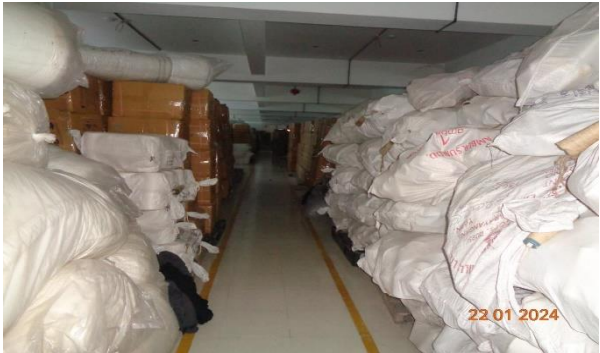
| F-11 | Egress Lighting | Directional signs are not provided where direction of the path of travel to an exit has changed. | Illuminated directional signs shall be provided where there is a change in the direction for the path of travel and the direction to an exit is not obvious. | Within 1 month |

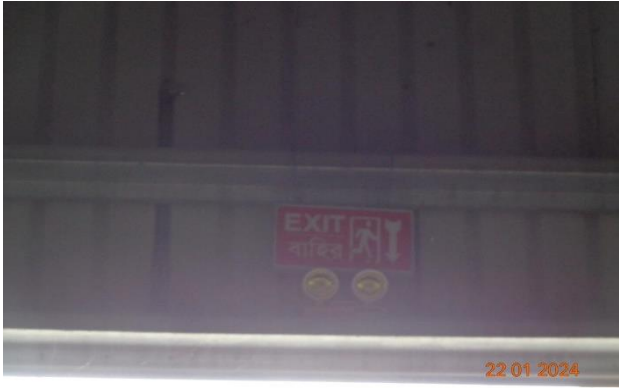
| F-12 | Egress Lighting | Exit signage was not illuminated at Knitting shed. | Regularly inspect all exit signage and replace/install lights as needed to illuminate signs. | Within 1 month |

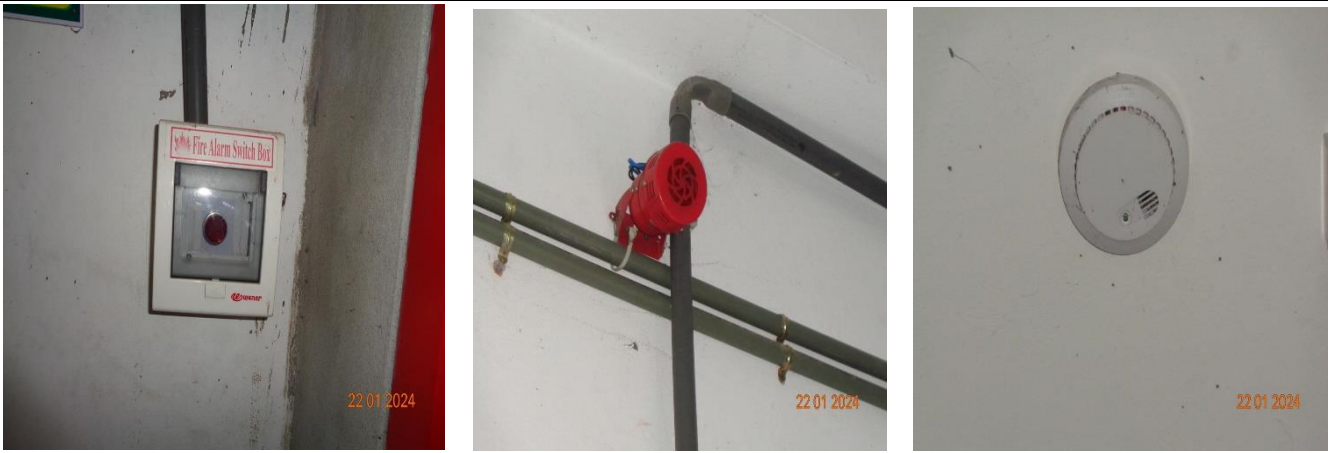
| F-15 | Fire Alarm and Detection System (FADS) | The fire alarm system is antiquated, not a listed system, and does not provide alarm and notification features consistent with acceptable standards. | Replace the fire alarm system with a new, listed addressable fire alarm system in accordance with NFPA 72. | Design-within 2 months.<br>Installation-within 6 months. |

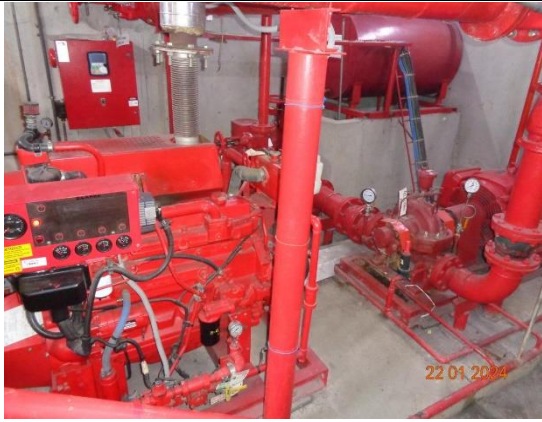
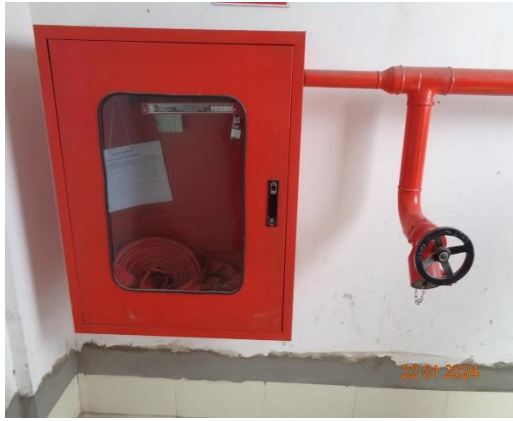
| F-18 | Fire Protection System (SUPS) | Water supply & standpipe system installation requires detailed review to confirm compliance with NFPA 14, 22, 25 and relevant standards.<br><b>Location:</b> Store Building. | Submit drawings, testing records, equipment certification and other relevant documentation to the RSC for review and approval. Installation and/or modification shall have to be done as per the reviewed design and standards. | Design- within 1 Month<br>Modification if required- within 3 Months |
