FIRE SAFETY INSPECTION REPORT

SAAD SAAN APPARELS LTD.

ACCORD ID: 12398

JAMIRDIA, VALUKA, MYMENSINGH, BANGLADESH.

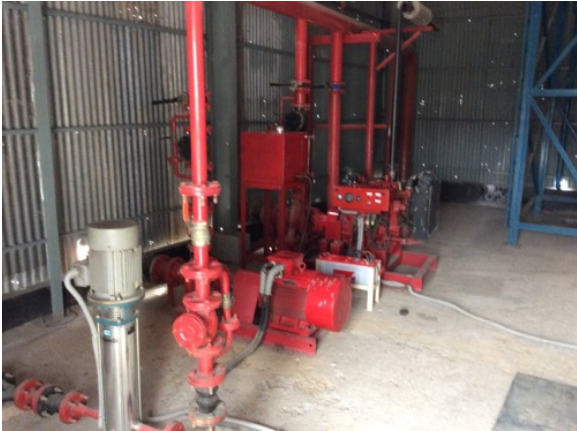
No.	Category	Finding	Recommendation	Remediation Timeframe
F-1	Fire Rated Construction	The fire pump room is not provided with adequate fire separation.	Provide fire pump room with 2 hr rated fire separation when not sprinklered and 1 hr rated fire separation when provided with automatic sprinklers, in accordance with NFPA 20.	Within 3 months

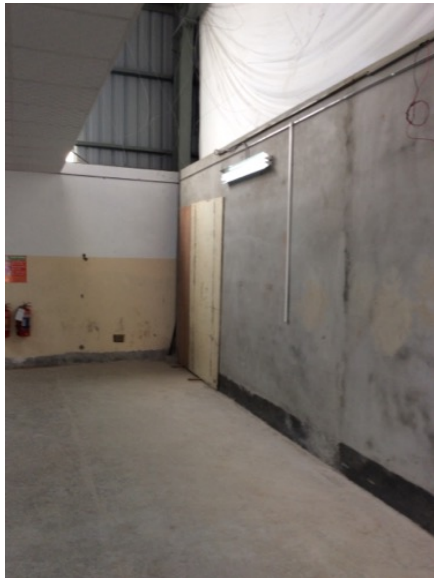
F-2	Fire Rated Construction	Rooms used for combustible storage are not separated form work area by a minimum 1-hr fire-rated construction.	Provide dedicated storage rooms separated by minimum 1-hr fire-rated construction.	Within 3 months

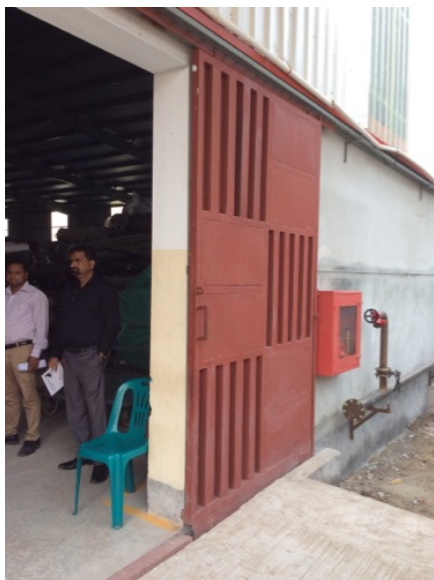
F-3 Egress

Sliding doors are provided at building exits

Replace all gates and sliding doors along the means of egress with side-hinged, swinging egress doors in accordance with ACCORD standard 6.8.1.

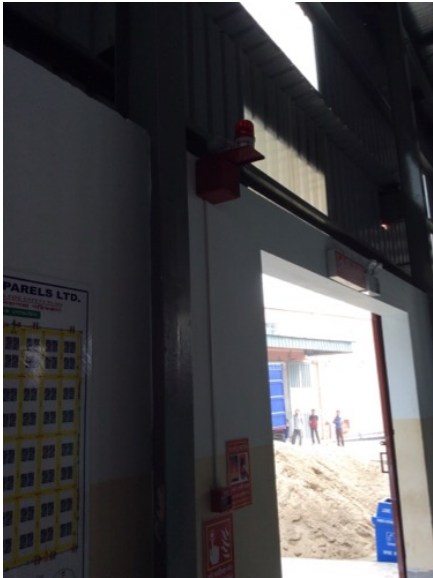
F-4	Fire Protection	The fire alarm system is antiquated, not a listed system and does not provide alarm and notification features consistent with acceptable standards.	Replace the fire alarm system with a new, listed automatic fire alarm system in accordance with NFPA 72 and ACCORD standards.	Design within 4 months, install within 9 months

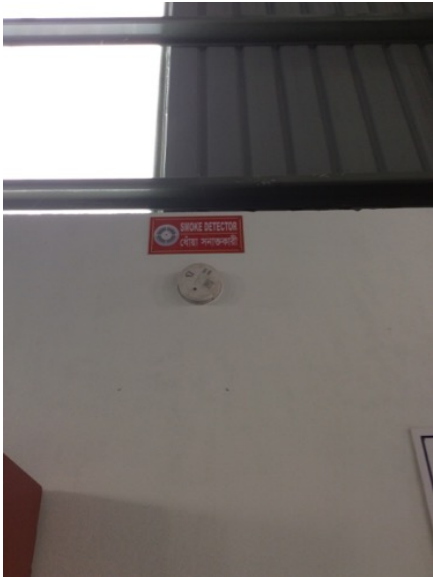
F-8	Fire Protection	Inspection, testing and maintenance of the standpipe system is not in accordance with NFPA 14.	Inspect, test and maintain the standpipe system and keep written records on-site, in accordance with NFPA 14 and ACCORD standards.	Within 3 months
F-9	Fire Protection	The building is equipped with single-station smoke alarms. Smoke alarm activation sounds only a local alarm and does not provide automatic fire alarm notification of occupants.	Remove single-station smoke alarms. Provide automatic smoke detection throughout the building, tied into the fire alarm system, in accordance with NFPA 72 and ACCORD standards.	Within 9 months
