# **FIRE SAFETY INSPECTION REPORT**

**PROSTAR APPARELS LTD.**

**ACCORD ID: 12223**

**POTKA, SREEPUR (MAWNA), GAZIPUR.**

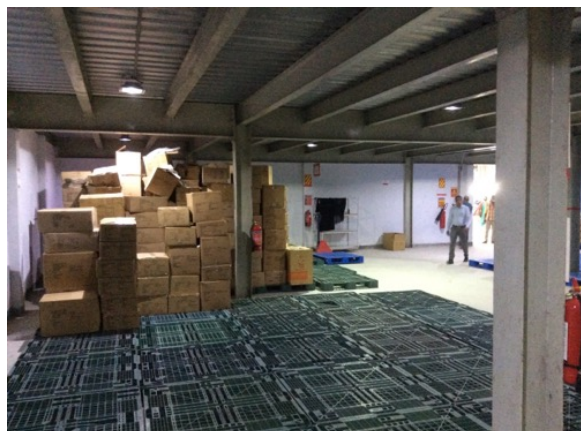
No.	Category	Finding	Recommendation	Remediation Timeframe
F-1	Fire Rated Construction	Rooms used for combustible storage on the ground floor are not separated by a minimum 1-hr fire-rated construction.	<p>Provide dedicated storage rooms separated by minimum 1-hr fire-rated construction.</p> <p>Where separate storage rooms are not feasible, provide defined storage areas and limit the storage arrangement as follows:</p> <ul style="list-style-type: none"> <li>- Maximum height of 2.45m (8 ft) and maximum area of 23m<sup>2</sup> (250 ft<sup>2</sup>)</li> <li>- If sprinkler protected: maximum height of 3.66m (12 ft) and maximum area of 93m<sup>2</sup> (1000 ft<sup>2</sup>)</li> </ul> <p>Separate areas of unenclosed combustible storage by a minimum clear distance of 3m (10ft).</p>	Within 3 months

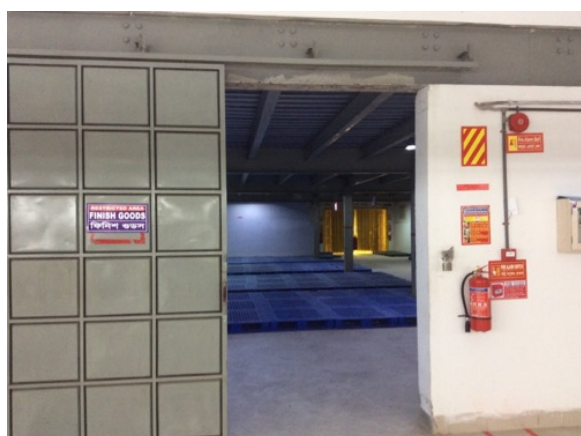
F-2	Egress	Egress doors and gates throughout the building with locking features are provided at building exits and exit discharge.	Remove locking features from all egress doors and gates.  If locks are required for security reasons, utilize special door locking features complying with ACCORD standard 6.8.2.	Immediately
-----	--------	---	---	-------------

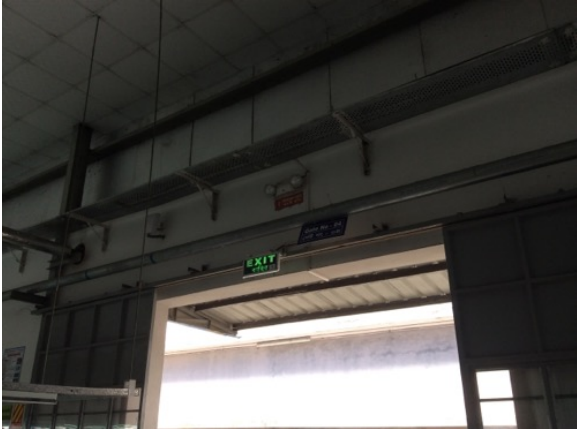
F-3	Egress	Collapsible gates and sliding doors throughout the building are provided at building exits and exit discharge.	Replace all gates and sliding doors along the means of egress with side-hinged, swinging egress doors in accordance with ACCORD standard 6.8.1.	Within 1 month
