# **FIRE SAFETY INSPECTION REPORT**

**M.I.M. FASHION WEAR LTD.**

**ACCORD ID: 12288**

October 18, 2015

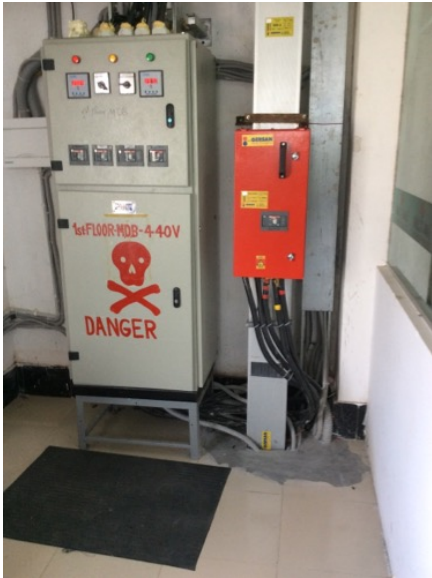
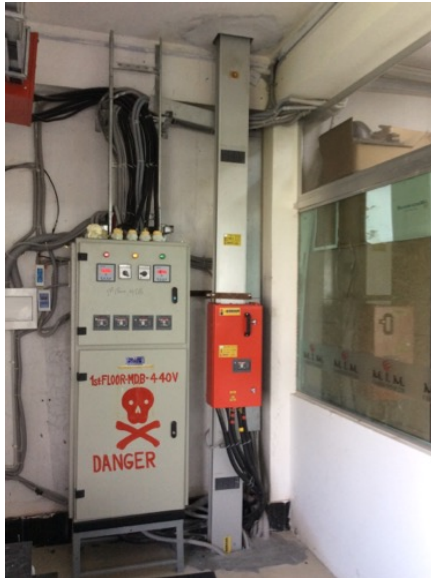
| No. | Category | Finding | Recommendation | Remediation Timeframe |
|---|---|---|---|---|
| F-1 | Fire Rated Construction | Unsealed electrical shafts are located in the fire-rated floor of 1st floor. | Provide a minimum 2-hr fire-rated shaft to separate the utility risers from each floor level and seal all penetrations in floor/ceiling assemblies to maintain the fire separation. | Within 3 months |

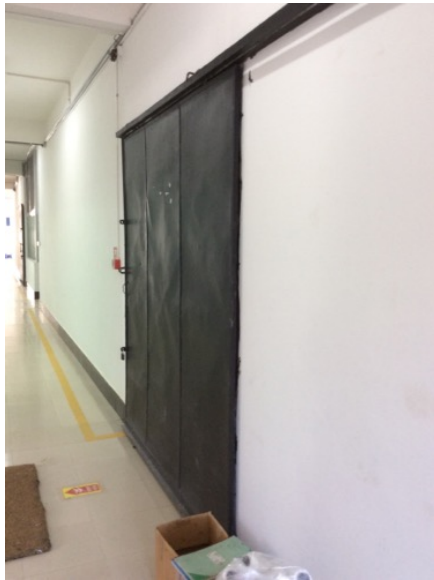
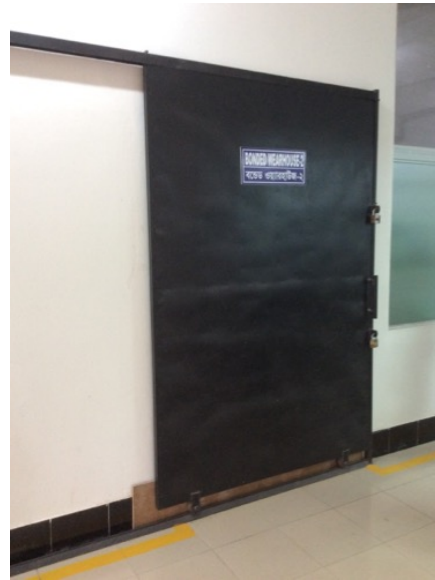
| No. | Category | Finding | Recommendation | Remediation Timeframe |
|---|---|---|---|---|
| F-2 | Fire Rated Construction | Rooms used for combustible storage on ground floor are not separated by a minimum 1-hr fire-rated construction. | Provide dedicated storage rooms separated by minimum 1-hr fire-rated construction. | Within 3 months |

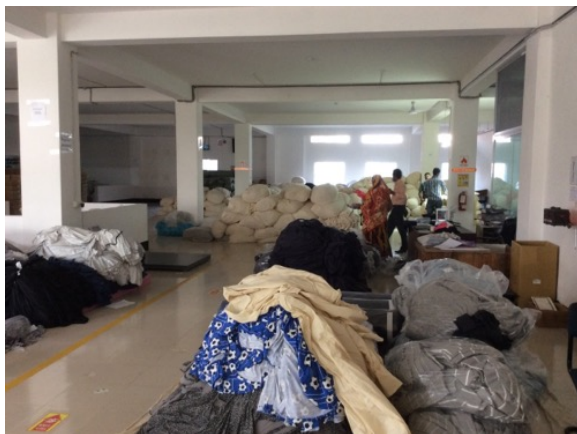
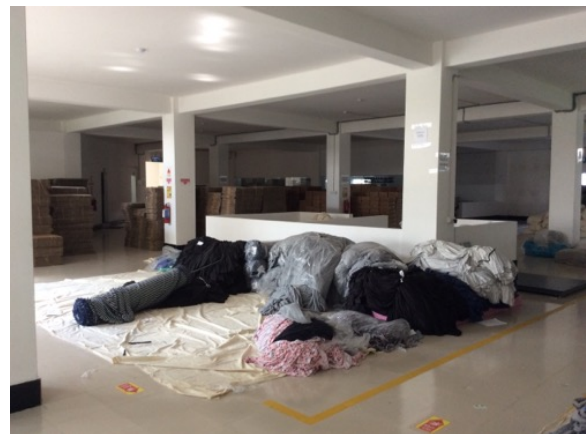
| F-3 | Fire Rated Construction | Areas used for combustible storage on ground floor open to the factory are not properly defined and/or not within limits. | Provide defined storage areas and limit the storage arrangement as follows:<br>- Maximum height of 2.45m (8 ft) and maximum area of 23m <sup>2</sup> (250 ft <sup>2</sup> )<br><br>Separate areas of unenclosed combustible storage by a minimum clear distance of 3m (10 ft). | Within 3 months |

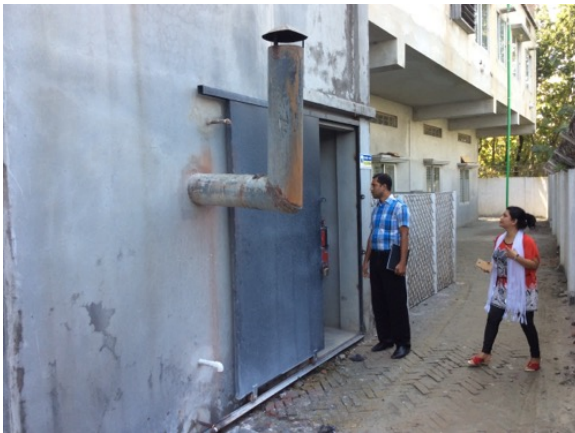
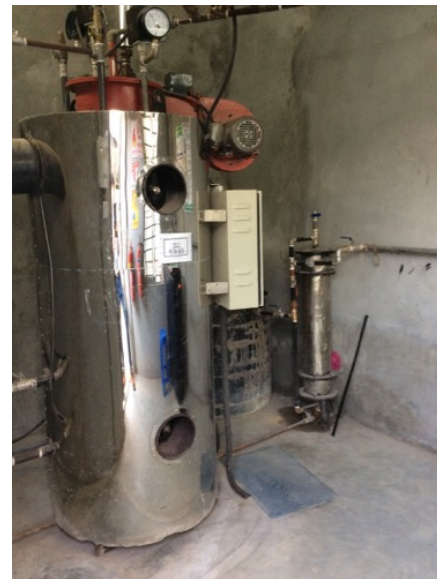
| F-4 | Fire Rated Construction | The boiler room is not separated by fire-rated construction due to non-rated door. | Separate the boiler room by a minimum 1-hr fire-rated construction for non-high rise. Seal and/or protect all openings to maintain the required fire separations. Provide proper ventilation and consult a qualified engineer. | Within 3 months |

When located to the exterior of a building, separate the boiler by a minimum distance of 3m (10 ft).

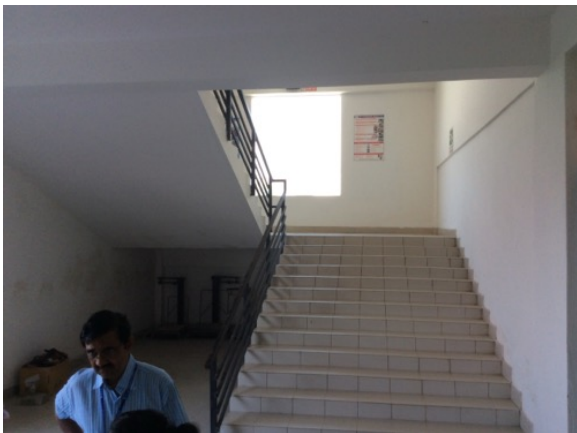
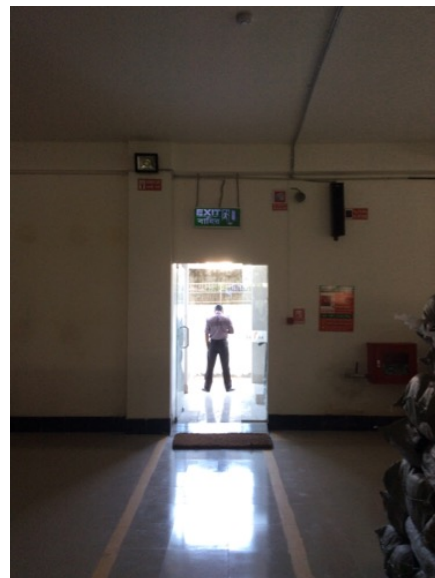
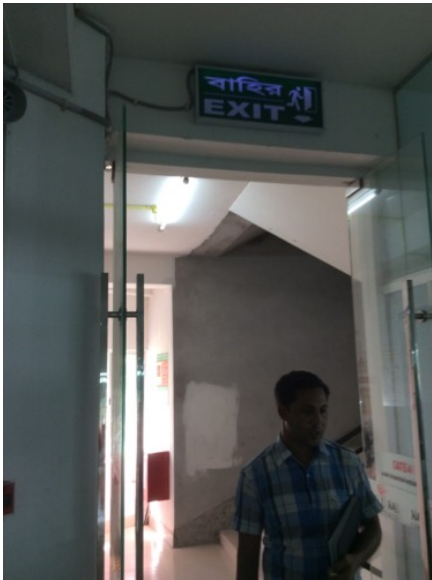
| F-5 | Fire Rated Construction | <p>All exit stairs are not separated from work areas and other spaces on each floor by fire-rated construction due to unprotected openings and penetrations.</p> <p>This finding is based on current construction plans. If building plans change and do not exceed 3 floors total fire ratings in the recommendation can be changed to 1-hr.</p> | <p>Separate the exit stairs from from work areas and other building spaces on all floor levels by minimum 2-hr fire-rated construction. Provide minimum 1.5-hr fire rated doors and seal all unprotected openings and penetrations to maintain the fire separation.</p> <p>Ensure that all fire doors are self-closing and positive latching, and are provided with fire exit (panic) hardware where serving production floors or assembly occupancies. If fire doors are required to be held open for functional reasons, provide automatic-closing devices tied to the fire alarm system.</p> <p>Once fire doors are installed, every door in a stair enclosure serving more than 5 stories shall be provided with re-entry unless it meets ACCORD standard 6.8.3.1.</p> | Within 3 months |

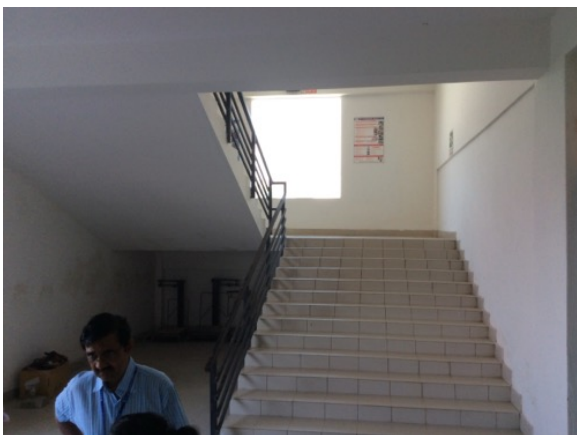
| F-6 | Egress | Handrails are not provided on both sides of the all exit stairs. | Provide handrails on both sides of the exit stair. New handrails shall have a minimum height of 865 mm (34 in.) and a maximum height of 965 mm (38 in.) as measured from the leading edge of the tread. Intermediate handrails shall be provided when the stair width exceeds 2.2 m (87 in.) . | Within 3 months |

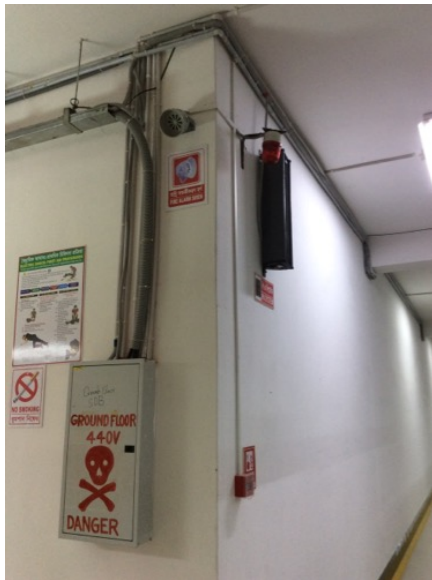
| F-7 | Fire Protection | The fire alarm system is antiquated, not a listed system and does not provide alarm and notification features consistent with acceptable standards. | Replace the fire alarm system with a new, listed automatic fire alarm system in accordance with NFPA 72 and ACCORD standards. | Design within 4 months, install within 9 months |

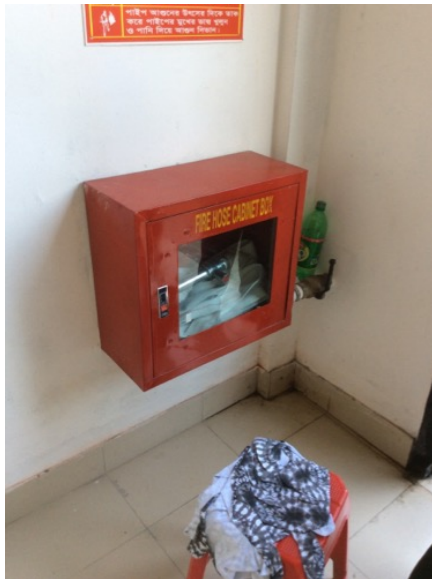
| F-12 | Fire Protection | Standpipe system is required for the building, which has an occupiable floor 10 m (33 ft) or more above grade.<br><br>This is required upon completion of construction. | Install a new class III standpipe system in accordance with ACCORD standard 5.4 and NFPA 14. A class I system shall be permitted in buildings protected throughout by an approved automatic sprinkler system. | Within 6 months |

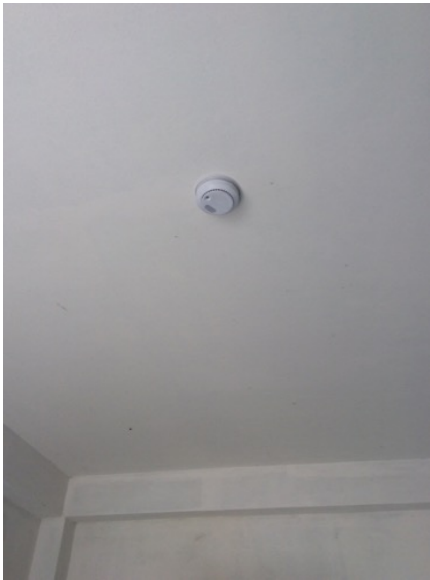
| F-13 | Fire Protection | The building is equipped with single-station smoke alarms. Smoke alarm activation sounds only a local alarm and does not provide automatic fire alarm notification of occupants. | Remove single-station smoke alarms. Provide automatic smoke detection throughout the building, tied into the fire alarm system, in accordance with NFPA 72 and ACCORD standards. | Within 9 months |
