# INITIAL FIRE SAFETY INSPECTION REPORT

**Mac-Tex Industries Ltd.**

**RSC ID: 25601**

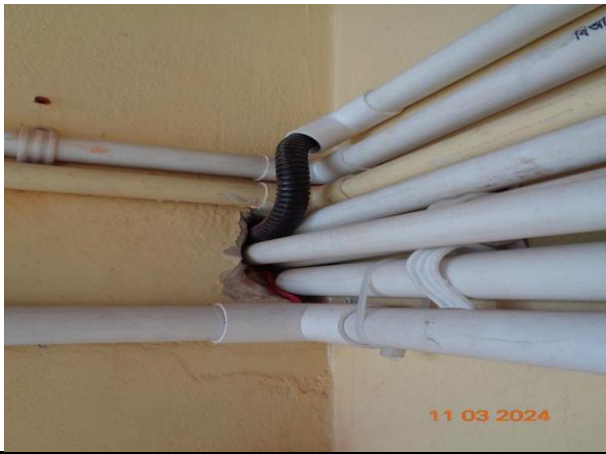
| SI No. | Category | Findings | Required Action | Remediation Time Frame |
|---|---|---|---|---|
| F-1 | Fire Rated Construction | Unsealed penetrations and openings are located in exit stair enclosure.<br>Location- Building-1_Stair-2 | Seal all penetrations and openings in floor/ceiling assemblies to maintain the fire separation at least by 3-hr. The used sealer shall be 3rd party certified and installation shall be as per manufacturer's datasheet. | Within 3 months |

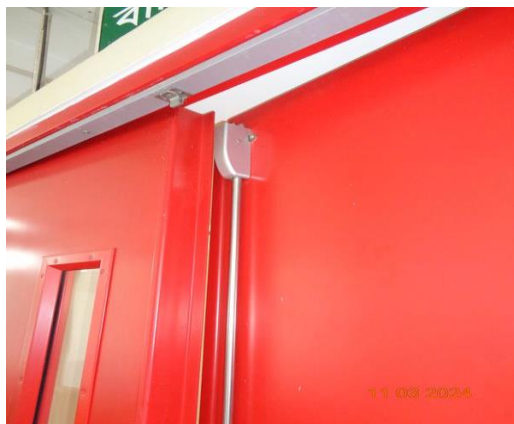
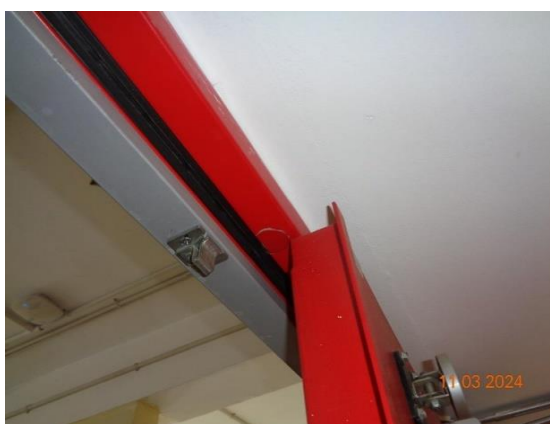
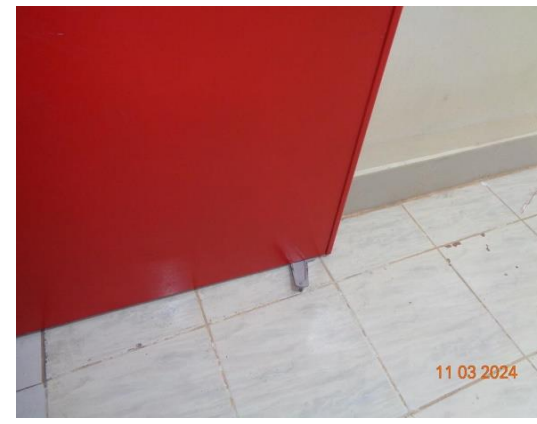
| F-2 | Fire Rated Construction | <p>The exit stairs are not separated from work areas, other spaces on each floor by fire-rated construction due to following issues</p> <p>1- Hardware of the Fire rated door has been found non functional.</p> <p>2- Fire Rated door has been found kept open manually so that the separation has not been ensured.</p> <p><b>Location:</b> B-1 (Stair-1 and 2)</p> | <p>Provide minimum 2-hr fire rated construction for buildings 4 storied or more and 1-hr for up to 3 storied. Seal all unprotected openings to separate the exit stairs from work areas and other spaces on all floor levels by 90 minutes for 2 hr. construction and 60 minutes for 1-hr construction.</p> <p>Ensure that the fire rated doors are self-closing and positive latching and that they are provided with fire exit (panic) hardware where serving production floors. If fire rated doors are required to be held open for functional reasons, provide automatic closing devices tied to the fire alarm system.</p> <p>Factory shall ensure the integrity of the fire rated door through accurate datasheet, 3rd party certificate and listing labeling.</p> | Within 3 months |

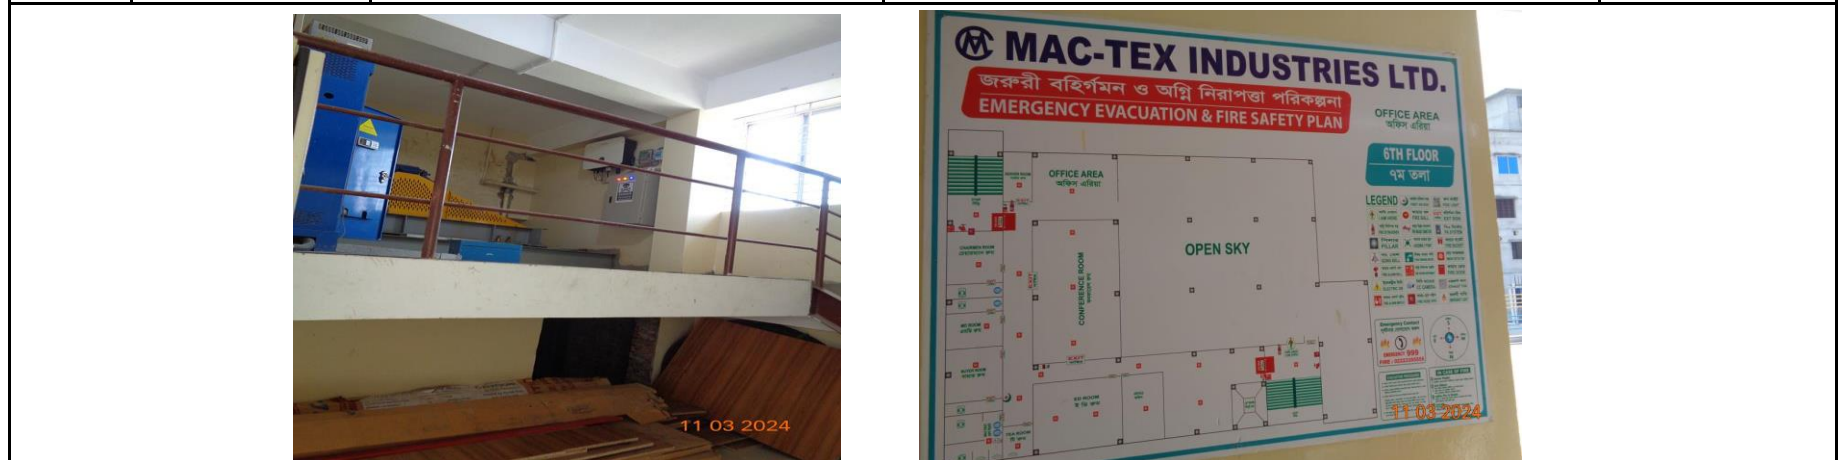
| F-3 | Fire Rated Construction | <p>Elevator shafts are directly open into production floor without proper fire separation (Doors are not fire rated).</p> <p>Location: Building 1_6th Floor</p> | <p>Ensure a minimum 1.5-hr fire rating for the doors of elevator shafts otherwise close the shafts area with a 2-hr fire-rated construction barrier and 1.5-hr fire-rated doors.</p> | Within 3 months |

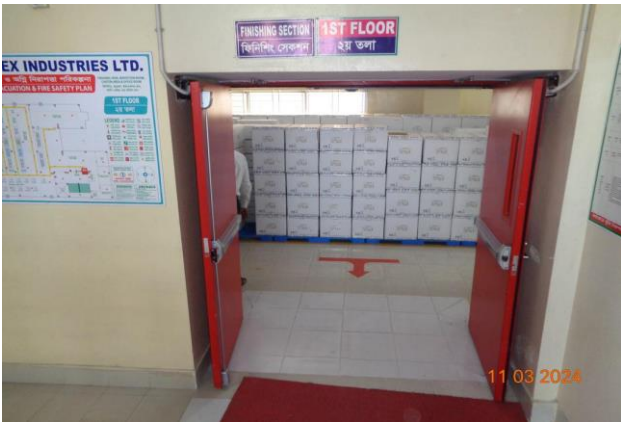
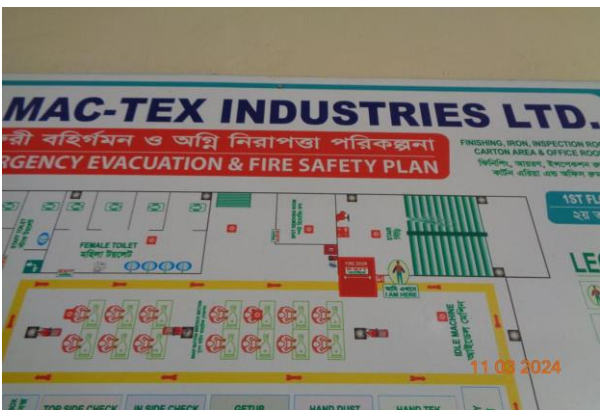
| F-4 | Fire Rated Construction | <p>Storage room discharges directly into exit stair enclosure.</p> <p>Location: Ground and 5th Floor.</p> | <p>Openings from exit enclosure to storage room, shall be provided with a vestibule with fire rated construction and openings.</p> <p>Provide a 1.5 hr. fire rated door on the exit stair side and a 1-hr. fire rated door on the store side. Ensure that the fire rating of the vestibule construction matches that of the exit stair enclosure. [6.14.3 of RSC Technical Guidelines Standard]</p> | Within 3 months |

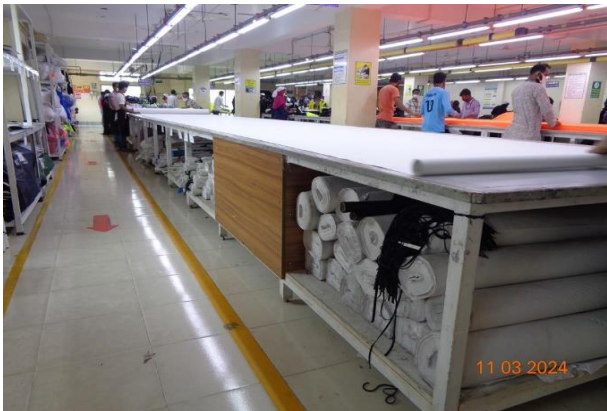
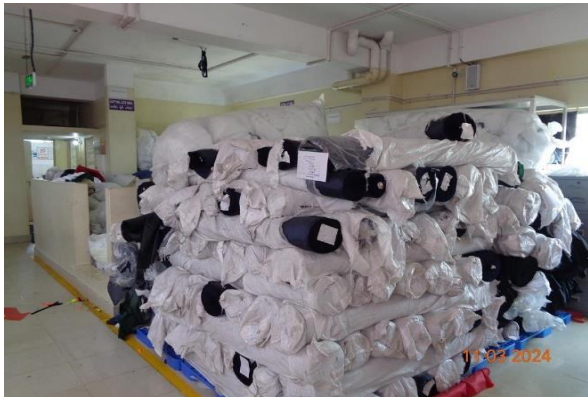
| F-5 | Fire Rated Construction | <p>Areas used for in-process storage of combustible materials are open to the surrounding occupancy. Moreover, materials have been found under the cutting table.</p> <p><b>Location:</b> 1st and 5th floor of Building-1</p> | <p>Provide defined storage areas and limit the storage arrangement as follows: -</p> <ol style="list-style-type: none"> <li>1. General Condition: Maximum height of 2.4m and maximum area of 23m<sup>2</sup>. Separate areas of unenclosed combustible storage by a minimum clear distance of 3m.</li> <li>2. If sprinkler protected: maximum height of 3.66m and maximum area of 93m<sup>2</sup>. Separate areas of unenclosed combustible storage by a minimum clear distance of 3m.</li> </ol> <p>or</p> <ol style="list-style-type: none"> <li>3. Enclose the storage area from the surrounding occupancy with a minimum 1-hour construction.</li> </ol> <p>Also remove storage from under the cutting table</p> | Within 3 months |

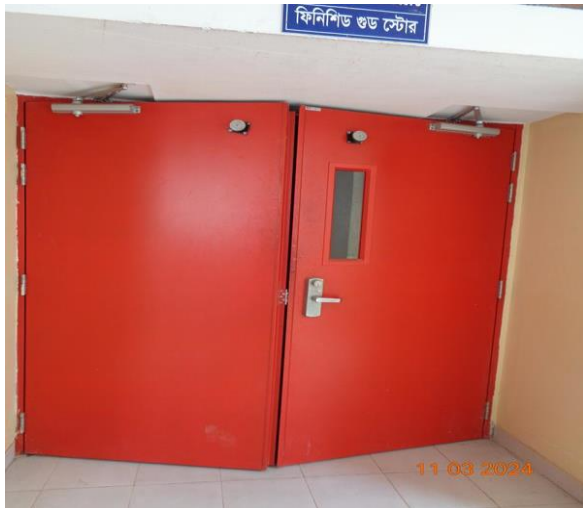
| F-6 | Fire Rated Construction | <p>Room used for combustible storage are not separated from production area by fire rated construction. Hardware of the fire rated door has been found non functional.</p> <p><b>Location:</b> Ground Floor.</p> | <p>Separate the storage room by a minimum 1- hr. fire-rated construction. Seal and/or protected all openings to maintain the required fire separations.</p> <p>Ensure that all hardware and accessories of the fire rated door are functional properly.</p> | Within 3 months |

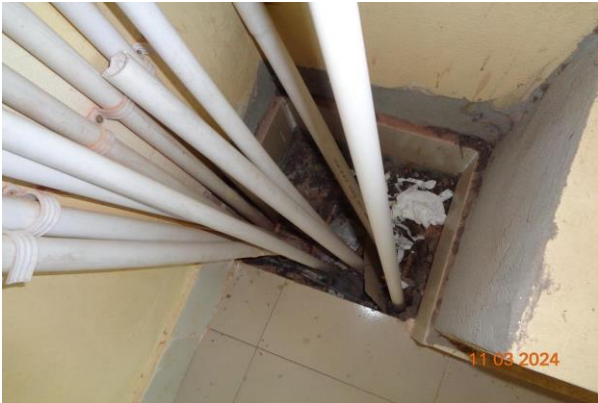
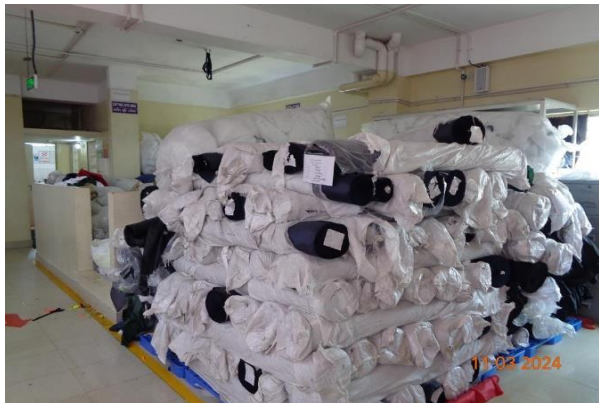
| F-7 | Fire Rated Construction | <p>Penetrations due to Plumbing pipes and BBT through floor/ceiling assemblies are found unsealed.</p> <p><b>Location(s):</b> Building-1</p> | <p>Seal all penetrations and openings in floor/ceiling (full thickness of the floor/ceiling) assemblies by fire rated materials to maintain the fire resistance rating of 3 hr. Prior to install any type of passive fire protection system (Collar, sealant, etc.), submit all datasheet, certificate, UL drawing to RSC for review.</p> | Within 3 months |

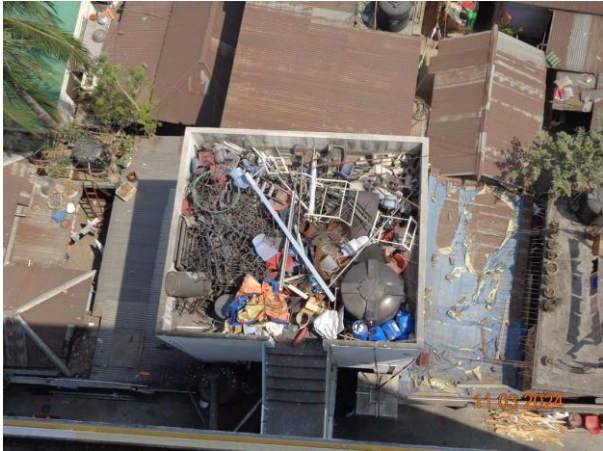
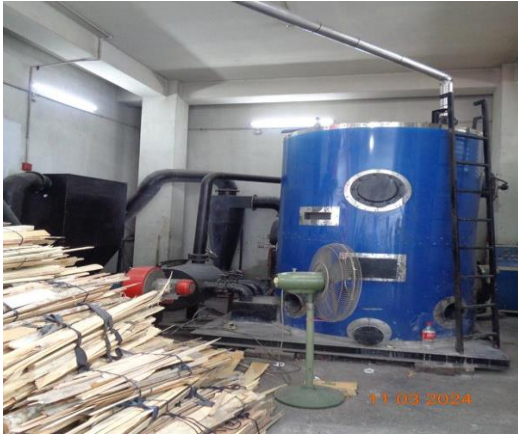
| F-8 | Fire Rated Construction | <p>Adjacent residential building has been found within 3 feet from the exterior of the Boiler building.</p> <p>Location: South side of the Building-1 and Boiler Building.</p> | Exterior wall of the factory requires 1 Hr. separation from the residential building as per Table 3.2.2 of BNBC-2006 (Part-3). | Within 3 months |

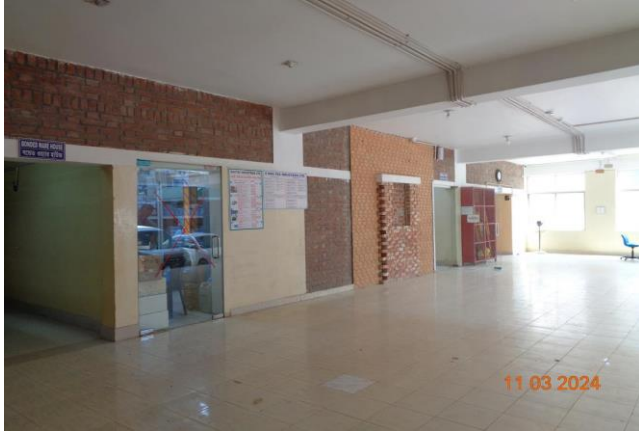
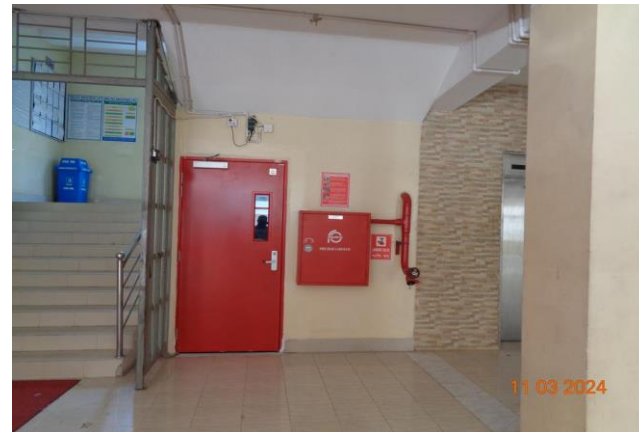
| F-9 | Fire Rated Construction | The interior exit stair discharges inside the building in the ground floor (Stair-1). | <p>A maximum of 50 percent of the number and capacity of the exit enclosures can discharge through areas on the level of exit discharge where all of the following are met:</p> <p>(1) Automatic sprinkler protection is provided throughout the level of exit discharge or portion of the level of discharge where separated from non sprinklered portions of the floor by fire barriers with the same fire resistance rating as the exit enclosure.</p> <p>(2) The interior discharge is not through a storage or hazardous occupancy.</p> <p>(3) The entire area of the level of exit discharge is separated from areas below by construction having a fire resistance rating not less than that required for the exit enclosure.</p> <p>(4) The way to the exterior shall be free and unobstructed and shall be readily visible and identifiable from the point of discharge of the interior exit.</p> <p>Or</p> <p>Re arrange the discharge direct to the outside.</p> | Within 3 months |

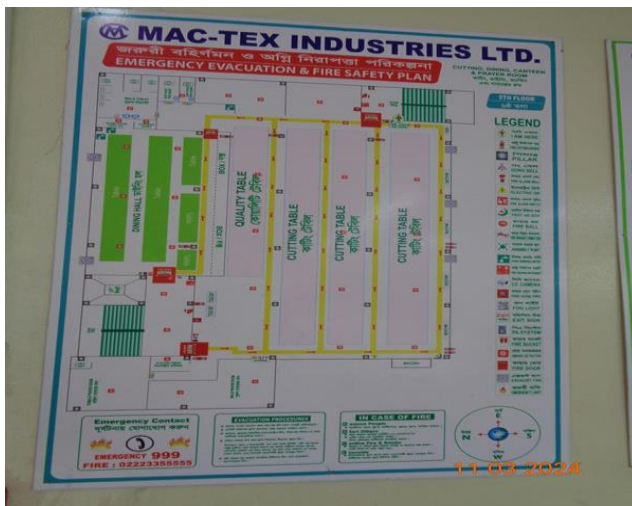
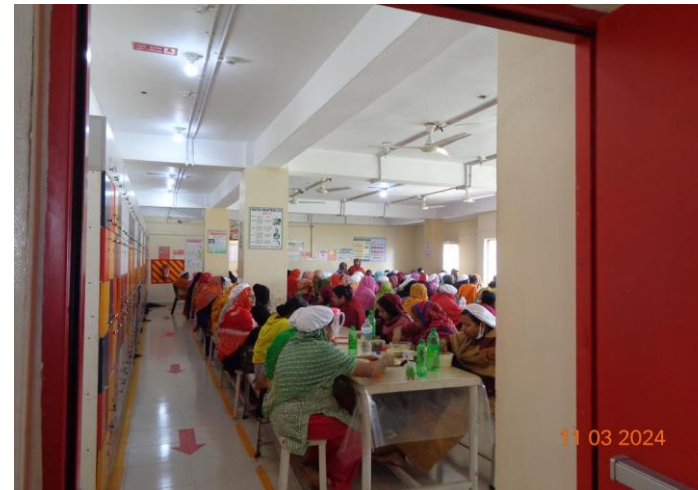
| F-10 | Fire Rated Construction | <p>Dining located on 5th Floor (Capacity of 100 approx.) did not have 2 no's direct exit.</p> <p>Location; building-1</p> | <p>Dining shall be separated from production area by minimum 3 Hr. rated separation. Seal and/or protect all openings to maintain the required fire separation.</p> <p>Assemblies of Occupancy E3, E4 and E5 shall have at least two means of exits leading directly to the street or leading to a corridor or open space having access to exits in two independent and different direction. (3.21.3-BNBC-2006).</p> | Within 1 month |

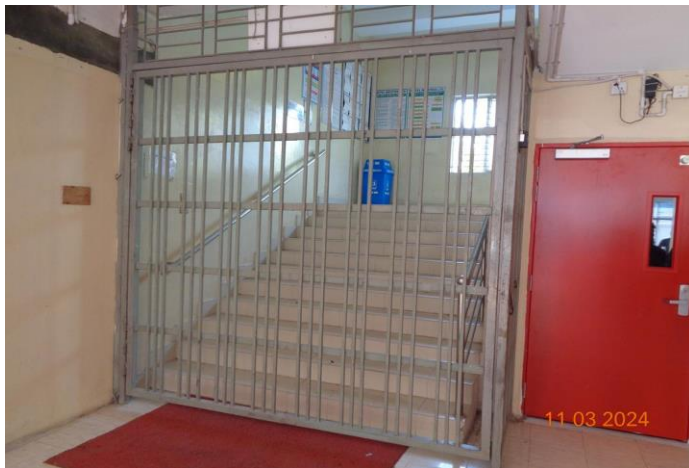
| F-11 | Means of Egress | <p>Sewing type door has been found on the exit discharge where it is possible to lock the gate manually.</p> <p>Location: Building 1 (Stair-1 and 2)</p> | <p>Ensure that all provision to lock the sewing type door has been removed.</p> <p>Or</p> <p>Replace the door by a specialized sewing type door where locking features complying with NFPA101.</p> | Within 1 month |

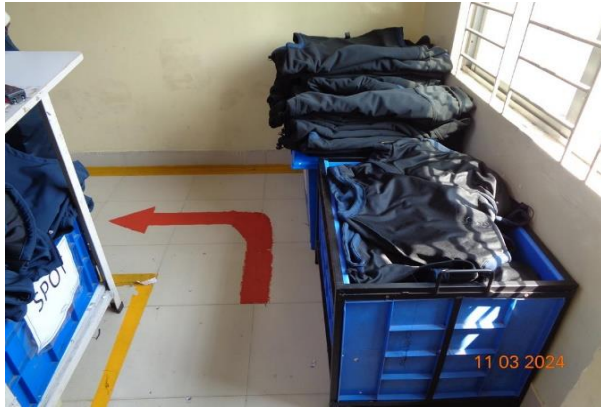
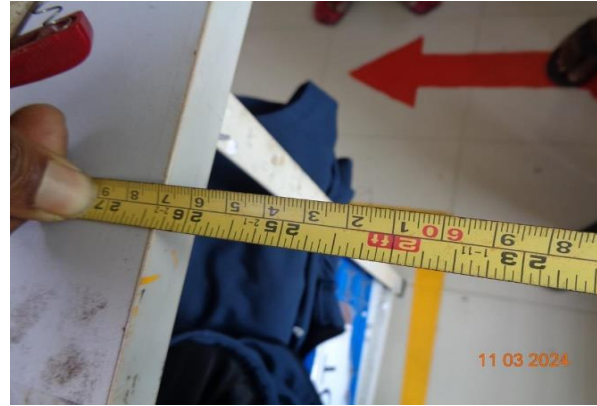
| F-12 | Means of Egress | <p>The width of egress aisles has been found less than 36-inch. Some cases, aisle was not marked properly.</p> <p>Location: Building-1_1st Floor, Ground Floor.</p> <p>Boiler Building_1st Floor</p> | <p>Provide minimum aisle widths of 36-inch. Mark the aisle according to the evacuation map.</p> | Within 1 month |

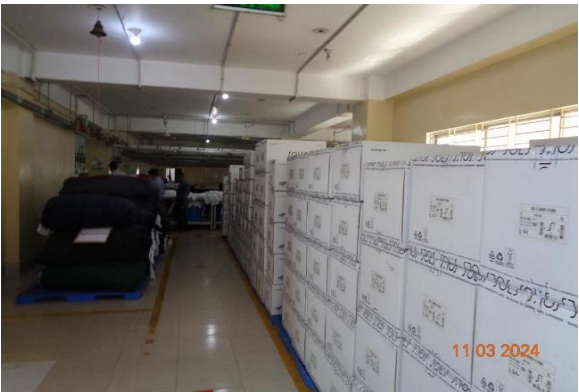
| F-14 | Egress Lighting | <p>The directional signs are not provided where there is a change in direction and where the continuation of the egress path is not obvious.</p> <p>Location: Building-1</p> | Install illuminated directional signs shall be provided where there is a change in the direction for the path of travel and the direction to an exit is not obvious. | Within 1 month |

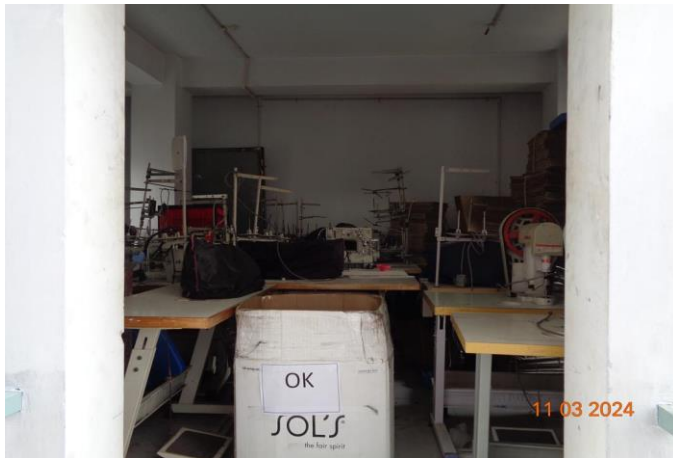
| F-15 | Egress Lighting | Based on the number and location of emergency lights observed, adequate illumination levels are not anticipated along egress routes.<br>Location: Building 1 | Test the emergency lighting system on each floor and provide additional emergency fixtures to provide adequate illumination along the means of egress. Provide a minimum illumination of 10 lux at the floor level within exit stairs and exit discharge paths and minimum 2.5 lux along exit access aisles. | Within 1 month |

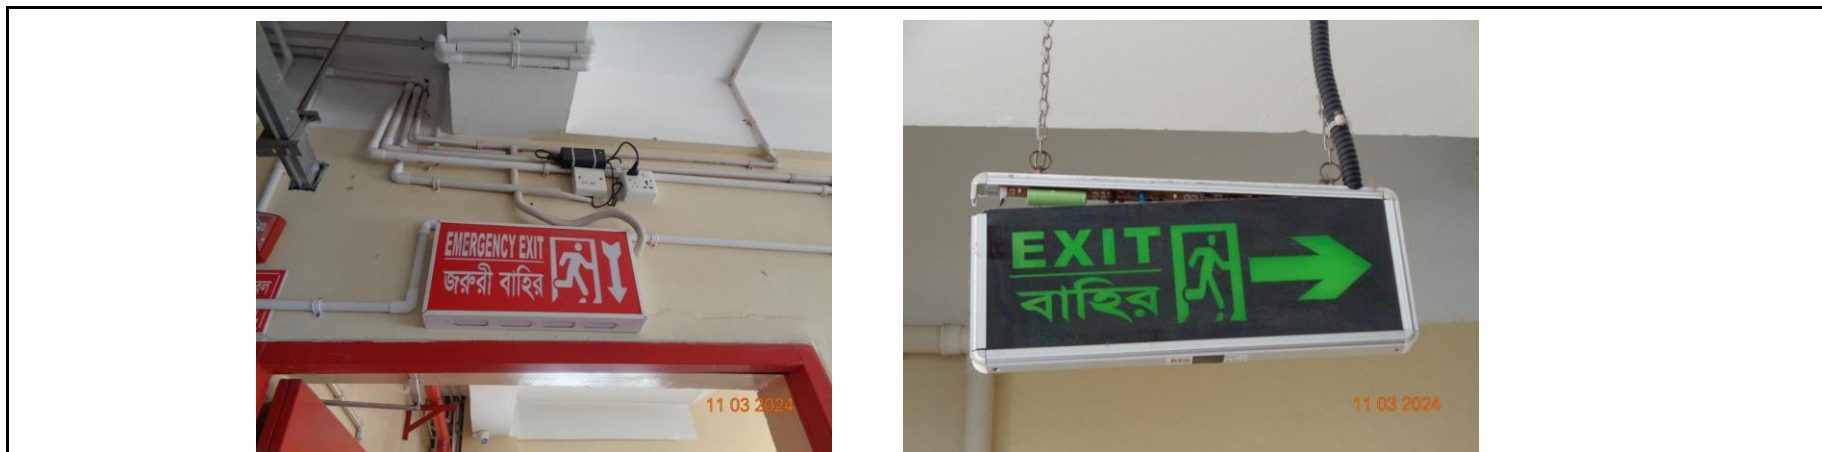
| F-16 | Egress Lighting | Exit signage not illuminated (burned out, broken, etc.).<br>Location: Building-1 and Boiler Building | Regularly inspect all exit signage and replace/install lights as needed to illuminate signs | Within 1 month |

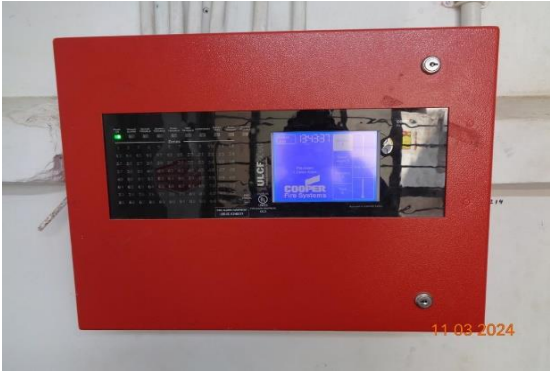
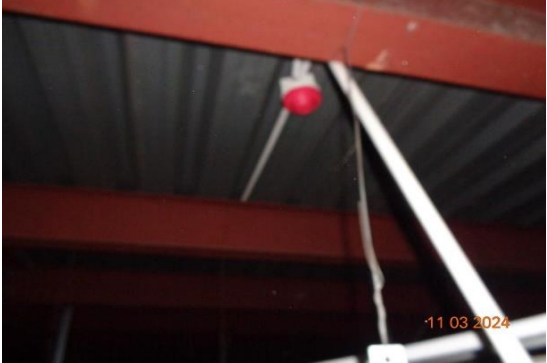
| F-17 | Fire Alarm & Detection system | Fire alarm and detection system installation complete which requires detailed review to confirm compliance with NFPA 72 and RSC Technical Guidelines (Standard). | Submit the fire alarm system design to RSC for review. Once the design is reviewed, install and modify the fire detection and alarm system throughout the building in accordance with review comment, Accord/ RSC Technical Guidelines (Standard) and NFPA 72. After installation the owner shall conduct internal testing and commissioning and then contact the RSC for witness of final acceptance testing. Also inspect, test and maintain the fire alarm system, and keep written records on-site, in accordance with Table-14.3.1 of NFPA 72 | Design review-1 Month<br>Modification if required-3 Months |

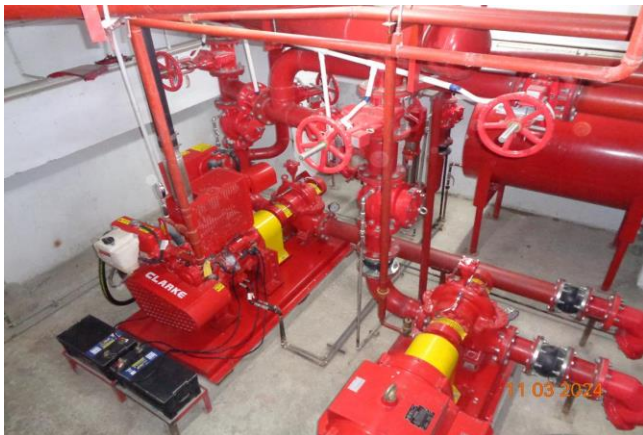
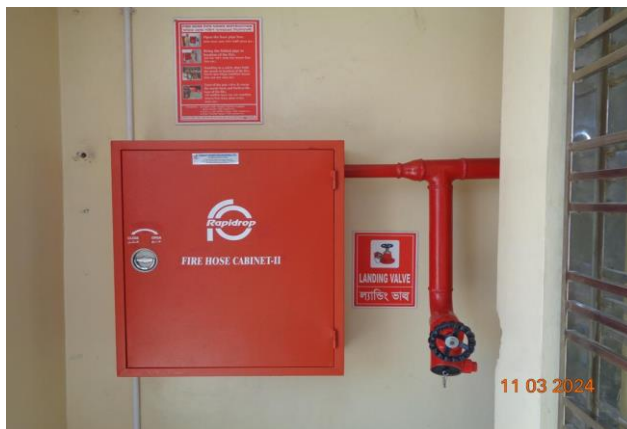
| F-19 | Fire Protection System (Standpipe) | The existing building has an occupied floor greater than 10 meter (33 feet) and Standpipe installation requires detailed review to confirm compliance with NFPA 14, 20 and RSC standards. | Submit the standpipe system drawing to RSC for review. Once reviewed, install or modify the standpipe system throughout the building in accordance with RSC standard and NFPA 14,20,22 and 24. After installation the owner shall contact the RSC for witness of conducting the final acceptance testing of the standpipe system. | Design-1 Month<br>Modification if required-3 Months |
