INITIAL FIRE SAFETY INSPECTION REPORT

Arrival Fashion Limited (Extension)

RSC ID: 25622

Date: 28 April 2024

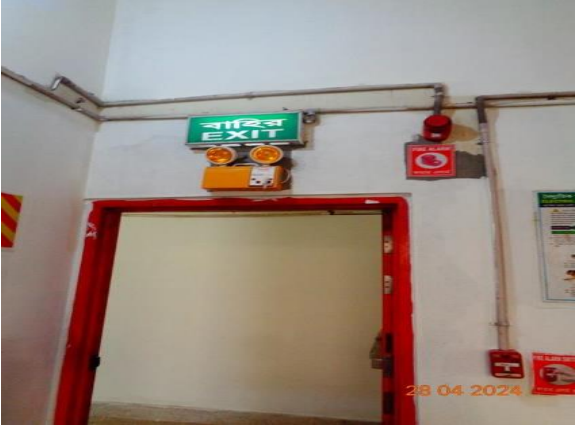
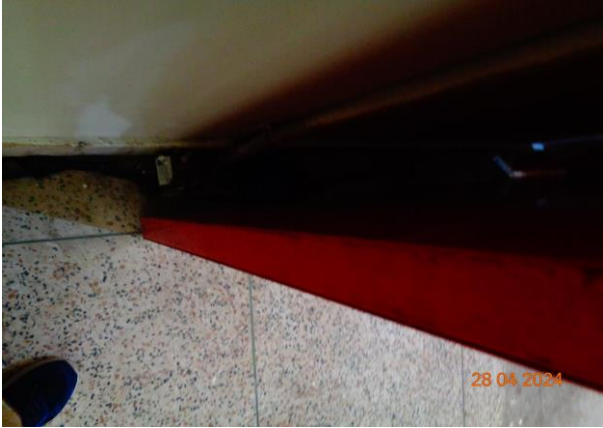
SI No.	Category	Findings	Required Action	Remediation Time Frame
F-1	Fire Rated Construction	The Boiler, Compressor room is not separated by fire rated construction (non functional fire door) from pump room at Ground floor.	Separate the Boiler/Compressor room by a minimum 1-hr fire-rated construction. Seal and/or protected all openings to maintain the required fire separations.	Within 3 Months
<div style="display: flex; justify-content: space-around;">

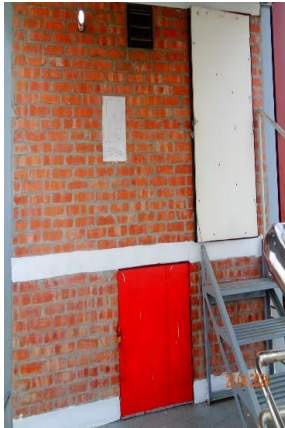
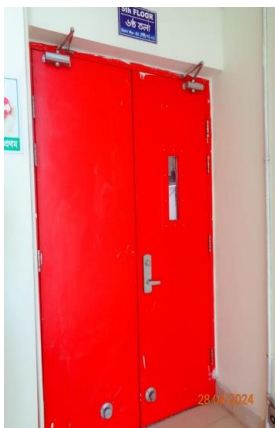
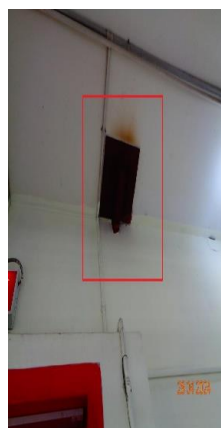
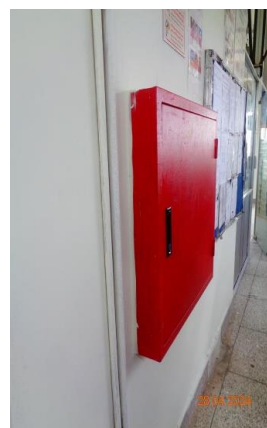
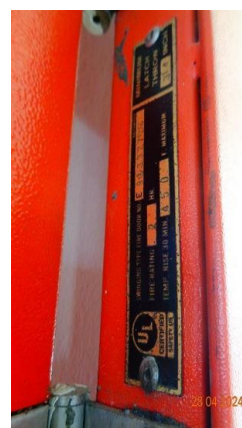
F-2	Fire Rated Construction	<p>The exit stairs are not separated due to unprotected opening at lift M/c room, basement store area, wall thickness due to Hose cabinet box, non rated stair steel support, door gap above 19 mm, door credibility of partex doors on each floor by fire-rated construction.</p>	<p>Provide minimum 2-hr fire rated construction for buildings 4 storied or more and 1-hr for upto 3 storied. Seal all unprotected openings to separate the exit stairs from work areas and other spaces on all floor levels by 90 minutes for 2 hr construction and 60 minutes for 1-hr construction. Ensure that the fire rated doors are self-closing and positive latching and that they are provided with fire exit (panic) hardware where serving production floors and provide vestibules to avoid direct discharge from storage to exit stair enclosure. If fire rated doors are required to be held open for functional reasons, provide automatic closing devices tied to the fire alarm system. Once fire doors are installed, every door in a stair enclosure serving more than 5 stories shall be provided with re-entry unless it meets RSC Technical Guidelines (Standard) 6.8.3.1 If fire doors are required to be held open for functional reasons, provide automatic-closing devices tied to the fire alarm system.</p>	Within 3 Months

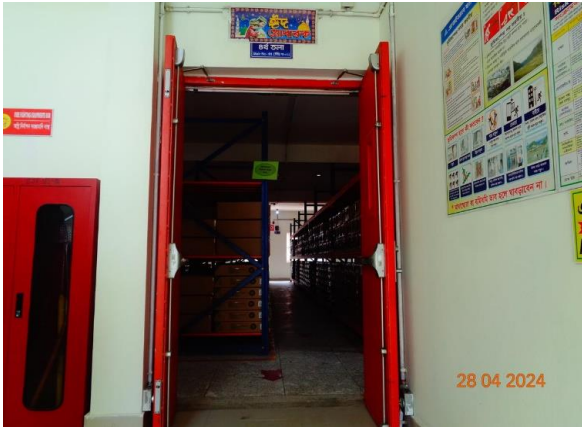
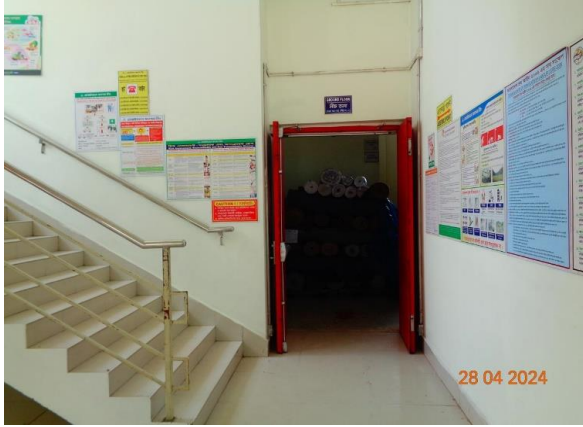
F-3	Fire Rated Construction	Finished Goods Storage rooms at 3rd floor, 2nd floor and ground floor discharges directly into the exit stair discharge.	Openings from exit enclosure to storage room, generator and hazard spaces shall be provided with a vestibule with fire rated construction and openings. Provide a 1.5 hr. fire rated door on the exit stair side and a 1-hr. fire rated door on the Store, generator, substation room side. Ensure that the fire rating of the vestibule construction matches that of the exit stair enclosure.	Within 3 Months
<div style="display: flex; justify-content: space-around; align-items: center;">

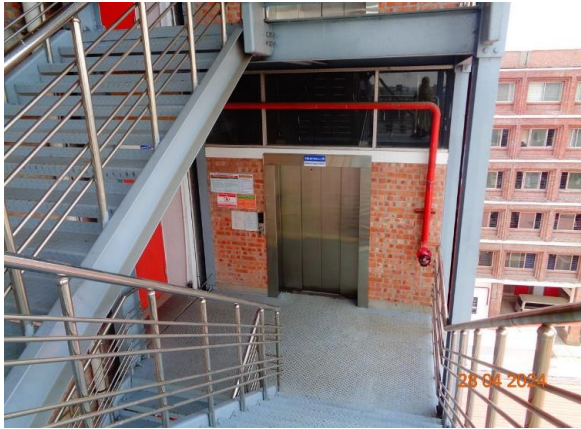
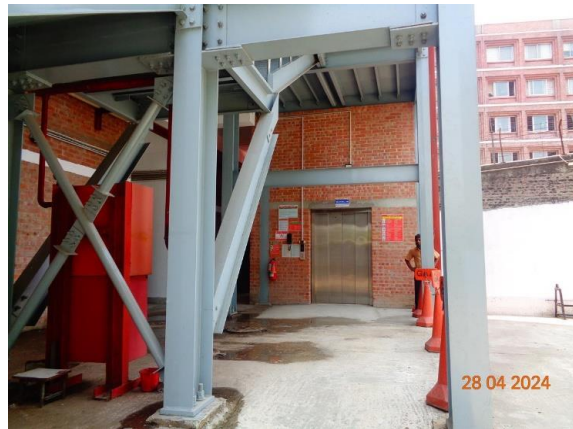
</div>				
F-4	Fire Rated Construction	Elevator shafts are directly open into the Exit Stair.	For interim construction, elevators shall not open into an exit enclosure as per RSC-6.14.3. So, separate the stair enclosure from elevator shaft throughout the building.	Within 3 Months

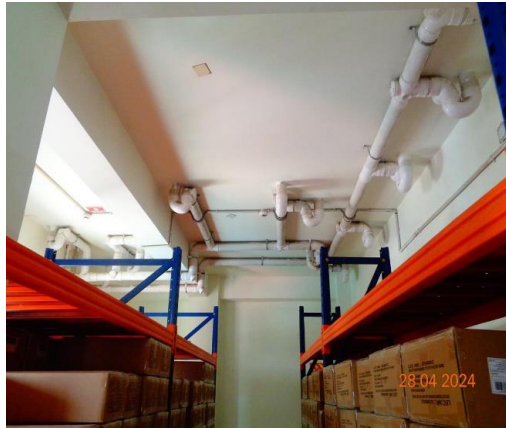
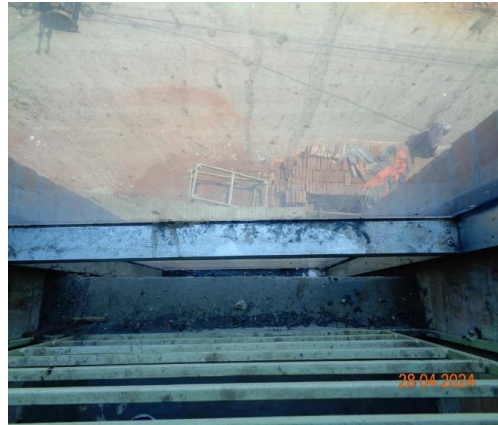
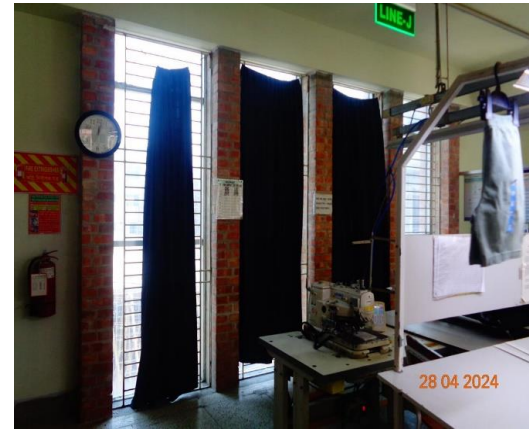
F-5	Fire Rated Construction	<p>Unsealed penetrations and openings are located in the fire rated floor/ceiling assemblies due to pvc pipe at 3rd floor toiler area and glass partition from 5th floor to 1st floor.</p>	<p>Seal all penetrations and openings in floor/ceiling (full thickness of the floor/ceiling) assemblies by fire rated materials to maintain the fire resistance rating.</p> <p>or,</p> <p>Provide a minimum 2-hr fire rated shaft to separate the BBT shaft & toilet area from each floor.</p>	<p>Within 3 Months</p>
-----	-------------------------	--	--	------------------------

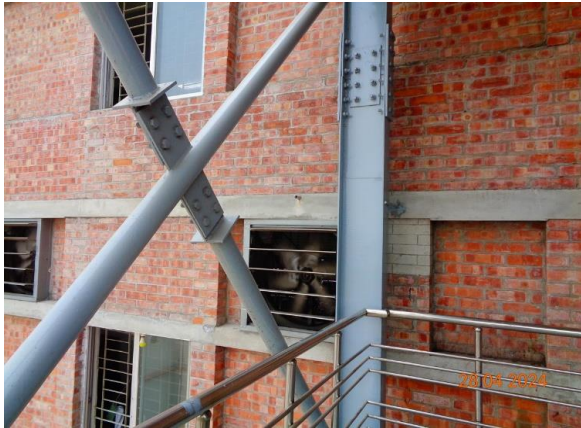
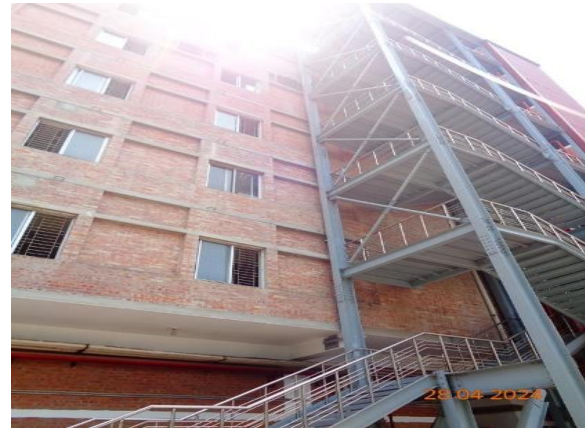
F-6	Fire Rated Construction	The Exit Stair-2 is less than 10ft wide and is not separated from the building interior.	Seal all penetrations and openings to the interior of the building along the discharge path, up to a height of 10 ft, to provide a minimum 1-hr fire separation. Alternatively, provide a second remote discharge path to the public way (only include this if feasible).	Within 3 Months
-----	-------------------------	--	---	-----------------

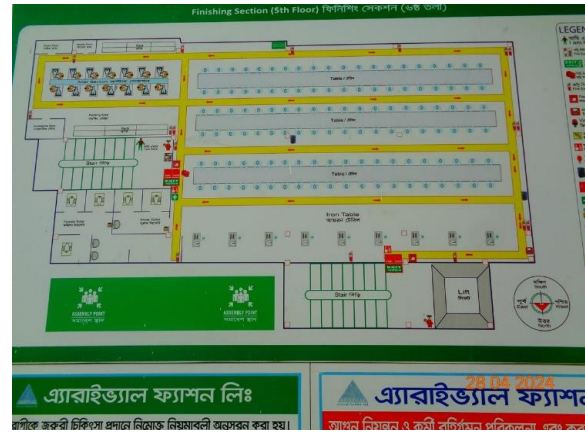
F-7	Means of Egress	The exits are not remotely located from each other such that a single fire event could compromise both exits.	Modify exit arrangement or Provide additional exit(s)	Within 3 Months
-----	-----------------	---	---	-----------------

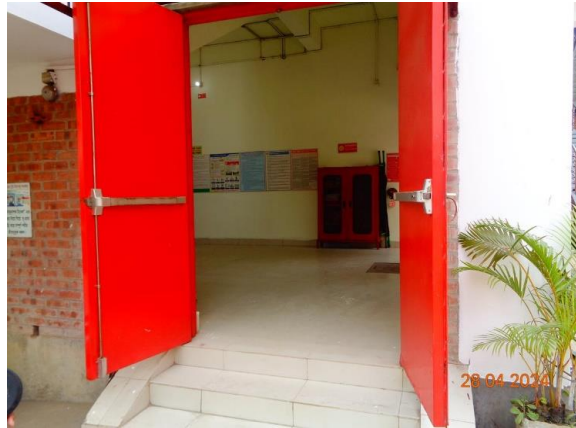
F-8	Means of Egress	Landings are not provided ground floor main exit discharge and exit discharge path of basement area.	Provide landings on both side of exit door and prevent door leaf does not swing on landing area to facilitate uninterrupted egress of occupants.	Within 1 Month
-----	-----------------	--	--	----------------

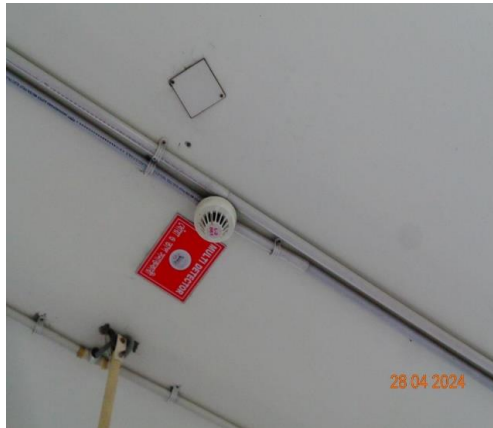
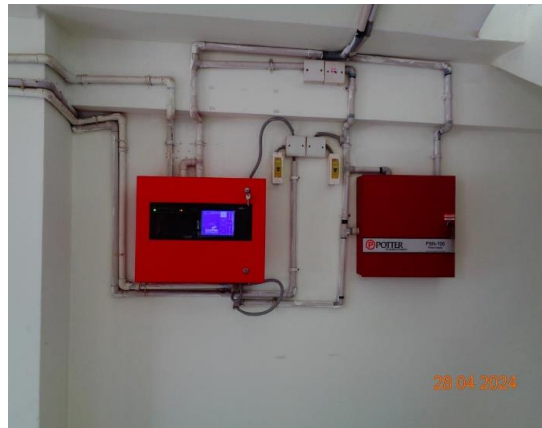
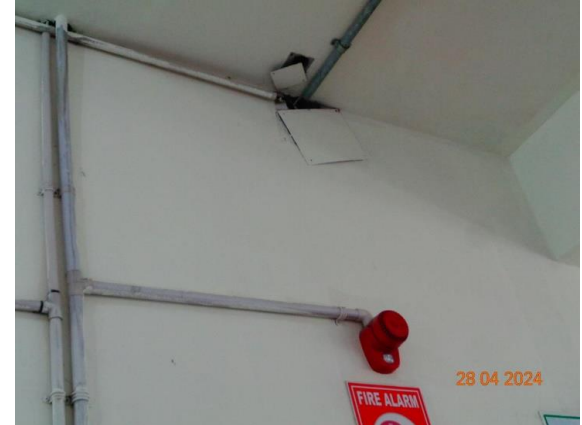
F-14	Fire Alarm and Detection System (FADS)	Fire alarm & detection system installation requires detailed review to confirm compliance with NFPA 72 and RSC Technical Guidelines (Standards).	Submit as-built drawings, testing records, equipment certification and other relevant documentation to the RSC for review and approval; modification (if required) shall have to done as per the reviewed design and standard.	Design Review within 2 months and installation within 4 months.
------	--	--	--	---

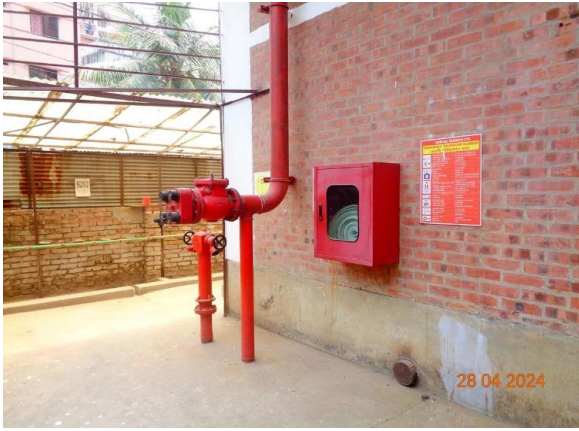
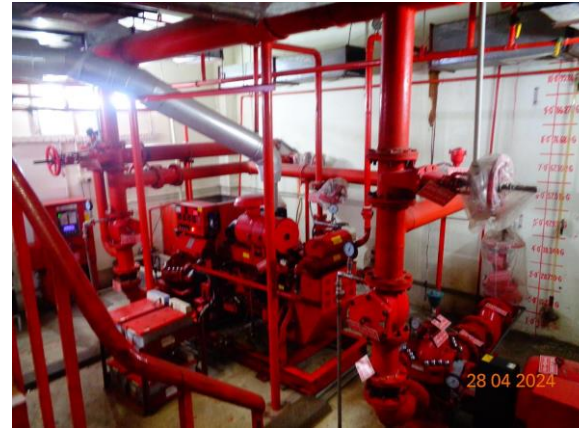
F-15	Inspection, Testing and Maintenance of FADS.	Inspection, testing and maintenance for the fire detection and alarm system was not in accordance with standard.	Inspect, test and maintain the fire alarm system and keep written records on-site, in accordance with Table-14.3.1 of NFPA 72.	Within 1 Month (after installation)
F-16	Fire Protection System(Standpipe)	Standpipe system installation requires detailed review to confirm compliance with NFPA 14 and RSC standards.	Submit as-built drawings, testing records, equipment certification and other relevant documentation to the RSC for review and approval.	Design Review within 2 months and installation within 4 months.
