# **FIRE SAFETY INSPECTION REPORT**

**AMITY DESIGNS LTD.**

**ACCORD**  
on Fire and Building Safety in Bangladesh

April 21, 2014

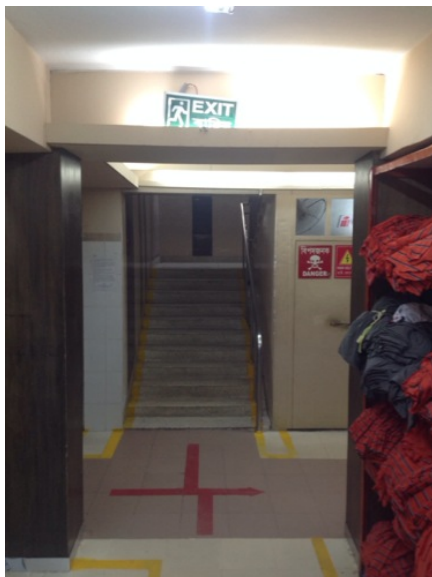
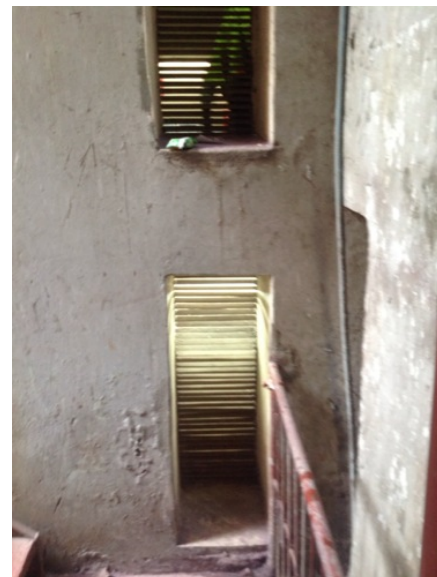
| No. | Category | Finding | Recommendation | Remediation Timeframe |
|---|---|---|---|---|
| F-1 | Fire Rated Construction | The exit stairs are not separated from work areas, other spaces on each floor by fire-rated construction. | <p>Provide minimum 1.5-hr fire rated doors and seal all unprotected openings to separate the exit stairs from work areas and other building spaces on all floor levels. Ensure that the fire doors are self-closing and positive latching and that they are provided with fire exit (panic) hardware where serving production floors.</p> <p>If fire doors are required to be held open for functional reasons, provide automatic-closing devices tied to the fire alarm system.</p> | Within 3 months |

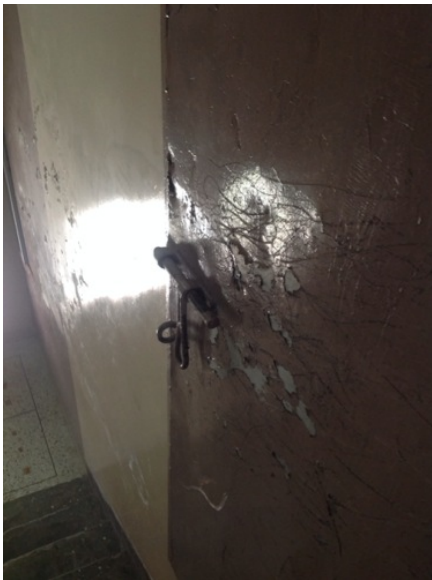
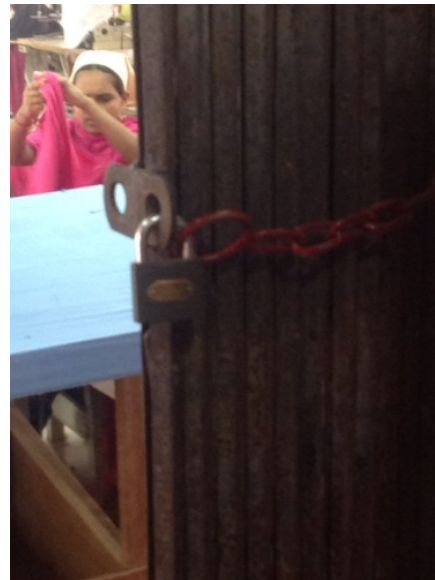
| F-2 | Egress | Egress doors / gates with locking features are provided at building exits, exit stairs, along egress routes, exit discharge. | Remove locking features from all egress doors / gates.<br><br>If locks are required for security reasons, utilize special door locking features complying with NFPA 101. | Immediate |

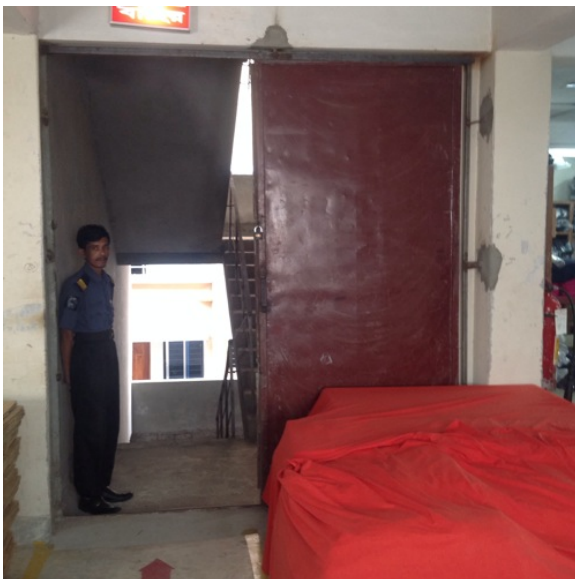
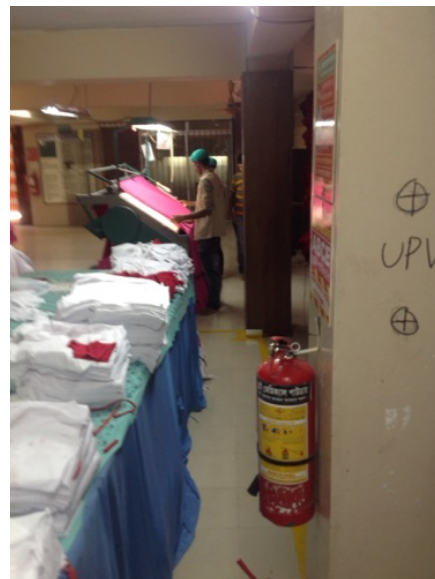
| F-3 | Egress | Storage was located in the egress path, west exit second floor. | Keep egress paths and stairs clear of storage. | Immediate |

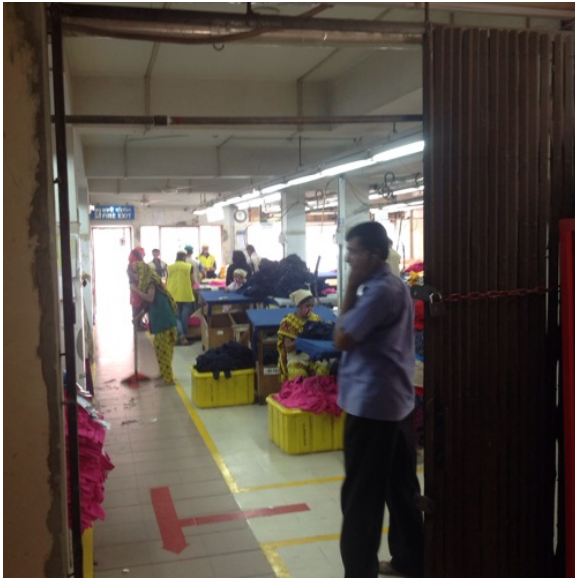
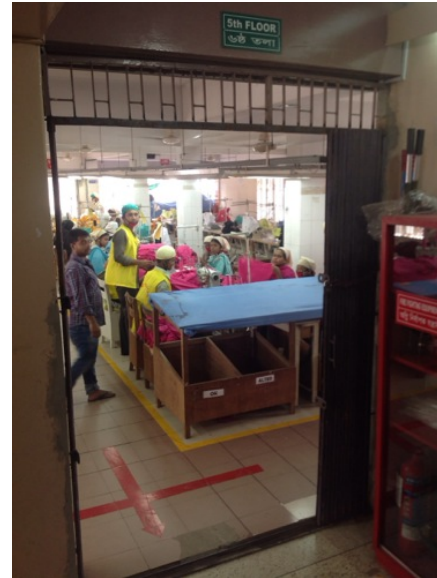
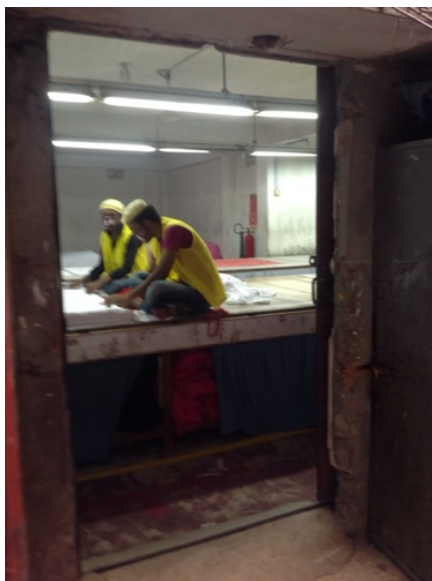
| F-4 | Egress | Collapsible gates / sliding doors are provided at building exits, exit stairs, along egress routes, exit discharges throughout the factory. | Replace all gates / sliding doors along the means of egress with side-hinged, swinging egress doors.<br><br>If locks are required for security reasons, utilize special door locking features complying with NFPA 101. | Within 1 month |

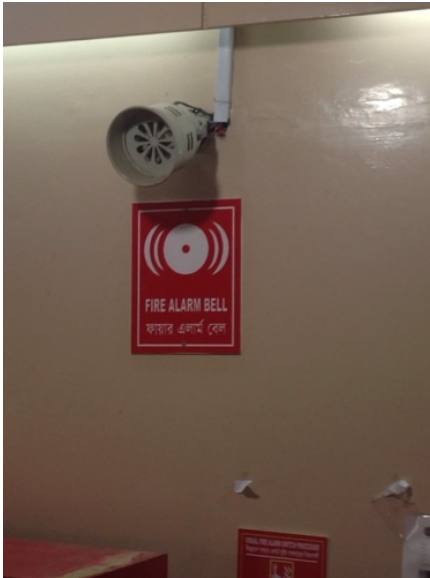
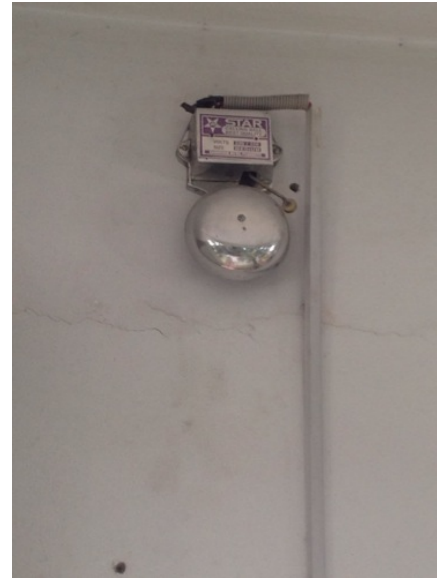
| F-5 | Fire Protection | The fire alarm system is antiquated, not a listed system, and does not provide alarm and notification features consistent with acceptable standards. | Replace the fire alarm system with a new, listed addressable fire alarm system in accordance with NFPA 72. | Design within 4 months, install within 9 months |

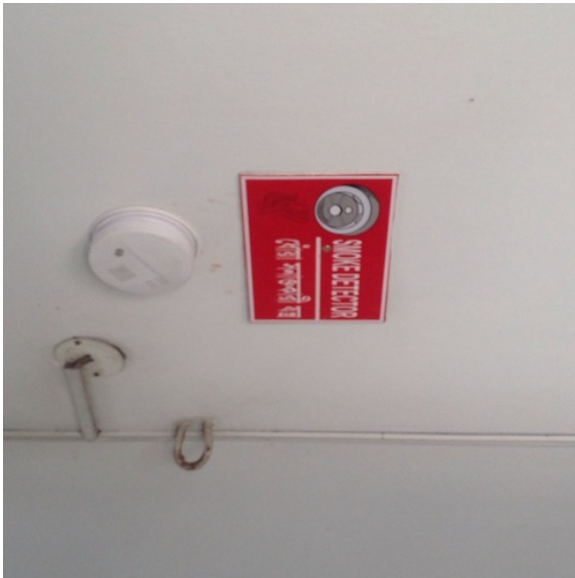
| F-7 | Fire Protection | The building is equipped with single-station smoke alarms. Smoke alarm activation sounds only a local alarm and does not provide automatic fire alarm notification of occupants. | Remove single-station smoke alarms. Provide automatic smoke detection throughout the building, tied into the fire alarm system, in accordance with NFPA 72. | Within 6 months |

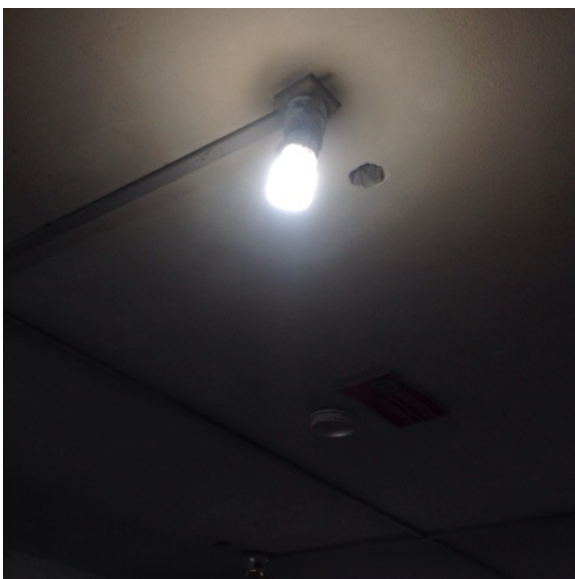
| F-8 | Egress Lighting | Based on the number and location of emergency lights observed, adequate illumination levels are not anticipated along egress routes on ground or first floor. | Test the emergency lighting system on each floor and provide additional emergency fixtures to provide adequate illumination along the means of egress. Provide a minimum illumination of 10 lux at the floor level within exit stairs and exit discharge paths and minimum 2.5 lux along exit access aisles. | Within 3 months |

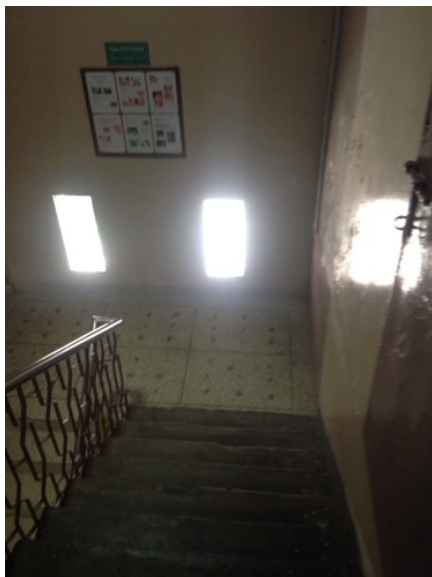
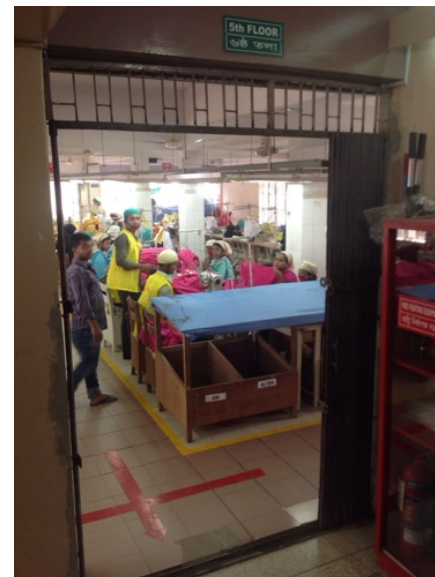
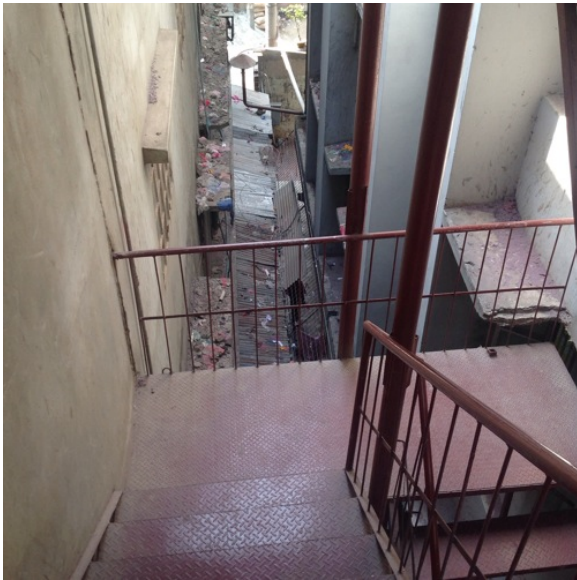
| No. | Category | Finding | Recommendation | Remediation Timeframe |
|---|---|---|---|---|
| F-1 | Fire Rated Construction | The exit stairs are not separated from work areas, other spaces on each floor by fire-rated construction. | <p>Provide minimum 1.5-hr fire rated doors and seal all unprotected openings to separate the exit stairs from work areas and other building spaces on all floor levels. Ensure that the fire doors are self-closing and positive latching and that they are provided with fire exit (panic) hardware where serving production floors.</p> <p>If fire doors are required to be held open for functional reasons, provide automatic-closing devices tied to the fire alarm system.</p> | Within 3 months |

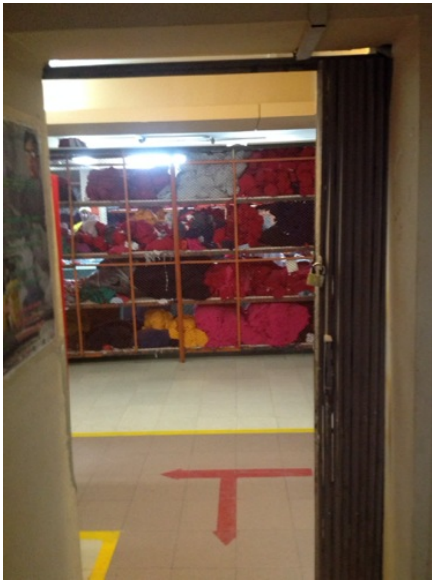
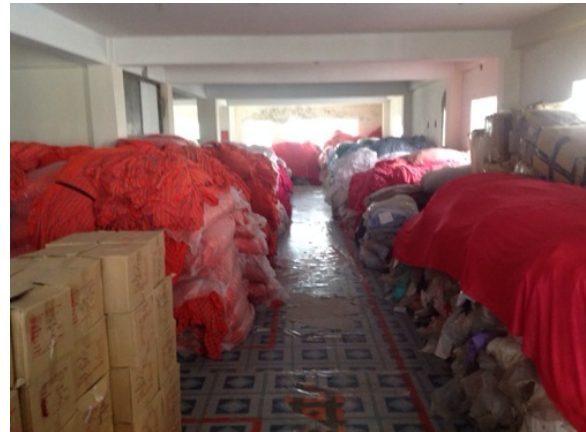
| F-2 | Fire Rated Construction | Areas used for storage are not separated by fire-rated construction on ground floor. | <p>Provide dedicated storage rooms separated by minimum 1-hr fire-rated construction.</p> <p>Where separate storage rooms are not feasible, provide defined storage areas and limit the storage arrangement as follows:</p> <ul style="list-style-type: none"><li>- Maximum height of 2.4m and maximum area of 23m<sup>2</sup></li><li>- If sprinkler protected: maximum height of 3.66m and maximum area of 93m<sup>2</sup></li></ul> <p>Separate areas of unenclosed combustible storage by a minimum clear distance of 3m.</p> | Within 3 months |

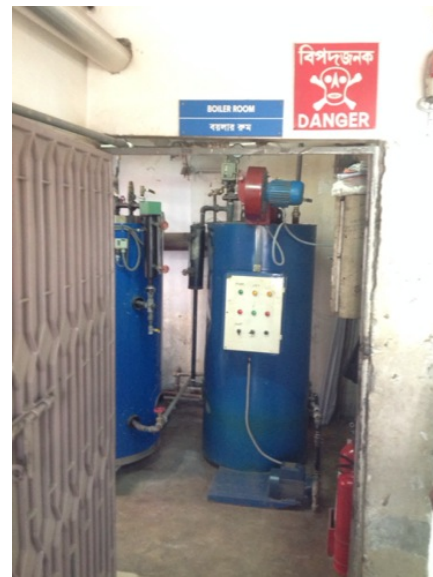
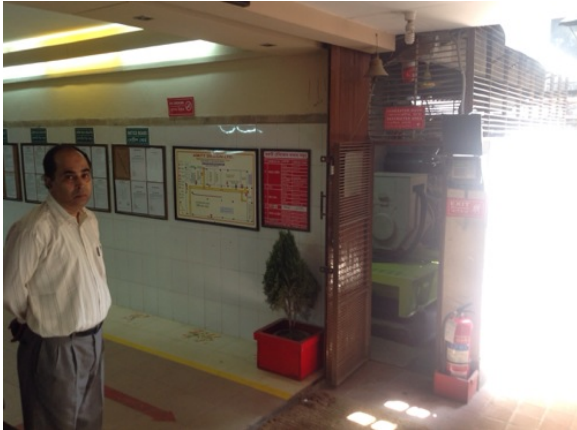
| F-3 | Fire Rated Construction | The main storage room is not constructed of proper fire rated materials. Several penetrations and other deficiencies compromise integrity of the room which could lead to increased fire spread. | Provide minimum 1hr fire rated room and seal all unprotected openings to separate from work areas and other building spaces on all floor levels. Ensure that the fire doors are self-closing and fire rated for use. | Within 6 months |

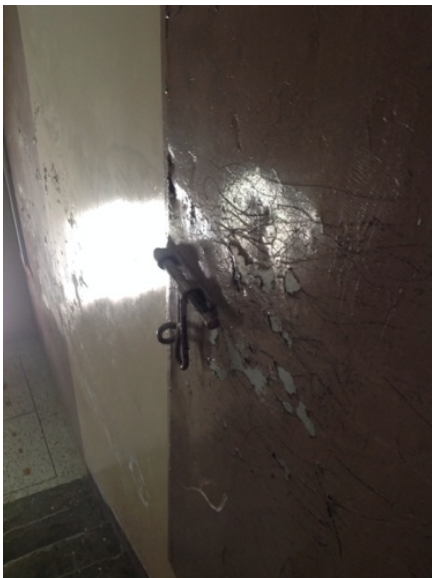
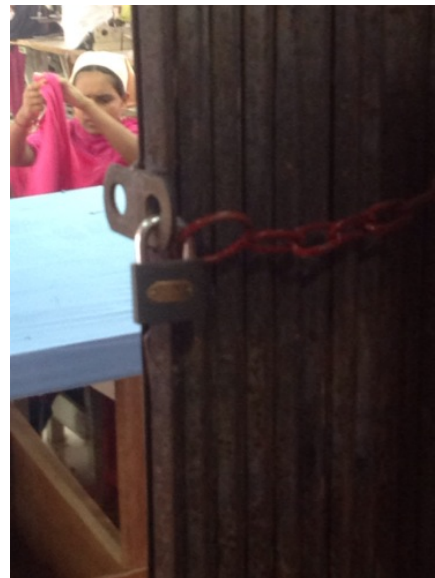
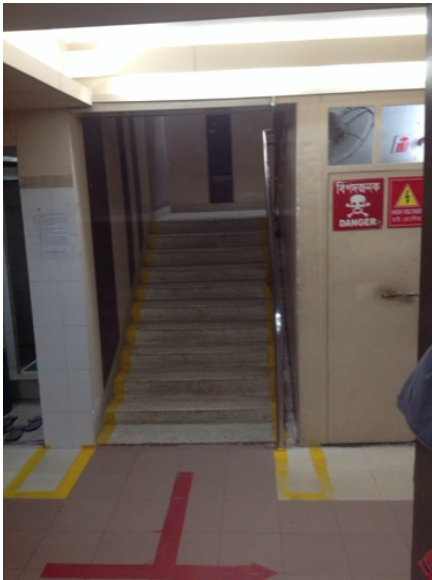
| F-4 | Egress | Egress doors / gates with locking features are provided at [building exits, exit stairs, along egress routes, exit discharge. | Remove locking features from all egress doors / gates.<br><br>If locks are required for security reasons, utilize special door locking features complying with NFPA 101. | Immediate |

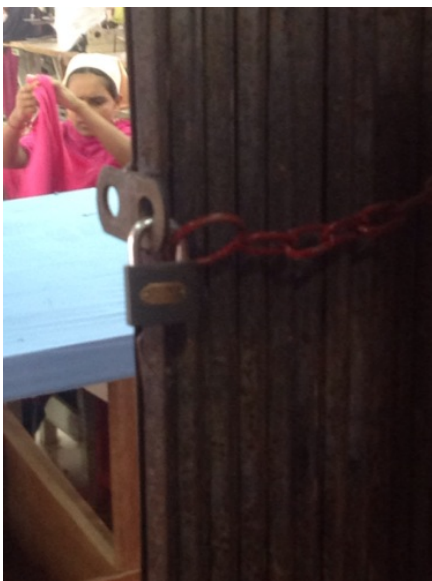
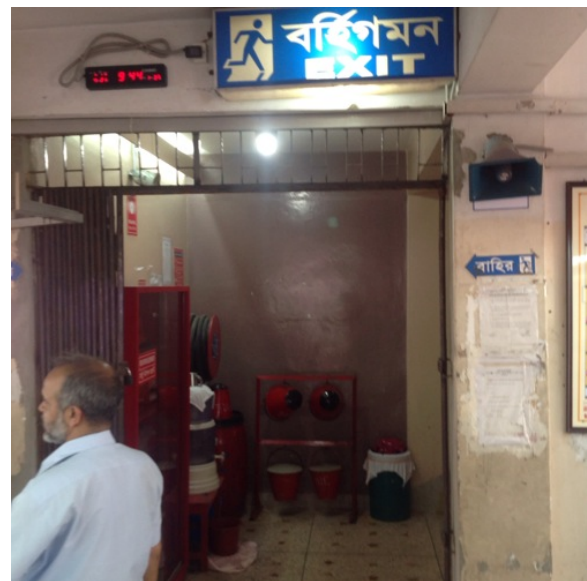
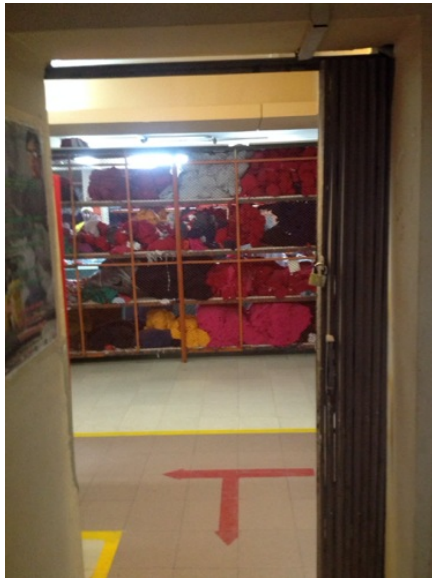
| F-5 | Egress | Collapsible gates / sliding doors are provided at building exits, exit stairs, along egress routes, exit discharges throughout the factory. | Replace all gates / sliding doors along the means of egress with side-hinged, swinging egress doors.<br><br>If locks are required for security reasons, utilize special door locking features complying with NFPA 101. | Within 1 month |

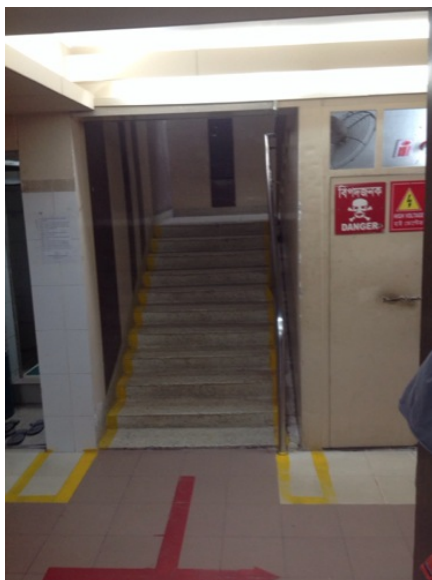
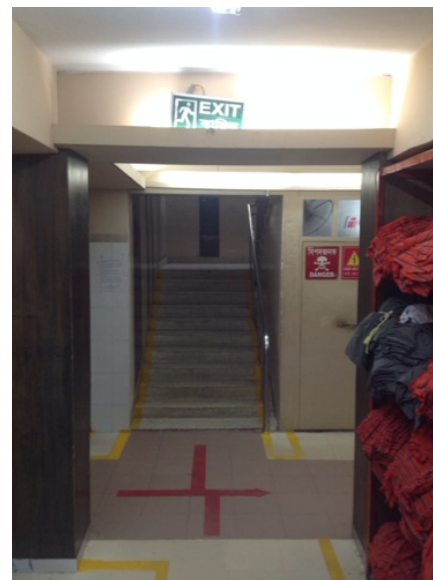
| F-6 | Egress | Exit stairs discharge inside the building ground floor from the south exit. | Provide 2-hr fire-rated exit passageway leading directly outside (vestibules to separate any storage areas). | Within 6 months |

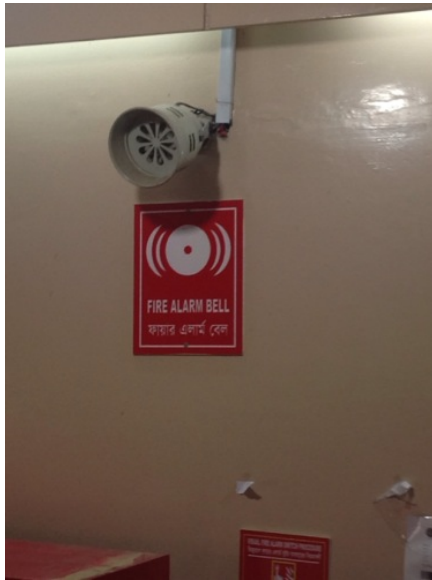
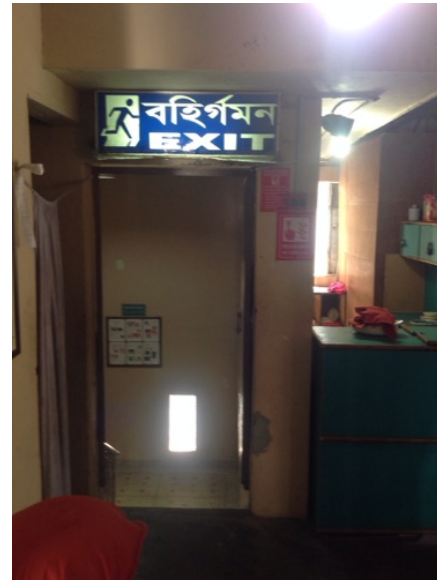
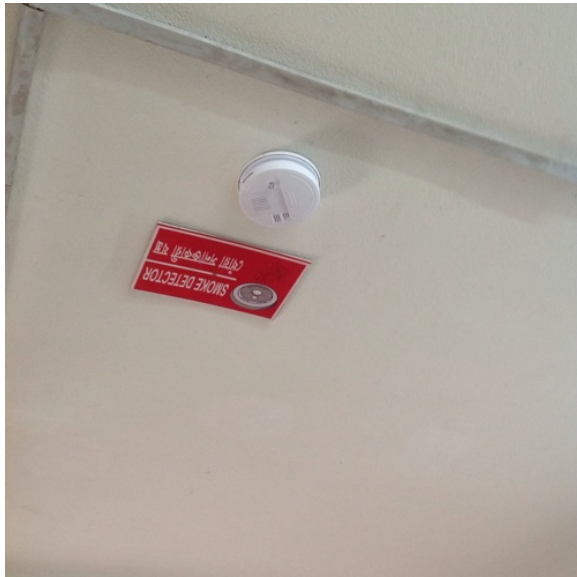
| F-7 | Fire Protection | The fire alarm system is antiquated, not a listed system, and does not provide alarm and notification features consistent with acceptable standards. | Replace the fire alarm system with a new, listed addressable fire alarm system in accordance with NFPA 72. | Design within 4 months, install within 9 months |

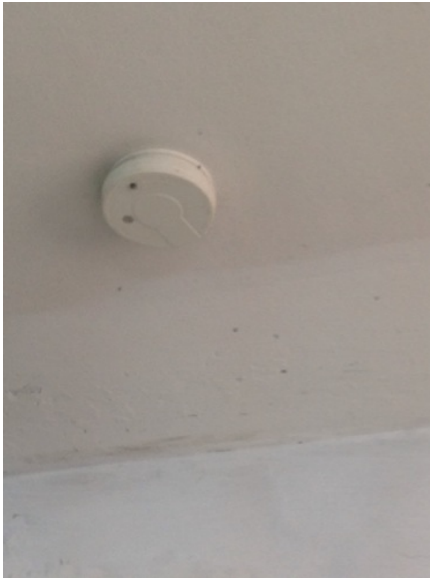
| F-9 | Fire Protection | The building is equipped with single-station smoke alarms. Smoke alarm activation sounds only a local alarm and does not provide automatic fire alarm notification of occupants. | Remove single-station smoke alarms. Provide automatic smoke detection throughout the building, tied into the fire alarm system, in accordance with NFPA 72. | Within 6 months |

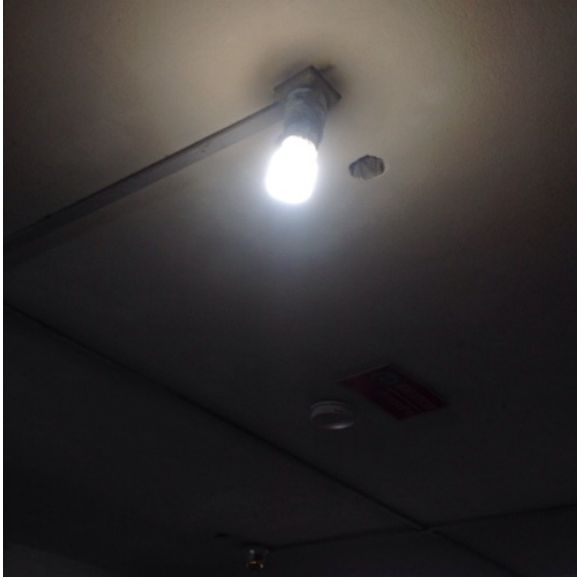
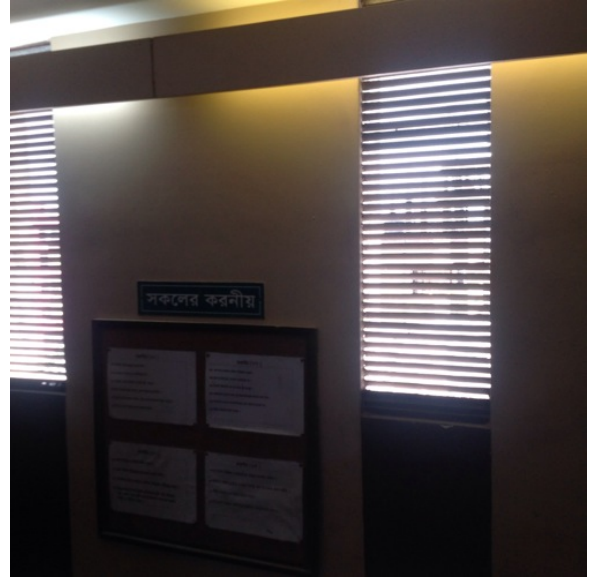
| F-10 | Egress Lighting | Based on the number and location of emergency lights observed, adequate illumination levels are not anticipated along egress routes on ground or first floor. | Test the emergency lighting system on each floor and provide additional emergency fixtures to provide adequate illumination along the means of egress. Provide a minimum illumination of 10 lux at the floor level within exit stairs and exit discharge paths and minimum 2.5 lux along exit access aisles. | Within 3 months |
