# **FIRE SAFETY INSPECTION REPORT**

## **APS APPARELS LIMITED**

March 25, 2014

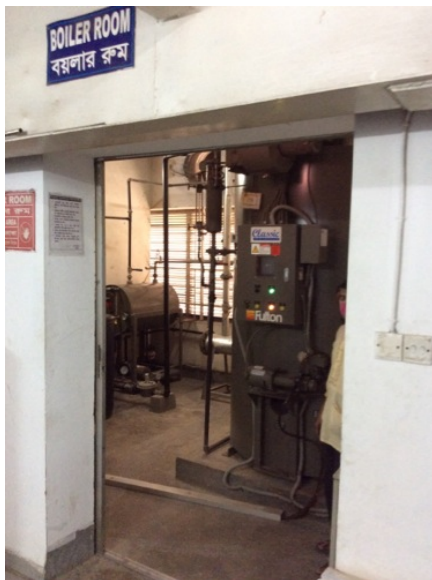
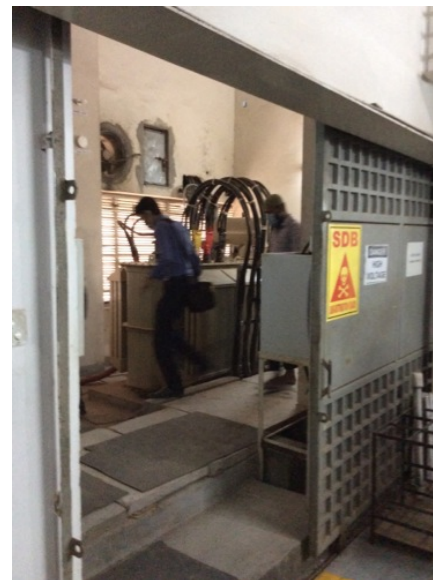
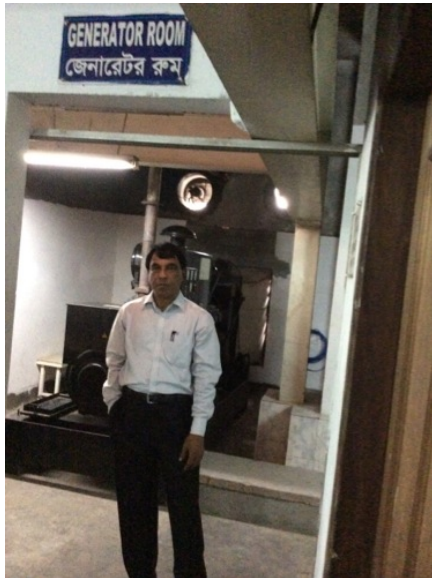
| No. | Category | Finding | Recommendation | Remediation Timeframe |
|---|---|---|---|---|
| F-1 | Fire Rated Construction | The boiler, generator and transformer room is not separated by fire-rated construction openings, non-rated doors and penetrations on the ground floor. | Separate the boiler, generator and transformer room by a minimum 2-hr fire-rated construction. Seal and/or protected all openings to maintain the required fire separations. | Within 3 months |

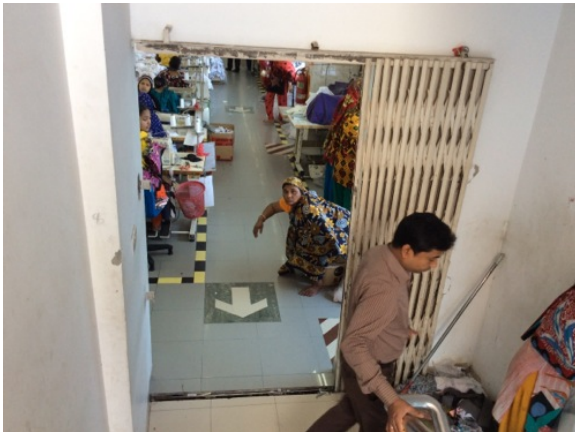
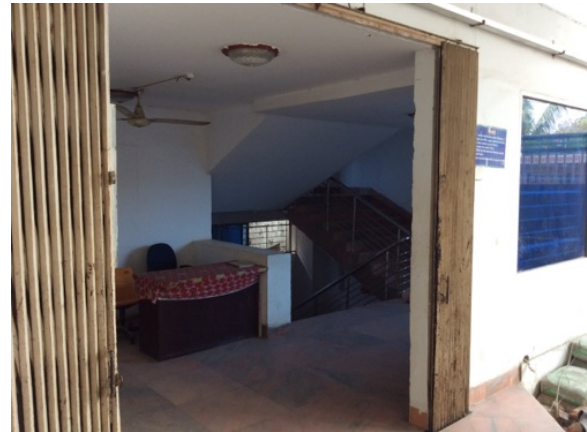
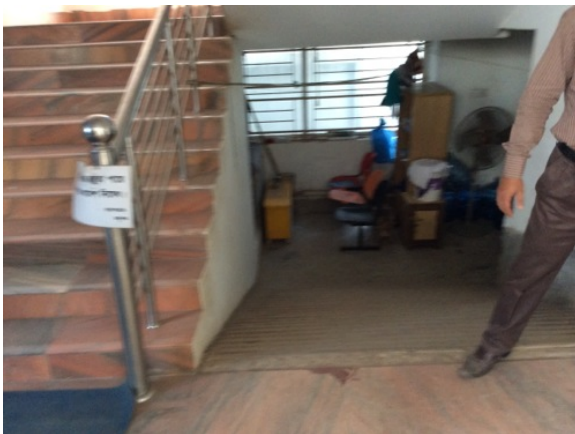
| F-2 | Fire Rated Construction | The exit stairs are not separated from work areas on each floor by fire-rated construction. | <p>Provide minimum 1.5-hr fire rated doors and seal all unprotected openings to separate the exit stairs from work areas on all floor levels. Ensure that the fire doors are self-closing and positive latching and that they are provided with fire exit (panic) hardware where serving production floors.</p> <p>If fire doors are required to be held open for functional reasons, provide automatic-closing devices tied to the fire alarm system.</p> | Within 3 months |

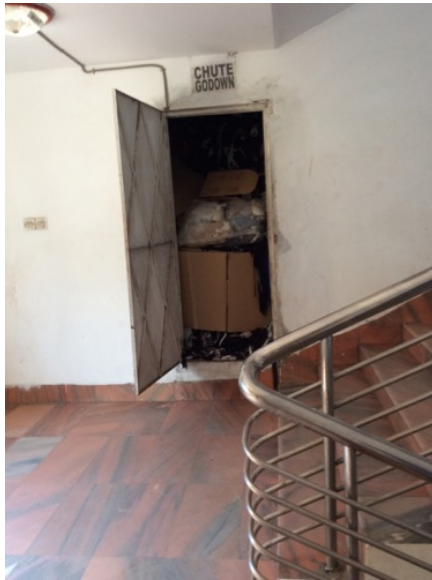
| F-3 | Fire Rated Construction | The "Fabric chute" is not separated by fire-rated construction in the SE exit stair. | Separate the "Fabric chute" by a minimum 2-hr fire-rated construction. Seal and/or protected all openings to maintain the required fire separations | Within 3 months |

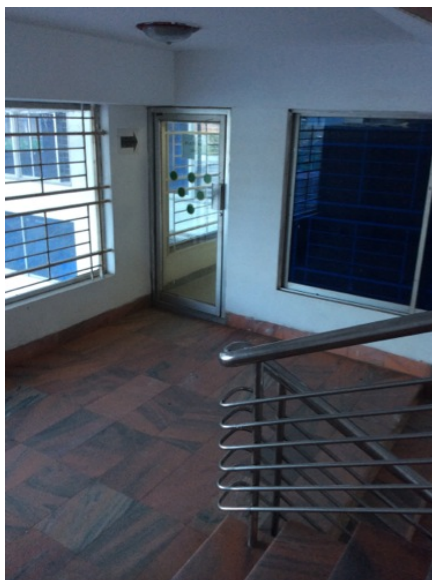
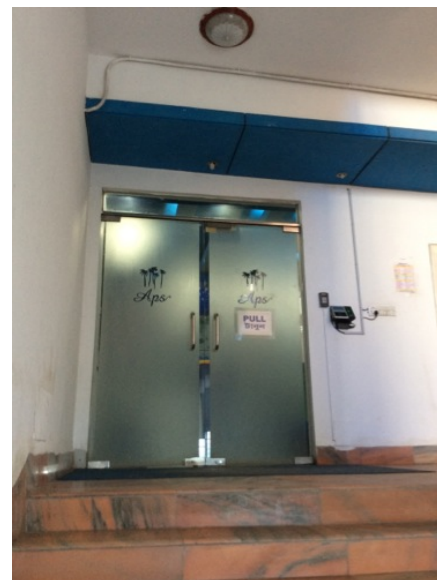
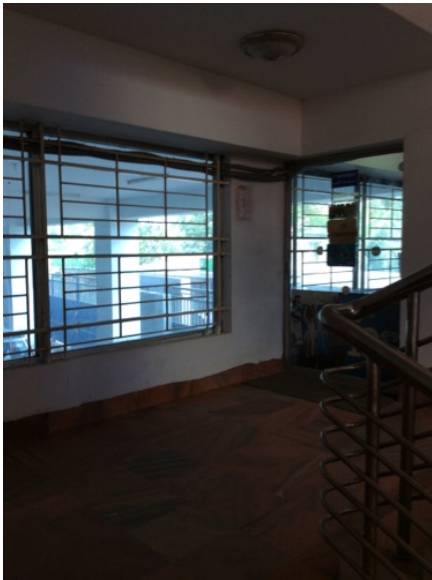
| F-4 | Fire Rated Construction | The exit stairs are not separated from office spaces in the SE and NE stair by fire-rated construction. | Provide minimum 1.5-hr fire rated doors and seal all unprotected openings to separate the exit stairs from office spaces on mezzanine floor levels. | Within 3 months |

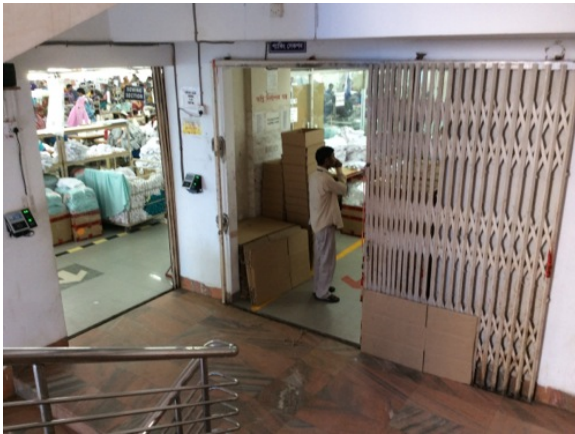
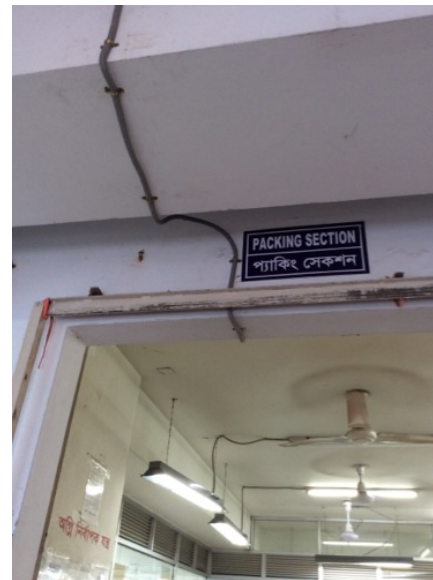
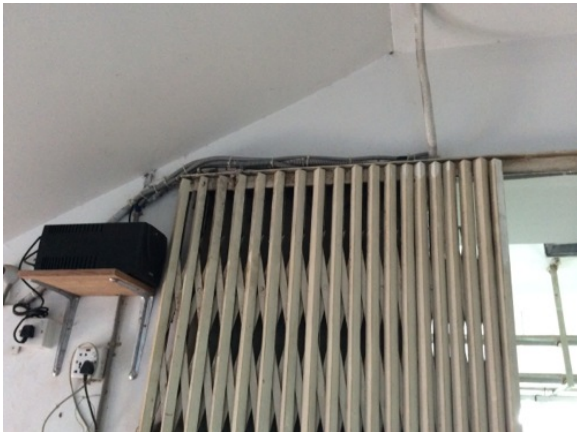
| F-5 | Fire Rated Construction | Unsealed penetrations and openings are located in exit stair enclosures. | Seal all penetrations and openings in exit stair enclosure walls to maintain the fire separation. | Within 3 months |

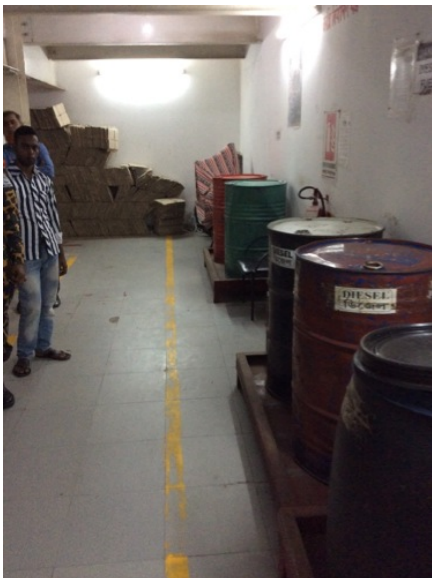
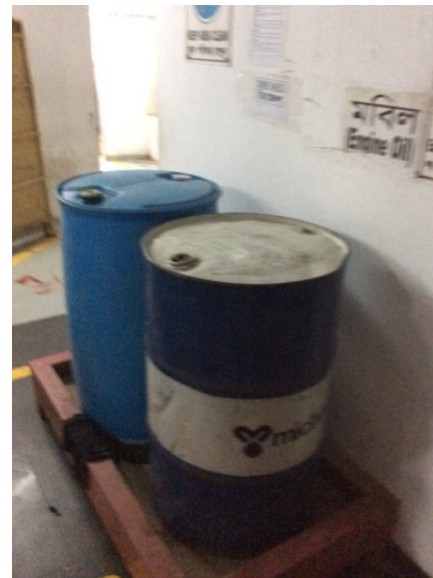
| F-6 | Fire Rated Construction | Diesel drum area is not separated by fire-rated construction on the ground floor. Diesel drum area is opening to egress path for the ground floor. | Separate the diesel drum area by a minimum 2-hr fire-rated construction. Seal and/or protected all openings to maintain the required fire separations. | Within 3 months |

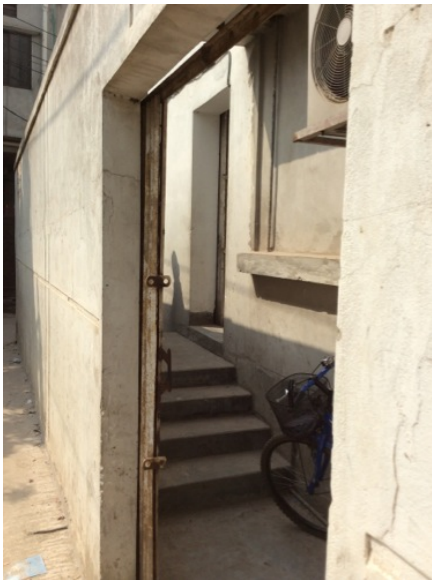
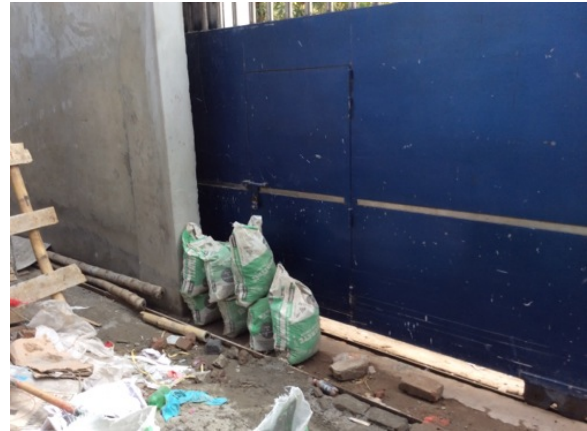
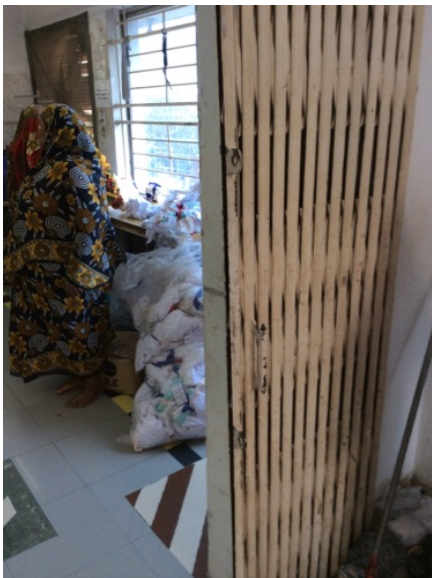
| F-7 | Egress | Egress doors and gates with locking features by a padlock are provided at building exits, exit stairs, along egress routes, exit discharge. | Remove locking features from all egress doors / gates.<br><br>If locks are required for security reasons, utilize special door locking features complying with NFPA 101. | Immediate |

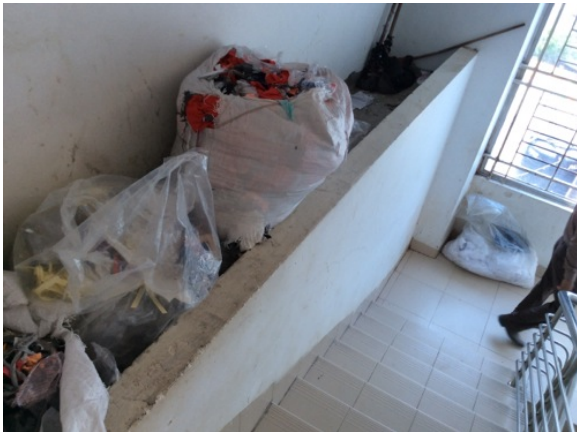
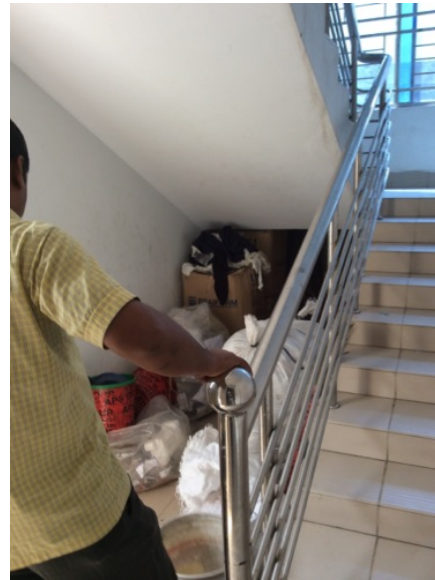
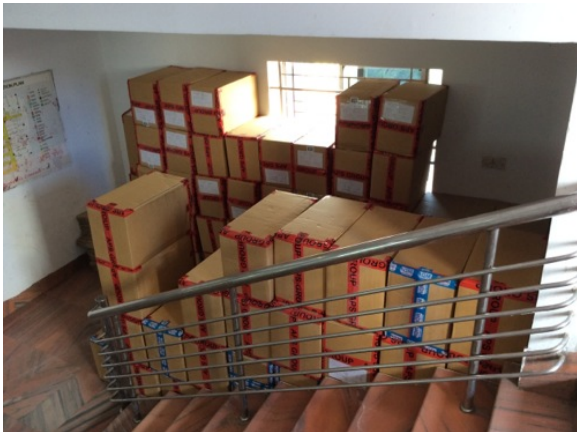
| F-8 | Egress | Storage was located in all exit stairs. | Remove all storage from exit stairs and egress paths. | Immediate |

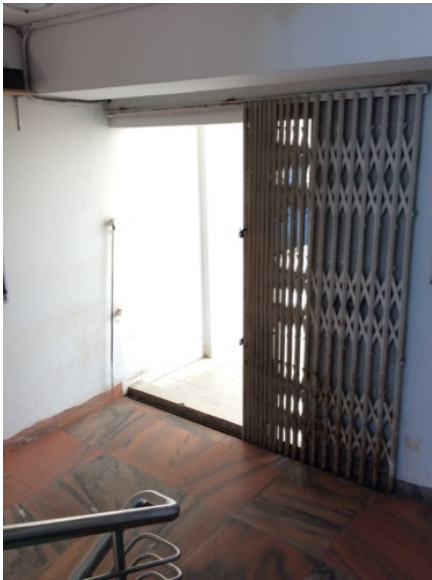
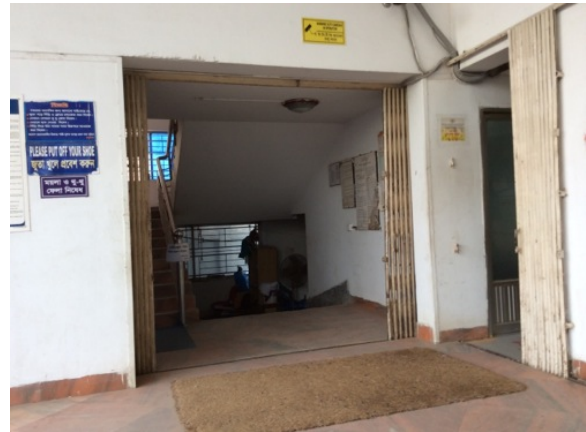
| F-9 | Egress | Collapsible doors and sliding gates are provided at the building exits, exit stairs and exit discharge. | <p>Replace all gates / sliding doors along the means of egress with side-hinged, swinging egress doors.</p> <p>If locks are required for security reasons, utilize special door locking features complying with NFPA 101.</p> | Within 1 month |

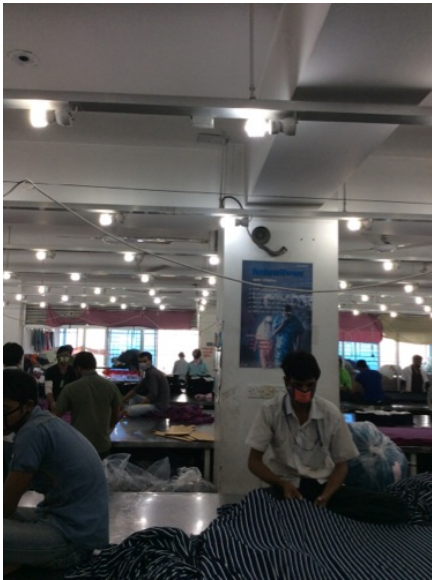
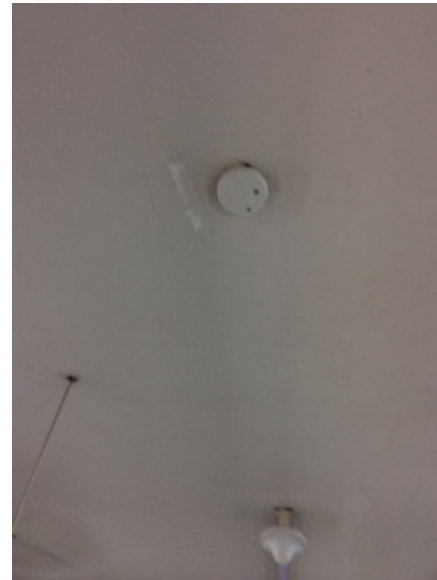
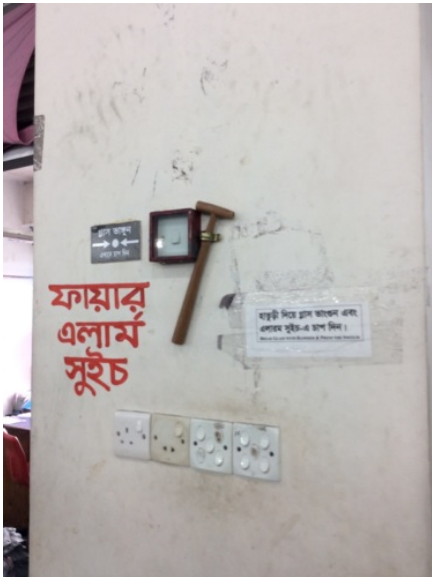
| F-11 | Fire Protection | The fire alarm system is antiquated, not a listed system, and does not provide alarm and notification features consistent with acceptable standards. | Replace the fire alarm system with a new, listed addressable fire alarm system in accordance with NFPA 72. | Within 3 months |
