# **FIRE SAFETY INSPECTION REPORT**

**SAMS FASHION LTD.  
KEOWA PASHIM KHANDA (KOROITOLA), MAWNA,  
SREEPUR, GAZIPUR.**

**ACCORD**  
on Fire and Building Safety in Bangladesh

May 27, 2014

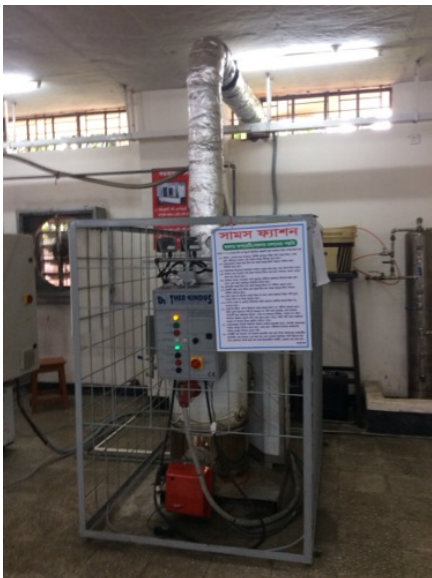
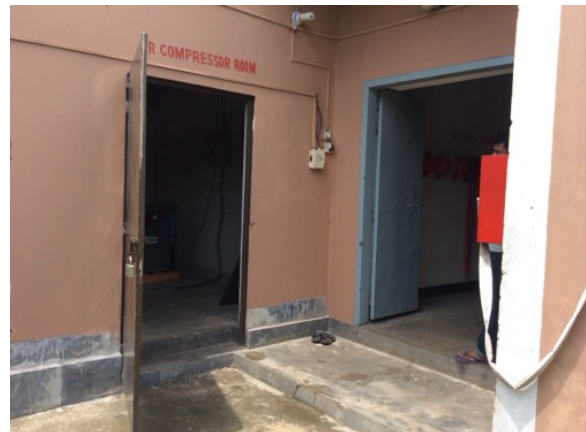
No.	Category	Finding	Recommendation	Remediation Timeframe
F-1	Fire Rated Construction	<p>The boiler room is not separated from the working areas (Finishing section) by means of fire-rated construction (unprotected openings and non-rated door).</p> <p>The compressor room is not separated from the discharge pathway of the north eastern exit stair by means of fire-rated construction (non-rated door).</p>	<p>Separate the boiler and compressor room from the adjacent working area and discharge pathway by a minimum 2-hr fire-rated construction. Seal and/or protected all openings to maintain the required fire separations.</p>	Within 3 months

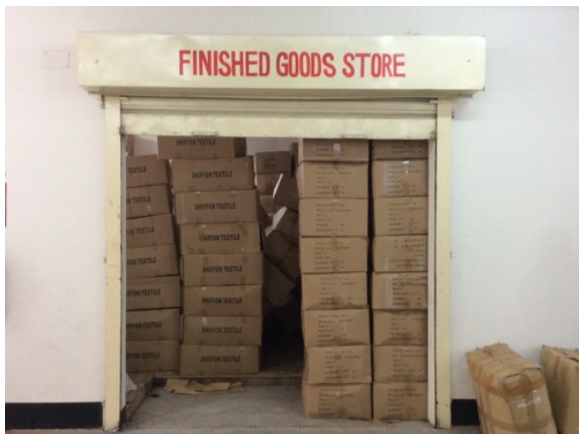
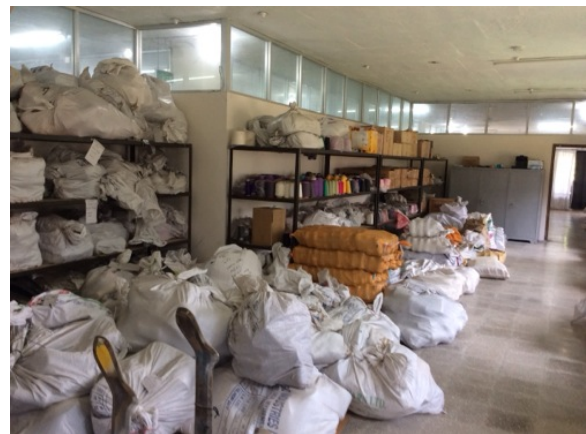
F-2	Fire Rated Construction	Dedicated storage areas (Bonded store and Finishing goods store) on the ground floor were not not separated form the working area by means of fire rated construction (non-rated door and unprotected openings)	Provide dedicated storage rooms separated by minimum 1-hr fire-rated construction.	Within 3 months
-----	-------------------------	---	--	-----------------

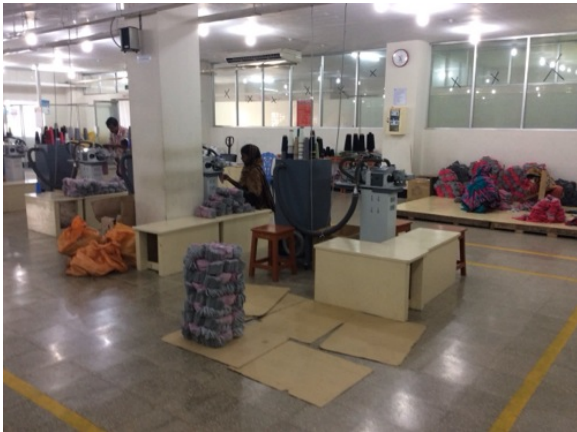
F-3	Fire Rated Construction	Transient storage areas (Packing area) on the ground floor are not separated from the adjacent working areas by means of fire rated construction.	Provide dedicated storage rooms separated by minimum 1-hr fire-rated construction.  Where separate storage rooms are not feasible, provide defined storage areas and limit the storage arrangement as follows: - Maximum height of 2.4m and maximum area of 23m <sup>2</sup> - If sprinkler protected: maximum height of 3.66m and maximum area of 93m <sup>2</sup>  Separate areas of unenclosed combustible storage by a minimum clear distance of 3m.	Within 3 months
-----	-------------------------	---	--	-----------------

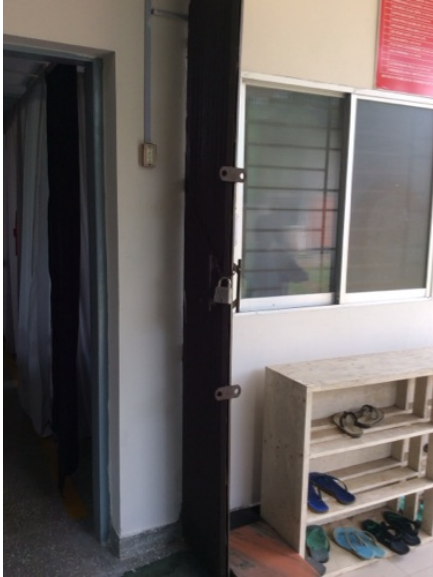
F-4	Egress	Egress doors and gates with locking features are provided at all building exits and exit discharges.	Remove locking features from all egress doors / gates.  If locks are required for security reasons, utilize special door locking features complying with NFPA 101.	Immediate
-----	--------	--	--	-----------

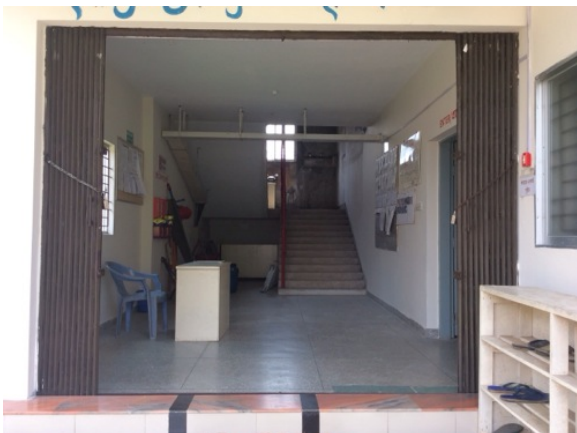
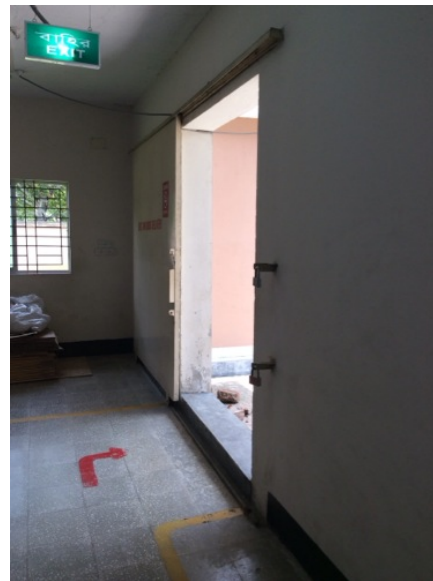
F-5 Egress

Collapsible gates and sliding doors are provided at all building exits and exit discharges.

Replace all gates / sliding doors along the means of egress with side-hinged, swinging egress doors.

If locks are required for security reasons, utilize special door locking features complying with NFPA 101.

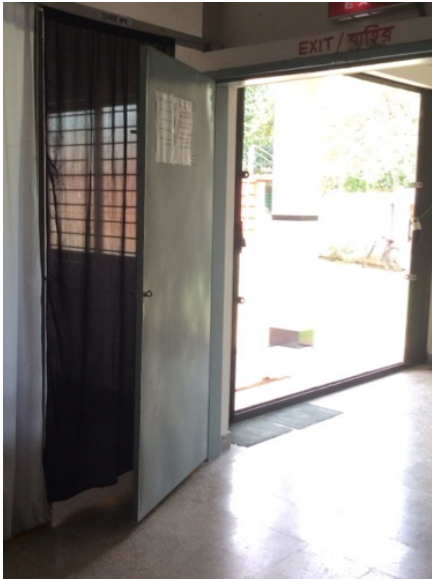
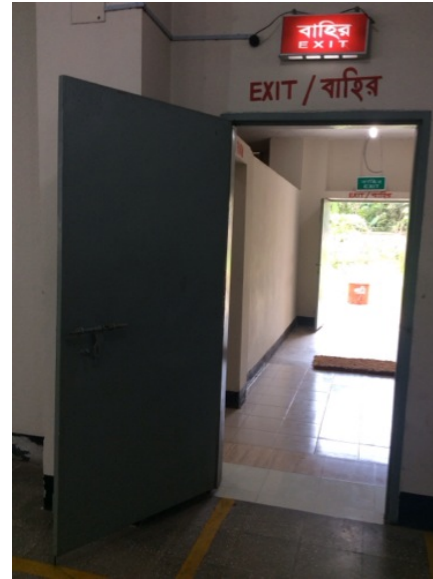
F-6	Egress	The western and north eastern exit stair door does not swing in the direction of egress travel.	Modify the egress door to swing in the direction of egress travel.	Within 3 months
-----	--------	---	--	-----------------
