FIRE SAFETY INSPECTION REPORT

TEXTOWN LIMITED

DEWAN IDRIS ROAD, BARA RANGAMATIA, ASHULIA

March 25, 2014

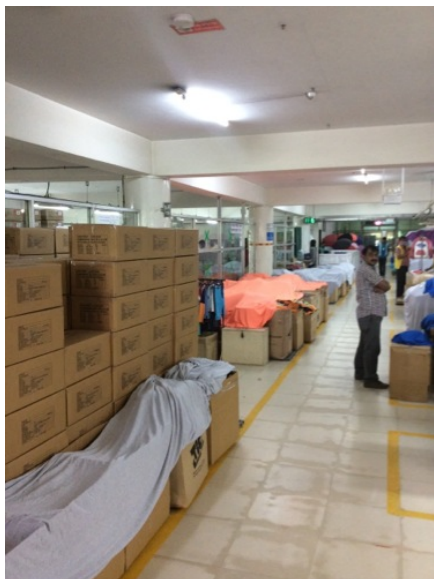
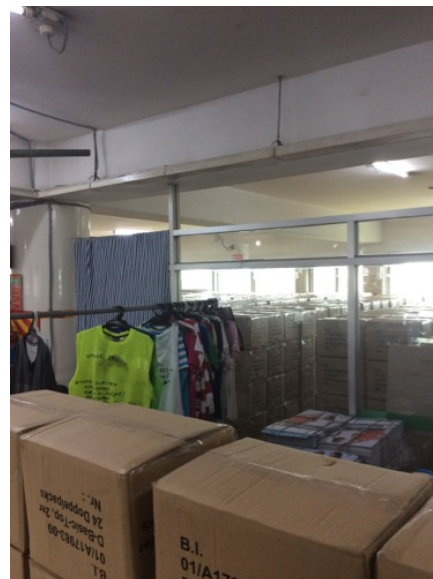
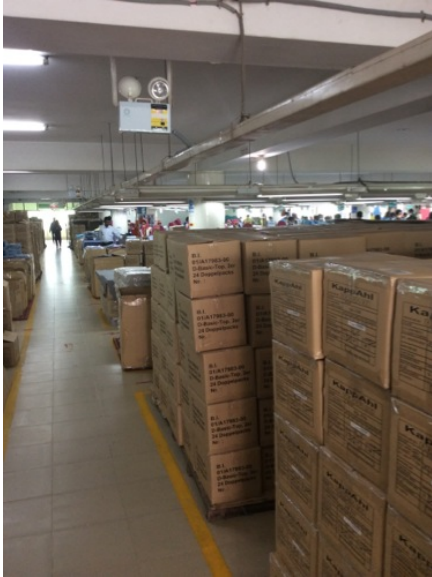
No.	Category	Finding	Recommendation	Remediation Timeframe
F-1	Fire Rated Construction	Areas used for combustible storage are not separated by fire-rated construction. Half height walling, non rated fire doors and combustible storage open to the first floor.	<p>Provide dedicated storage rooms separated by minimum 1-hr fire-rated construction.</p> <p>Where separate storage rooms are not feasible, provide defined storage areas and limit the storage arrangement as follows:</p> <ul style="list-style-type: none"> - Maximum height of 2.4m and maximum area of 23m² - If sprinkler protected: maximum height of 3.66m and maximum area of 93m² <p>Separate areas of unenclosed combustible storage by a minimum clear distance of 3m.</p>	Within 3 months

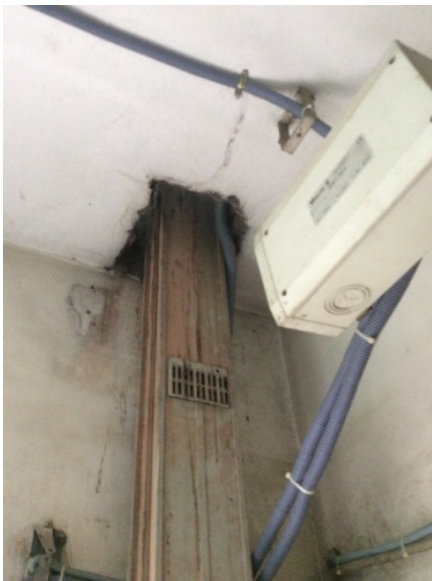
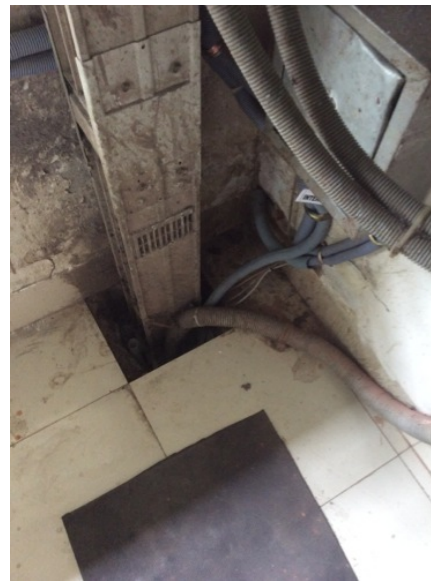
F-2	Fire Rated Construction	Unsealed penetrations and openings are located in the fire-rated floor/ceiling assemblies, Electrical shaft open to all Texttown occupied floors.	Provide a minimum 2-hr fire-rated shaft to separate the utility risers from each floor level. Seal all penetrations and openings in floor/ceiling assemblies to maintain the fire separation.	Within 3 months
-----	-------------------------	---	--	-----------------

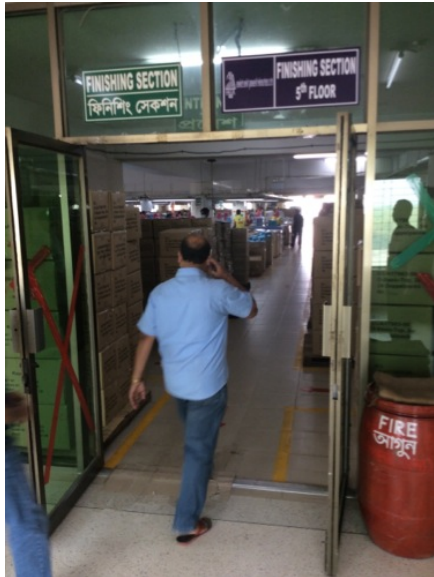
F-3	Fire Rated Construction	Unsealed penetrations and openings are located in exit stair enclosures.	Seal all penetrations and openings in exit stair enclosure walls to maintain the fire separation.	Within 3 months
-----	-------------------------	--	---	-----------------

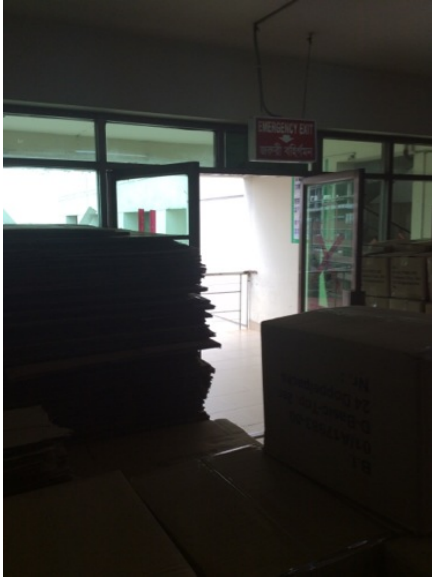
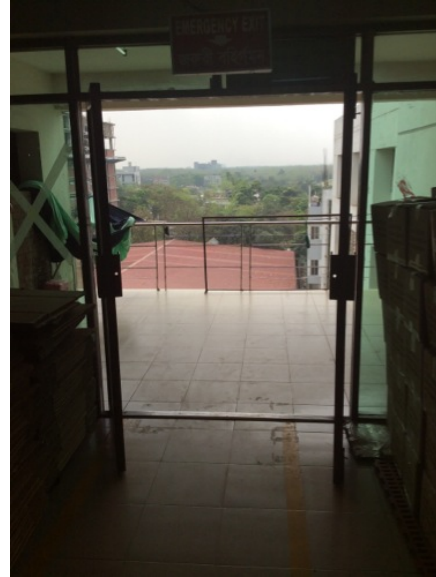
F-4	Fire Rated Construction	The exit stairs are not separated from work areas, other spaces on each floor by fire-rated construction.	Provide minimum 1.5-hr fire rated doors and seal all unprotected openings to separate the exit stairs from work areas and other building spaces on all floor levels. Ensure that the fire doors are self-closing and positive latching and that they are provided with fire exit (panic) hardware where serving production floors. If fire doors are required to be held open for functional reasons, provide automatic-closing devices tied to the fire alarm system.	Within 3 months
-----	-------------------------	---	---	-----------------

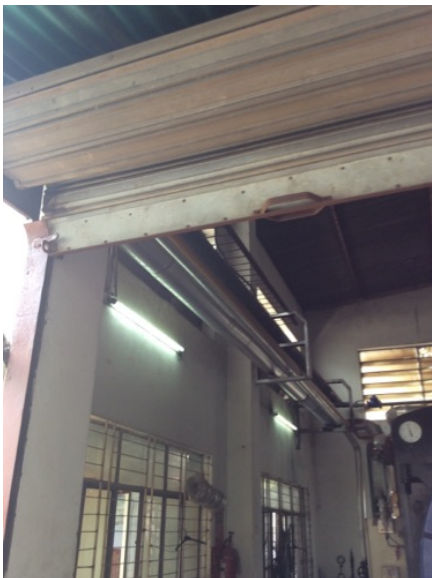
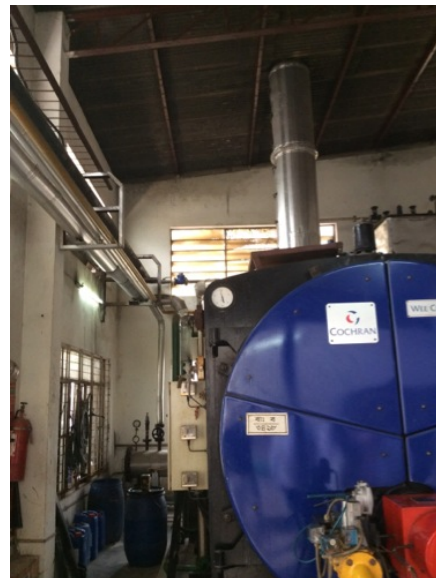
F-5	Fire Rated Construction	The boiler and generator room is not separated by fire-rated construction. Openings, non-rated doors and penetrations are present at both locations open to egress paths.	Separate the boiler / generator room by a minimum 2-hr fire-rated construction. Seal and/or protected all openings to maintain the required fire separations	Within 3 months
-----	-------------------------	---	--	-----------------

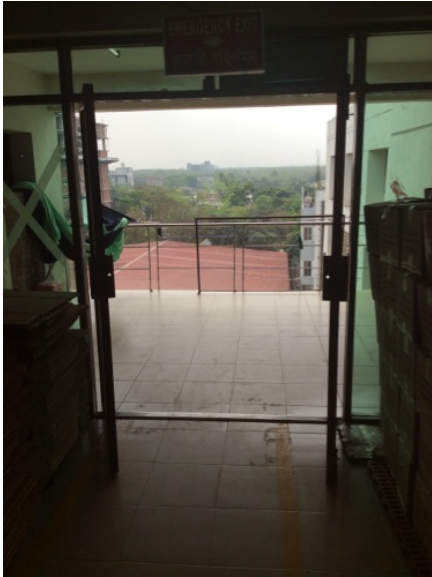
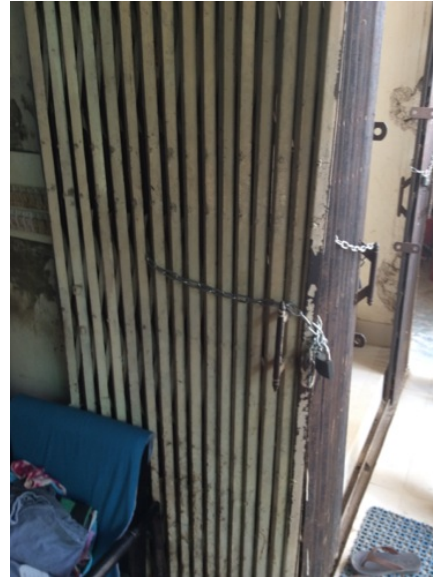
F-6	Egress	Egress doors & gates with locking features are provided at all building exits, exit stairs, along egress routes and exit discharge. All doors were open and unlocked during the inspection.	Remove locking features from all egress doors / gates. If locks are required for security reasons, utilize special door locking features complying with NFPA 101.	Immediate
-----	--------	---	--	-----------

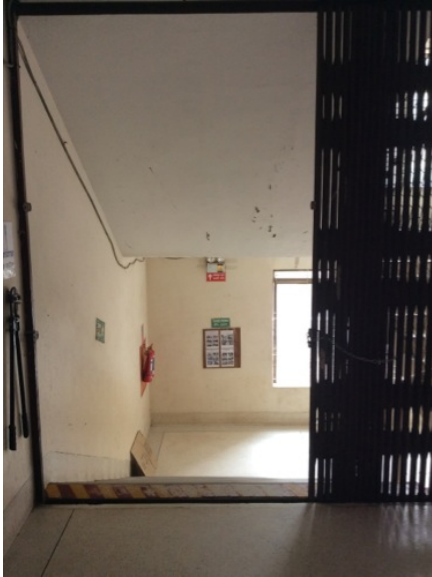
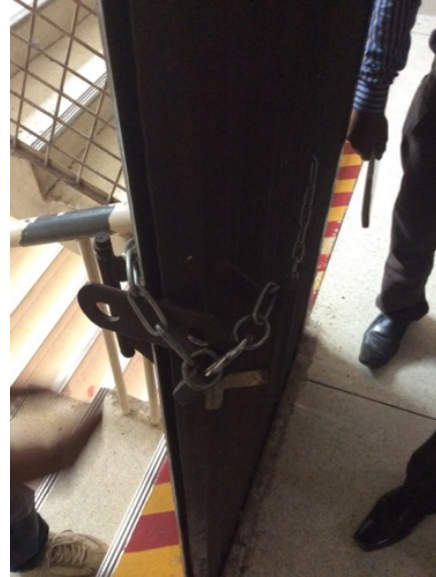
F-8	Egress	Collapsible gates & sliding doors are provided at building exits, exit stairs, along egress routes and main exit discharge throughout Building 1.	Replace all gates / sliding doors along the means of egress with side-hinged, swinging egress doors. If locks are required for security reasons, utilize special door locking features complying with NFPA 101.	Within 1 month
-----	--------	---	--	----------------

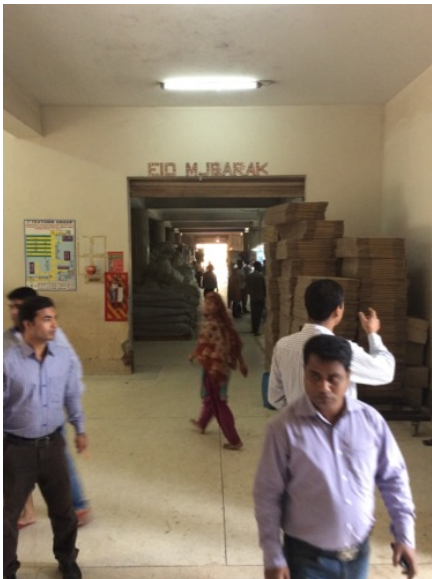
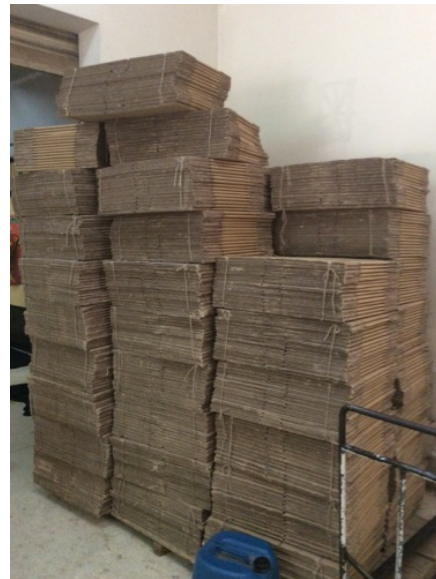
F-9	Egress	Storage was located in the egress path at ground level adjacent with the dying shed egress point.	Keep egress paths and stairs clear of storage.	Within 3 months
-----	--------	---	--	-----------------

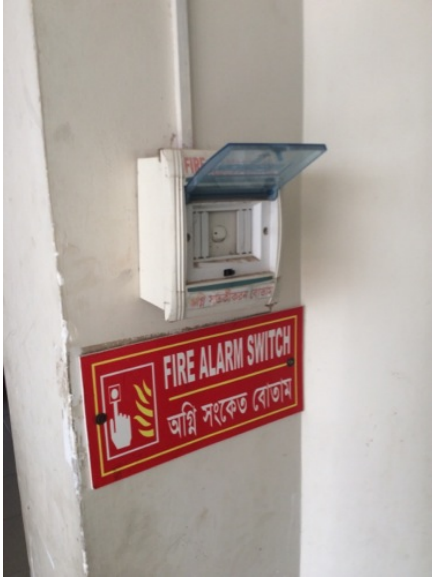
F-10	Fire Protection	The fire alarm system is antiquated, not a listed system, and does not provide alarm and notification features consistent with acceptable standards.	Replace the fire alarm system with a new, listed addressable fire alarm system in accordance with NFPA 72.	Design within 4 months, install within 9 months
------	-----------------	--	--	---

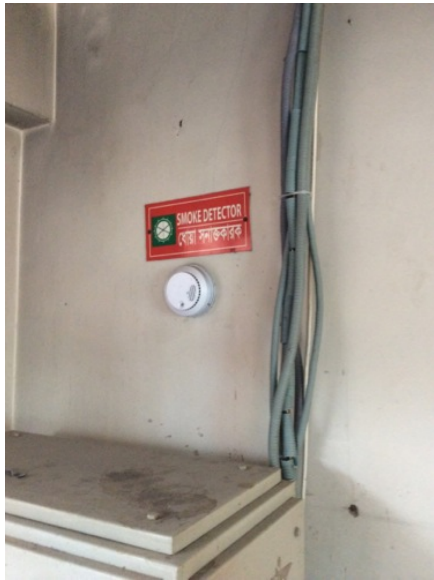
F-11	Fire Protection	Inspection, testing, and maintenance of the fire alarm system is not in accordance with NFPA 72.	Inspect, test and maintain the fire alarm system, and keep written records on-site, in accordance with NFPA 72.	Within 3 months
F-12	Fire Protection	The building is equipped with single-station smoke alarms. Smoke alarm activation sounds only a local alarm and does not provide automatic fire alarm notification of occupants.	Remove single-station smoke alarms. Provide automatic smoke detection throughout the building, tied into the fire alarm system, in accordance with NFPA 72.	Within 6 months

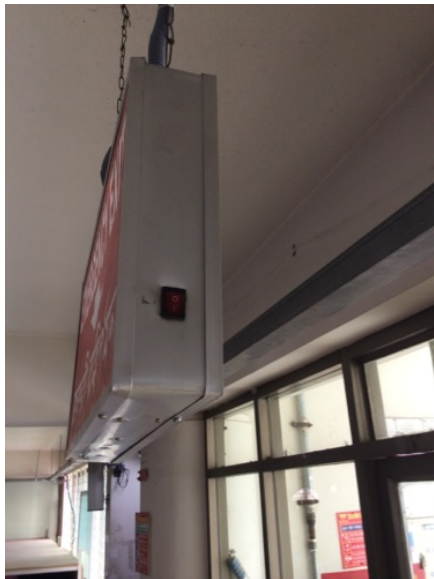
F-13	Egress Lighting	Manual on-off switch is provided for emergency lighting / exit signage units on all floors.	Remove manual on/off switches from emergency lighting / exit signage units to prevent them from being switched off.	Within 1 month
------	-----------------	---	---	----------------

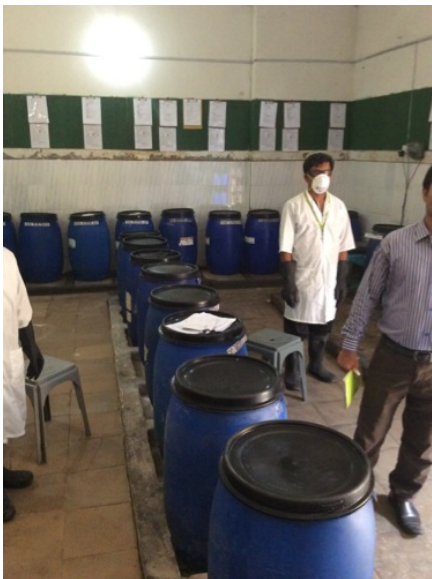
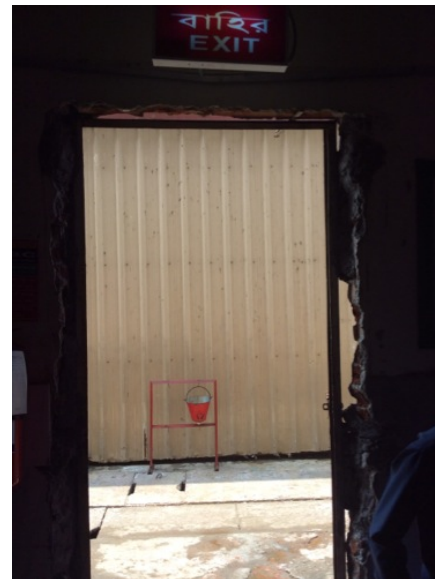
No.	Category	Finding	Recommendation	Remediation Timeframe
F-1	Fire Rated Construction	Hazardous materials and flammable liquid storage area located on the ground floor is not separated by fire-rated construction. Openings, non-rated doors and penetrations present located on the ground floor.	Separate the hazardous materials / flammable liquid storage room by a minimum 2-hr fire-rated construction. Seal and/or protected all openings to maintain the required fire separations.	Within 3 months

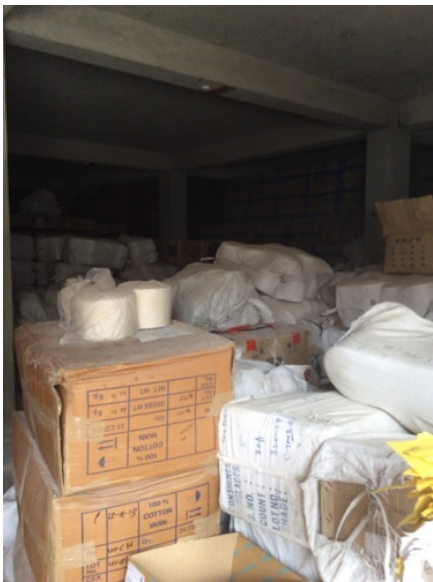
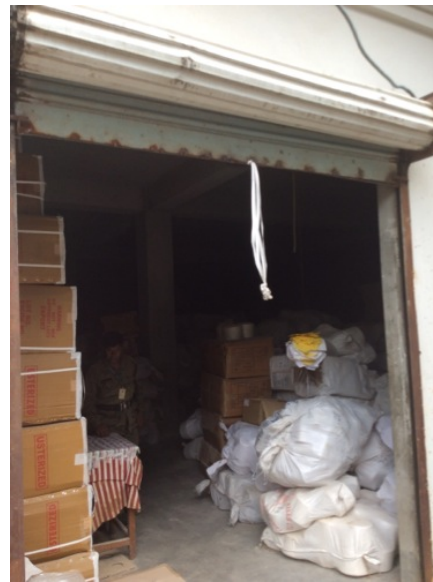
F-2	Fire Rated Construction	Areas used for combustible storage on the ground floor are not separated by fire-rated construction, roller shutters are used for entry to and from the storage space.	<p>Provide dedicated storage rooms separated by minimum 1-hr fire-rated construction.</p> <p>Where separate storage rooms are not feasible, provide defined storage areas and limit the storage arrangement as follows:</p> <ul style="list-style-type: none"> - Maximum height of 2.4m and maximum area of 23m² - If sprinkler protected: maximum height of 3.66m and maximum area of 93m² <p>Separate areas of unenclosed combustible storage by a minimum clear distance of 3m.</p>	Within 3 months
-----	-------------------------	--	--	-----------------

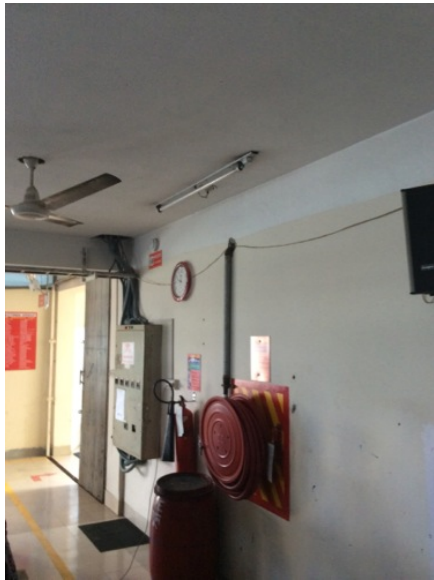
F-3	Fire Rated Construction	Unsealed penetrations and openings are located in the fire-rated floor/ceiling assemblies.	<p>Provide a minimum 2-hr fire-rated shaft to separate the utility risers from each floor level.</p> <p>Seal all penetrations and openings in floor/ceiling assemblies to maintain the fire separation.</p>	Within 3 months
-----	-------------------------	--	---	-----------------

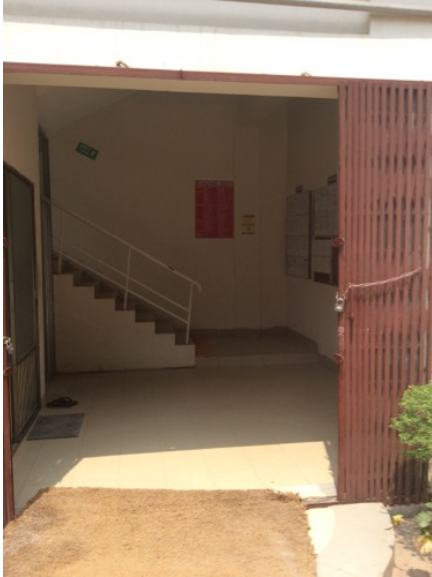
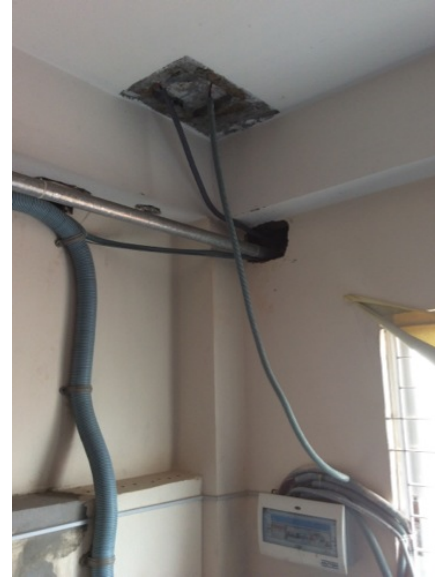
F-4	Fire Rated Construction	The exit stairs are not separated from work areas, other spaces on each floor by fire-rated construction. Steel gated sliding doors are present on each floor.	Provide minimum 1.5-hr fire rated doors and seal all unprotected openings to separate the exit stairs from work areas and other building spaces on all floor levels. Ensure that the fire doors are self-closing and positive latching and that they are provided with fire exit (panic) hardware where serving production floors.	Within 3 months
			If fire doors are required to be held open for functional reasons, provide automatic-closing devices tied to the fire alarm system.

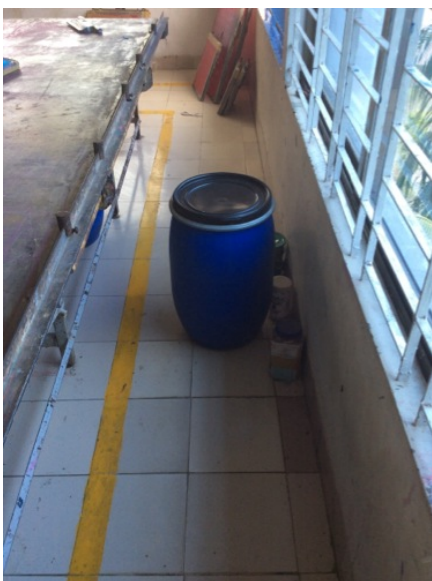
F-6	Egress	Storage was located in the egress path on the Third floor.	Keep egress paths and stairs clear of storage.	Immediate
-----	--------	--	--	-----------

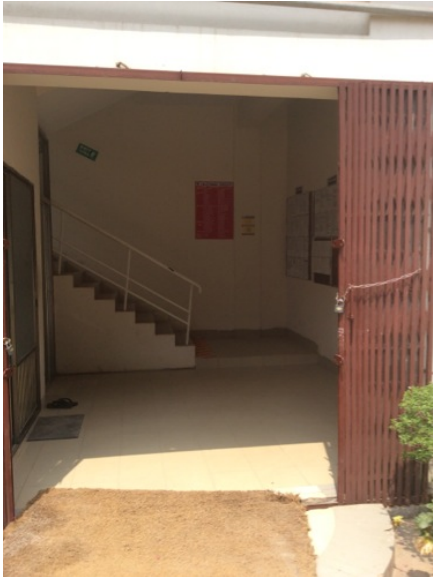
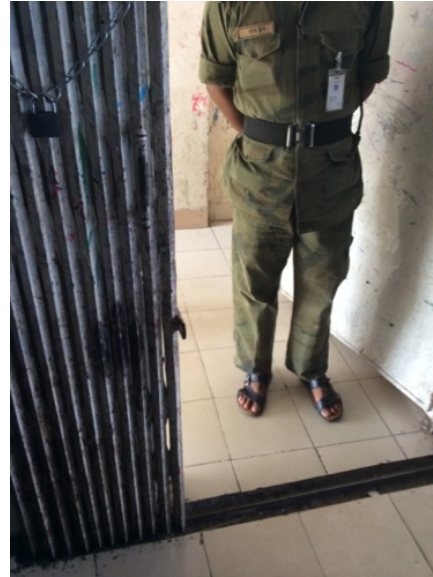
F-7	Egress	Egress doors gates with locking features are provided at building exits and main exit discharge. All gates/doors were open and unlocked during the inspection.	Remove locking features from all egress doors / gates. If locks are required for security reasons, utilize special door locking features complying with NFPA 101.	Immediate
-----	--------	--	--	-----------

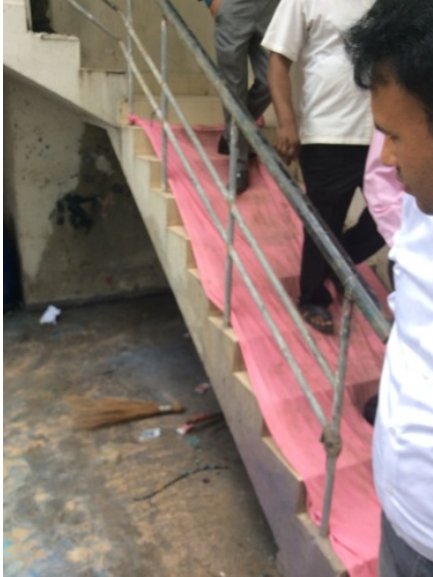
F-8	Egress	Fabric material has been fixed to stair risers and treads creating tripping and slipping hazard at the rear exit stairwell to the ground floor.	Remove fabric from stair treads	Immediate
-----	--------	---	---------------------------------	-----------

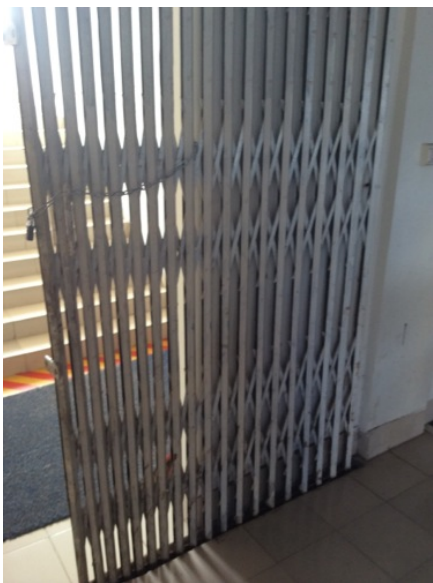
F-9 Egress

Collapsible gates / sliding doors are provided at building exits and main exit discharge points.

Replace all gates / sliding doors along the means of egress with side-hinged, swinging egress doors.

If locks are required for security reasons, utilize special door locking features complying with NFPA 101.

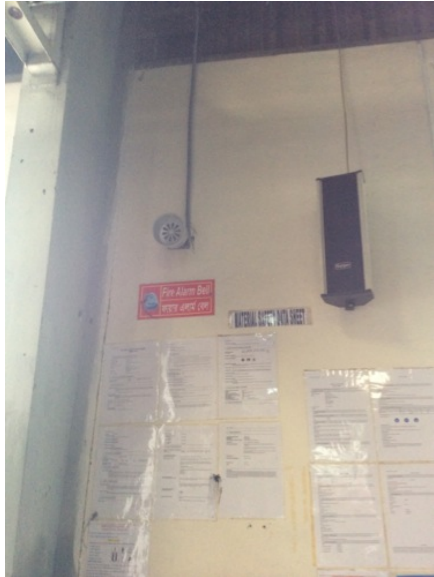
F-10	Fire Protection	Activation of the fire alarm system by a manual fire alarm station provides automatic occupant notification only on the floor of alarm and not throughout the building.	Configure the fire alarm system to initiate automatic occupant notification on all floor levels to facilitate whole-building evacuation upon any manual fire alarm station activation.	Within 1 months
------	-----------------	---	--	-----------------

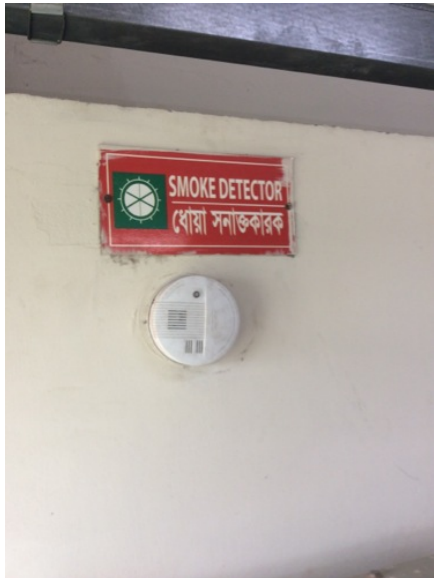
F-12	Fire Protection	The building is equipped with single-station smoke alarms. Smoke alarm activation sounds only a local alarm and does not provide automatic fire alarm notification of occupants.	Remove single-station smoke alarms. Provide automatic smoke detection throughout the building, tied into the fire alarm system, in accordance with NFPA 72.	Within 6 months
------	-----------------	--	---	-----------------

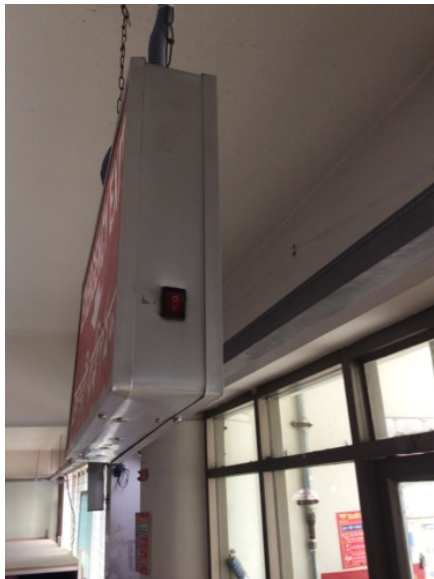
F-13	Egress Lighting	Manual on-off switch is provided for emergency lighting / exit signage units throughout the factory floors.	Remove manual on/off switches from emergency lighting / exit signage units to prevent them from being switched off.	Within 1 month
------	-----------------	---	---	----------------

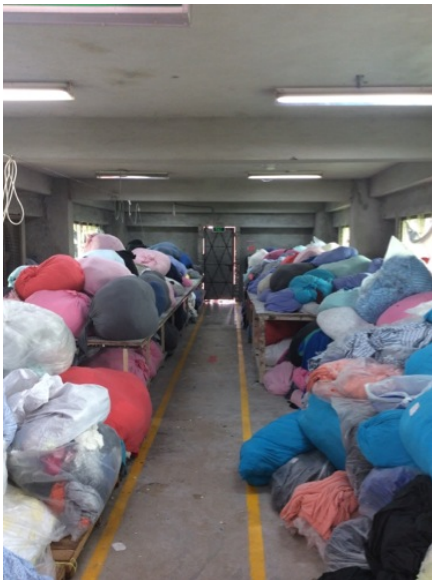
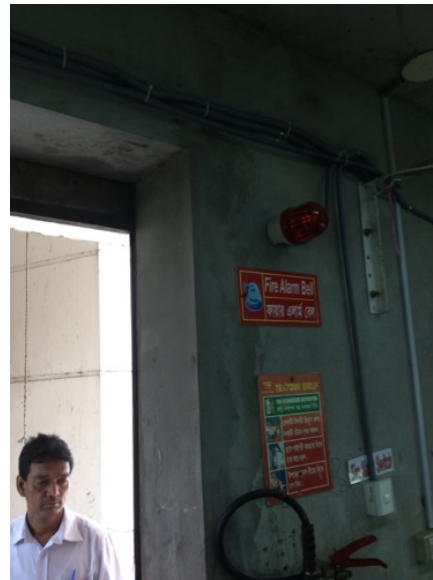
F-1	Fire Rated Construction	Areas used for combustible storage are not separated by fire-rated construction on the third floor, both exit doors are non fire rated.	Provide dedicated storage rooms separated by minimum 1-hr fire-rated construction.	Within 3 months
-----	-------------------------	---	--	-----------------

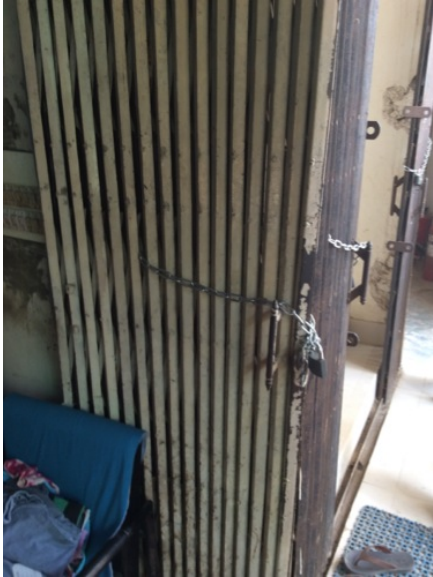
F-2	Egress	Egress doors and gates with locking features are provided at all building exits, exit stairs, along egress routes and main exit discharge. The doors were open and unlocked during the inspection.	Remove locking features from all egress doors / gates. If locks are required for security reasons, utilize special door locking features complying with NFPA 101.	Immediate
-----	--------	--	--	-----------

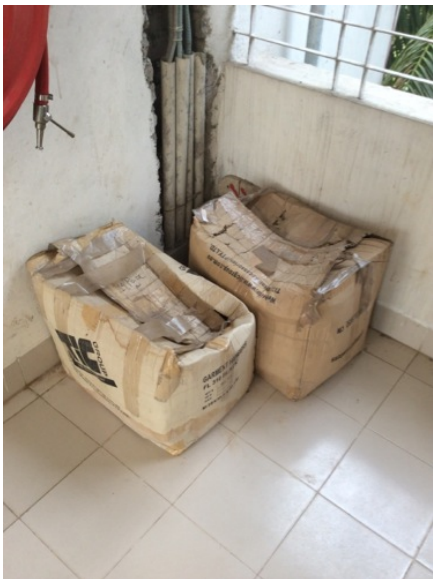
F-3	Egress	Storage was located throughout the exit stair.	Remove all storage from exit stairs and egress paths.	Immediate
-----	--------	--	---	-----------

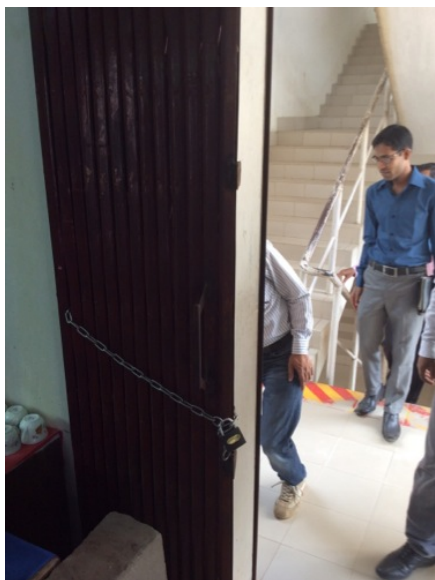
F-4	Egress	Collapsible gates and sliding doors are provided at all building exits, exit stairs, along egress routes and main exit discharge.	Replace all gates / sliding doors along the means of egress with side-hinged, swinging egress doors. If locks are required for security reasons, utilize special door locking features complying with NFPA 101.	Within 1 month
-----	--------	---	--	----------------

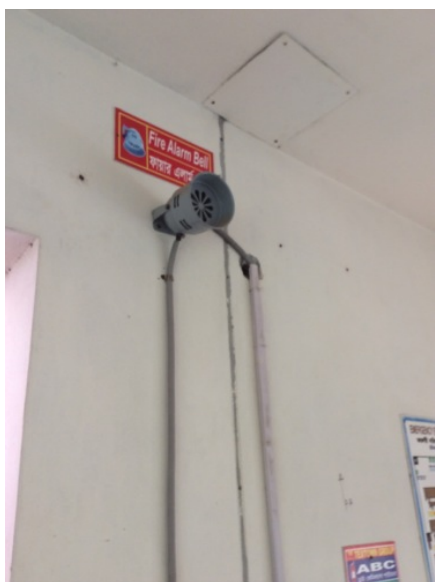
F-5	Fire Protection	The fire alarm system is antiquated, not a listed system, and does not provide alarm and notification features consistent with acceptable standards.	Replace the fire alarm system with a new, listed addressable fire alarm system in accordance with NFPA 72.	Design within 4 months, install within 9 months
-----	-----------------	--	--	---

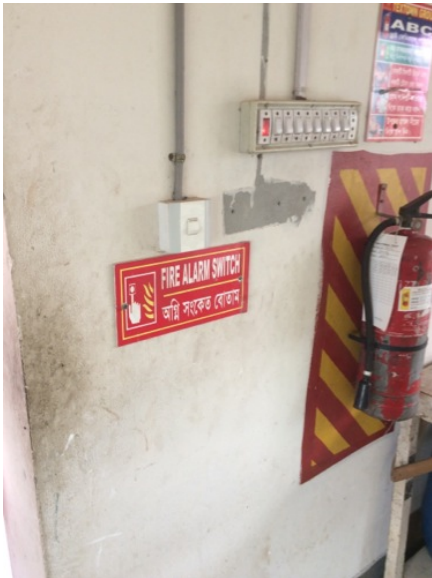
F-6	Fire Protection	Inspection, testing, and maintenance of the fire alarm system is not in accordance with NFPA 72.	Inspect, test and maintain the fire alarm system, and keep written records on-site, in accordance with NFPA 72.	Within 3 months
-----	-----------------	--	---	-----------------

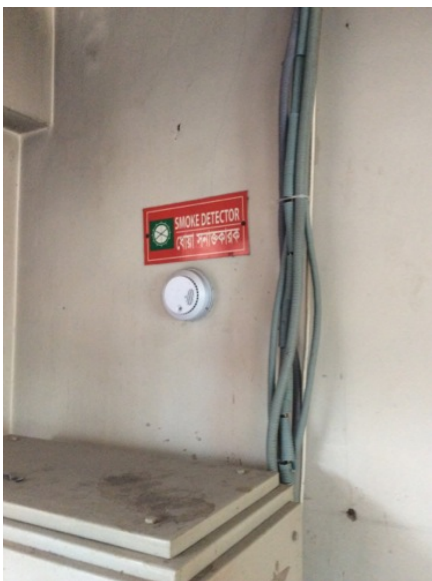
F-7	Fire Protection	The building is equipped with single-station smoke alarms. Smoke alarm activation sounds only a local alarm and does not provide automatic fire alarm notification of occupants.	Remove single-station smoke alarms. Provide automatic smoke detection throughout the building, tied into the fire alarm system, in accordance with NFPA 72.	Within 6 months
-----	-----------------	--	---	-----------------

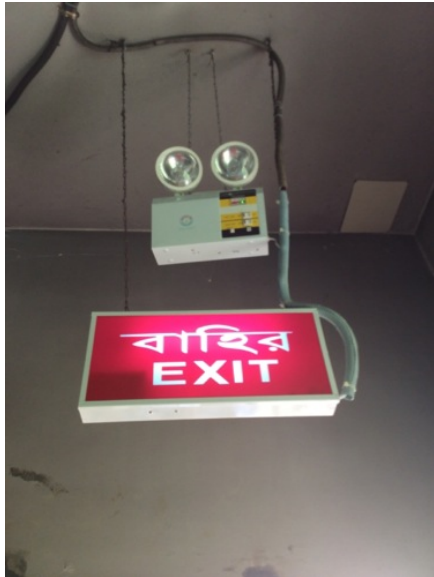
F-8	Egress Lighting	Manual on-off switch is provided for emergency lighting / exit signage units in this building.	Remove manual on/off switches from emergency lighting / exit signage units to prevent them from being switched off.	Within 1 month
-----	-----------------	--	---	----------------

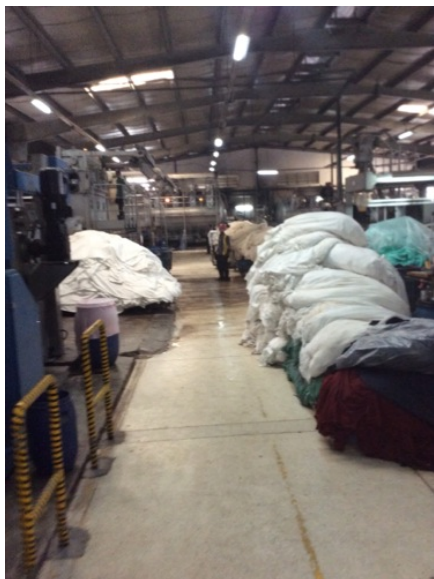
No.	Category	Finding	Recommendation	Remediation Timeframe
F-1	Fire Rated Construction	Areas used for combustible storage are not separated by fire- rated construction on the ground floor washing area.	<p>Provide dedicated storage rooms separated by minimum 1-hr fire-rated construction.</p> <p>Where separate storage rooms are not feasible, provide defined storage areas and limit the storage arrangement as follows:</p> <ul style="list-style-type: none"> - Maximum height of 2.4m and maximum area of 23m² - If sprinkler protected: maximum height of 3.66m and maximum area of 93m² <p>Separate areas of unenclosed combustible storage by a minimum clear distance of 3m.</p>	Within 3 months

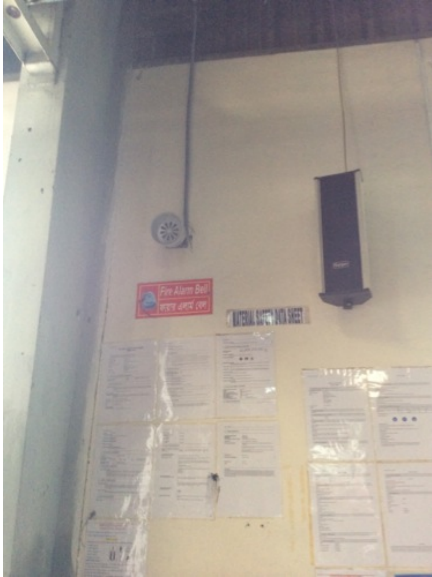
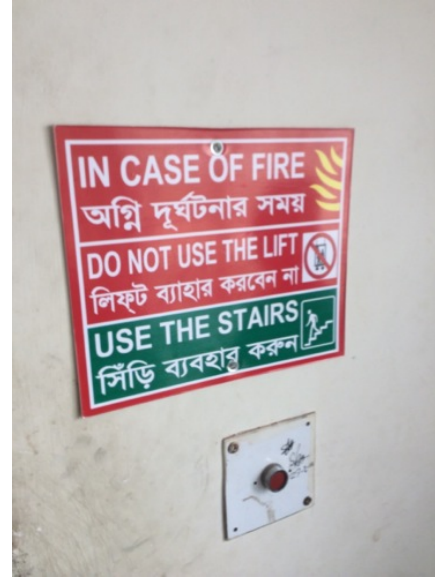
F-3	Fire Protection	The fire alarm system is antiquated, not a listed system, and does not provide alarm and notification features consistent with acceptable standards.	Replace the fire alarm system with a new, listed addressable fire alarm system in accordance with NFPA 72.	Design within 4 months, install within 9 months
-----	-----------------	--	--	---

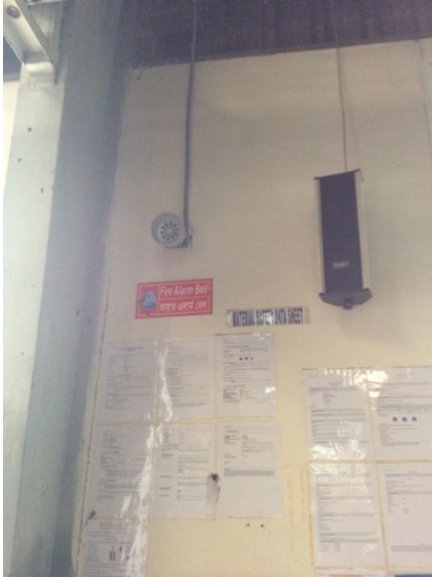
F-4	Fire Protection	Inspection, testing, and maintenance of the fire alarm system is not in accordance with NFPA 72.	Inspect, test and maintain the fire alarm system, and keep written records on-site, in accordance with NFPA 72.	Within 3 months
F-5	Fire Protection	The fire alarm system at present does not appear to provide adequate audible notification coverage required for the decibel levels the production on this factory floor creates.	Provide additional notification appliances such that the fire alarm system is audible throughout the building in accordance with NFPA 72.	Within 6 months

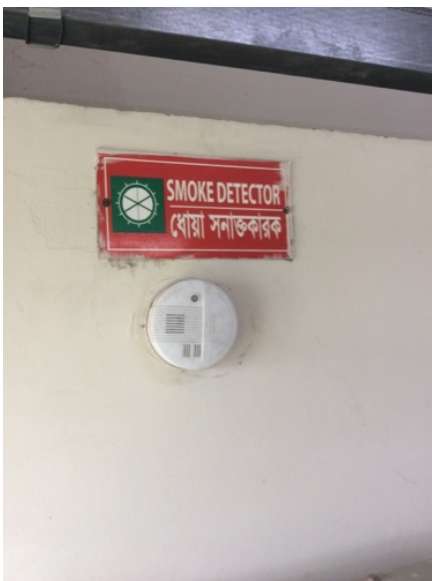
F-6	Fire Protection	The building is equipped with single-station smoke alarms. Smoke alarm activation sounds only a local alarm and does not provide automatic fire alarm notification of occupants.	Remove single-station smoke alarms. Provide automatic smoke detection throughout the building, tied into the fire alarm system, in accordance with NFPA 72.	Within 6 months
-----	-----------------	--	---	-----------------

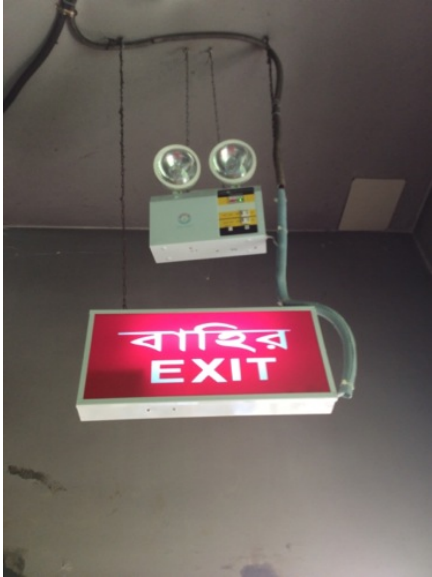
F-7	Egress Lighting	Manual on-off switch is provided for emergency lighting / exit signage units on the ground and mezzanine level of this shed building.	Remove manual on/off switches from emergency lighting / exit signage units to prevent them from being switched off.	Within 1 month
-----	-----------------	---	---	----------------

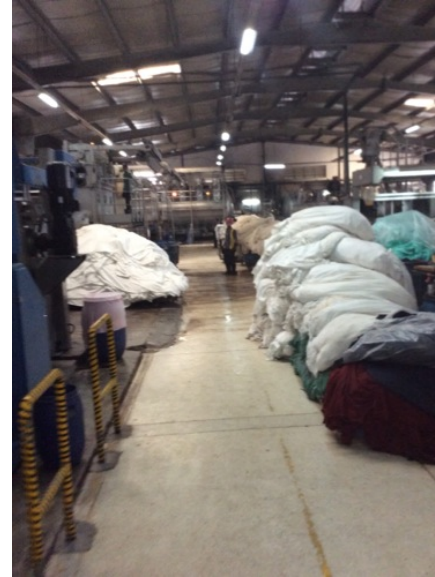
F-8	Egress Lighting	Based on the number and location of emergency lights observed, adequate illumination levels are not anticipated along egress routes at ground floor level.	Test the emergency lighting system on each floor and provide additional emergency fixtures to provide adequate illumination along the means of egress. Provide a minimum illumination of 10 lux at the floor level within exit stairs and exit discharge paths and minimum 2.5 lux along exit access aisles.	Within 3 months
-----	-----------------	--	--	-----------------
