INITIAL FIRE SAFETY INSPECTION REPORT

SP Garments Ltd (Extension 2)

RSC ID: 25771

Date: 07-Oct-2024

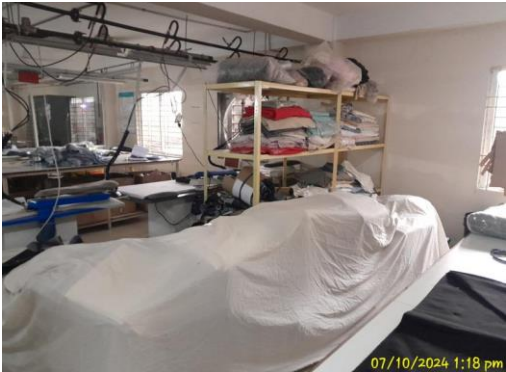
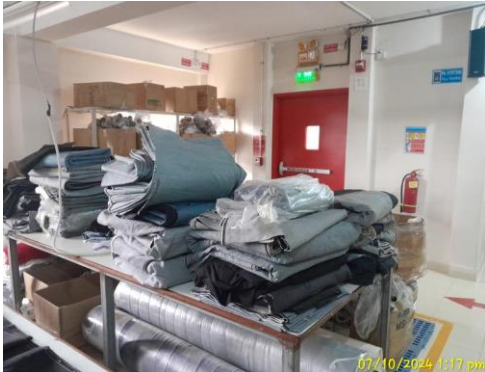
SI No.	Category	Findings	Required Action	Remediation Time Frame
F-1	Fire rated Construction	<p>Areas used for combustible storage open to the factory are not maintained or separated by fire-rated construction.</p> <p>Location: Ground floor</p>	<p>Separate the dedicated storage rooms by minimum 1-hr fire-rated construction. Provide 0.75 hr. fire rated door and seal all penetrations and openings by 1 hr. fire rated fire rated barrier construction.</p> <p>Or</p> <p>Where separate storage rooms are not feasible, provide defined storage areas and limit the storage arrangement as follows: -</p> <ul style="list-style-type: none"> - Maximum height of 2.45m (8ft.) , maximum area of 23m2 (250 ft2) and 3m (10ft.) clear distance from adjacent another unenclosed combustible storage. - If the building/floor is sprinkler protected: maximum height of 3.66m (12ft.) and maximum area of 93m2 (1000 ft2). -In process storage shall be limited to 10 percent of the building area of the story in which they occur. 	Within 3 months

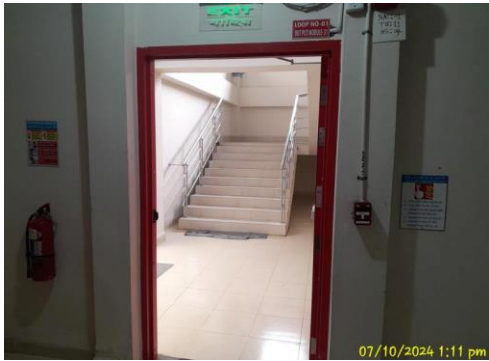
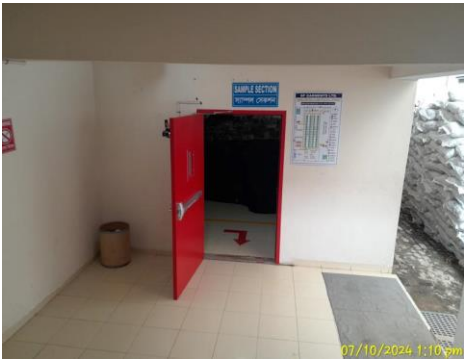
F-2	Mean of Egress	<p>Exit stairs are not separated from work areas & other spaces on each floor by fire-rated construction due to fire door interfacing with the FACP has not been completed yet.</p> <p>Location: Ground floor.</p>	<p>Separate the exit stairs from work areas and other building spaces on all floor levels by minimum 2- hr. fire-rated construction for fewer stories & 1 -hr. fire rated construction for buildings with 3 stories.</p> <p>Provide minimum 1-hr rated doors for buildings with 3 or fewer stories and 1.5-hr fire-rated doors for buildings that are 4 or more stories. Seal all unprotected openings to separate the exit stairs from work areas and other building spaces on all floor levels. Ensure that all fire doors are self-closing and positive latching, and are provided with fire exit (panic) hardware where serving production floors or assembly occupancies.</p> <p>If fire doors are required to be held open for functional reasons, provide automatic closing devices tied to the fire alarm system. Once fire doors are installed, every door in a stair enclosure serving more than 5 stories shall be provided with re-entry unless it meets RSC Technical Guidelines (Standard) 6.8.3.1.</p>	Within 3 months

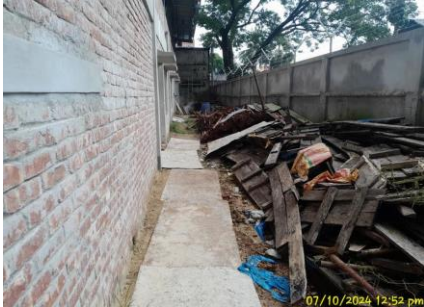
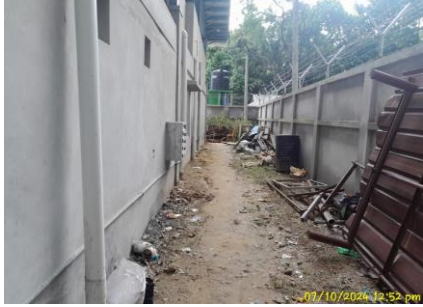
F-3	Mean of Egress	<p>Uneven path of travel and blockage in exit discharge path due to construction purposes.</p> <p>Locations: South exit discharge path.</p>	<p>Remove unnecessary items and level exit path to the public way. Means of egress shall be maintained continuously free and clear of all obstructions</p>	Within 2 months

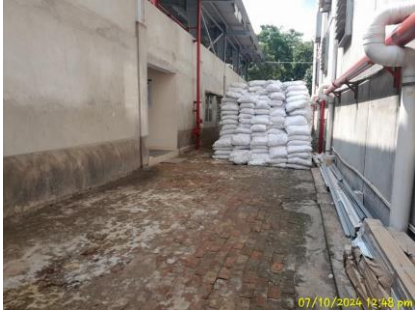
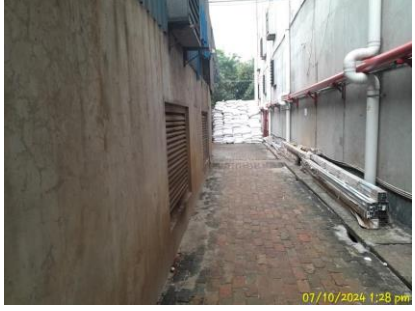
F-4	Means of Egress	<p>The exit discharge path from the south exit discharge continuing through the north side of the building is not separated from the exterior openings within 10 ft due to the adjacent temporary storage area & openings from the utility building.</p> <p>Location: North exit discharge route</p>	<p>Egress courts less than 3050 mm (10 ft) in width (as measured from the building and the adjacent property line) shall be provided with walls having a 1-hr fire resistance rated construction for a distance of 3050 mm (10 ft) above the floor of the court.</p>	Within 3 months
		<div style="display: flex; justify-content: space-around;">

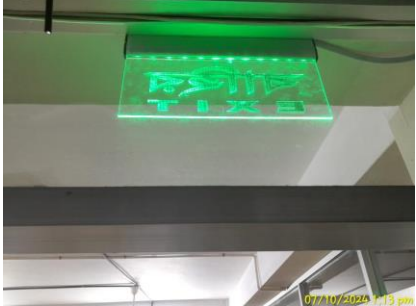
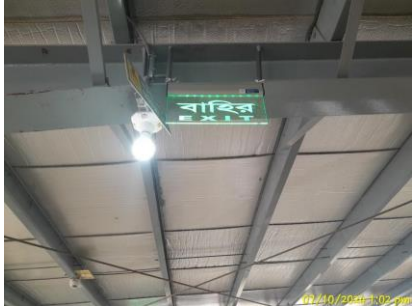
F-7	Means of Egress	<p>Directional Exit signage was not provided along the path of egress where there is a change in the direction for the path of travel and the direction to an exit is not obvious.</p> <p>Locations: All floors</p>	<p>Provide directional exit signs above all building exits to the exterior, all doors to the exit stairs and along all paths of travel where a change of direction is not obvious. Lighted directional signs shall be provided with either battery backup or uninterruptable power supply systems and shall be continuously illuminated.</p>	Within 1 month
F-8	Means of Egress	<p>Some illuminated exit signs were illuminated from both sides (transparent) which may misguide the occupant to a direction of exit where there is none.</p> <p>Locations: All floors</p>	<p>Ensure that lighted exit signs are only visible from the side that directs people toward an exit path.</p>	Within 1 month

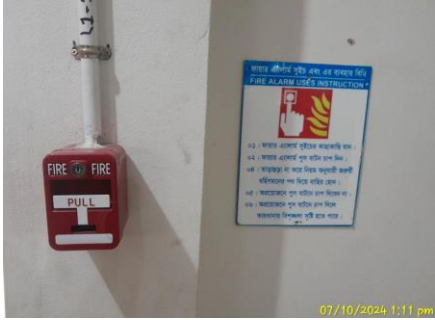
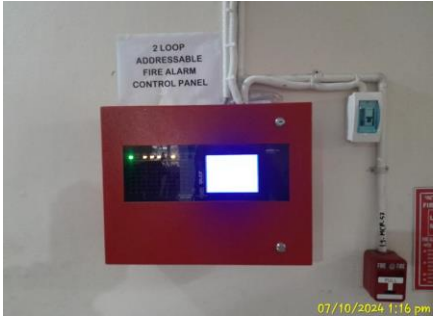
<p>F-9</p>	<p>Fire Alarm & Detection System (FADS)</p>	<p>Automatic fire alarm & detection system installation requires detailed review to confirm compliance with NFPA 72 and RSC standards.</p>	<p>Design & Installation of Fire Alarm & Detection system shall be in accordance with RSC standard and NFPA 72. Submit as-built design, documents and calculations to RSC for review prior installation/modification.</p> <p>After installation/modification, the owner shall contact the RSC for witness of conducting the final acceptance testing of the fire detection & alarm system installation.</p> <p>Also inspect, test and maintain the fire alarm system, and keep written records on-site, in accordance with NFPA 72.</p>	<p>Design Review within 2 months and installation within 4 months.</p>
<div style="display: flex; justify-content: space-around;">
