# INITIAL FIRE SAFETY INSPECTION REPORT

**TS Casual Wear Limited**

**RSC ID: 25934**

**Date: 24-November-2024**

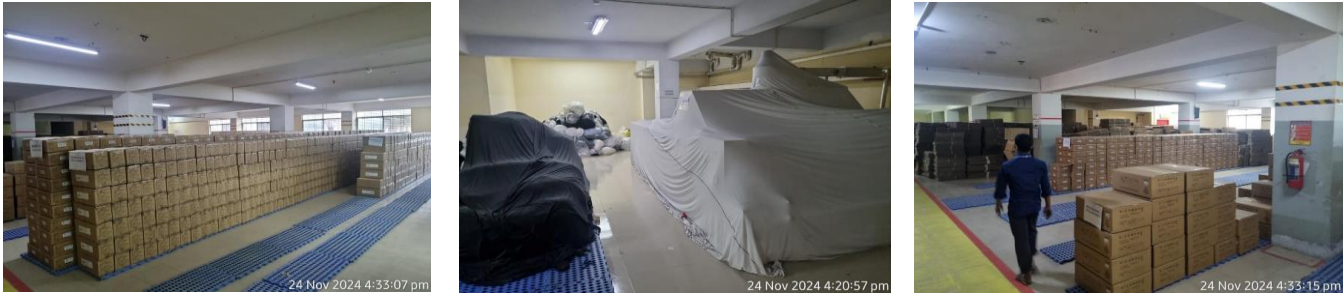
SI No.	Category	Findings	Required Action	Remediation Time Frame
F-01	Fire rated Construction	<p>Areas used for combustible storage are open to the factory floor area and are not separated by fire rated construction.</p> <p>Location: 2nd and 4th floor of Building-1.</p>	<p>Provide dedicated storage rooms separated by a minimum 1-hr fire-rated construction. Provide minimum 0.75 hr. fire rated doors and seal all penetrations and openings by 1 hr. fire rated barrier construction.</p> <p>Where separate storage rooms are not feasible, provide defined storage areas and limit the storage arrangement as follows: -</p> <ul style="list-style-type: none"> <li>- Maximum height of 2.45m (8ft.) , maximum area of 23m<sup>2</sup> (250 ft<sup>2</sup>) and 3m (10ft.) clear distance from adjacent another unenclosed combustible storage.</li> <li>- If the building/floor is sprinkler protected: maximum height of 3.66m (12ft.) and maximum area of 93m<sup>2</sup> (1000 ft<sup>2</sup>) and 3m (10ft.) clear distance from adjacent another unenclosed combustible storage.</li> </ul>	Within 2 months

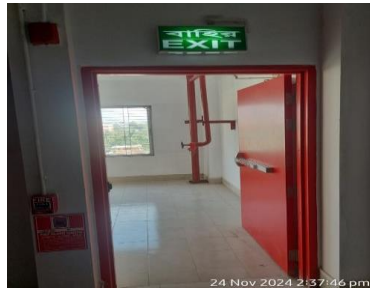
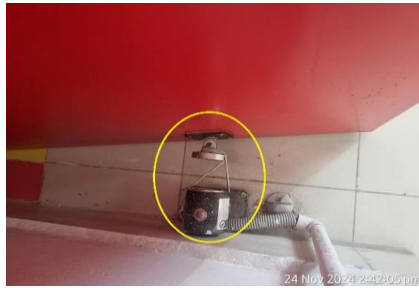
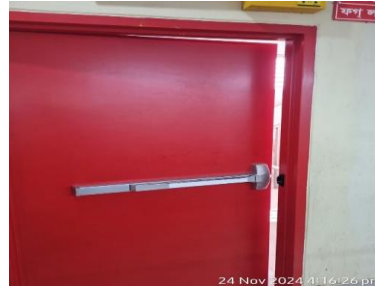
F-02	Means of egress	<p>The exit stairs are not separated from work areas and other spaces on each floor by fire rated construction due to non-functional fire rated doors. Several fire doors did not latch properly. A few fire doors were found tied open by ropes. The fire door interfacing work has not been fully completed.</p> <p>Location: Building-1.</p>	<p>The exit stair enclosure shall be provided with a minimum 2- hr. fire resistance rating for buildings four (4) stories or more. Provide a minimum 1.5 hr. fire rated door and seal all penetrations and openings by 2 hr. fire rated barrier construction for building with 4 or more stories.</p> <p>Ensure that the fire doors are self-closing and positive latching and that they are provided with fire exit (panic) hardware where serving production floors. If fire doors are required to be held open for functional reasons, provide automatic closing devices tied to the fire alarm system.</p>	Within 2 months

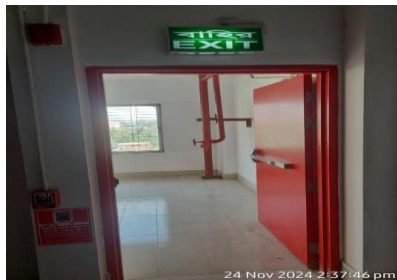
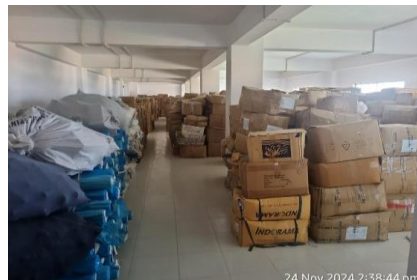
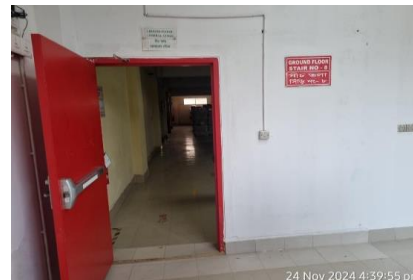
F-03	Means of egress	<p>Storage rooms discharges directly into exit stair enclosure without vestibules.</p> <p>Location: Ground floor, 1st floor, 2nd floor &amp; 5th floor of Building-1.</p>	<p>Openings from the exit enclosure to the storage room, shall be provided with a vestibule with fire-rated construction and openings.</p> <p>Provide a minimum 1.5 hr. fire rated door on the exit stair side and a minimum 0.75- hr. fire rated door on the storage room side. Ensure that the fire rating of the vestibule construction matches that of the exit stair enclosure.</p> <p>The minimum width for vestibules shall not be less than 1.1 m and length 1.8 m.</p>	Within 3 months
------	-----------------	---	---	-----------------

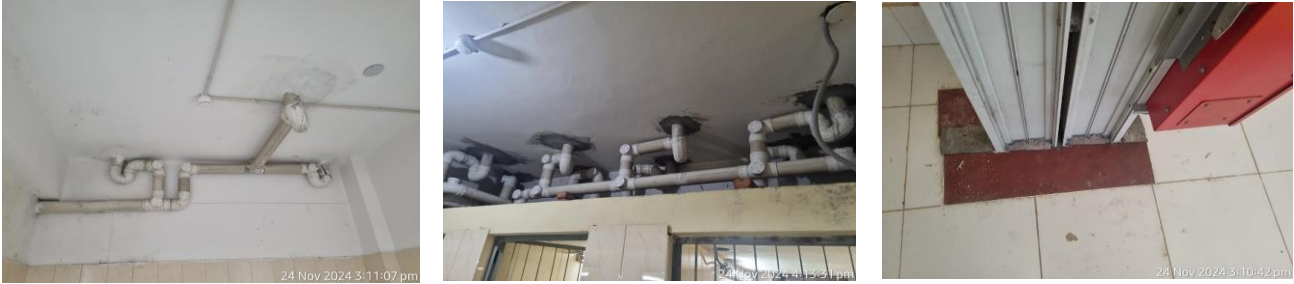
F-04	Fire rated Construction	<p>Unsealed penetrations and openings due to plastic sanitary pipe and electrical busbar risers are located in the fire-rated floor/ceiling assemblies in many places through out the building.</p> <p>Location: Building-1. Plastic pipe penetration was observed in the drinking water zone and inside mail and female toilet areas. BBT penetration was observed through all floors.</p>	<p>Provide a minimum 2-hr fire-rated shaft to separate the sanitary pipe and electrical busbar riser from each floor level. or Seal all penetrations and openings in floor/ceiling assemblies by 3-hr fire rated listed/certified materials. The installation of such fire-rated materials shall be following certified design.</p>	Within 3 months

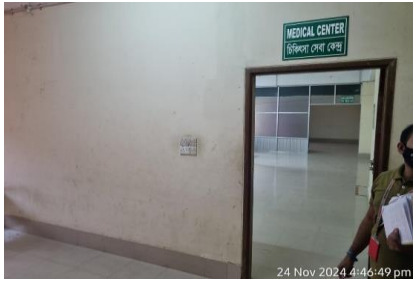
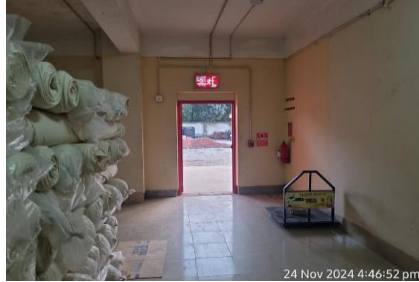
F-05	Means of egress	<p>The maximum travel distance of the daycare room was found to be more than 9 m (30 ft). The daycare room discharges the occupants inside the storage area.</p> <p>Location: Ground floor of Building-1.</p>	<p>Day-care shall be located on the ground floor with a maximum travel distance of 9 m (30 ft) or located one story above level of exit discharge with direct access to an exit enclosure. If the above is not possible provide a minimum 2-hr fire rated exit corridor between the day-care room and exit stair.</p>	Within 2 months

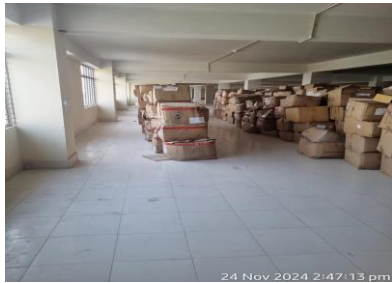
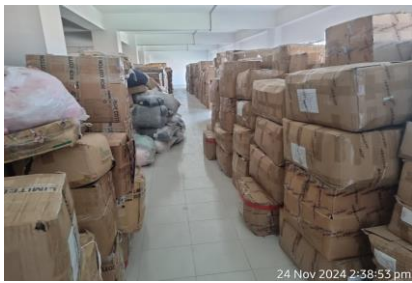
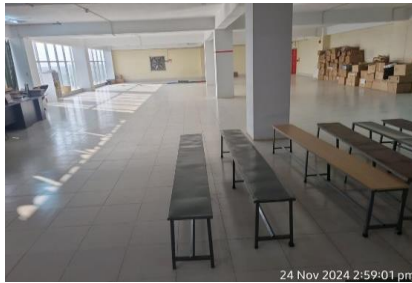
F-06	Means of egress	<p>Aisles marks were found missing on several locations throughout the building.</p> <p>Location: Building 1.</p>	<p>Provide minimum aisle widths of 36-in. Aisles mark shall be clearly visible.</p>	<p>Within 1 month</p>
------	-----------------	---	---	-----------------------

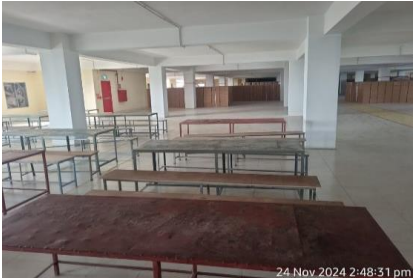
F-07	Means of egress	<p>Fire evacuation maps were not posted at the entrance to each exit stairs.</p> <p>Location: 4th floor and 5th floor of Building-1.</p>	<p>Post fire evacuation maps at the entrance to each exit stair.</p>	<p>Within 1 month</p>
F-08	Fire rated Construction	<p>Dining area (E3 occupancy) is not separated by fire-rated construction from combustible storage area.</p> <p>Location: 5th floor, Building-1.</p>	<p>Separate the dining area from the storage occupancy by a minimum 3-hr. fire rated construction with a minimum 3-hr. rated opening protectives. Seal and/or protect all openings to maintain the required fire separations. Need to ensure at least two means of exits from the dining area leading directly to the street or leading to a corridor or open space having access to exits in two independent and different direction.</p>	<p>Within 3 months</p>

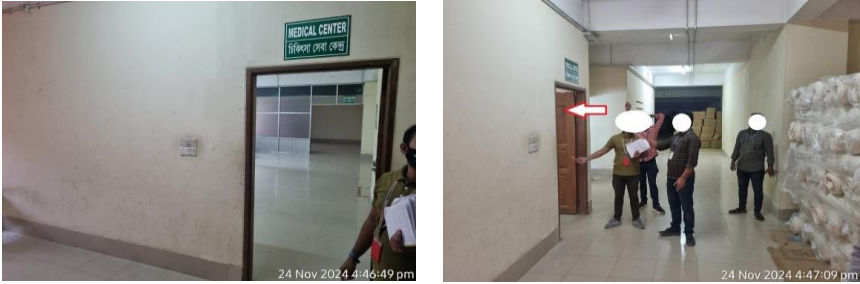
F-09	Fire rated Construction	<p>The childcare room (C1) and the Medical Room (D1) is not separated from the Fabric Store (H2) by fire rated construction.</p> <p>Location: Ground floor, Building-1</p>	<p>Separate the Childcare Room and the Medical Room from the Fabric Store by a minimum 4-hr fire rated construction. No opening assembly is permitted in a 4-hr fire rated wall.</p>	<p>Within 3 months</p>

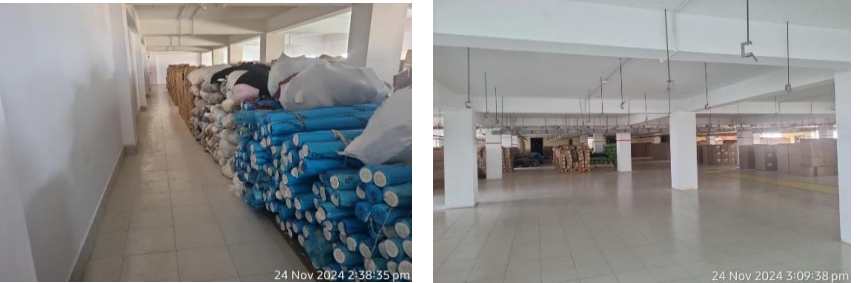
F-10	Fire Protection System	<p>The travel distance between portable fire extinguishers were found to be more than 30 m (100 ft).</p> <p>Location: 4th and 5th floor of Building-1.</p>	<p>Portable fire extinguishers shall be installed throughout all new, interim, and existing facilities in accordance with BNBC 2020 and NFPA 10. Extinguishers shall be placed so that maximum travel distance to the nearest unit shall not exceed 30 m (100 ft).</p>	Within 1 month

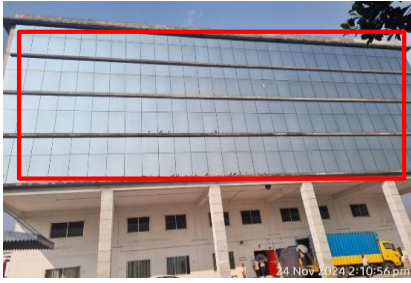
F-11	Fire rated Construction	<p>Unprotected openings were observed in the exterior wall of the building in two consecutive floors lying within 1.5 m and vertical spread of fire is not restricted.</p> <p>Location: South side of Building-1.</p>	<p>Provide flame barriers as similar as sunshades or cornices or projected wall at least 750 mm from the external face of the exterior wall.</p> <p>The flame barrier shall have a fire resistance rating of not less than three-fourths hour.</p>	Within 3 months

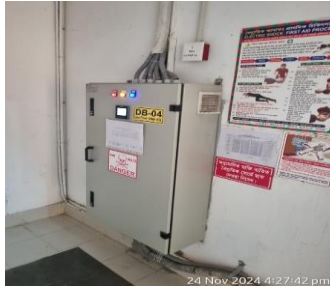
F-12	Means of egress	<p>Electrical panels were observed inside the exit stair enclosure.</p> <p>Location: Ground floor, 2nd floor and 3rd floor of stair-3, Building-1.</p>	Remove/relocate the electrical panels from the exit stair enclosures.	Within 2 months
------	-----------------	--	---	-----------------

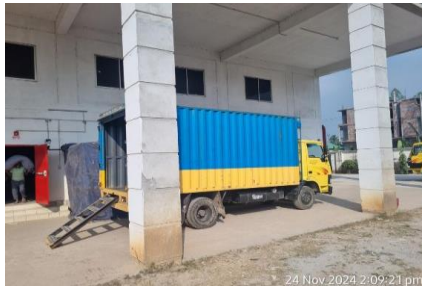
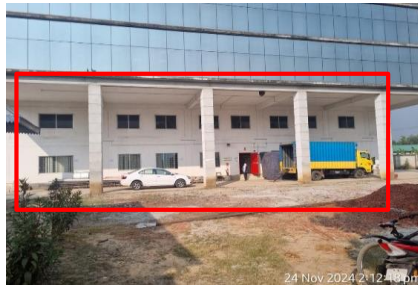
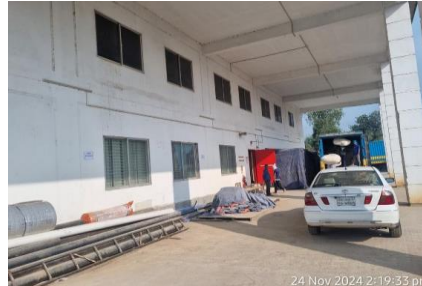
F-13	Means of egress	<p>The south side exit from the ground floor discharges inside the loading-unloading area. Location: Building-1.</p>	<p>Exits shall discharge directly to the exterior of the building unless meeting the requirements of 6.17.2 or 6.17.3 of RSC Technical Guidelines (Standard). The exit discharge shall be at grade or provide direct access to grade. Exit discharge shall not re-enter a building.</p> <p>An egress court serving as a portion of the exit discharge shall be open to the sky or provided with a fire resistance rated enclosure the same as the exit enclosure. Egress courts less than 3050 mm (10 ft) in width (as measured from the building and the adjacent property line) shall be provided with walls having a 1-hr fire resistance rated construction for a distance of 3050 mm (10 ft) above the floor of the court.</p> <p>Or,</p> <p>A maximum of 50 percent of the number and capacity of the exit enclosures can discharge through areas on the level of exit discharge where all of the following are met:</p> <p>(1) Automatic sprinkler protection is provided throughout the level of exit discharge or portion of the level of discharge where separated from non sprinklered portions of the floor by fire barriers with the same fire resistance rating as the exit enclosure.</p> <p>(2) The interior discharge is not through a storage or hazardous occupancy.</p> <p>(3) The entire area of the level of exit discharge is separated from areas below by construction having a fire resistance rating not less than that required for the exit enclosure.</p> <p>(4) The way to the exterior shall be free and unobstructed and shall be readily visible and identifiable from the point of discharge of the interior exit.</p>	Within 3 months

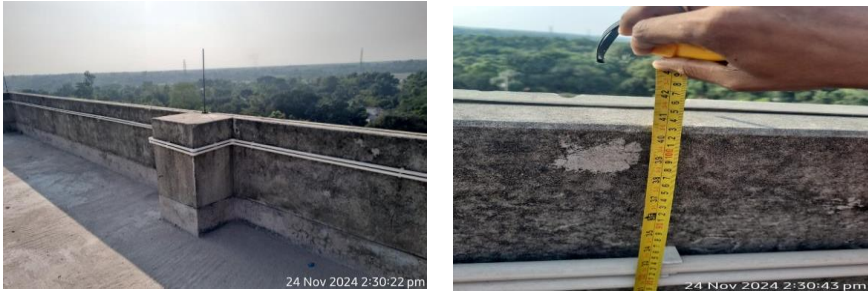
F-14	Means of Egress	<p>Occupiable roofs were provided with parapets but the parapet heights were found to be less than 42 inches.</p> <p>Location: Roof floor of Building-1.</p>	<p>Provide parapets for occupiable roofs with a minimum height of 1067mm (42 inch.).</p>	<p>Within 1 month</p>

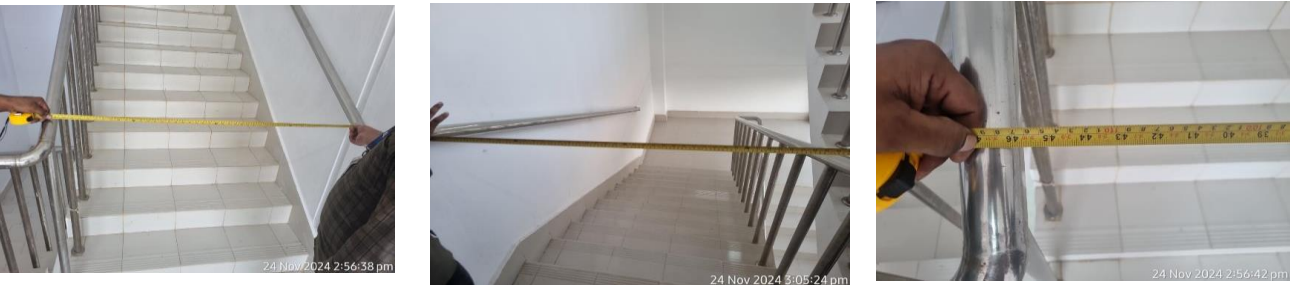
F-15	Means of Egress	<p>Widths of exit stairs were found to be less than 1.5 m (60 in.).</p> <p>Location: Stair-1, Stair-4 and Stair-5 of Building-1.</p>	<p>In interim construction and for newly constructed stairs, stairs shall have a minimum width of 1.50 m (60 in.) for all industrial occupancies according to section 6.5.6.2.1 RSC Technical Guidelines (Standard).</p>	<p>Within 3 months</p>

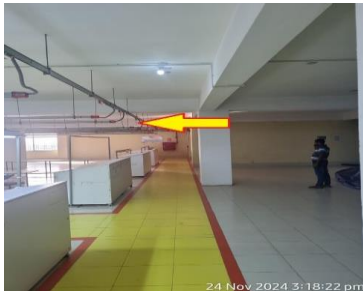
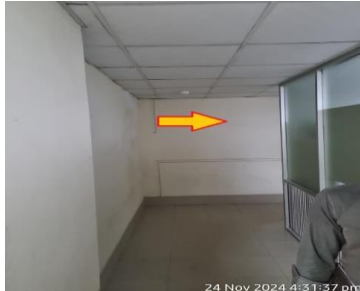
F-18	Emergency Lighting	The directional signs are not provided where there is a change in direction and where the continuation of the egress path is not obvious.  Location: All floors of Building-1.	Illuminated directional signs shall be provided where there is a change in the direction for the path of travel and the direction to an exit is not obvious.	Within 1 month

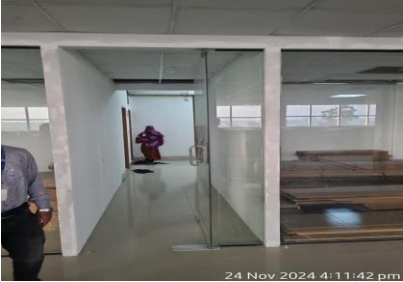
F-19	Emergency Lighting	Exit signs were not provided at entrance to exits. Location: Office area, 3rd floor of Building- 1.	Provide exit signs above all building exits to the exterior, all doors to the exit stairs and along all paths of travel where a change of direction is not obvious. Lighted exit signs shall be provided with either battery backup or uninterruptable power supply systems and shall be continuously illuminated.	Within 1 month

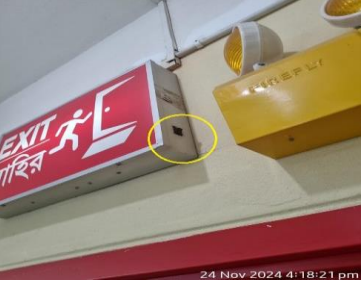
F-20	Emergency Lighting	Manual on-off switches are provided for exit signs. Location: Ground floor to 3rd floor of Building- 1.	Remove manual on/off switches from exit signage units to prevent them from being switched off.	Within 1 month

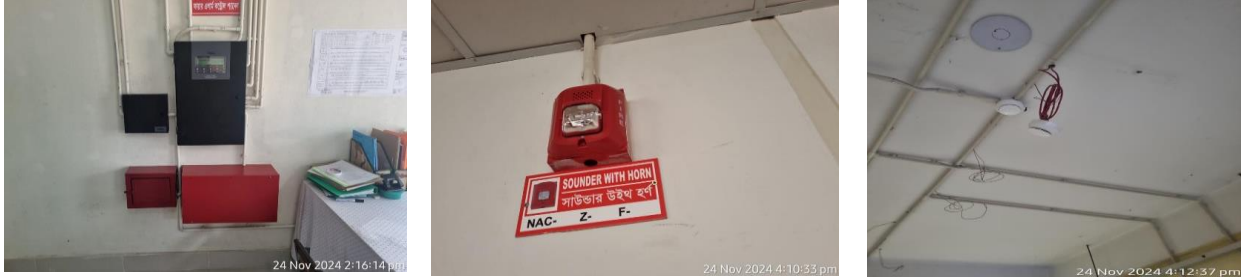
F-22	Fire Detection & Alarm System	<p>Automatic fire alarm and detection system installation found ongoing which requires detailed review to confirm compliance with NFPA 72 and The RSC Technical Guidelines (Standard).</p> <p>Location: All structures under this factory ID.</p>	<p>Submit the fire alarm system design to RSC for review. Once the design is reviewed, install and/or modify the fire detection and alarm system throughout the buildings in accordance with review comment, RSC Technical Guidelines (Standard) and NFPA 72 standard. After installation the owner shall conduct internal testing and commissioning and then contact the RSC for witness of final acceptance testing.</p>	<p>Design Review within 2 months and installation/modification within 4 months</p>

<p>The first photograph shows a fire alarm control panel with a red fire alarm pull station below it. The second photograph shows a red fire alarm sounder with a sign that reads 'SOUNDER WITH HORN' and 'সড়িতার উইথ হর্ন' (Sounder with Horn) and 'NAC- Z- F-'. The third photograph shows the ceiling area with fire alarm wiring and a sounder horn.</p>

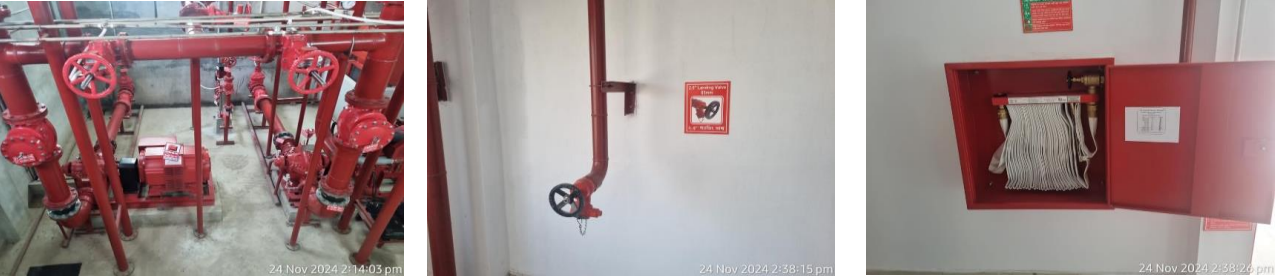
F-24	Fire Protection System	<p>The highest occupied floor level of Building-1 is more than 10 m (33 ft) where Class III automatic standpipe and hose system is required. Class III standpipe system was found installed which is supplied by a fire pump and a water supply system. The standpipe system and fire pump and water supply system requires detailed review to confirm compliance with the RSC Technical Guidelines (Standard), NFPA 14, 20, 22 and other relevant standards.</p> <p>Location: Building-1.</p>	<p>Submit the automatic standpipe and hose system design along with the fire pump and water supply system design to RSC for review. Once the design is reviewed, install and/or modify the automatic standpipe and hose system design throughout the buildings in accordance with review comments, RSC Technical Guidelines (Standard) and NFPA 14, 20, 22 and other relevant standards. After installation the owner shall conduct internal testing and commissioning and then contact the RSC for witness of final acceptance testing.</p>	<p>Design Review within 2 months and installation within 4 months</p>
