INITIAL FIRE SAFETY INSPECTION REPORT

REEDISHA TEXSTRIPE LTD. (EXTENSION)

RSC ID: 25962

TEKNOGPARA,SALNA,GAZIPUR,BANGLADESH

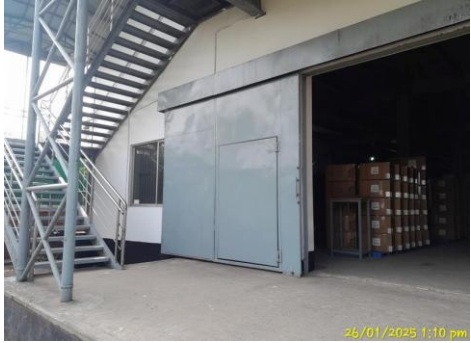
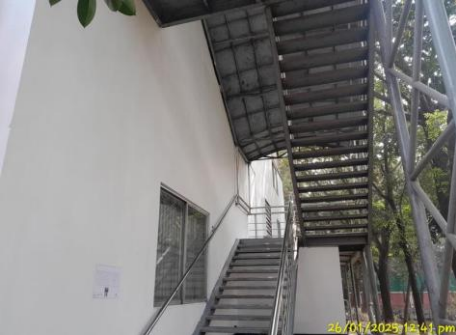
SI No.	Category	Findings	Required Action	Remediation Time Frame
F-1	Means of Egress	<p>The exterior exit stair is not separated from the building interior due to non-rated openings.</p> <p>Location: Building-13.</p>	<p>Exterior exit stairs shall be separated from the building with a rating requirement of 1 hr. fire rating for 3 or fewer stories or 2 hr. fire rating for 4 or more stories. The rating of the exterior wall shall extend 3.05 m (10ft) beyond the ends of the stair structure.</p> <p>RSC Technical Guidelines (Standard) 6.3.1.3.</p>	Within 3 months
<div style="display: flex; justify-content: space-around;">

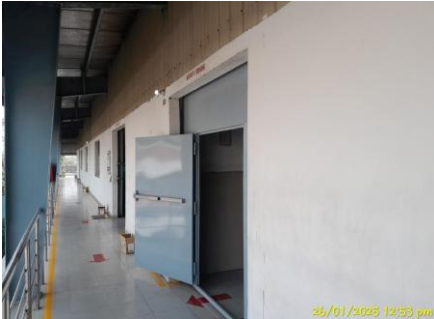
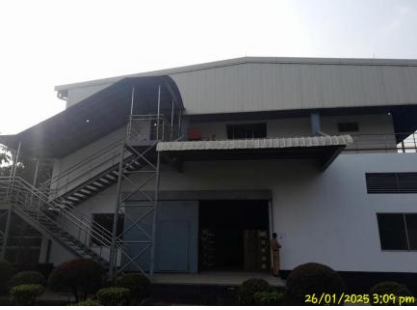
F-2	Means of Egress	<p>Stair-1 (East) exit access corridor from dining is not separated by fire-rated construction from the store area.</p> <p>Locations: 1st floor; Building-13.</p>	<p>Exit access corridors serving an occupant load exceeding 30 shall be separated by walls having a fire-resistance rating of 1 hr unless provided with automatic sprinkler protection throughout the story or building.</p> <p>RSC Technical Guidelines (Standard) 6.3.1.1.</p>	Within 3 months

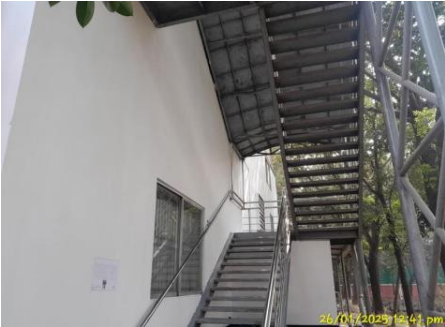
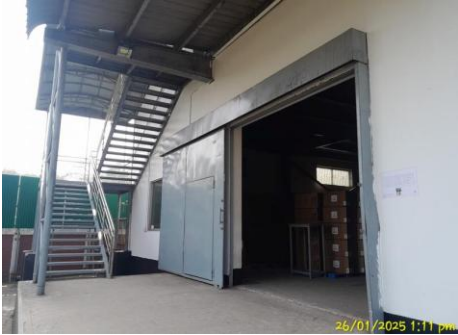
F-3	Means of Egress	<p>Both exit stairs are less than the required minimum width of 1.5 meters (60 inches).</p> <p>Location: Building-13.</p>	<p>As per RSC Technical Guidelines (Standard) Section 6.5.6.2.1 In new and interim construction and constructed stairs, stairs shall have a minimum width of 1.5 m (60 in.) for all industrial occupancies.</p>	Within 3 months
<div style="display: flex; justify-content: space-around;">

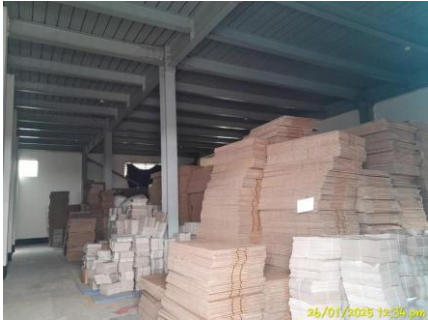
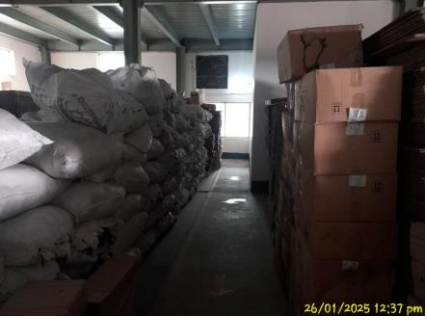
F-4	Means of Egress	<p>Single exit travel distance exceeds the allowable limit 30 m.</p> <p>Location: GF, Carton Store, Building-13.</p>	<p>Rearrange the exit arrangement or provide additional exits. The number of means of egress from any floor, story or portion thereof shall not be less than 2 except where a single exit is permitted by 6.6.2.</p> <p>RSC Technical Guidelines (Standard) 6.6.1.</p>	Within 1 month
<div style="display: flex; justify-content: space-around;">

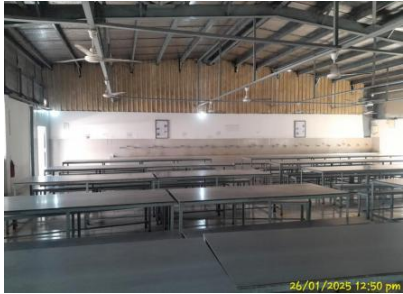
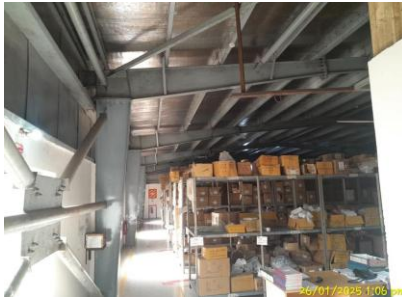
F-5	Fire Rated Construction	<p>Dining area (E4) is not separated by fire-rated construction from the Store area.</p> <p>Locations: 1st floor; Building-13.</p>	<p>Separate the dining area from the store with 3-hr fire-rated construction, provide minimum 3-hr. rated doors for the openings, and seal the unprotected penetrations.</p> <p>Provide required exits that lead directly to the street or exit stairwell or lead to a rated corridor or open space.</p>	Within 3 months
<div style="display: flex; justify-content: space-around;">

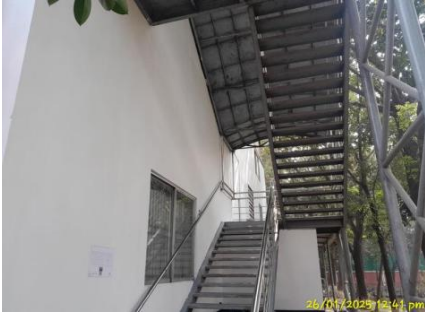
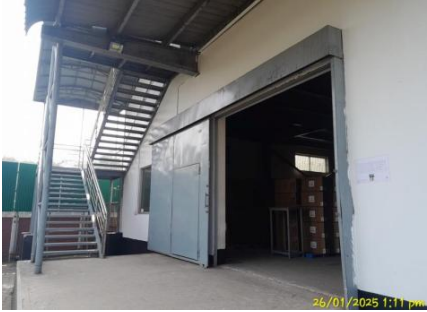
F-6	Means of Egress	<p>Both Stair widths were found less than 1.5m (60 inches).</p> <p>Location: Building-13.</p>	<p>As per RSC Technical Guidelines (Standard) Section 6.5.6.2.1 In new and interim construction and constructed stairs, stairs shall have a minimum width of 1.5 m (60 in.) for all industrial occupancies.</p>	Within 3 months
<div style="display: flex; justify-content: space-around;">

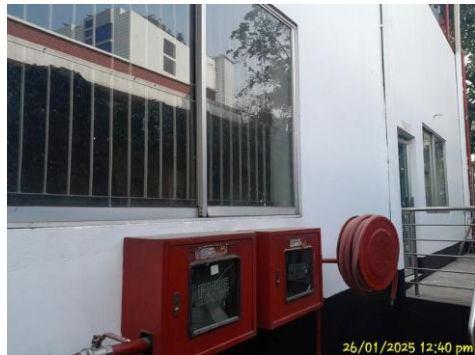
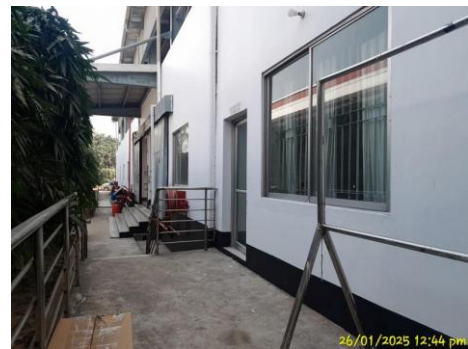
F-7	Means of Egress	<p>The child care egress court serving as a portion of exit discharge is not separated from the building interior due to non-rated openings within 10 feet of the stair structure.</p> <p>Location: Child Care, Building-13</p>	<p>Egress courts less than 3050 mm (10 ft) in width (as measured from the building and the adjacent property line) shall be provided with walls having a 1-hr fire resistance rated construction for a distance of 3050 mm (10 ft) above the floor of the court.</p>	Within 3 months
-----	-----------------	--	--	-----------------

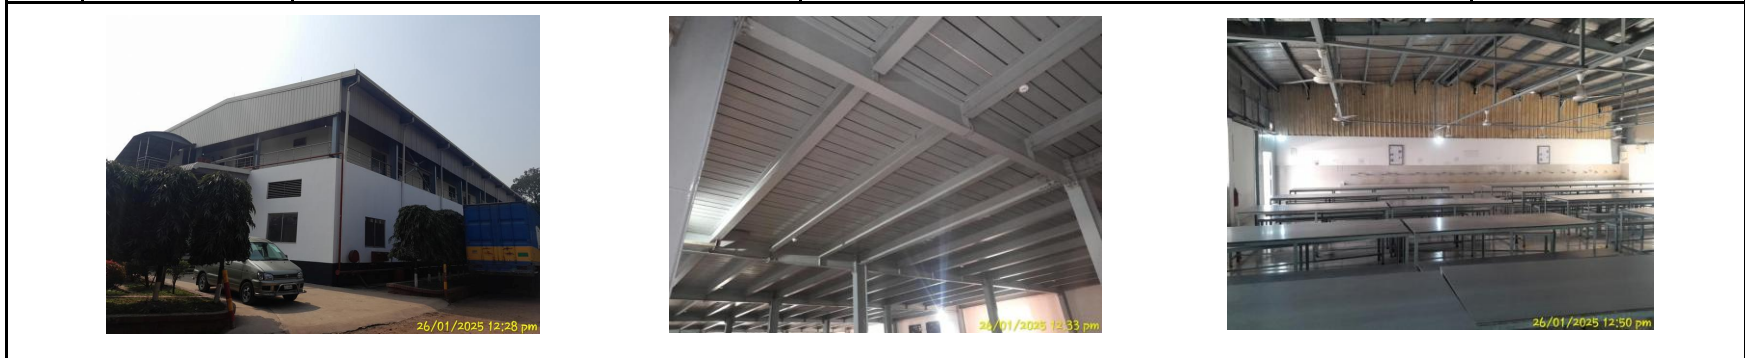
F-8	Fire Rated Construction	<p>The main structural elements of Building-13 (2-storied) are constructed of steel elements which are non-rated and were found in exposed condition without any fire protection.</p> <p>Location: Building-13.</p>	<p>The "Ministry of Housing and Public Works" has issued a resolution based on the recommendations from the House Building Research Institute (HBRI) and the Public Works Department (PWD) to assess structural fire protection requirements of steel buildings (unprotected non-combustible construction type) according to BNBC 2020. The construction type shall be confirmed to be in accordance with BNBC 2020 Part-3, Table 3.1.7. Ensure fire resistive rated construction following Table 3.3.1 (a) Part 3 Section-3, Table 3.2.2 and Table 3.2.3 Part 3 Section 2 and Table 4.1.1 from BNBC 2020 Part 4 Section 1. Provide design philosophy to determine the construction type as per BNBC 2020.</p> <p>If any construction rating is required, Consult a qualified fire protection engineer to achieve the required fire rating.</p>	Within 6 months

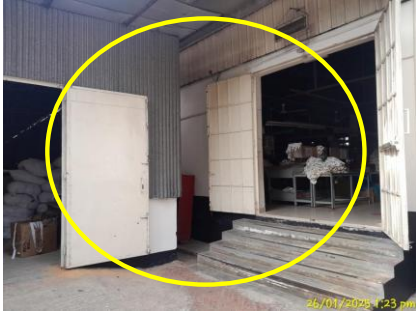
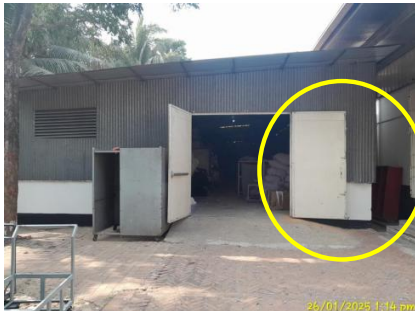
F-9	Means of Egress	<p>The south exit discharge path from Building-11 is not separated from Building-12 exterior non rated openings.</p> <p>Location: Building-11.</p>	<p>Where nonrated walls or unprotected openings enclose the exterior of the stairway and the walls or openings are exposed by other parts of the building at an angle of less than 180 degrees (3.14 rad), the building exterior walls within 3050 mm (10 ft) horizontally of a nonrated wall or unprotected opening shall have a fire-resistance rating of not less than 1 hr. Openings within such exterior walls shall be protected by opening protectives having a fire protection rating of not less than ¾ hr.</p>	Within 3 months
<div style="display: flex; justify-content: space-around;">

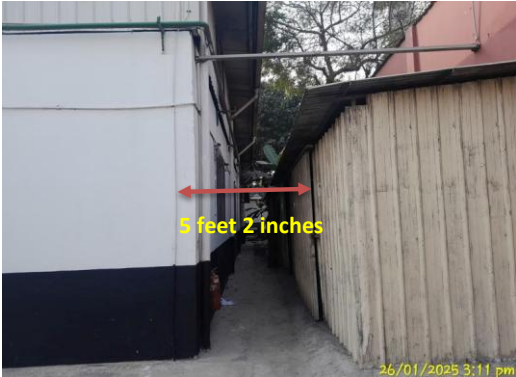
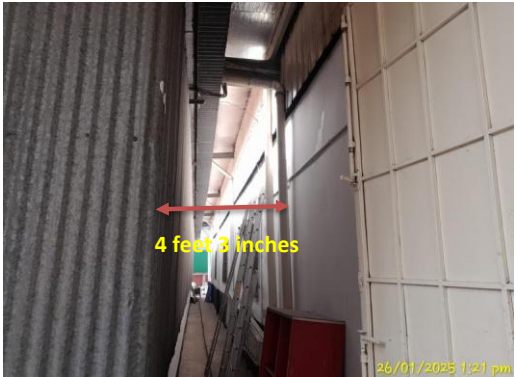
F-10	Fire Rated Construction	<p>Non-rated construction & openings were found from the Diesel & Mobil Shed (5 feet 2 inches) and Idle Machine Shed (4 feet 3 inches) away from Building-11.</p> <p>Location: Building-11. North & South Side</p>	<p>Provide the required fire-rated separation wall between two buildings as per BNBC 2006, Table 3.2.2. No opening is permitted on a 4-hr rating wall.</p>	<p>Within 3 months</p>

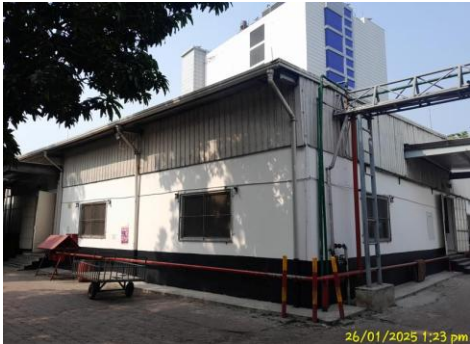
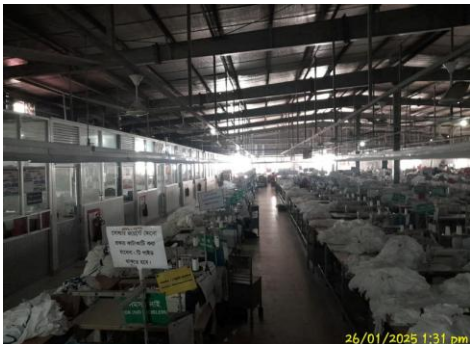
F-11	Fire Rated Construction	<p>The main structural elements of Building-11 (Single-storied) are constructed of steel elements which are non-rated and were found in exposed condition without any fire protection.</p> <p>Location: Building-11.</p>	<p>The "Ministry of Housing and Public Works" has issued a resolution based on the recommendations from the House Building Research Institute (HBRI) and the Public Works Department (PWD) to assess structural fire protection requirements of steel buildings (unprotected non-combustible construction type) according to BNBC 2020. The construction type shall be confirmed to be in accordance with BNBC 2020 Part-3, Table 3.1.7. Ensure fire resistive rated construction following Table 3.3.1 (a) Part 3 Section-3, Table 3.2.2 and Table 3.2.3 Part 3 Section 2 and Table 4.1.1 from BNBC 2020 Part 4 Section 1. Provide design philosophy to determine the construction type as per BNBC 2020.</p> <p>If any construction rating is required, Consult a qualified fire protection engineer to achieve the required fire rating.</p>	Within 6 months

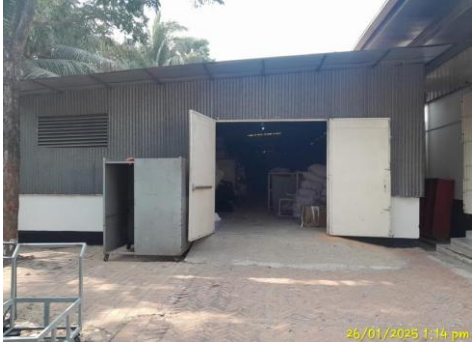
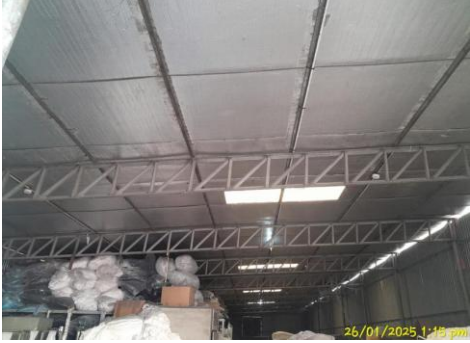
F-12	Fire Rated Construction	<p>The main structural elements of Building-12 (Single-storied) are constructed of steel elements which are non-rated and were found in exposed condition without any fire protection.</p> <p>Location: Building-12.</p>	<p>The "Ministry of Housing and Public Works" has issued a resolution based on the recommendations from the House Building Research Institute (HBRI) and the Public Works Department (PWD) to assess structural fire protection requirements of steel buildings (unprotected non-combustible construction type) according to BNBC 2020. The construction type shall be confirmed to be in accordance with BNBC 2020 Part-3, Table 3.1.7. Ensure fire resistive rated construction following Table 3.3.1 (a) Part 3 Section-3, Table 3.2.2 and Table 3.2.3 Part 3 Section 2 and Table 4.1.1 from BNBC 2020 Part 4 Section 1. Provide design philosophy to determine the construction type as per BNBC 2020.</p> <p>If any construction rating is required, Consult a qualified fire protection engineer to achieve the required fire rating.</p>	Within 6 months

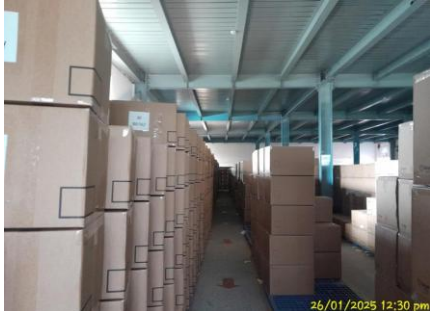
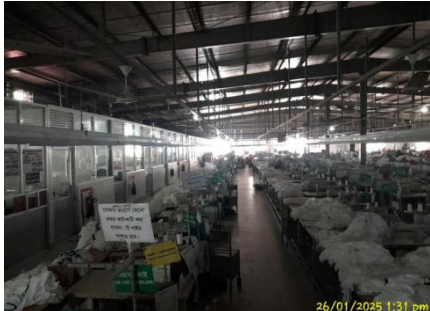
F-14	Egress Lighting	<p>Based on the number and location of emergency lights observed, adequate illumination levels are not anticipated along egress routes.</p> <p>Locations: All Buildings.</p>	<p>Test the emergency lighting system on each floor and provide additional emergency fixtures to provide adequate illumination along the means of egress. Provide a minimum illumination of 10 lux at the floor level within exit stairs and exit discharge paths and minimum 2.5 lux along exit access aisles.</p>	Within 1 month

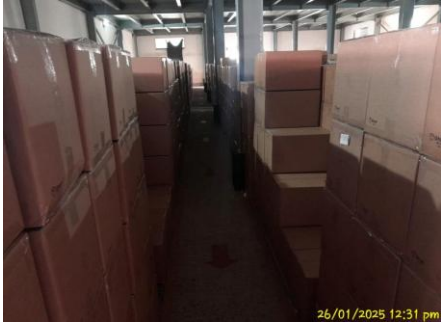
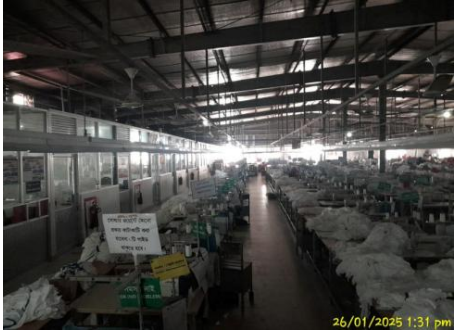
F-15	Egress Lighting	<p>Directional Exit signage was not provided along the path of egress where there was a change in the direction for the path of travel and the direction to an exit is not obvious.</p> <p>Location: Building 11, 12, 13.</p>	<p>Provide directional exit signs above all building exits to the exterior, all doors to the exit stairs and along all paths of travel where a change of direction is not obvious. Lighted directional signs shall be provided with either battery backup or uninterruptable power supply systems and shall be continuously illuminated.</p>	Within 1 month

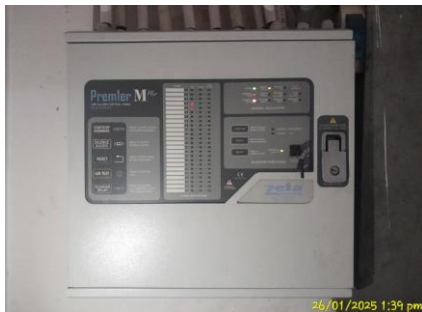
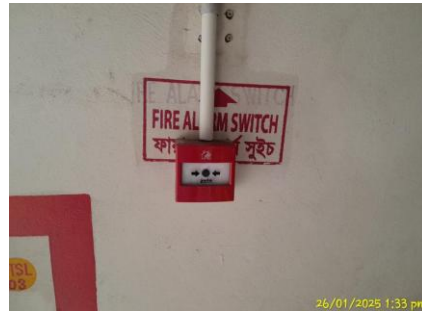
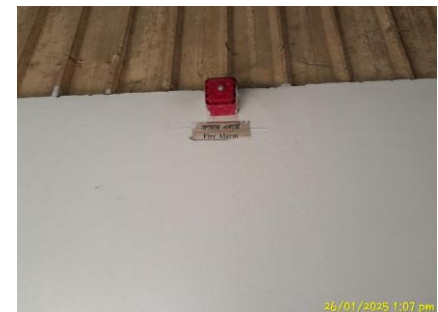
F-17	Fire Alarm & Detection System (FADS)	<p>Automatic fire alarm & detection system installation requires detailed review to confirm compliance with NFPA-72 and RSC Technical Guidelines (Standard).</p> <p>Location: All buildings and sheds.</p>	<p>Submit the fire alarm system design to RSC for review. Once the design is reviewed, install and modify the fire detection and alarm system throughout the buildings in accordance with review comment, RSC Technical Guidelines (Standard) and NFPA 72. After installation the factory shall conduct internal testing and commissioning and then contact the RSC for witness of final acceptance testing. Also inspect, test and maintain the fire alarm system, and keep written records on-site, in accordance with Table-14.3.1 of NFPA 72.</p>	<p>Design Review within 2 months and installation/modification within 4 months.</p>
------	--------------------------------------	---	---	---
