FIRE SAFETY INSPECTION REPORT

**SENSIBLE FASHION (PVT.) LTD.
NORTH MASDAIR (MALANCHANAGAR) FATULLAH,
NARAYANGANJ-1400, BANGLADESH**

ACCORD
on Fire and Building Safety in Bangladesh

June 10, 2014

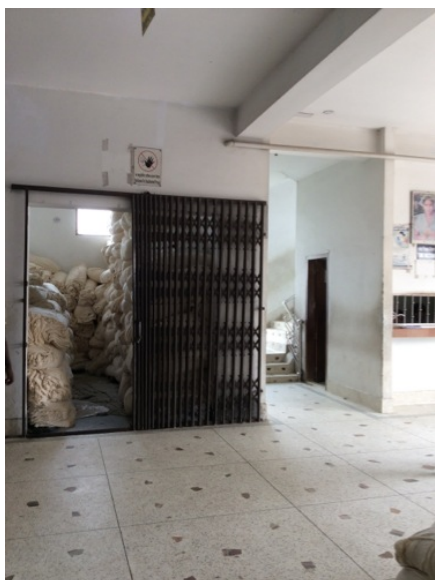
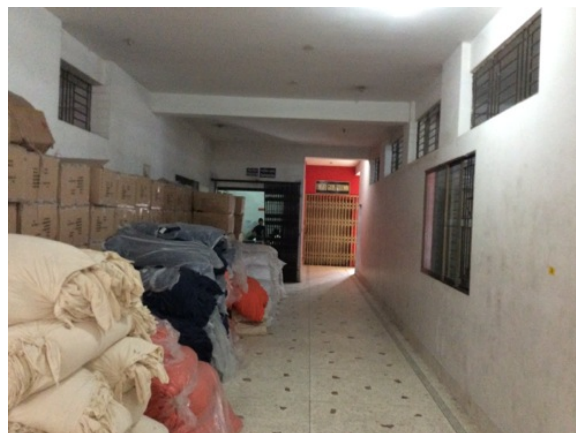
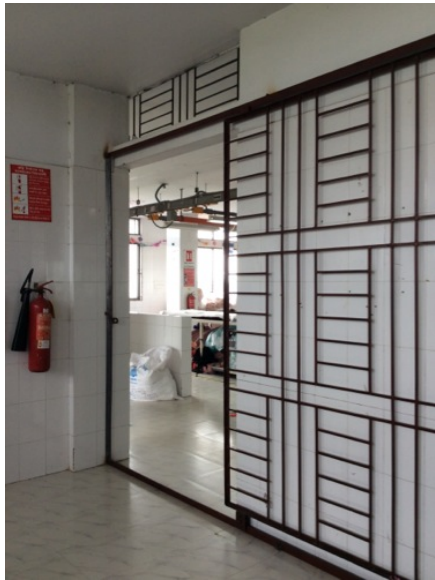
No.	Category	Finding	Recommendation	Remediation Timeframe
F-1	Fire Rated Construction	Areas used for combustible storage at the ground and 3rd floors are not fire-rated separated from factory floors nor exit discharge.	Provide dedicated storage rooms separated by minimum 1-hr fire-rated construction.	Within 3 months

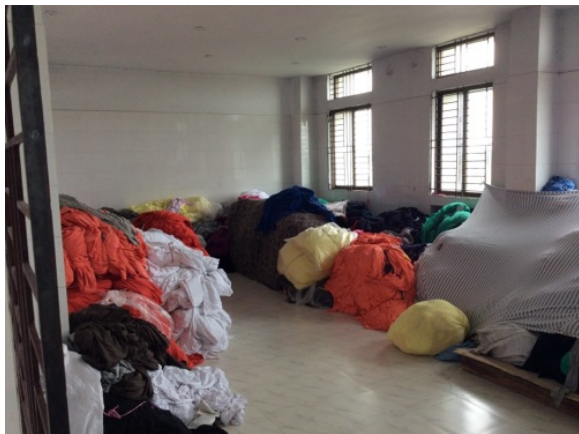
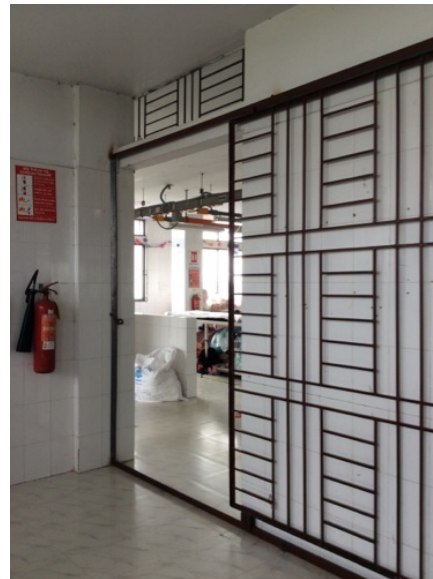
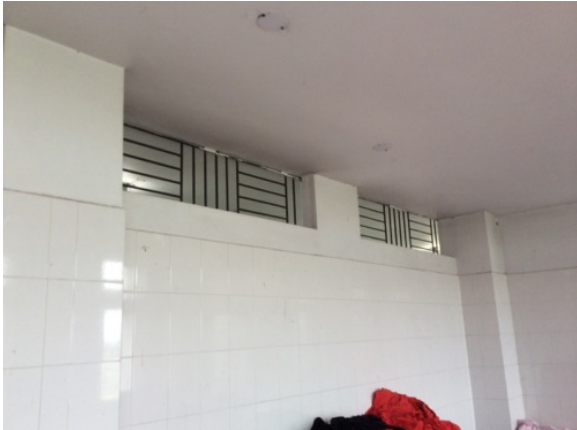
F-2	Fire Rated Construction	Areas used for combustible storage at the 3rd floor are not separated by fire-rated construction.	Provide 1-hour fire-rated walls up to structure and 0.75 hour fire-rated openings.	Within 3 months
-----	-------------------------	---	--	-----------------

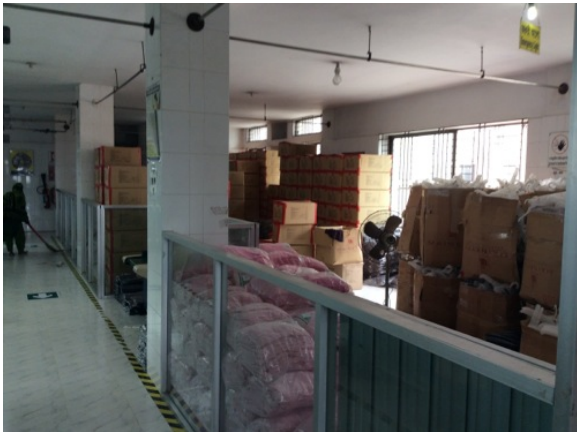
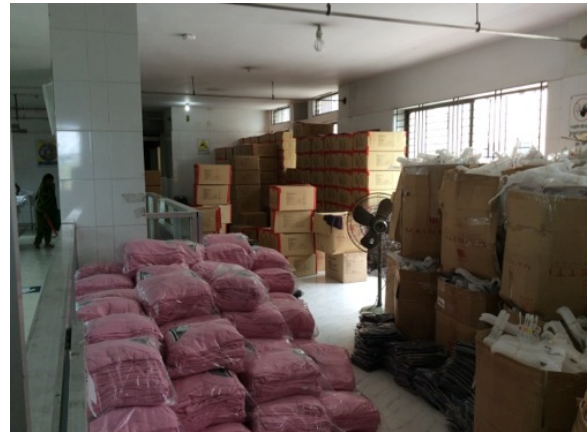
F-3	Fire Rated Construction	Areas used for combustible storage at the 1st floor are not separated by fire-rated construction.	<p>Provide dedicated storage rooms separated by minimum 1-hr fire-rated construction.</p> <p>Where separate storage rooms are not feasible, provide defined storage areas and limit the storage arrangement as follows:</p> <ul style="list-style-type: none">- Maximum height of 2.4m and maximum area of 23m²- If sprinkler protected: maximum height of 3.66m and maximum area of 93m² <p>Separate areas of unenclosed combustible storage by a minimum clear distance of 3m.</p>	Within 3 months
-----	-------------------------	---	---	-----------------

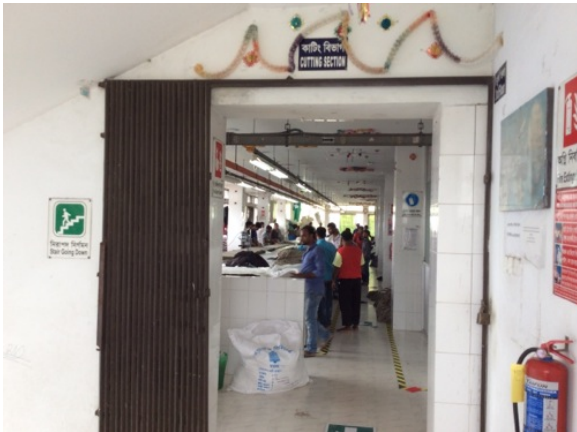
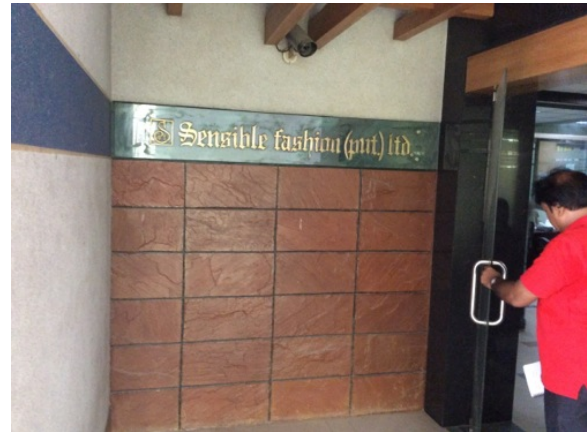
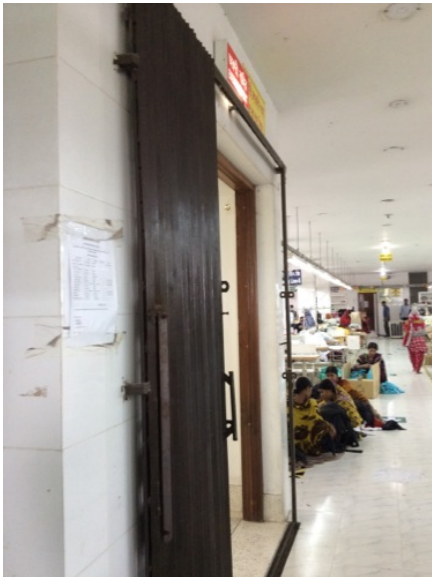
F-4	Fire Rated Construction	The exit stairs are not separated from work areas on each floor by fire-rated construction.	<p>Provide minimum 1.5-hr fire rated doors and seal all unprotected openings to separate the exit stairs from work areas and other building spaces on all floor levels. Ensure that the fire doors are self-closing and positive latching and that they are provided with fire exit (panic) hardware where serving production floors.</p> <p>If fire doors are required to be held open for functional reasons, provide automatic-closing devices tied to the fire alarm system.</p>	Within 3 months
-----	-------------------------	---	--	-----------------

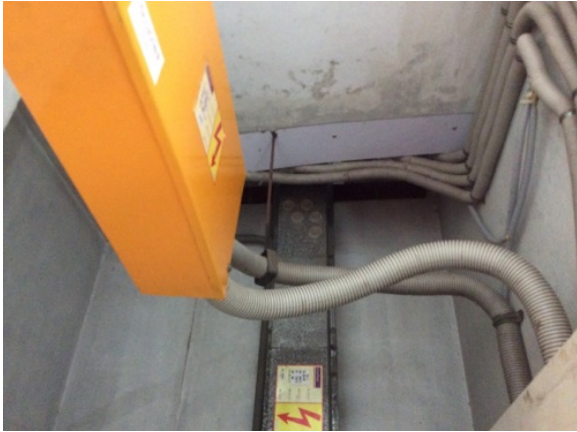
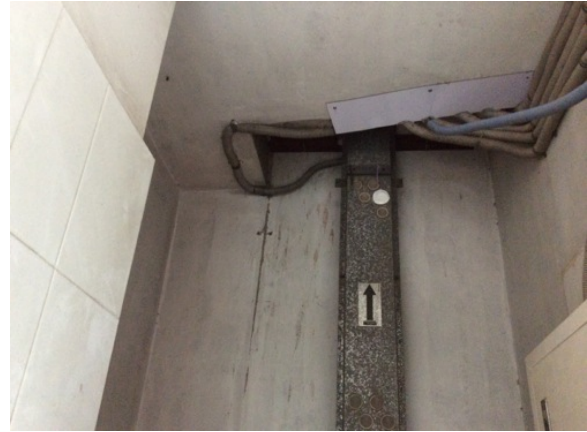
F-5	Fire Rated Construction	Unsealed penetrations and openings are located in the fire-rated floor/ceiling assemblies.	Provide a minimum 2-hr fire-rated shaft to separate the utility risers from each floor level.	Within 3 months
			Seal all penetrations and openings in floor/ceiling assemblies to maintain the fire separation.

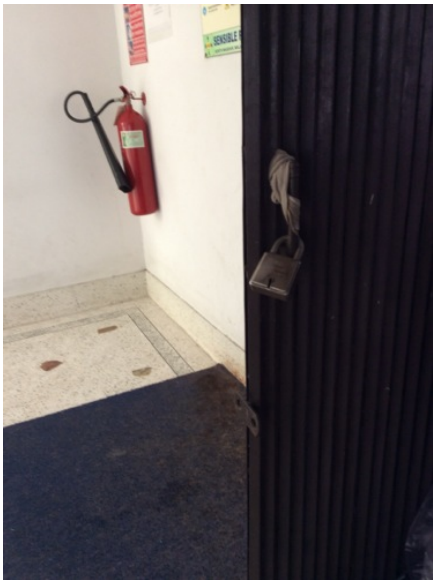
F-7	Egress	<p>Egress gates with locking features are provided at building exits, exit stairs, along egress routes and exit discharge.</p> <p>Lockable collapsible gates we're provide at most exits, gates were open and unlocked during the inspection.</p>	<p>Remove locking features from all egress gates.</p> <p>If locks are required for security reasons, utilize special door locking features complying with NFPA 101.</p>	Immediate
-----	--------	---	---	-----------

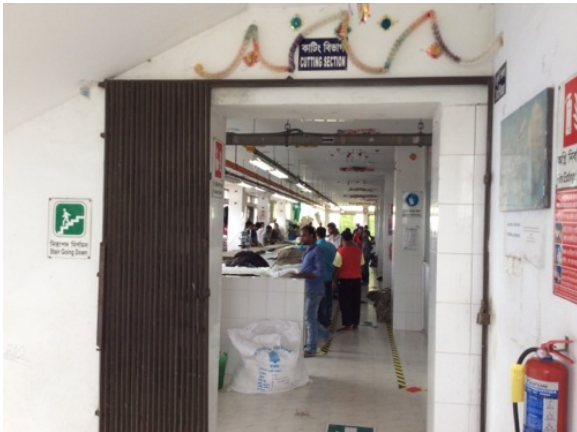
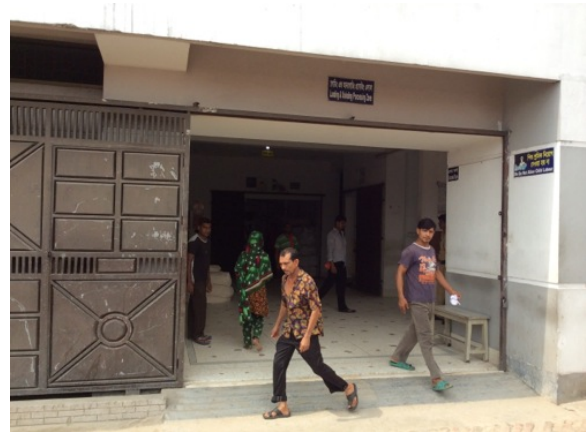
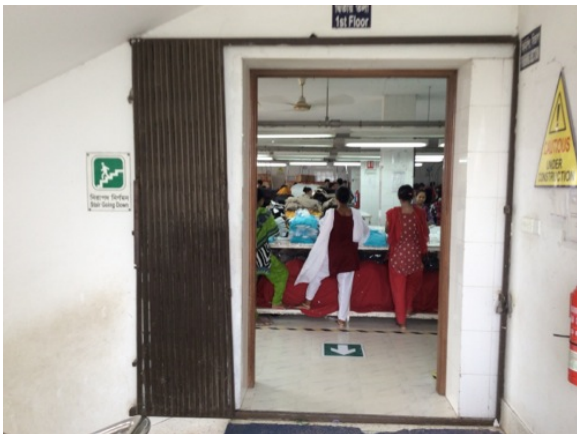
F-8	Egress	<p>Collapsible and sliding gates are provided at most building exits, exit stairs, along egress routes and exit discharge.</p>	<p>Replace all collapsible gates along the means of egress with side-hinged, swinging egress doors.</p> <p>If locks are required for security reasons, utilize special door locking features complying with NFPA 101.</p>	Within 3 months
-----	--------	--	---	-----------------

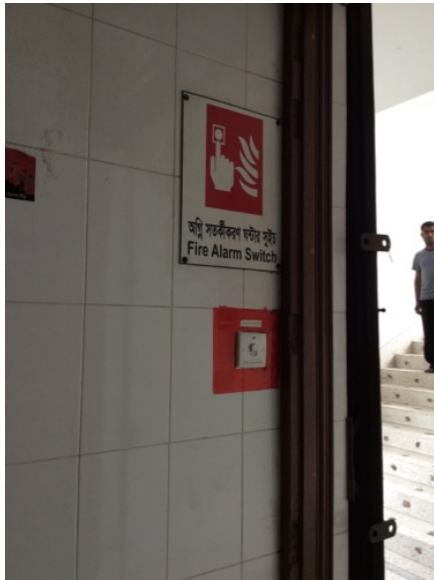
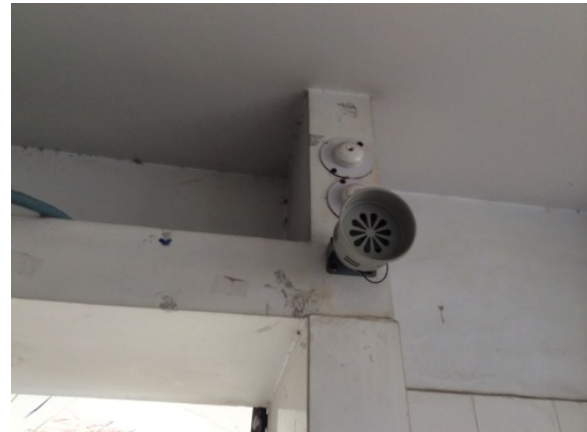
F-9	Fire Protection	The fire alarm system is antiquated, not a listed system, and does not provide alarm and notification features consistent with acceptable standards.	Replace the fire alarm system with a new, listed addressable fire alarm system in accordance with NFPA 72.	Design within 4 months, install within 9 months
-----	-----------------	--	--	---

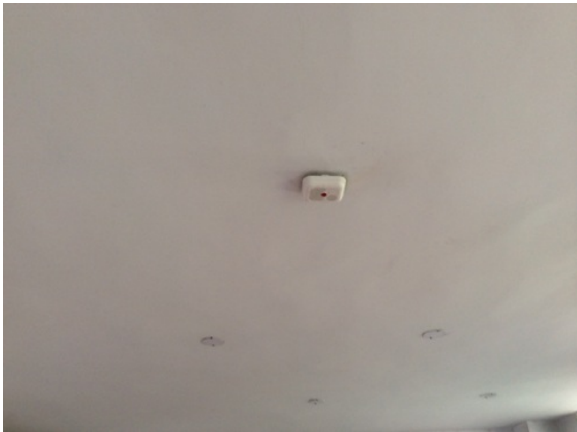
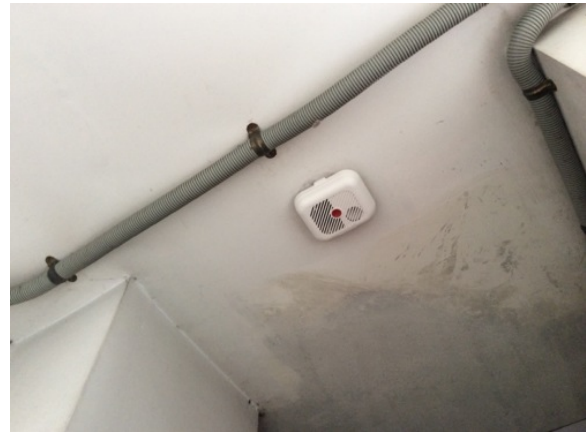
F-10	Fire Protection	Inspection, testing, and maintenance for the fire alarm system was not in accordance with NFPA 72.	Inspect, test and maintain the fire alarm system, and keep written records on-site, in accordance with NFPA 72.	Within 3 months
F-11	Fire Protection	The building is equipped with single-station smoke alarms. Smoke alarm activation sounds only a local alarm and does not provide automatic fire alarm notification of occupants.	Replace the single-station smoke alarms with automatic smoke detectors tied into the fire alarm system in accordance with NFPA 72.	Within 6 months
