# INITIAL FIRE SAFETY INSPECTION REPORT

**Hi-Tech Performance Apparels Ltd.**

**RSC ID: 26021**

**Date: 11-Mar-2025**

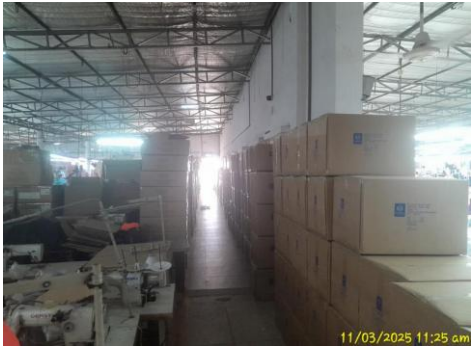
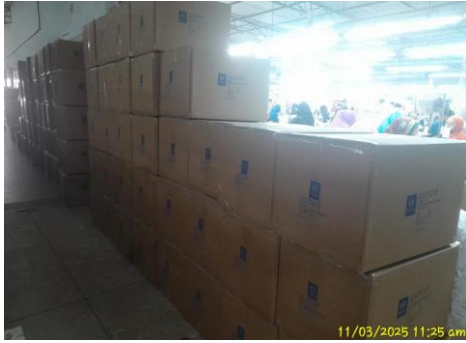
| SI No. | Category | Findings | Required Action | Remediation Time Frame |
|---|---|---|---|---|
| F-1 | Fire Rated Construction | <p>Areas used for in-process storage of combustible materials are open to the surrounding occupancy, exceeding the allowable limit</p> <p><b>Location(s): Shed-1.</b></p> | <p>Provide defined storage areas and limit the storage arrangement as follows: -</p> <ol style="list-style-type: none"> <li>1. General Condition: Maximum height of 2.4m and maximum area of 23m<sup>2</sup>. Separate areas of unenclosed combustible storage by a minimum clear distance of 3m.</li> <li>or,</li> <li>2. If sprinkler protected: maximum height of 3.66m and maximum area of 93m<sup>2</sup>. Separate areas of unenclosed combustible storage by a minimum clear distance of 3m.</li> <li>or</li> <li>3. Enclose the storage area from the surrounding occupancy with a minimum 1-hour construction.</li> </ol> | Within 3 months |

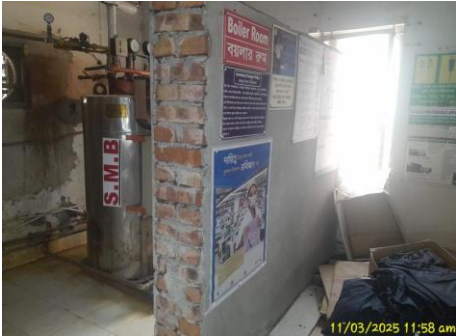
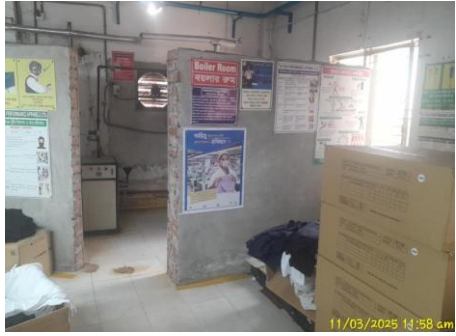
| F-2 | Fire Rated Construction | <p>The boiler room is not separated by fire-rated construction due to openings</p> <p><b>Location(s): Shed-1.</b></p> | <p>Separate the boiler room by a minimum 1-hr fire-rated construction for non-high rise, and 2-hr fire-rated construction for high rise. Seal and/or protect all openings to maintain the required fire separations. When located to the exterior of a building, a 3m (10 ft.) spatial distance shall be maintained around the boiler room as per RSC Technica Guidelines (Standard) 3.4.2.1.2. Ensure proper ventilation for the boiler/compressor room.</p> | Within 3 months |

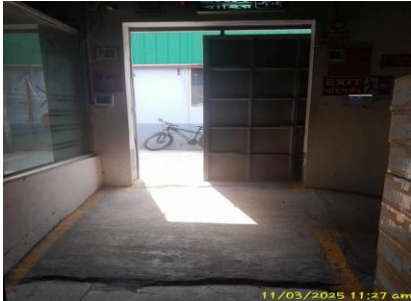
| F-3 | Means of Egress | <p>Sliding doors have provided along means of egress.</p> <p><b>Location(s): Shed-1.</b></p> | <p>Replace all sliding-type doors &amp; gates with side-hinged swinging-type doors.</p> <p>If locks are required for security reasons, utilize special door locking features complying with NFPA 101.</p> | Within 1 month |

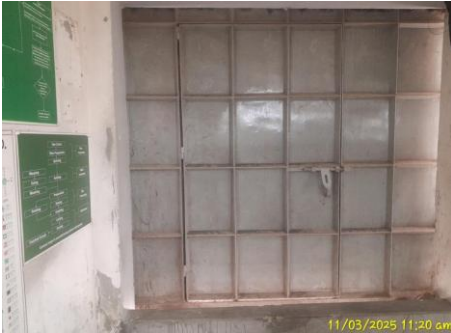
| F-4 | Means of Egress | <p>Headroom measured less than 80 inches in the west exit.</p> <p><b>Location(s): Shed-1.</b></p> | <p>All means of egress shall have a minimum ceiling height of 2.3 m (7 ft 6 in.) with projections from the ceiling not less than 2.03 m (6 ft 8 in.). The minimum ceiling height shall be maintained for at least 2/3 of the space or room as long as the remaining area shall be not less than 2.03 m (6 ft 8 in.). Headroom on stairs shall not be less than 2.03 m (6 ft 8 in.).</p> | Within 1 month |

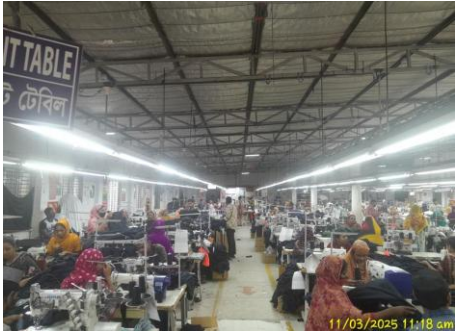
| F-5 | Means of Egress | <p>Directional Exit signage was not provided along the path of egress where there was a change in the direction for the path of travel, and the direction to an exit was not obvious.</p> <p><b>Location(s): Shed-1.</b></p> | <p>Provide directional exit signs above all building exits to the exterior, all doors to the exit stairs and along all paths of travel where a change of direction is not obvious. Lighted directional signs shall be provided with either battery backup or uninterruptable power supply systems and shall be continuously illuminated.</p> | Within 1 month |

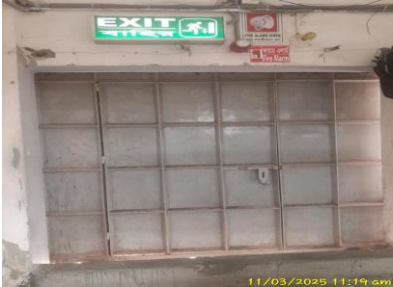
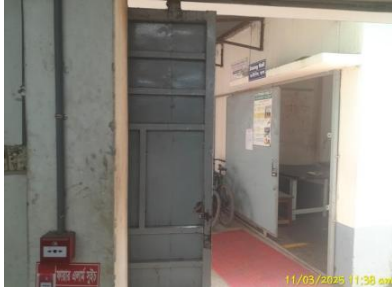
| F-9 | Means of Egress | Egress door on exit discharge serving 50 or more occupants but does not swing in the direction of egress travel.<br><br><b>Location(s): Shed-1, Shed-2.</b> | Modify the swing direction of egress doors to the direction of egress travel. Doors serving an occupant load of more than 50 shall swing in the direction (outward) of egress travel. | Within 1 month |

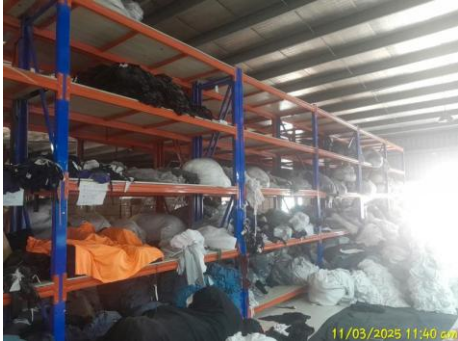
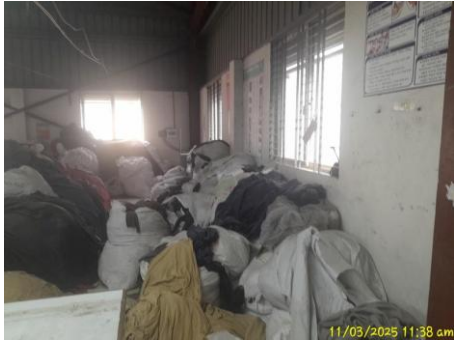
| F-10 | Fire Rated Construction | <p>Areas used for in-process storage of combustible materials are open to the surrounding occupancy, exceeding the allowable limit.</p> <p><b>Location(s): Shed-2.</b></p> | <p>Provide defined storage areas and limit the storage arrangement as follows: -</p> <ol style="list-style-type: none"> <li>1. General Condition: Maximum height of 2.4m and maximum area of 23m<sup>2</sup>. Separate areas of unenclosed combustible storage by a minimum clear distance of 3m.<br/>or,</li> <li>2. If sprinkler protected: maximum height of 3.66m and maximum area of 93m<sup>2</sup>. Separate areas of unenclosed combustible storage by a minimum clear distance of 3m.<br/>or</li> <li>3. Enclose the storage area from the surrounding occupancy with a minimum 1-hour construction.</li> </ol> | Within 3 months |

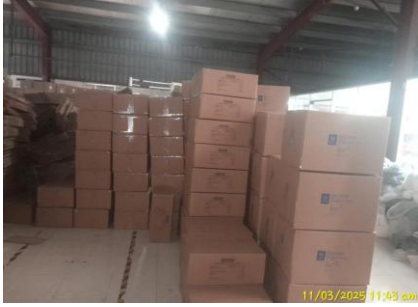
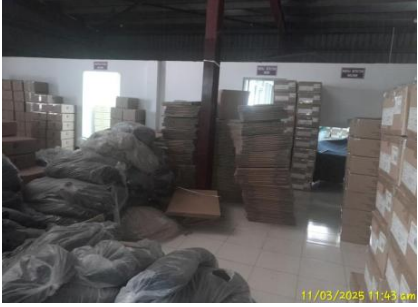
| F-11 | Fire Rated Construction | <p>Rooms used for storage of combustible materials are not separated from the surrounding occupancies.</p> <p><b>Location(s): Shed-2.</b></p> | Rooms used for storage of combustible materials shall be separated from the surrounding occupancy with a minimum 1 hour construction. | Within 3 months |

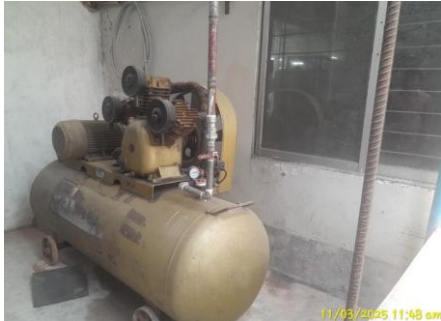
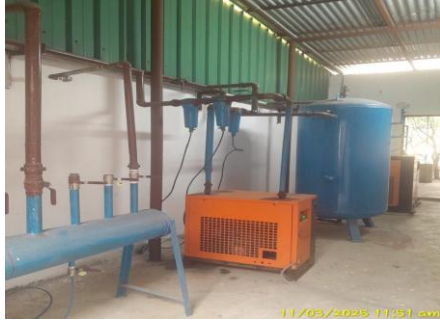
| F-12 | Fire Rated Construction | <p>The compressor room is not separated by fire-rated construction due to non-rated openings.</p> <p><b>Location(s): Shed-2.</b></p> | <p>Separate the compressor room by a minimum 1-hr fire-rated construction for non-high rise, and 2-hr fire-rated construction for high rise. Seal and/or protect all openings to maintain the required fire separations.</p> <p>When located to the exterior of a building 3m (10 ft.) spatial distance shall be maintained around the compressor.</p> <p>Ensure proper ventilation for the compressor room.</p> | Within 3 months |

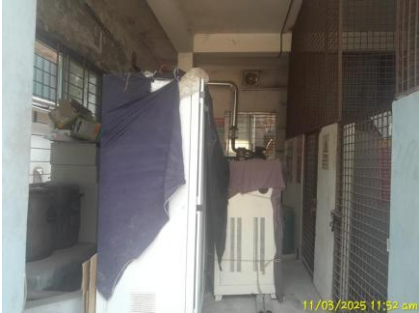
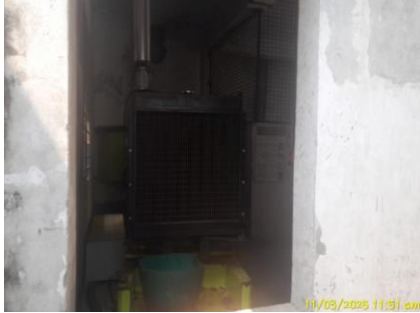
| F-13 | Fire Rated Construction | <p>The generator room (within 10 feet) is not separated from Shed-2 by fire-rated construction due to openings, non-rated doors, and penetrations.</p> <p><b>Location(s): Shed-2.</b></p> | <p>Generator sets shall be separated from all other occupancy areas by a minimum 2 hour construction or by a minimum spatial separation of 3 m (10 ft) where located exterior to the building as per <b>RSC Technical Guidelines (Standard), Section 3.4.2.1.3.</b></p> <p>Ensure proper ventilation for the generator room.</p> | Within 3 months |

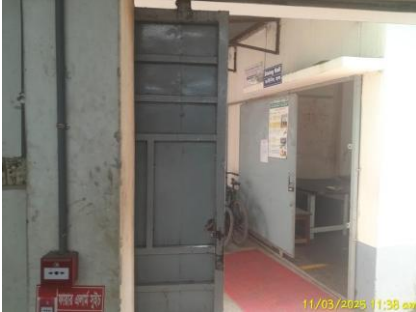
| F-14 | Means of Egress | Sliding doors have provided along means of egress.<br><br><b>Location(s): Shed-2.</b> | Replace all sliding-type doors & gates with side-hinged swinging-type doors.<br><br>If locks are required for security reasons, utilize special door locking features complying with NFPA 101. | Within 1 month |

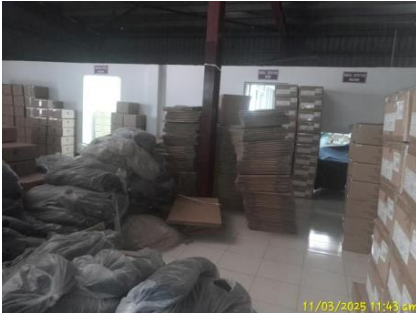
| F-15 | Means of Egress | Aisles have not been marked properly, and the aisles' width is less than 36 inches.<br><br><b>Location(s): Shed-2</b> | Aisles mark shall be provided at required places with a minimum unobstructed clear-width of 0.9 m (36 in.). | Within 1 month |

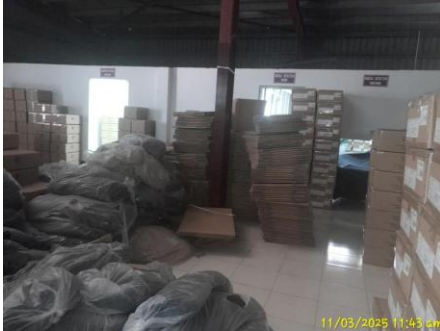
| F-16 | Means of Egress | <p>Directional Exit signage was not provided along the path of egress where there was a change in the direction for the path of travel, and the direction to an exit was not obvious.</p> <p><b>Location(s): Shed-2.</b></p> | <p>Provide directional exit signs above all building exits to the exterior, all doors to the exit stairs and along all paths of travel where a change of direction is not obvious. Lighted directional signs shall be provided with either battery backup or uninterruptable power supply systems and shall be continuously illuminated.</p> | Within 1 month |

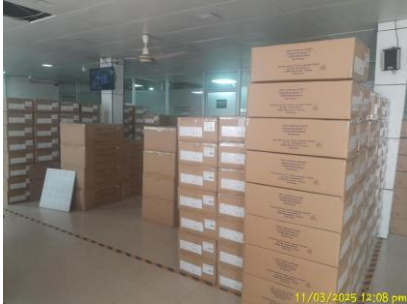
| F-20 | Fire Rated Construction | <p>Rooms used for storage of combustible materials are not separated from the surrounding occupancies.</p> <p><b>Location(s): Shed-4.</b></p> | <p>Rooms used for storage of combustible materials shall be separated from the surrounding occupancy with a minimum 1 hour construction.</p> | Within 3 months |

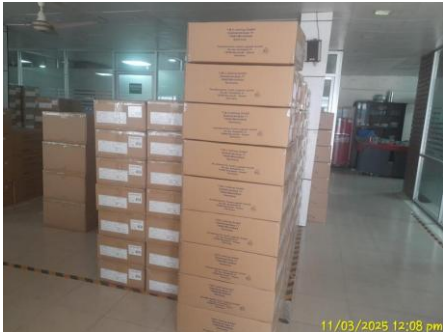
| F-22 | Means of Egress | <p>Directional Exit signage was not provided along the path of egress where there was a change in the direction for the path of travel, and the direction to an exit was not obvious.</p> <p><b>Location(s): Shed-4.</b></p> | <p>Provide directional exit signs above all building exits to the exterior, all doors to the exit stairs and along all paths of travel where a change of direction is not obvious. Lighted directional signs shall be provided with either battery backup or uninterruptable power supply systems and shall be continuously illuminated.</p> | Within 1 month |

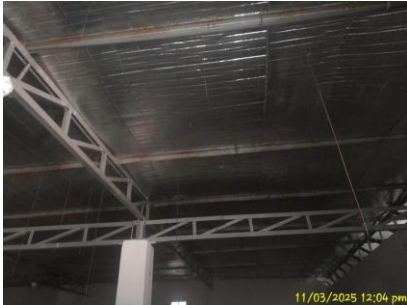
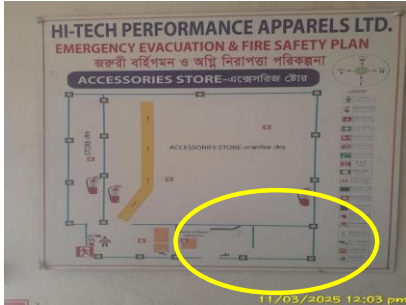
| F-24 | Fire Rated Construction | <p>Rooms used for storage of combustible materials are not separated from the surrounding occupancies (medical).</p> <p><b>Location(s): Shed-5.</b></p> | <p>Rooms used for storage of combustible materials shall be separated from the surrounding occupancy with a minimum 1 hour construction.</p> | Within 3 months |

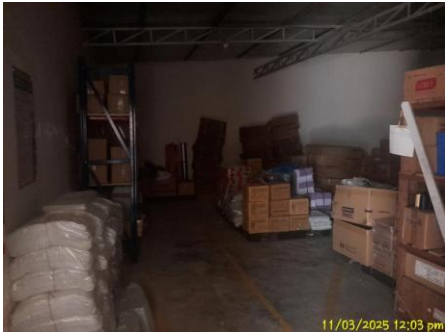
| F-25 | Means of Egress | <p>Directional Exit signage was not provided along the path of egress where there was a change in the direction for the path of travel, and the direction to an exit was not obvious.</p> <p><b>Location(s): Shed-5.</b></p> | <p>Provide directional exit signs above all building exits to the exterior, all doors to the exit stairs and along all paths of travel where a change of direction is not obvious. Lighted directional signs shall be provided with either battery backup or uninterruptable power supply systems and shall be continuously illuminated.</p> | Within 1 month |

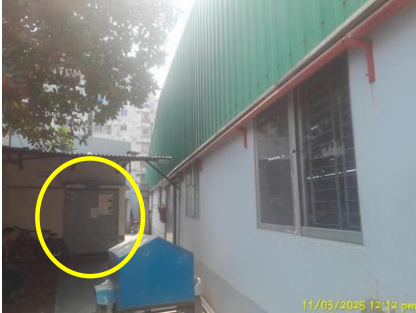
| <b>F-28</b> | Means of Egress | Sliding doors have provided along means of egress.<br><br><b>Location(s): Shed-3.</b> | Replace all sliding-type doors & gates with side-hinged swinging-type doors.<br><br>If locks are required for security reasons, utilize special door locking features complying with NFPA 101. | Within 1 month |
