# INITIAL FIRE SAFETY INSPECTION REPORT

## Radisson Casual Wear (Extension)

**RSC ID: 26008**

**Date: 02-March-2025**

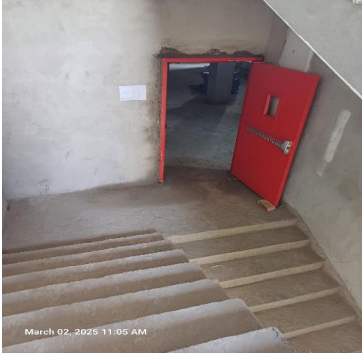
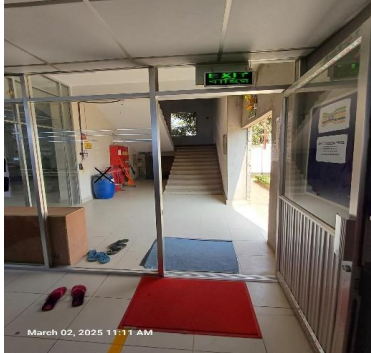
| SI No. | Category | Findings | Required Action | Remediation Time Frame |
|---|---|---|---|---|
| 1 | Means of egress | <p>The exit stair of the New building is not separated from the floors, as the fire-rated door was found to be open through unauthorized means on the first floor. Additionally, the production area on the ground floor was open (non rated glass partition) to stair without any fire separation.</p> <p><b>Location: New building</b></p> | <p>Provide minimum 1-hr fire rated construction for buildings with 3 or fewer stories and 2-hr fire rated construction for buildings that are 4 or more stories. Seal all unprotected openings to separate the exit stairs from work areas and other building spaces on all floor levels. Ensure that the fire doors are self-closing and positive latching and that they are provided with fire exit (panic) hardware where serving production floors. If fire doors are required to be held open for functional reasons, provide automatic closing devices tied to the fire alarm system.</p> <p>Fire door shall install as per manufacturer guidelines. Clearance under the bottom of a door shall be a maximum of 3/4in. (19 mm). Product datasheet, certificate shall keep available at site for fire door, frame &amp; accessories.</p> | Within 3 Months |

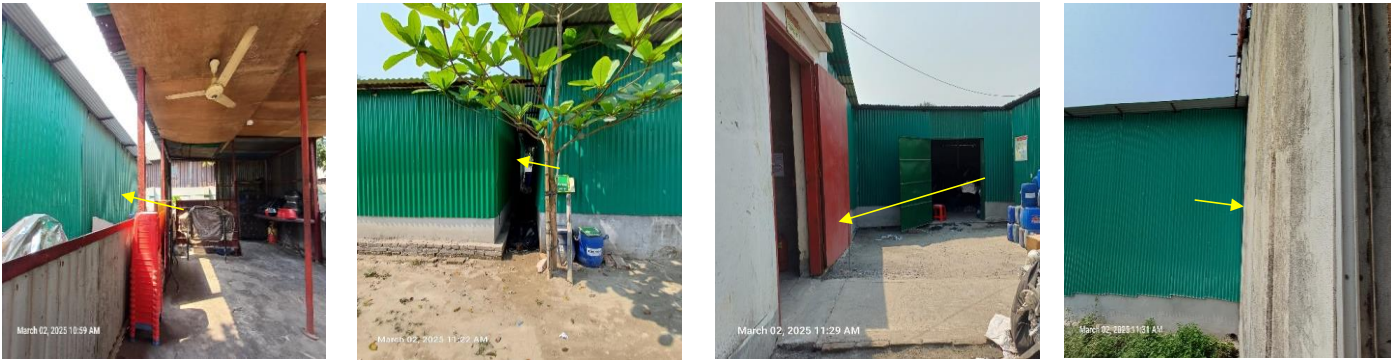
| 2 | Fire-Rated Construction | <p>The required fire separation distance for Sheds does not comply with the requirements of BNBC 2020.</p> <p><b>Location: Multipurpose Shed, Fabric Shed, Wastage Shed, Leftover storage Shed &amp; Staff Dining &amp; Kitchen Shed.</b></p> | <p>The exterior walls shall have a fire resistance and opening protection as specified in BNBC 2020 Part 3 Table 3.2.2 &amp; 3.2.3 and BNBC 2020 Part 3 Section 2.4.1.3.</p> | Within 6 Months |

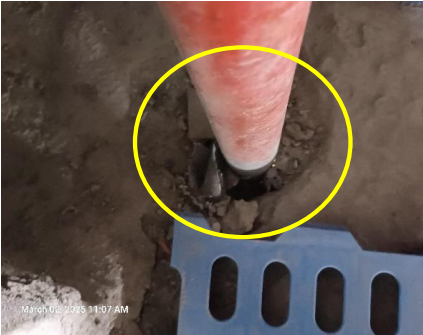
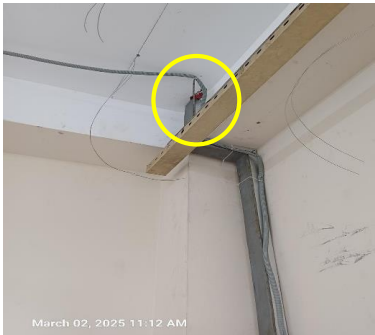
| 3 | Fire-Rated Construction | <p>The separation between floors is not maintained in the New Building from the ground floor to the first floor because of the presence of a hydrant pipe and cable riser that passing through the ceiling area.</p> <p><b>Location: New building</b></p> | <p>Provide a minimum 2-hr fire rated shaft to separate the utility risers from each floor level or seal all penetrations and openings in floors/ceiling assemblies by 2-hr fire rated listed/certified materials. The installation of such fire rated materials shall be following certified design.</p> | Within 3 Months |

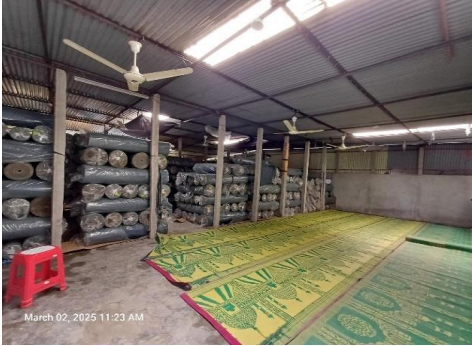
| 4 | Fire Rated Construction | <p>Prayer room is located in the Multipurpose Shed with the store area without any separation.</p> <p><b>Location: Multipurpose Shed.</b></p> | Remove the storeroom area or relocate the prayer area to ensure compliance with BNBC 2020 Table 3.2.1. | Within 3 Months |

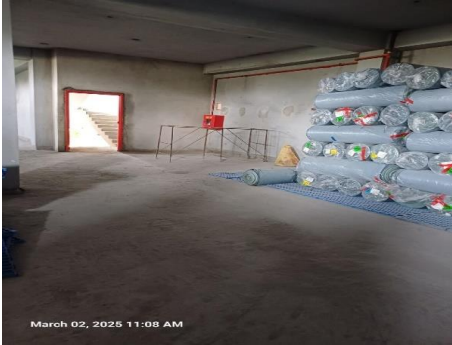
| 5 | Means of egress | <p>Fabric storage room on the 1st floor discharges directly into exit stair enclosure without any vestibules at New building.</p> <p><b>Location: New building.</b></p> | <p>Openings from exit enclosure to storage room spaces shall be provided with a vestibule with fire rated construction and openings. Provide a 1.5 hr. fire rated door on the exit stair side and a 1-hr. fire rated door on the Store room side. Ensure that the fire rating of the vestibule construction matches that of the exit stair enclosure. The minimum width of a vestibule shall be at least 1.1 m and not less than the width of the corridor leading to the vestibule. The minimum length of a vestibule in the direction of escape travel shall be 1.8 m.</p> | Within 3 Months |

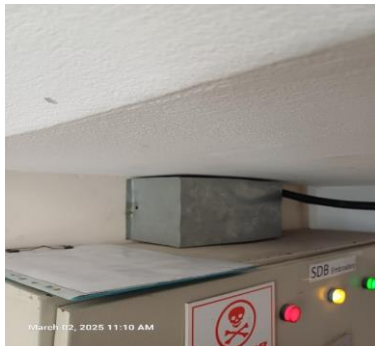
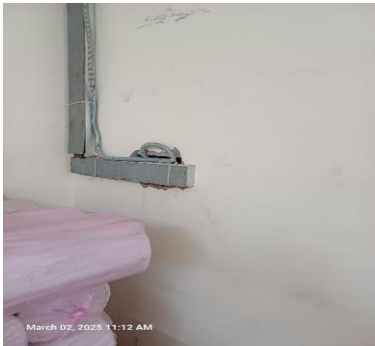
| 6 | Fire Rated Construction | <p>Unsealed penetrations in the wall due to cable are located in exit stair enclosures on the ground floor.</p> <p><b>Location: New building.</b></p> | <p>No other penetration into and through the exit enclosure except for fire alarm equipment electrical raceway, required exit doors, sprinkler piping, standpipes, and electrical conduit serving the exit enclosure is permitted. So, relocate the electrical wires/raceways to somewhere else avoiding the exit enclosure, and seal the created unprotected openings with a minimum of 1 hours listed/certified fire-rated materials or 1-hr masonry construction.</p> | Within 3 Months |

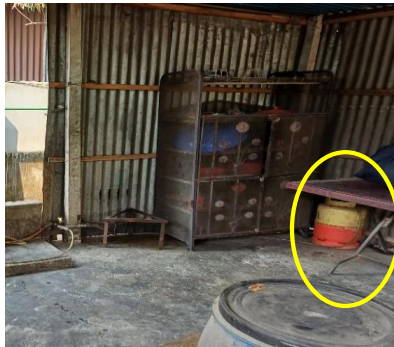
| 7 | Fire Rated Construction | <p>LPG gas cylinder was observed in the Staff Dining &amp; Kitchen shed.</p> <p><b>Location: Staff Dining &amp; Kitchen shed.</b></p> | <p>Remove the liquefied or compressed flammable gas cylinders. The storage or use of liquefied or compressed flammable gas (LPG/CNG) cylinders within the factory building as per section 3.4.2.1.11 of RSC Technical Guidelines (Standard)<sup>1</sup> V1.0.</p> <p>Or,</p> <p>Factory shall follow the requirements RSC Published "SUPPLEMENTARY PAPER ON TECHNICAL GUIDANCE NOTE FOR USE OF LIQUIFIED OR COMPRESSED FLAMMABLE GAS IN FACTORY PREMISES" to use or store liquefied or compressed flammable gas cylinders in the factory premises.</p> | Within 3 Months |

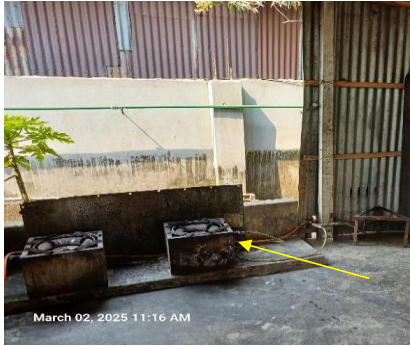
| 8 | Fire Rated Construction | <p>Cooking operations were observed in the Staff Dining &amp; Kitchen.</p> <p><b>Location: Staff Dining &amp; Kitchen shed.</b></p> | <p>Cooking operations that produce grease laden vapors shall be prohibited unless ventilation and a fire protection system is provided in accordance with NFPA 96.</p> | Within 1 Month |

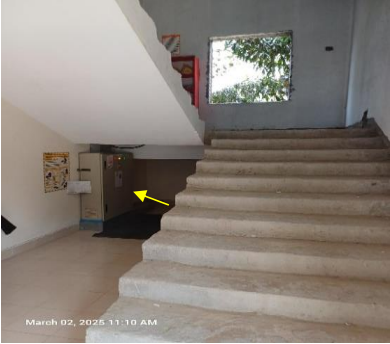
| 9 | Means of egress | <p>SDB were located inside the stair on the ground floor.</p> <p><b>Location: New building.</b></p> | Remove and re-locate all electrical panels from exit stair enclosure. | Within 1 Month |

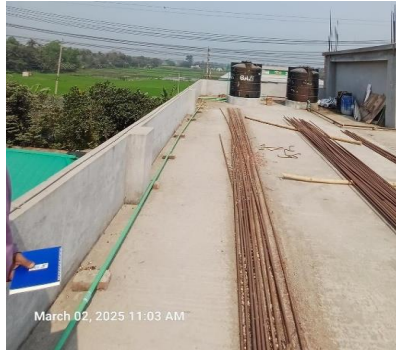
| 10 | Means of egress | <p>Parapet of New building found 2 feet 8 inches which is not as per standard.</p> <p><b>Location: New building.</b></p> | <p>All occupiable roofs shall be provided with parapets or guards with a minimum height of 1067mm (42 in.).</p> | Within 1 Month |

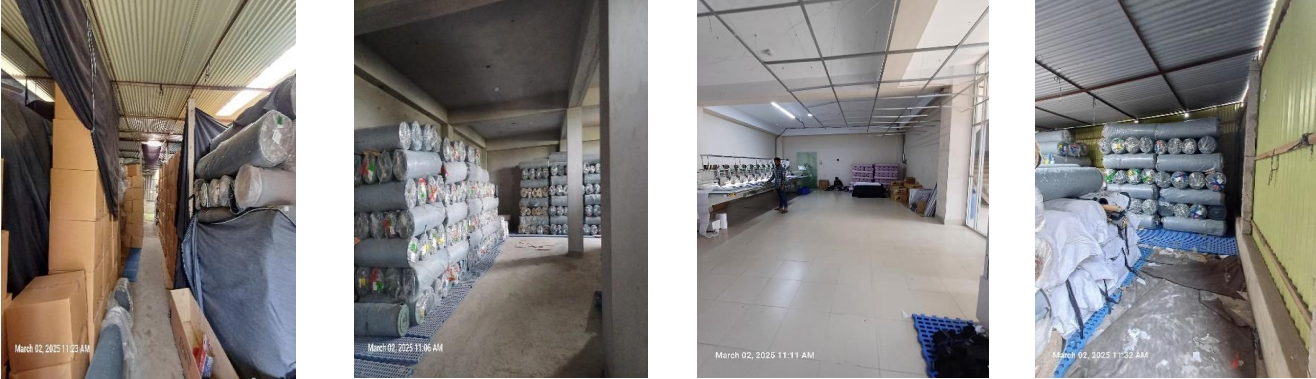
| 13 | Means of egress | <p>Aisles are not provided throughout the factory as per standard.</p> <p><b>Location: All Building.</b></p> | <p>Aisles shall be provided with a minimum unobstructed clear-width of 0.9 m (36 in.).</p> | Within 3 Months |

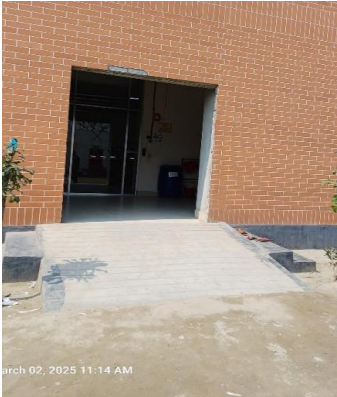
| 14 | Means of egress | <p>No guard are installed at exit discharge on the ground floor.</p> <p><b>Location: New building.</b></p> | <p>Guards shall be provided at all open sides of means of egress that exceed 760 mm (30 in.) above the floor or finished ground below. Guards shall have a minimum height of 1067 mm (42 in.).</p> | Within 1 Month |

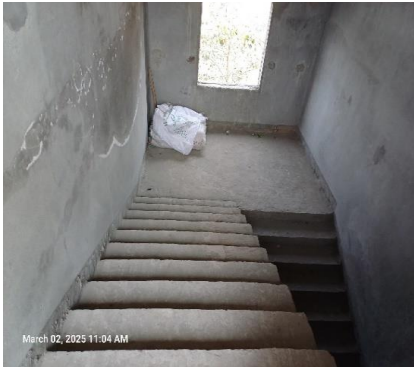
| 15 | Means of egress | <p>Handrails are not provided at both sides in the exit stair.</p> <p><b>Location: New building.</b></p> | <p>Provide handrails on both side of the stairs which have a minimum height of 865 mm (34 in.) and a maximum height of 965 mm (38 in.) as measured from the leading edge of the tread.</p> <p>Guards are required to be according to RSC Technical Guidelines 6.12.2 ( a sphere of 200 mm (8 in.) in diameter cannot pass through any opening up to a height of 865 mm (34 in.).</p> | Within 1 Month |

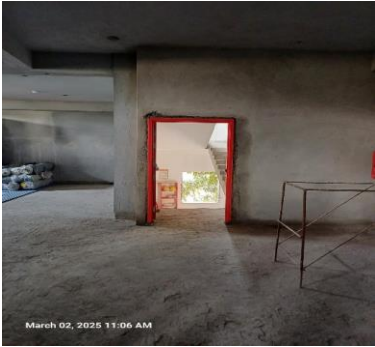
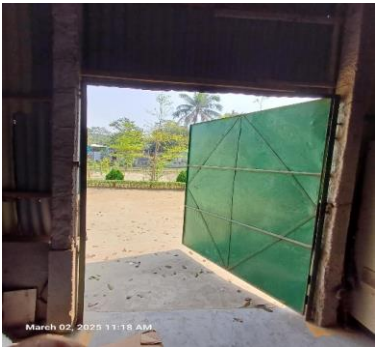
| 16 | Egress Lighting | <p>No exit signs are provided at required exits at all sheds and 1st floor of New building.</p> <p><b>Location: All Building.</b></p> | <p>Provide exit signs above all building exits to the exterior, all doors to the exit stairs. Lighted exit signs shall be provided with either battery backup or uninterruptable power supply systems and shall be continuously illuminated.</p> | Within 1 Month |

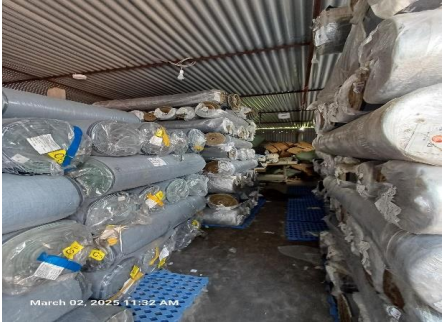
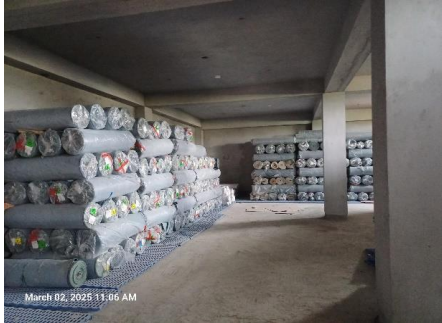
| 17 | Egress Lighting | <p>Based on the number and location of emergency lights observed, adequate illumination levels are not anticipated along egress routes and at exit stairs on all floors.</p> <p><b>Location: All Building.</b></p> | <p>Test the emergency lighting system on each floor and provide additional emergency fixtures to supply adequate illumination along the means of egress. Provide a minimum illumination of 10 lux at the floor level within exit stairs and along exit discharge paths and a minimum 2.5 lux along exit access aisles.</p> | Within 2 Months |

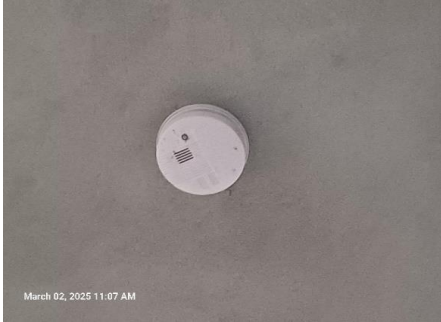
| 19 | Fire Alarm & Detection system | The fire alarm system is antiquated, not a listed system and does not provide alarm and notification features consistent with acceptable standards. | <p>Replace the fire alarm system with a new, listed addressable fire alarm system in accordance with NFPA 72.</p> <p>Submit the proposed fire alarm system design to RSC for review. Once the design is reviewed, install and modify the fire detection and alarm system throughout the building in accordance with review comment, RSC/ RSC Technical Guidelines (Standard) and NFPA 72. After installation the owner shall conduct internal testing and commissioning and then contact the RSC for witness of final acceptance testing. Complete the fire alarm installation as per NFPA 72. Submit drawings, testing records, equipment certification and other relevant documentation to the RSC prior installation for review.</p> | Design within 2 month and modification/ installation with 4 months |
