# INITIAL FIRE SAFETY INSPECTION REPORT

**BIDI APPARELS LTD.**

**RSC ID: 26172**

**Date: 27-April-2025**

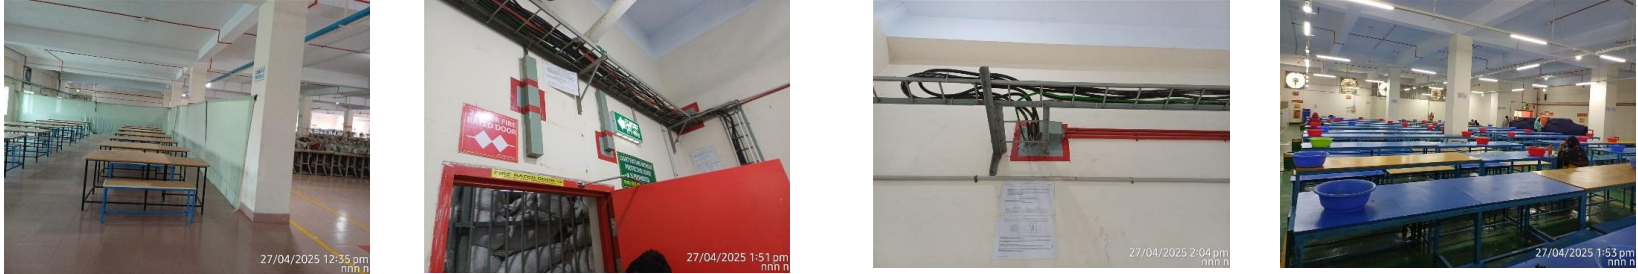
| SI No. | Category | Findings | Required Action | Remediation Time Frame |
|---|---|---|---|---|
| F-01 | Fire Rated Construction | The prayer room and training room (E4) is not separated from adjacent occupancies (production areas) with fire rated assemblies on 3rd floor of main building. Also the canteen area (E4) is not separated from adjacent occupancies (bonded warehouse, wastage store and printing section) with fire rated assemblies on ground floor of main building. Location: Ground Floor and 3rd Floor of Main Building. | To classify the occupancy as E4, it's necessary to limit the occupant load to below 300 as E3 (more than 300) is not permitted adjacent to production. Ensure required fire separation and opening protection as per BNBC table 3.2.1 and 3.2.3. Additionally, ensure that there are required direct exits to the stair enclosure from the assembly area. | Within 3 Months |

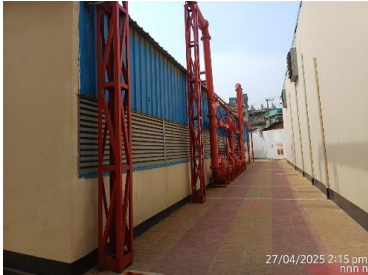
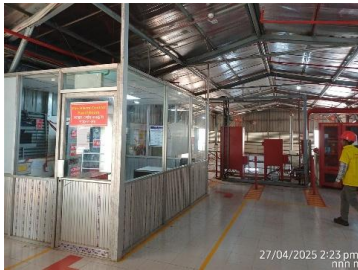
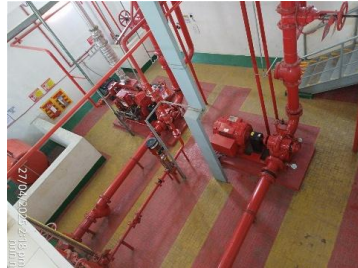
| F-02 | Fire Rated Construction | <p>The fire pump room is not provided with adequate fire separation.</p> <p>Location: Ground Floor, Fire Pump Shed.</p> | <p>Provide fire pump room with 2 hr. rated fire separation when not sprinklered and 1 hr. rated fire separation when provided with automatic sprinklers in accordance with NFPA 20. Or, Physically separate the pump room from the protected building by a minimum of 50 ft. (15.3 m) in accordance with NFPA 20</p> | Within 3 Months |

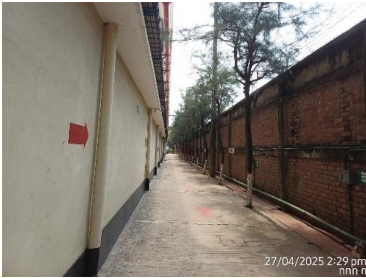
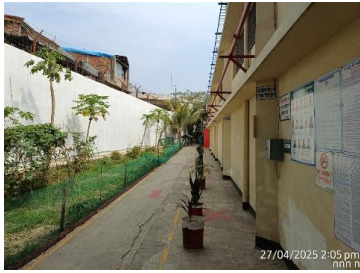
| F-03 | Fire Rated Construction | <p>The required fire separation distance for Building-01 does not comply with the requirements of BNBC 2006.</p> <p>Location: Main Building.</p> | <p>The exterior walls shall have a fire resistance and opening protection as specified in BNBC 2006, Tables 3.2.2 and Part 3 Section 2.4.1.3.</p> | Within 6 Months |

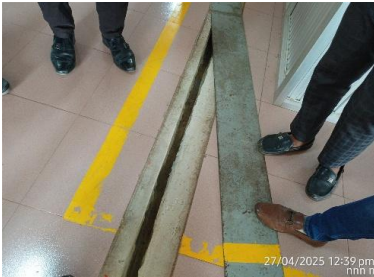
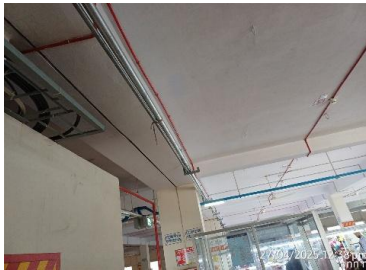
| F-04 | Fire Rated Construction | <p>Building expansion joint opening is not sealed by fire rated sealant/material.</p> <p>Location: All Floors at Main Building.</p> | <p>Expansion and contraction joints provided to accommodate expansion, contraction, wind or seismic movement shall be protected with a listed material having the same degree of fire resistance as that of the wall or floor in which it is installed.</p> <p>Installation shall be as per manufacturer published installation guideline and the certification authority guideline to ensure the fire-rating.</p> | Within 3 Months |

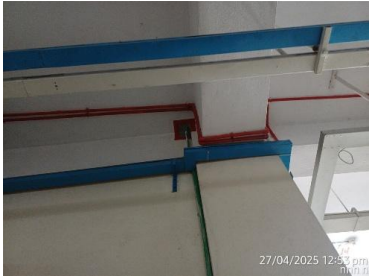
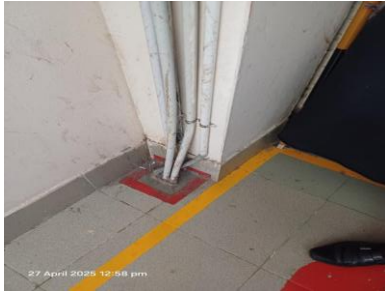
| F-05 | Fire Rated Construction | <p>Floor to floor penetration due to plumbing pipe and electric cable riser are found in main building which are not separated by fire rated construction or fire rated sealant.</p> <p>Location: All Floor of Main Building.</p> | <p>Seal all penetrations and openings in floor/ceiling assemblies to maintain the fire separation at least by 3-hr. The used sealer shall be 3rd party certified and installation shall be as per manufacturer's datasheet.</p> <p>Or</p> <p>Provide a minimum 2-hr fire rated shaft to separate the utility risers from each floor if required. If fire doors are required to be held open for functional reasons, provide automatic closing devices tied to the fire alarm system.</p> | Within 3 Months |

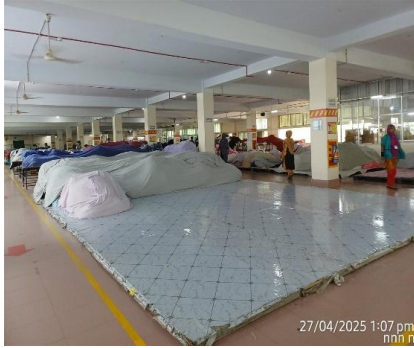
| F-06 | Fire Rated Construction | Areas used for in-process storage of combustible materials are open to the surrounding occupancy.<br>Location: 1st Floor of Main Building. | <p>Provide defined storage areas and limit the storage arrangement as follows:<br/>Maximum height of 2.45 m and maximum area of 23 m<sup>2</sup> and is separated by a minimum 3.0 m (10ft) from other storage areas and they do not exceed 10 percent of the building area of the story in which they occur.</p> <p>or,</p> <p>If sprinkler protected, Maximum height 12 ft (3.66 m) and maximum area of 1000 ft<sup>2</sup> (93 m<sup>2</sup>) and separated by at least 25 ft (7.62 m) and does not constitute more than 10 percent of the building area or 4000 ft<sup>2</sup> (372 m<sup>2</sup>) of the sprinklered area, whichever is greater.</p> <p>or,</p> <p>Enclose the storage area from the surrounding occupancy with a minimum 1 hour construction</p> | Within 3 Months |

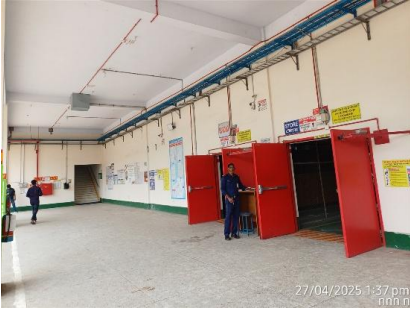
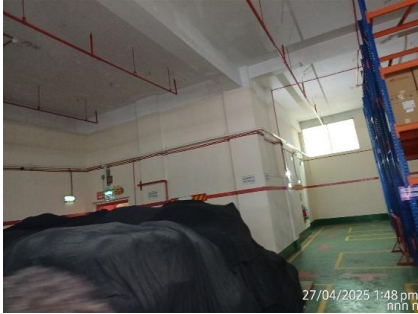
| F-07 | Means of Egress | <p>Dedicated storage room (bonded warehouse) is found on ground floor during the inspection, and no vestibules were found with exit stair enclosure as discharges from the storage room is directly to the exit stair enclosures.</p> <p>Location: Ground Floor of Main Building.</p> | <p>Openings from exit enclosure to Storage areas/ basements/ transformer rooms/ generator rooms/ boiler rooms and similar normally unoccupied spaces shall be provided with a vestibule with fire rated construction and openings in accordance with section 6.14.3 of RSC Technical Guidelines (Standard)<sup>1</sup> V1.0. . Provide a 1.5 hr. fire rated door on the exit stair side and a 1-hr. fire rated door on the Store, generator, sub-station room side . Ensure that the fire rating of the vestibule construction matches that of the exit stair enclosure as per RSC Technical Guidelines (Standard)<sup>1</sup> V1.0. section 6.14.3. The minimum width for vestibules shall not be less than 1.1m and length 1.8m.</p> | Within 3 Months |

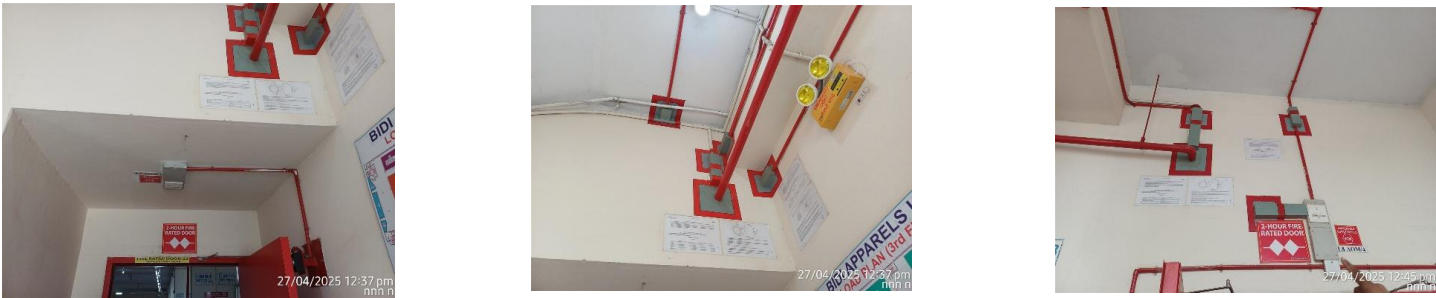
| F-08 | Means of Egress | <p>The exit stairs are not separated from work areas, and other spaces due to penetrations with operational areas.<br/>Location: Main Building.</p> | <p>The exit stair enclosure shall be provided with a minimum 1-hr fire resistance rating for buildings with 3 or fewer stories and a minimum of 2-hr. fire resistance rating for buildings 4 or more stories. Provide 1-hr. fire rated door and seal all penetrations and openings by 1 hr. fire rated fire rated barrier construction for building with 3 or fewer stories. Provide 1.5 hr. fire rated door and seal all penetrations and openings by 2 hr. fire rated fire rated barrier construction for building with 4 or more stories in accordance with section 6.3.1.2 of RSC Technical Guidelines (Standard)<sup>1</sup> V1.0.</p> <p>Provide a fire-resistive rated assembly between the exterior exit stairs and the building up to 10 ft. beyond the end of the stair to achieve the required separation. The rated assembly shall be approved and/or designed by a qualified fire protection engineer.</p> <p>Ensure that the fire doors are self-closing and positive latching and that they are provided with fire exit (panic) hardware where serving production floors. If fire doors are required to be held open for functional reasons, provide automatic closing devices tied to the fire alarm system.</p> | Within 3 Months |

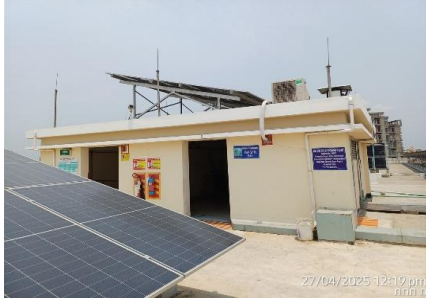
| F-09 | Means of Egress | Parapet/Guards are found missing at accessible roof of stairs.<br>Location: Rooftop of Main Building. | Provide parapets or guards with a minimum height of 1067mm (42 inch.) in accordance with RSC Technical Guidelines (Standard) <sup>1</sup> V1.0 Section 6.12. | Within 3 Months |

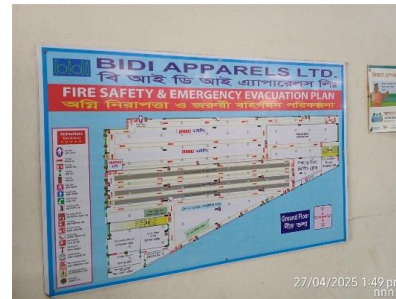
| F-10 | Means of Egress | Fire evacuation maps are not updated as per site condition<br>Locations: Ground Floor of Main Building. | Update the fire evacuation map and shall be posted at the entrance to each exit stair in accordance with RSC Technical Guidelines (Standard) <sup>1</sup> V1.0 Section 13.3. | Within 1 Month |

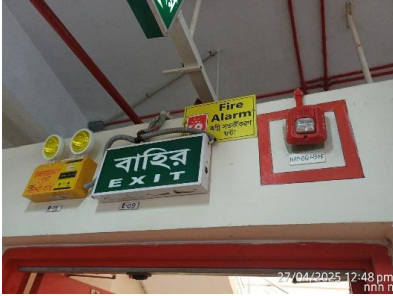
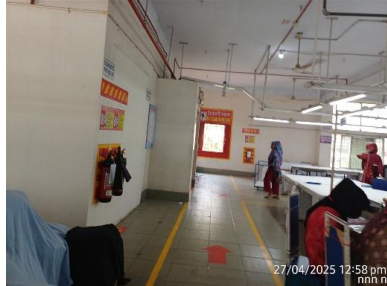
| F-11 | Egress Lighting | <p>Illumination level of exit signs and directional signs are found inadequate. Also directional signs are not provided adequately where direction of the path of travel to an exit has changed.</p> <p>Location: All floor of Main Building.</p> | <p>Lighted exit signs shall be placed at entrance to an exit. Additionally, directional exit signs shall be placed throughout the facility anywhere the continuation of the egress is not obvious. Lighted exit signs shall be provided with either battery backup or uninterruptable power supply systems and shall be continuously illuminated as per standard.</p> | Within 1 Month |

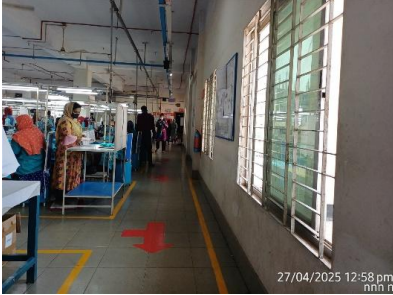
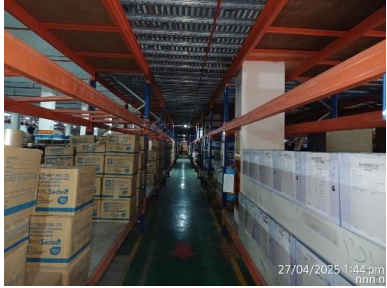
| F-12 | Egress Lighting | <p>Based on the number and location of emergency lights observed, adequate illumination levels are not anticipated along egress routes.</p> <p>Location: All floor of the Main Building.</p> | <p>Test the emergency lighting system on each floor and provide additional emergency fixtures to provide adequate illumination along the means of egress. Provide a minimum illumination of 10 lux at the floor level within exit stairs and exit discharge paths and minimum 2.5 lux along exit access aisles.</p> | Within 3 Months |

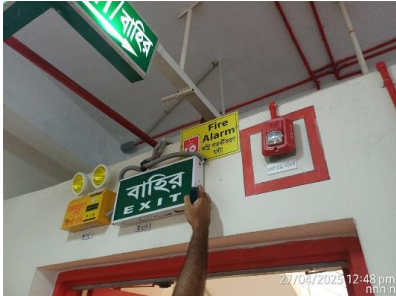
| F-13 | Egress Lighting | Manual on-off switches are provided for emergency lighting and exit signage units.<br>Location: All Buildings. | Remove manual on/off switches from emergency lighting and exit signage units to prevent them from being switched off. | Within 1 Month |

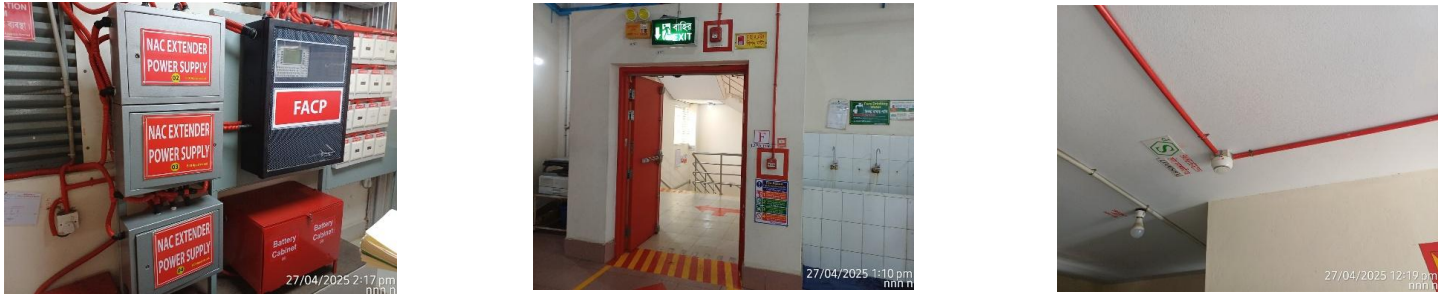
| F-14 | Fire Alarm & Detection System (FADS) | <p>The fire alarm and detection system has been installed, which requires a detailed review to confirm compliance with NFPA 72 and RSC Technical Guidelines (Standard).<br/>Location: All Buildings.</p> | <p>Submit the as built fire alarm and detection system drawing and documents to RSC for review. Once the design is reviewed, install/modify the fire alarm and detection system throughout the building in accordance with review comment, RSC Technical Guidelines (Standard) and NFPA 72.<br/>After installation/modification the owner shall conduct internal testing and commissioning and then contact the RSC for witness of final acceptance testing.</p> | <p>Design within 2 Months and<br/>Modification/<br/>Installation within 4 Months</p> |

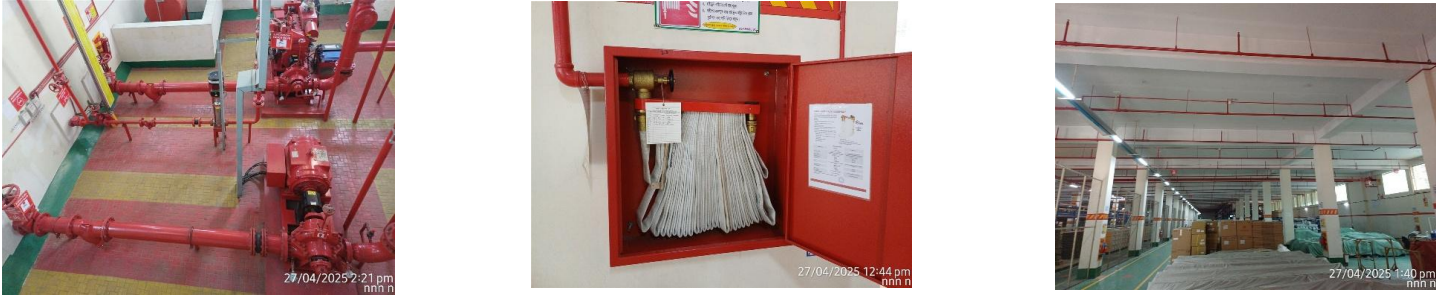
| F-16 | Fire Suppression System (SUPS) | The highest occupied floor of production building from the grade level is 44 feet 11 inch. So class-III standpipe system is required for the entire building and was found installed during the inspection. Also, the factory has installed sprinkler system in the bonded warehouse at the ground floor of main building. Standpipe and hose system, sprinkler system and, fire pump installation require a detailed review to ensure compliance with NFPA 13, 14, 20, and RSC Technical Guidelines (Standard). | Submit the standpipe and hose system, sprinkler system and fire pump system drawing and documents to RSC for review. Once reviewed, install or modify the standpipe and hose system, sprinkler (where installed) and fire pump system throughout the building in accordance with RSC Technical Guideline (Standard) and NFPA 13, 14, 20. After installation the owner shall contact the RSC for witness of conducting the final acceptance testing of the standpipe and hose system. | Design within 2 Months and Modification/ Installation within 4 Months |
