# **FIRE SAFETY INSPECTION REPORT**

**SHOMAHAR SWEATERS LTD.**  
**A-99/1, BOKTERPUR, KALIAKOIR, GAZIPUR**

**ACCORD**  
on Fire and Building Safety in Bangladesh

May 28, 2014

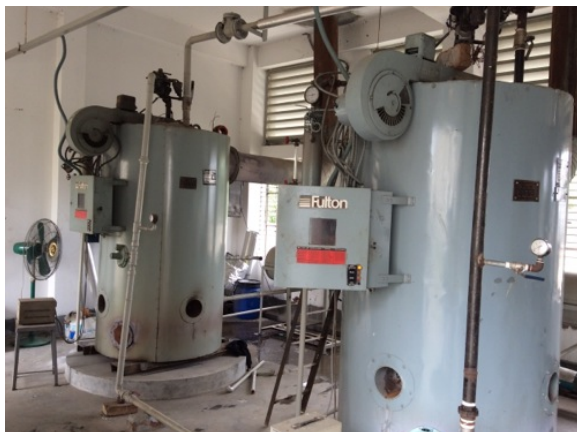
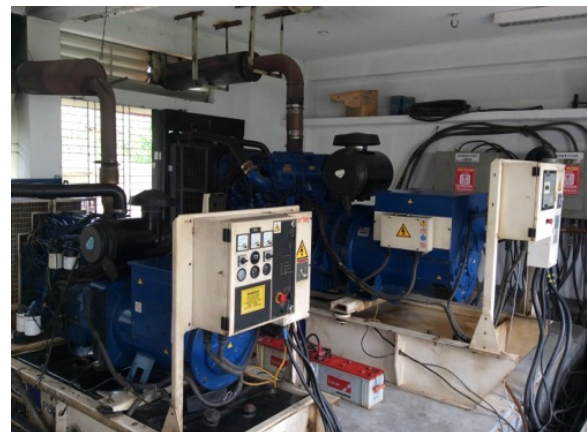
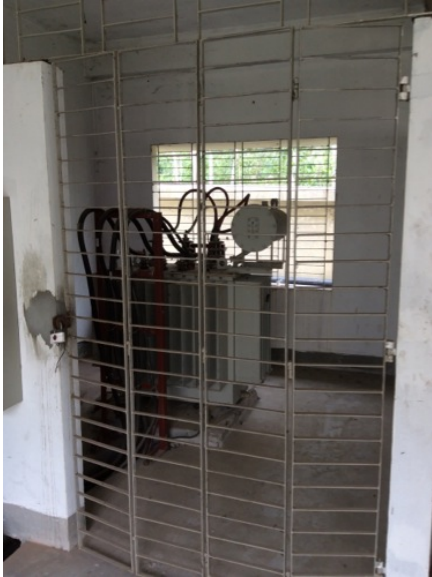
| No. | Category | Finding | Recommendation | Remediation Timeframe |
|---|---|---|---|---|
| F-1 | Fire Rated Construction | The boiler, generator and transformer rooms are not separated by fire-rated construction (openings, non-rated doors, penetrations). The rooms are open to egress path. | Separate the boiler, generator and transformer rooms by a minimum 2-hr fire-rated construction. Seal and or protected all openings to maintain the required fire separations | Within 3 months |

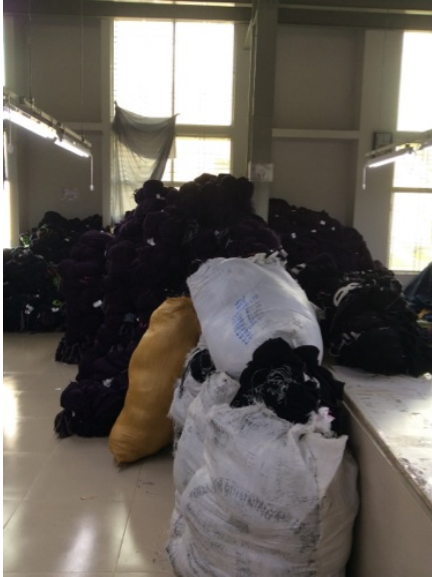
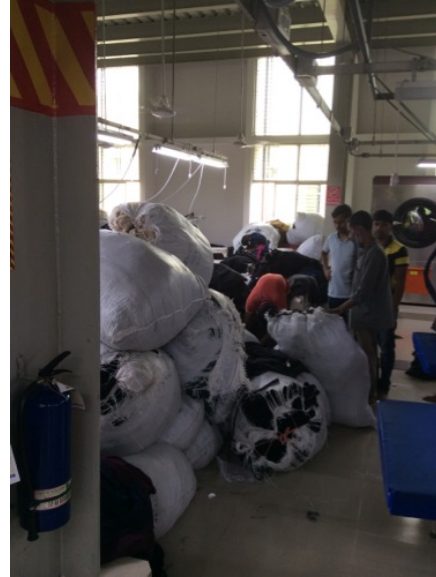
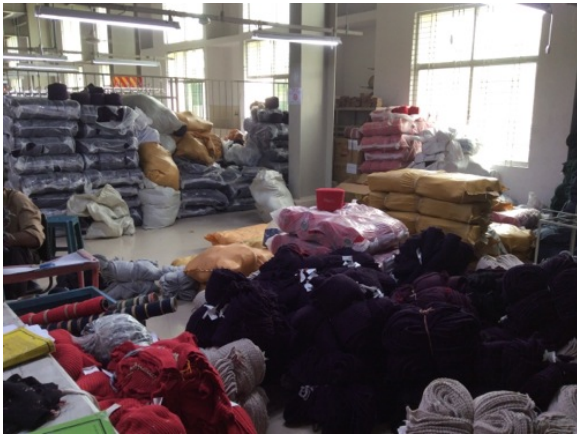
| F-2 | Fire Rated Construction | Areas used for combustible storage in all floors are not separated by fire-rated construction. | <p>Provide dedicated storage rooms separated by minimum 1-hr fire-rated construction.</p> <p>Where separate storage rooms are not feasible, provide defined storage areas and limit the storage arrangement as follows:</p> <ul style="list-style-type: none"><li>- Maximum height of 2.4m and maximum area of 23m<sup>2</sup></li><li>- If sprinkler protected: maximum height of 3.66m and maximum area of 93m<sup>2</sup></li></ul> <p>Separate areas of unenclosed combustible storage by a minimum clear distance of 3m.</p> | Within 3 months |

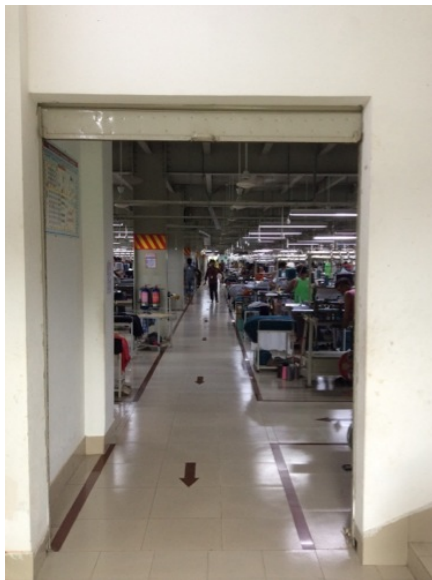
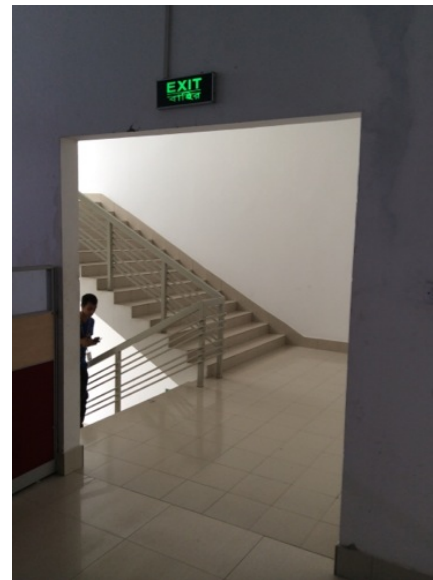
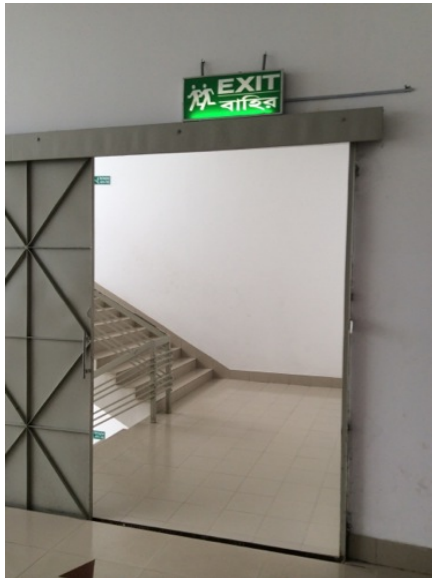
| F-3 | Fire Rated Construction | The exit stairs are not separated from work areas or other spaces on each floor by fire-rated construction. | Provide minimum 1.5-hr fire rated doors and seal all unprotected openings to separate the exit stairs from work areas and other building spaces on all floor levels. Ensure that the fire doors are self-closing and positive latching and that they are provided with fire exit (panic) hardware where serving production floors.<br><br>If fire doors are required to be held open for functional reasons, provide automatic-closing devices tied to the fire alarm system. | Within 3 months |

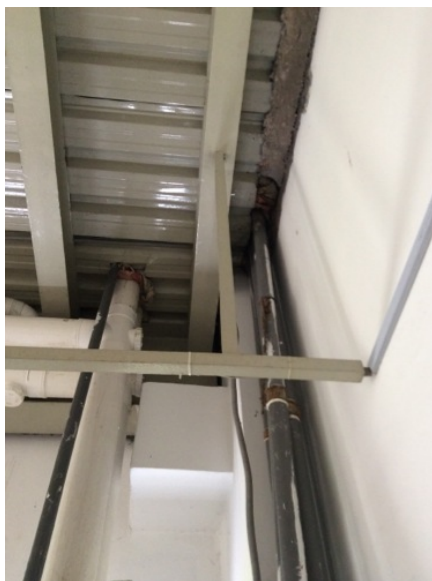
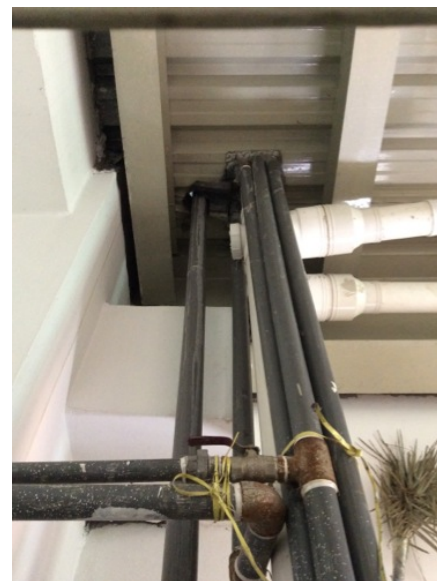
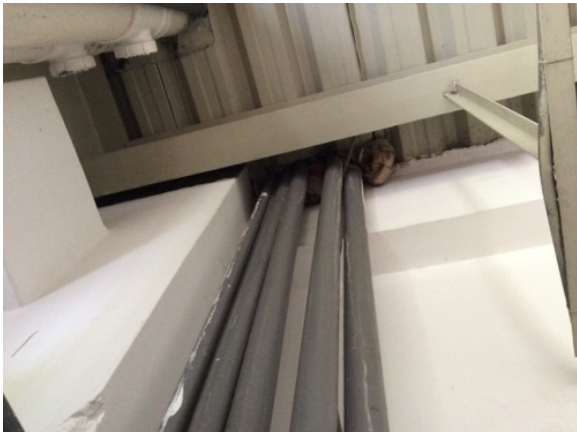
| F-4 | Fire Rated Construction | Unsealed penetrations and openings for pipe shaft in all toilets are located in the fire-rated floor/ceiling assemblies. | Provide a minimum 2-hr fire-rated shaft to separate the utility risers from each floor level.<br><br>Seal all penetrations and openings in floor/ceiling assemblies to maintain the fire separation. | Within 3 months |

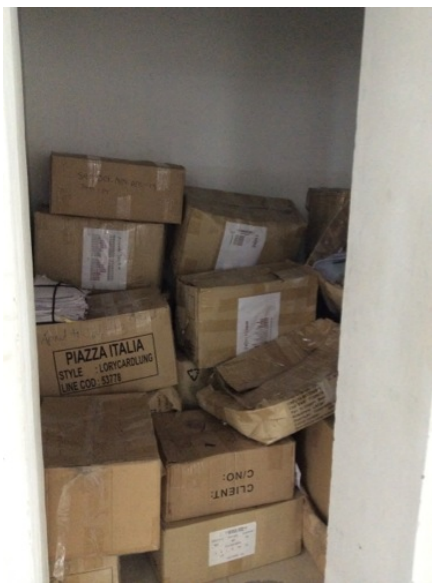
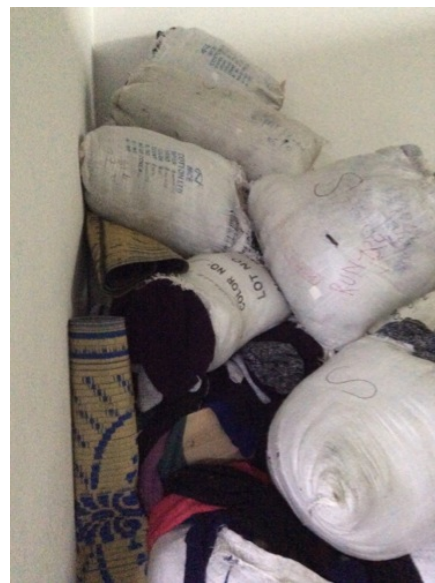
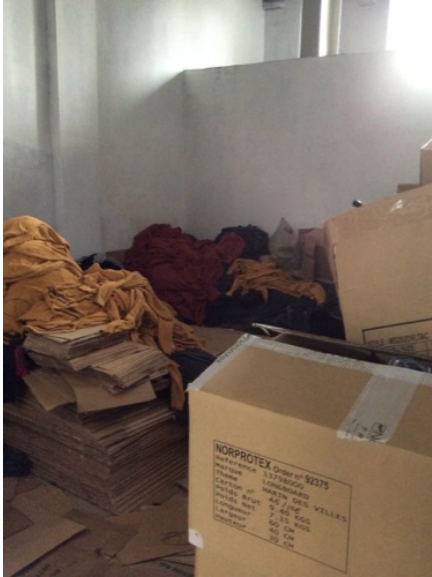
| F-5 | Fire Rated Construction | Areas used for combustible storage room in all floors are not separated by fire-rated construction. Also storage rooms on the shed 3 and 9 are not separated by fire-rated construction. | Provide dedicated storage rooms separated by minimum 1-hr fire-rated construction. | Within 3 months |

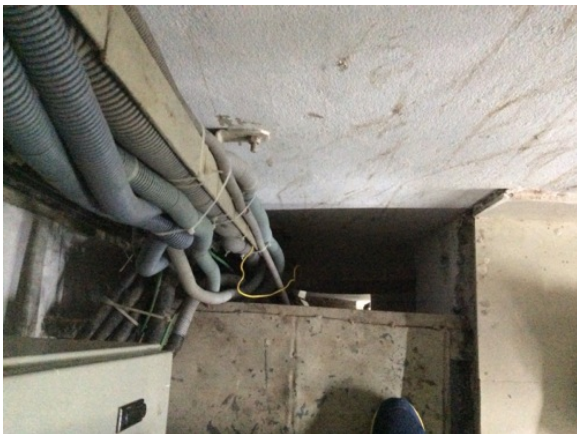
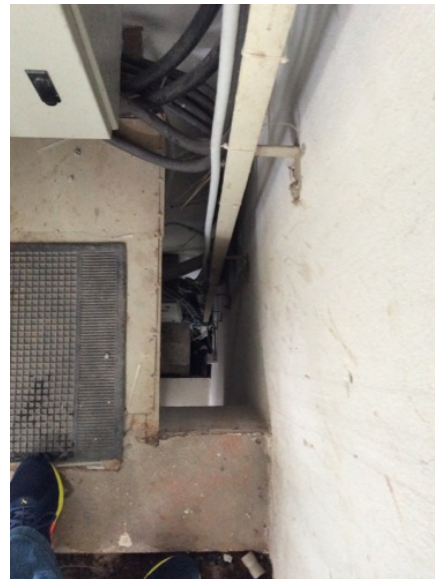
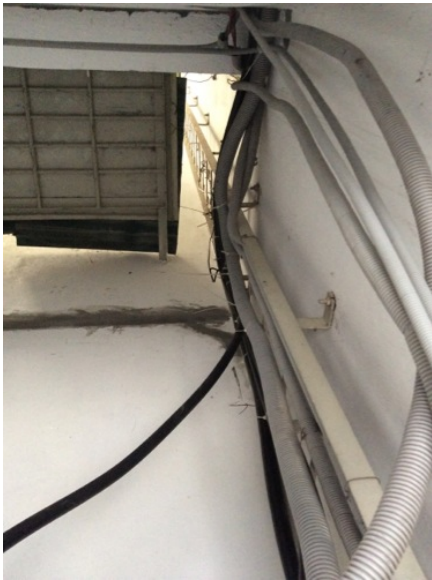
| F-6 | Fire Rated Construction | Unsealed penetrations and openings in electric shaft are located in the fire-rated floor/ceiling assemblies. | Provide a minimum 2-hr fire-rated shaft to separate the utility risers from each floor level. | Within 3 months |

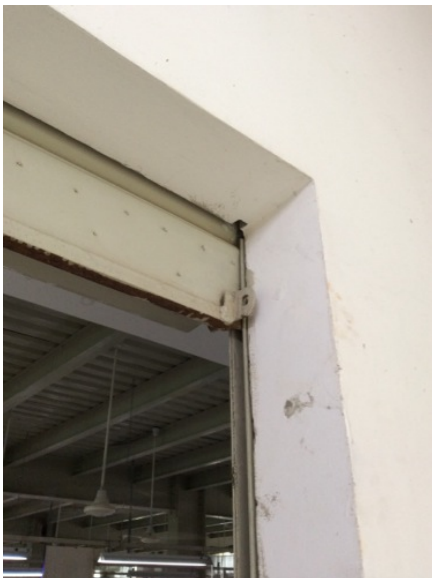
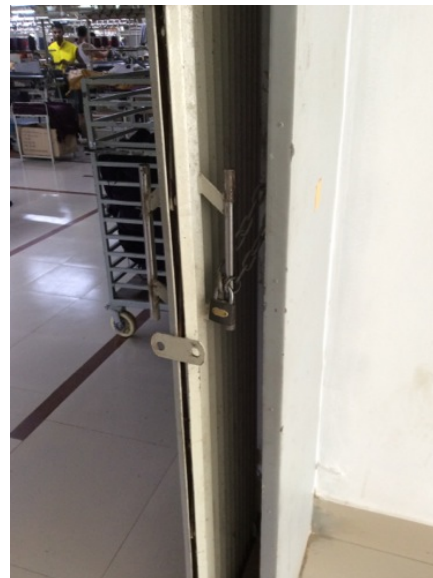
| F-7 | Egress | <p>Egress doors / gates with locking features are provided at building exits and exit stairs.</p> <p>All gates/doors were open and unlocked during the inspection.</p> | <p>Remove locking features from all egress doors / gates.</p> <p>If locks are required for security reasons, utilize special door locking features complying with NFPA 101.</p> | Immediate |

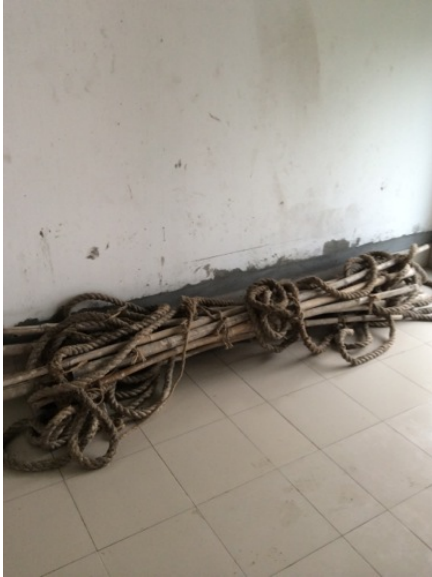
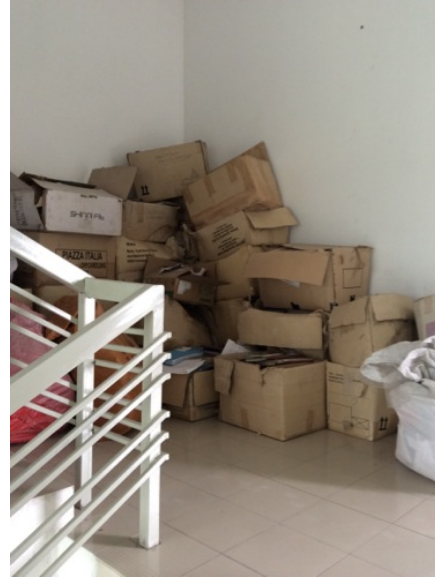
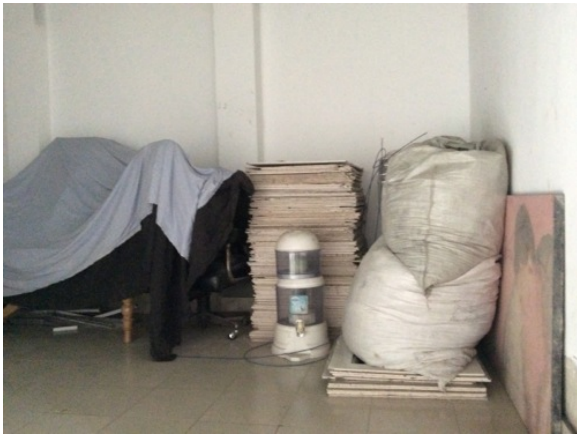
| F-8 | Egress | <p>Storage was located in all exit stairs.</p> | <p>Remove all storage from exit stairs and egress paths.</p> | Immediate |

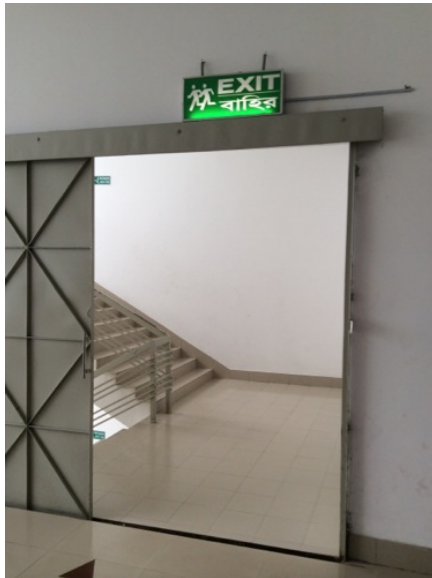
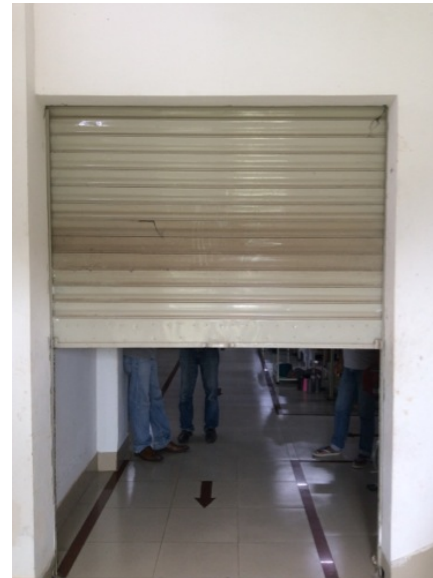
| F-9 | Egress | Collapsible gates / sliding doors in ground floor are provided at exits and exit stairs. | Replace all gates / sliding doors along the means of egress with side-hinged, swinging egress doors.<br><br>If locks are required for security reasons, utilize special door locking features complying with NFPA 101. | Within 1 month |

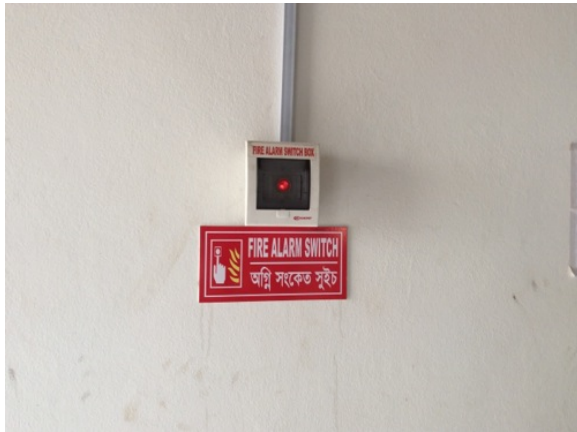
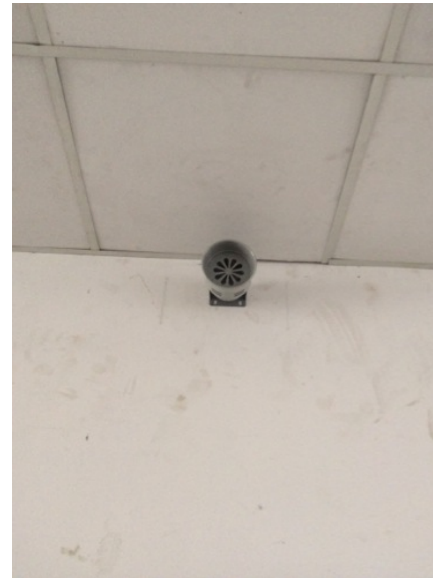
| F-11 | Fire Protection | The fire alarm system is antiquated, not a listed system, and does not provide alarm and notification features consistent with acceptable standards. | Replace the fire alarm system with a new, listed addressable fire alarm system in accordance with NFPA 72. | Design within 4 months, install within 9 months |

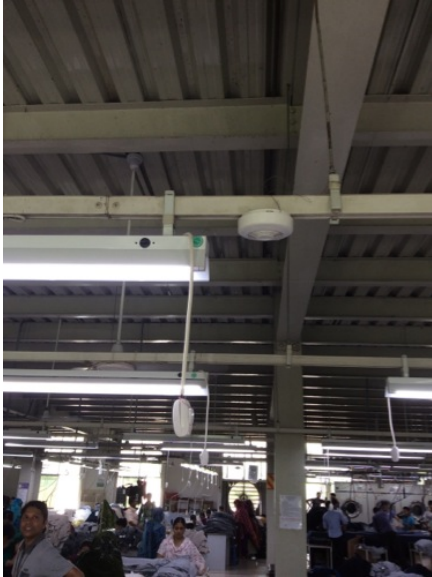
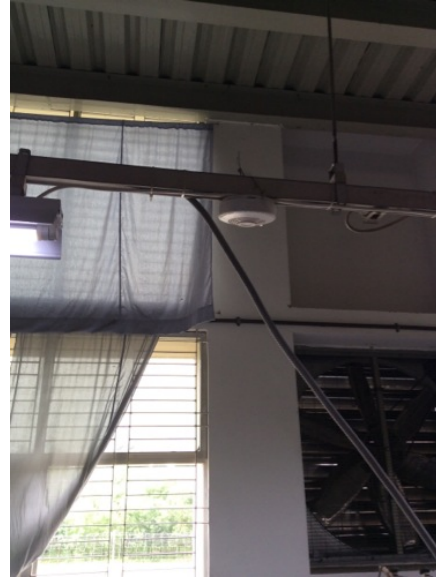
| F-13 | Fire Protection | The building is equipped with single-station smoke alarms. Smoke alarm activation sounds only a local alarm and does not provide automatic fire alarm notification of occupants. Also the shed 1, 3 and 4 do not provide automatic fire alarm and detection system. | Remove single-station smoke alarms. Provide automatic smoke detection throughout the building, tied into the fire alarm system, in accordance with NFPA 72. | Within 6 months |

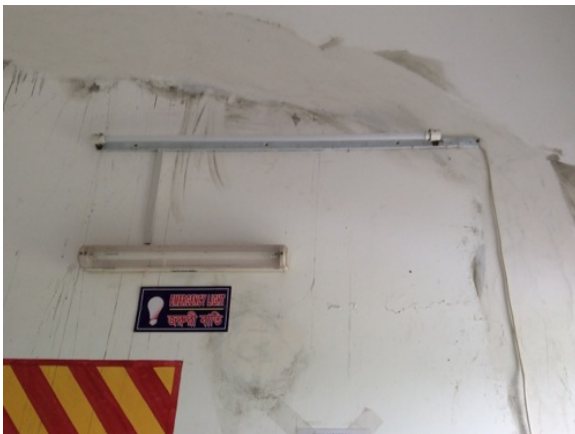
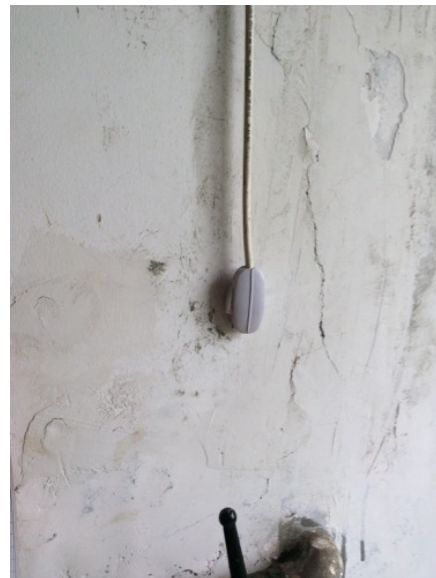
F-14 Egress  
Lighting

Manual on-off switches in several locations are provided for emergency lighting / exit signage units.

Remove manual on/off switches from emergency lighting / exit signage units to prevent them from being switched off.
