FIRE SAFETY INSPECTION REPORT

V-KNITWEAR & COMPOSITE LTD
MAHANA, GOLAKANDAIL, BHULTA, RUPGONJ,
NARAYANGONJ

ACCORD
on Fire and Building Safety in Bangladesh

June 2, 2014

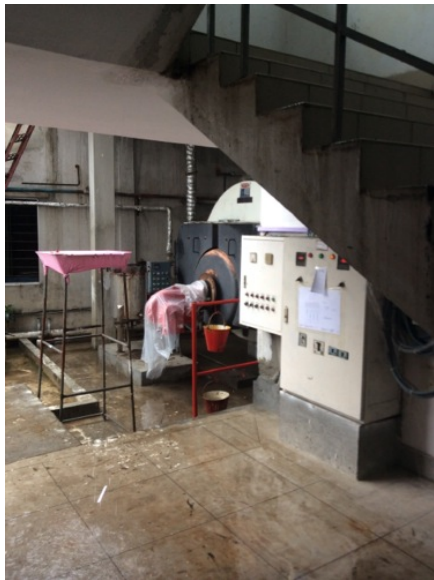
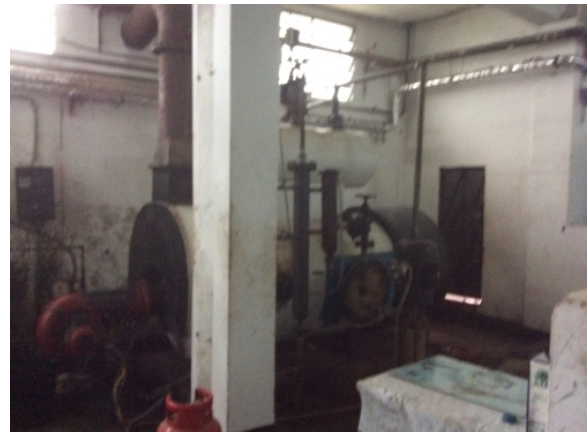
| F-1 | Fire Rated Construction | The boiler rooms are not separated by fire-rated construction (openings, non-rated doors, penetrations) on the ground floor. | Separate the boiler rooms by a minimum 2-hr fire-rated construction. Seal and/or protected all openings to maintain the required fire separations | Within 3 months |

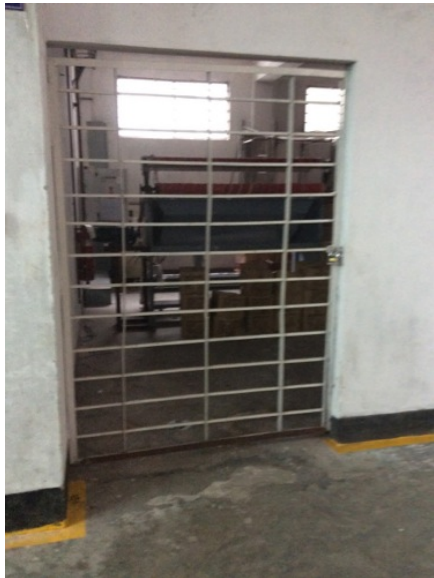
| F-2 | Fire Rated Construction | Store rooms used for combustible storage are not separated by fire-rated construction on the ground floor. | Provide dedicated storage rooms separated by minimum 1-hr fire-rated construction. | Within 3 months |

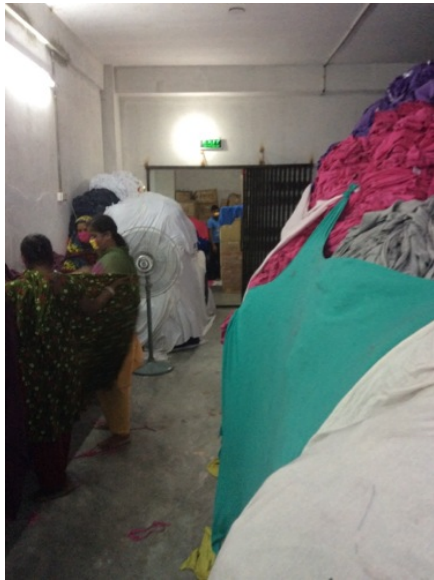
| F-3 | Fire Rated Construction | Areas used for combustible storage are not separated by fire-rated construction on the ground floor. | Where separate storage rooms are not feasible, provide defined storage areas and limit the storage arrangement as follows: - Maximum height of 2.4m and maximum area of 23m ² - If sprinkler protected: maximum height of 3.66m and maximum area of 93m ² Separate areas of unenclosed combustible storage by a minimum clear distance of 3m. | Within 3 months |

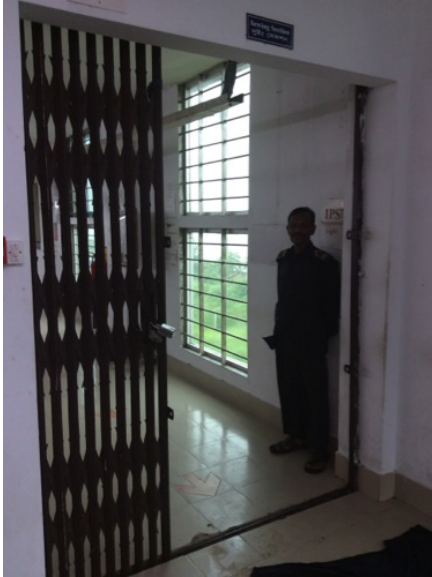
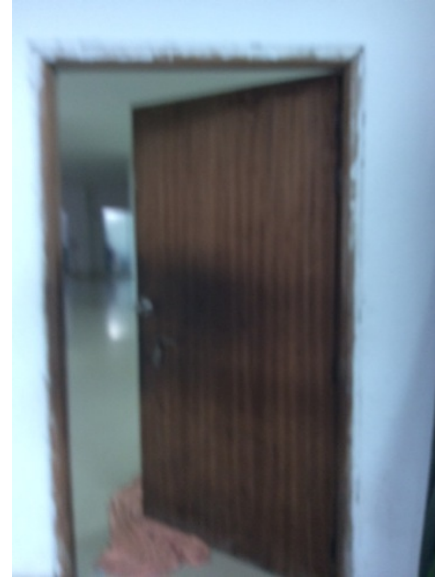
| F-4 | Fire Rated Construction | The exit stairs are not separated from work areas on each floor by fire-rated construction. | Provide minimum 1.5-hr fire rated doors and seal all unprotected openings to separate the exit stairs from work areas and other building spaces on all floor levels. Ensure that the fire doors are self-closing and positive latching and that they are provided with fire exit (panic) hardware where serving production floors. If fire doors are required to be held open for functional reasons, provide automatic-closing devices tied to the fire alarm system. | Within 3 months |

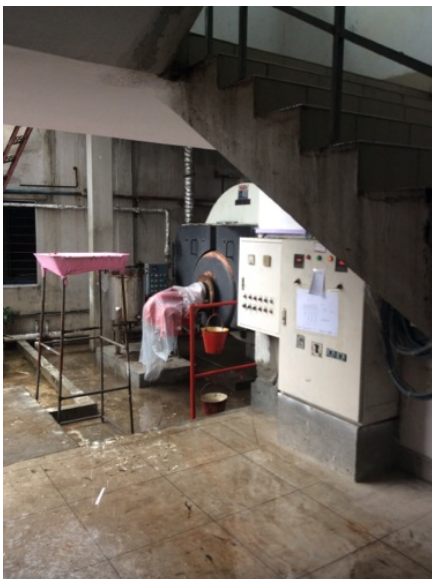
| F-5 | Fire Rated Construction | The exit discharge path serving southeast exit is less than 10 ft wide and is not separated from the building interior. | Seal all penetrations and openings to the interior of the building along the discharge path, up to a height of 10 ft., to provide a minimum 1-hr fire separation. Alternatively, provide a second remote discharge path to the public way (only include this if feasible). | Within 6 months |

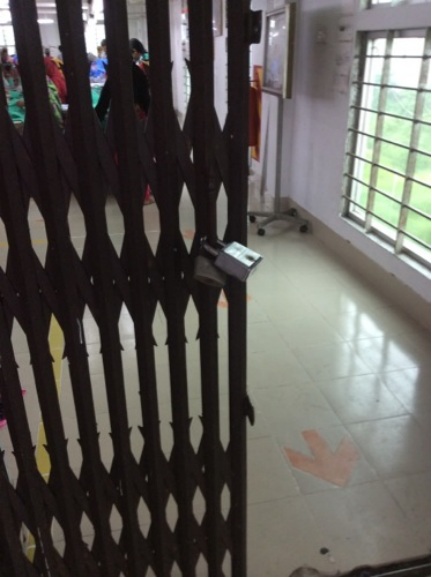
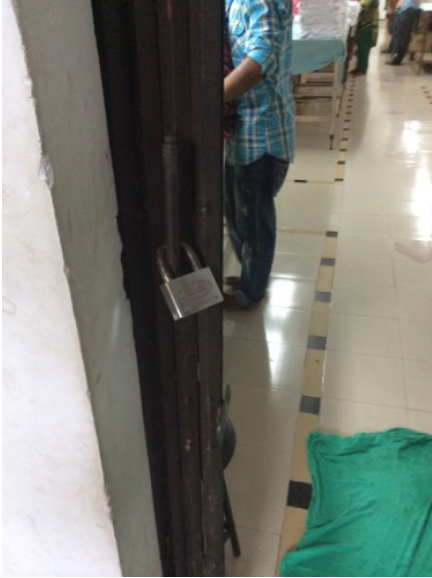
| F-7 | Egress | Egress doors with locking features are provided at exit stairs on every floor. | Remove locking features from all egress doors. If locks are required for security reasons, utilize special door locking features complying with NFPA 101. | Immediate | |

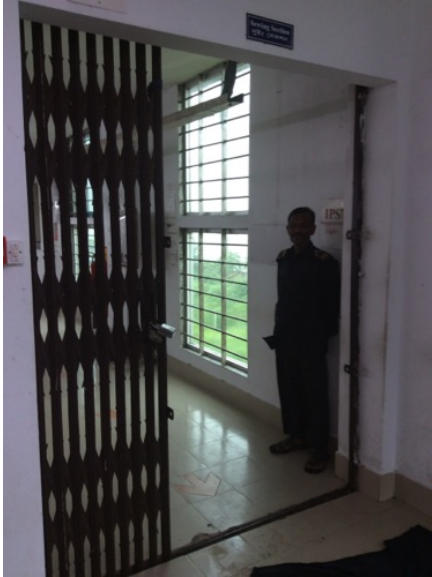
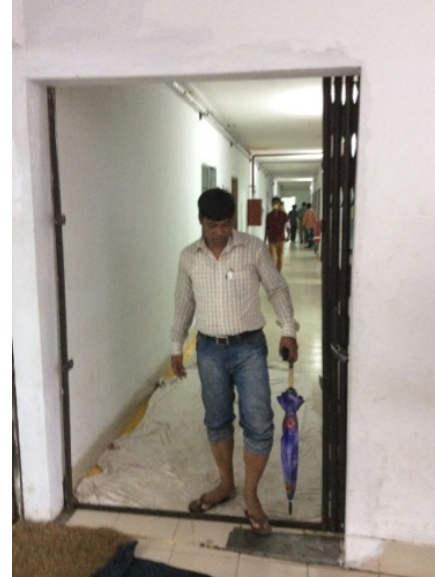
| F-8 | Egress | Sliding doors are provided at exit stairs on every floor. | Sliding doors along the means of egress with side-hinged, swinging egress doors. If locks are required for security reasons, utilize special door locking features complying with NFPA 101. | Within 1 month | |

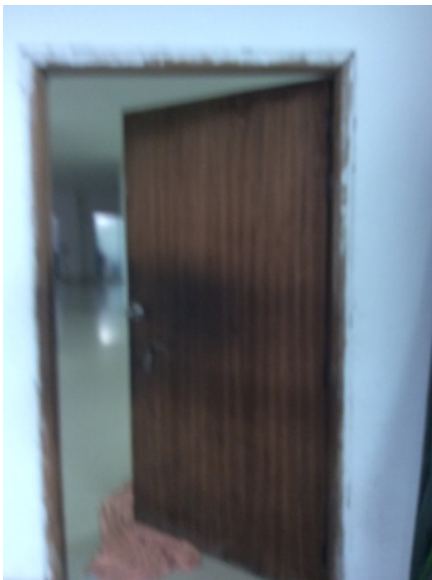
| F-9 | Egress | Exit stair door does not swing in the direction of egress travel on the 1st floor. | Modify the egress door to swing in the direction of egress travel. | Within 3 months |

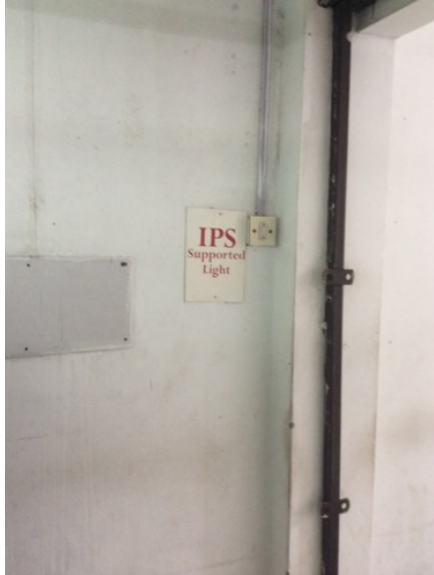
| F-11 | Egress Lighting | Manual on-off switch is provided for emergency lighting units on every floor. | Remove manual on/off switches from emergency lighting units to prevent them from being switched off. | Within 1 month |

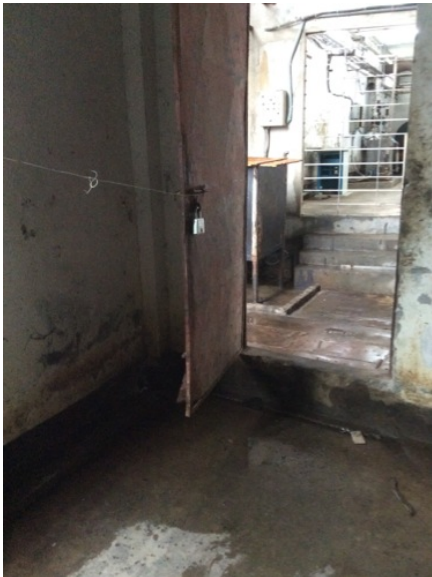
| F-1 | Fire Rated Construction | The exit discharge path serving west exit is less than 10 ft wide and is not separated from the building interior. | <p>Seal all penetrations and openings to the interior of the building along the discharge path, up to a height of 10 ft., to provide a minimum 1-hr fire separation.</p> <p>Alternatively, provide a second remote discharge path to the public way (only include this if feasible).</p> | Within 6 months |

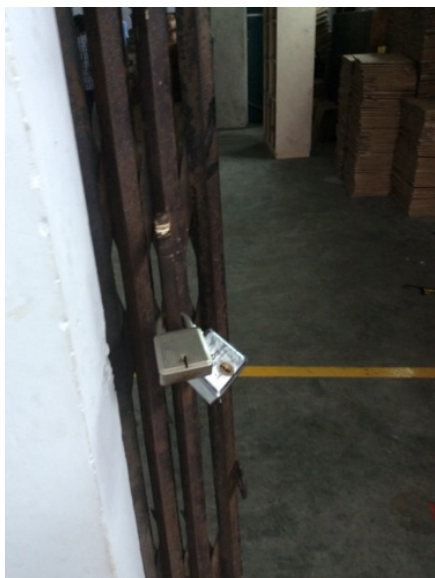
| F-2 | Egress | Egress doors with locking features are provided at building exits,. | <p>Remove locking features from all egress doors.</p> <p>If locks are required for security reasons, utilize special door locking features complying with NFPA 101.</p> | Immediate |
