# **FIRE SAFETY INSPECTION REPORT**

## **S-21 APPARELS**

**276, NARSHINGHAPUR, ASHULIA, DHAKA-1341**

June 10, 2014

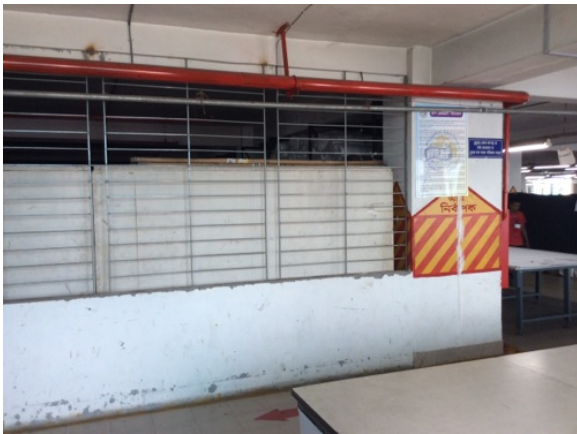
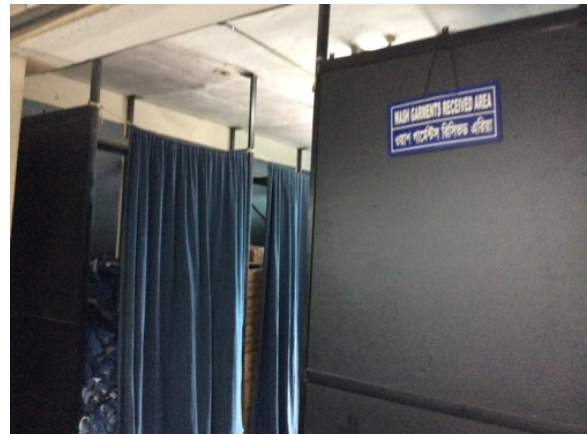
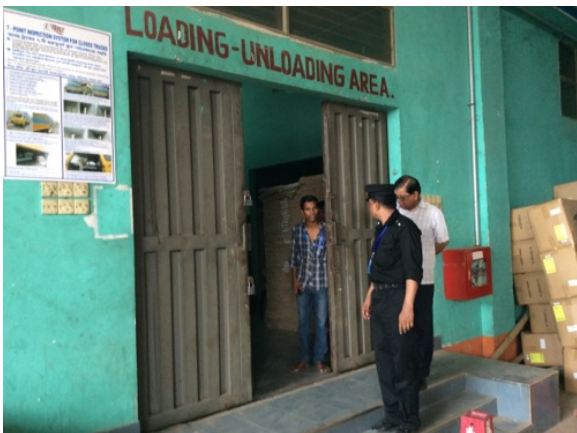
| No. | Category | Finding | Recommendation | Remediation<br>Timeframe |
|---|---|--|--|---|
| F-1 | Fire Rated<br>Construction | Storage rooms used for combustibles were not separated by fire-rated construction on Floors G, 1, and 2. | Provide dedicated storage rooms separated by minimum 1-hr fire-rated construction. | Within 3<br>months |

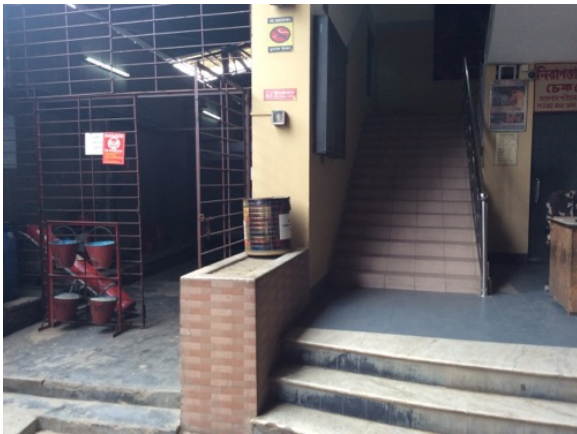
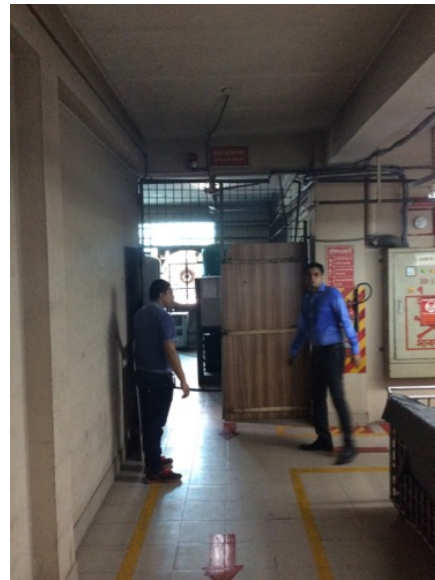
| F-2 | Fire Rated Construction | The boiler, generator and transformer were not separated from the egress paths by fire-rated construction. The boiler room is open to production areas on Floor 1 and the generator/transformer room is open to the West exit stair on the ground floor. | Separate the boilers, generator and transformer by a minimum 2-hr fire-rated construction. Seal and/or protect all openings to maintain the required fire separations | Within 3 months |

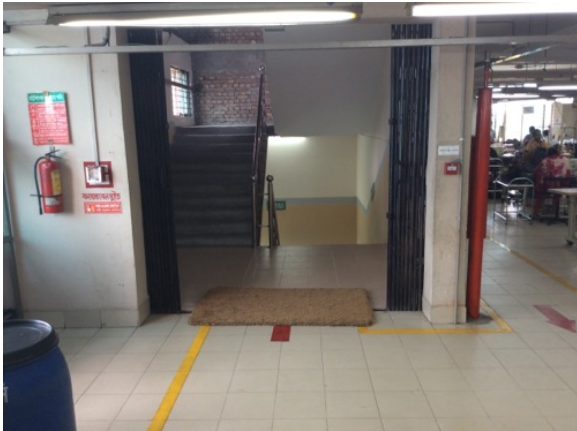
| F-3 | Fire Rated Construction | The exit stairs were not separated from work or storage areas on each floor by fire-rated construction. | <p>Provide minimum 1.5-hr fire rated doors and seal all unprotected openings to separate the exit stairs from work areas and other building spaces on all floor levels. Provide vestibules to separate storage areas from egress paths. Ensure that the fire doors are self-closing and positive latching and that they are provided with fire exit (panic) hardware where serving production floors.</p> <p>If fire doors are required to be held open for functional reasons, provide automatic-closing devices tied to the fire alarm system.</p> | Within 3 months |

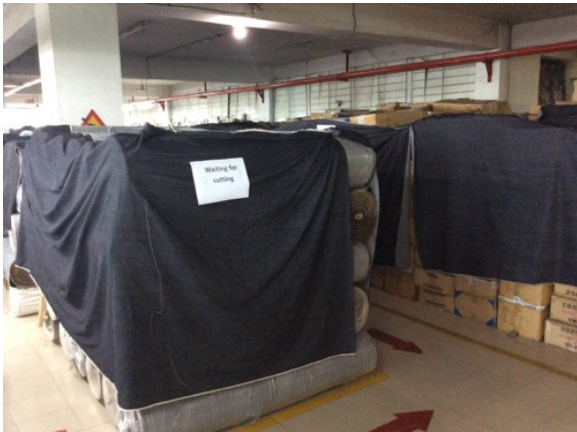
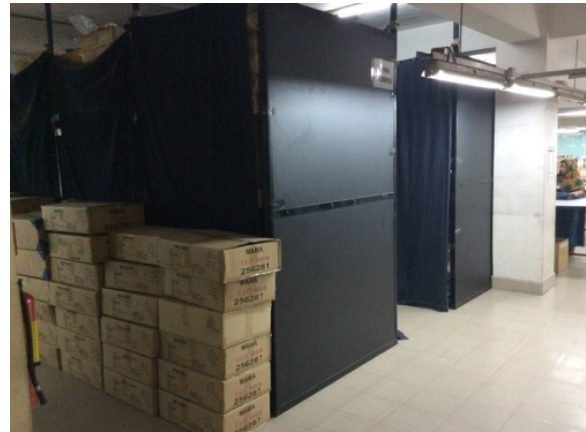
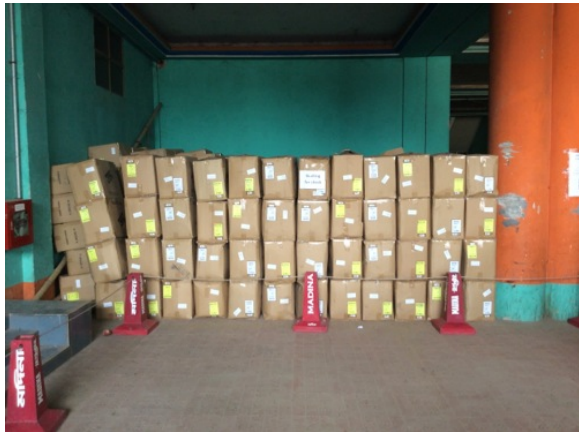
| F-4 | Fire Rated Construction | Areas used for combustible storage were open to the factory floor on Floors G, 1, and 2. | <p>Provide dedicated storage rooms separated by minimum 1-hr fire-rated construction.</p> <p>Where separate storage rooms are not feasible, provide defined storage areas and limit the storage arrangement as follows:</p> <ul style="list-style-type: none"> <li>- Maximum height of 2.4m and maximum area of 23m<sup>2</sup></li> <li>- If sprinkler protected: maximum height of 3.66m and maximum area of 93m<sup>2</sup></li> </ul> <p>Separate areas of unenclosed combustible storage by a minimum clear distance of 3m.</p> | Within 3 months |

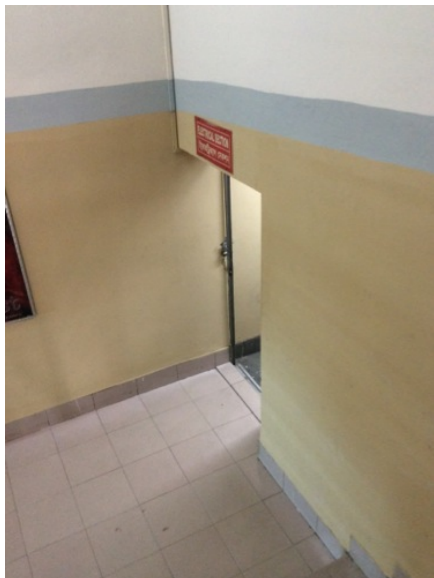
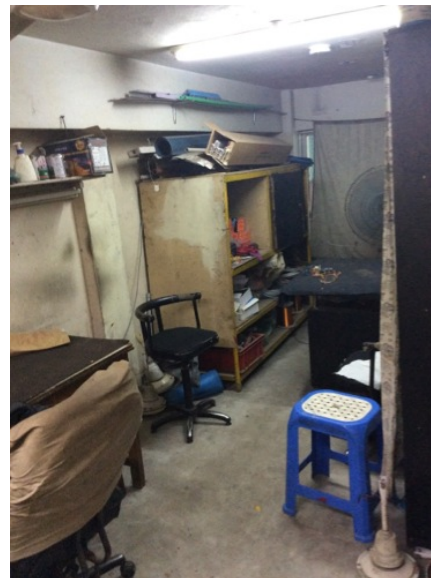
| F-5 | Fire Rated Construction | Unsealed penetrations and openings are located in exit stair enclosures. An electrical parts room is open to the West exit stair on the first floor landing. | Remove electrical parts room from exit stair enclosure and seal all penetrations. | Within 3 months |

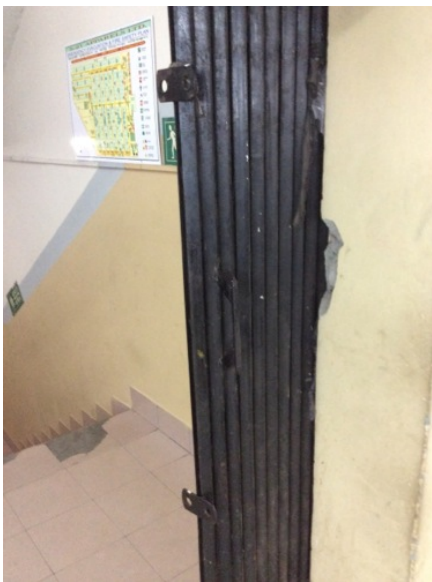
| F-6 | Egress | <p>Egress doors / gates with locking features are provided at building exits, exit stairs, and exit discharge. Not locks were present, however the capability to lock the doors remained.</p> | <p>Remove locking features from all egress doors / gates.</p> <p>If locks are required for security reasons, utilize special door locking features complying with NFPA 101.</p> | Immediate |

All gates/doors were open and unlocked during the inspection.

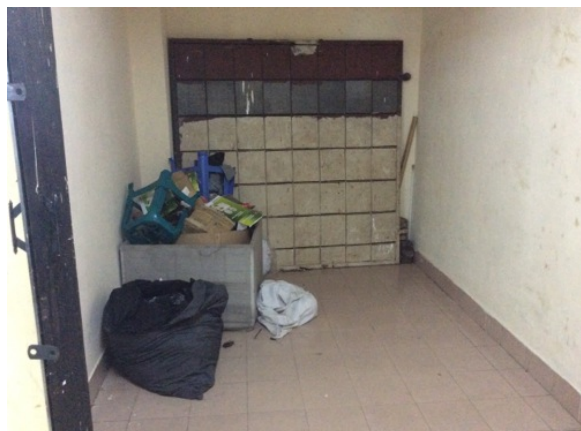
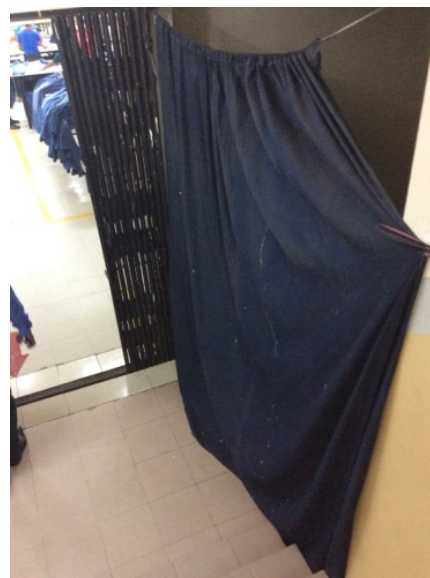
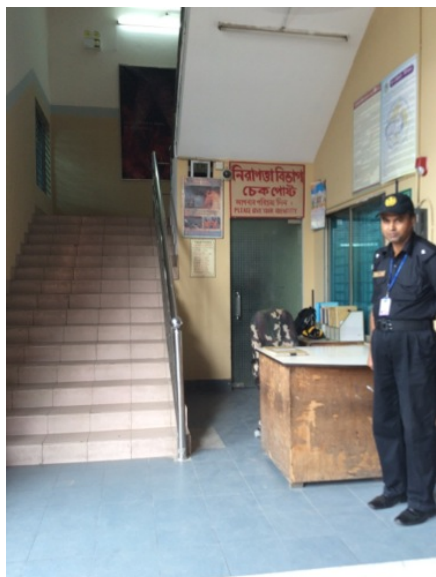
| F-7 | Egress | <p>Storage was located on the ground floor of the West exit stair and Floors 1, 2, and 3 of the East exit stair.</p> | <p>Remove all storage from exit stairs.</p> | Immediate |

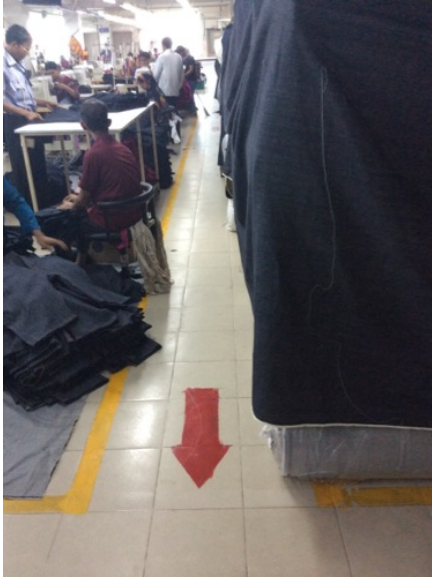
| F-8 | Egress | Storage was located in the egress path on Floor 2. | Keep egress paths and stairs clear of storage. | Immediate |

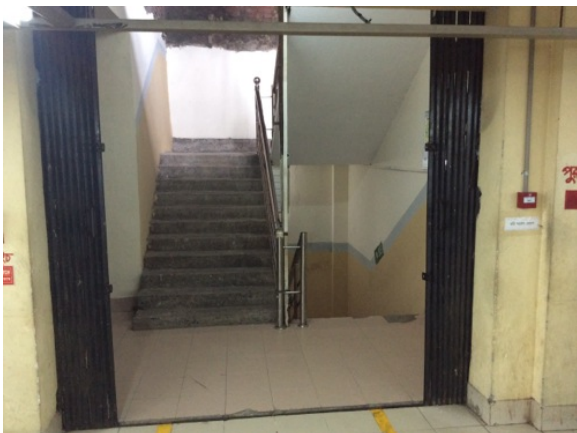
| F-9 | Egress | Collapsible gates / sliding doors are provided at building exits, exit stairs, and exit discharges. | <p>Replace all gates / sliding doors along the means of egress with side-hinged, swinging egress doors.</p> <p>If locks are required for security reasons, utilize special door locking features complying with NFPA 101.</p> | Within 1 month |

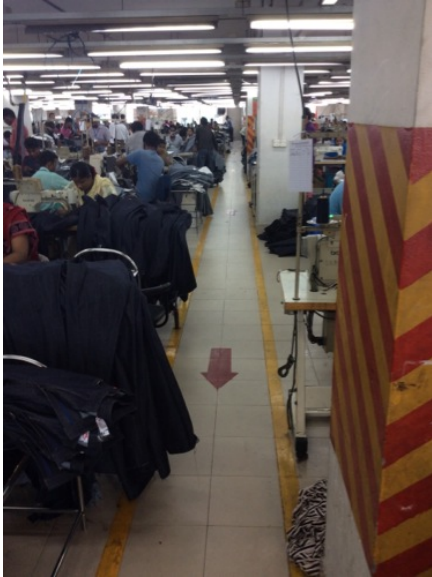
| F-10 | Egress | The width of egress aisles was less than 36-in. on Floor 3. | Provide minimum aisle widths of 36-in. | Within 3 months |

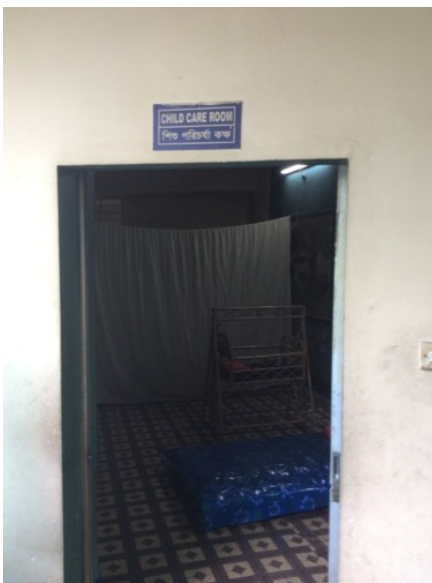
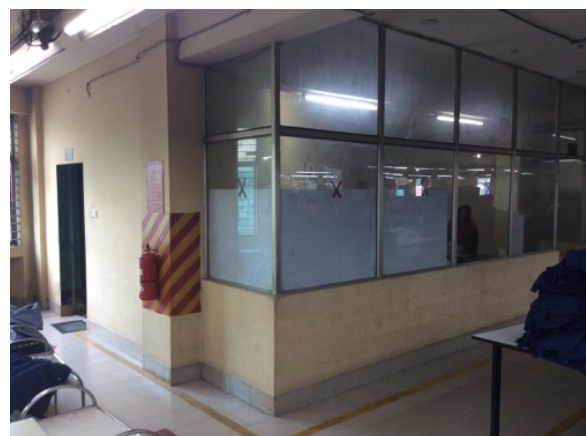
F-11 Egress

The day-care room does not have direct access to an exit stair and was not separated from the storage area.

Provide a minimum 2-hr fire-rated exit corridor between the day-care room and exit stair.

Relocate day-care room to ground floor with maximum travel distance of 9m (30 ft).

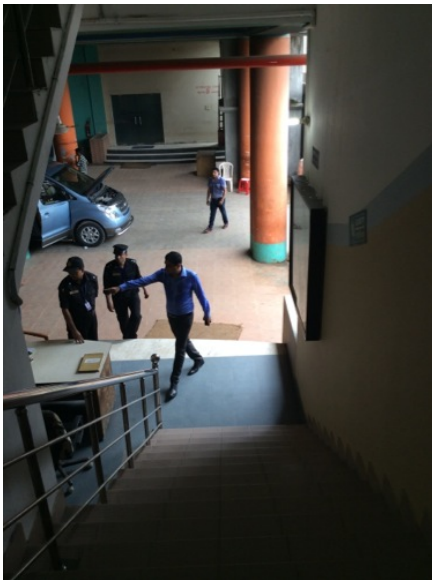
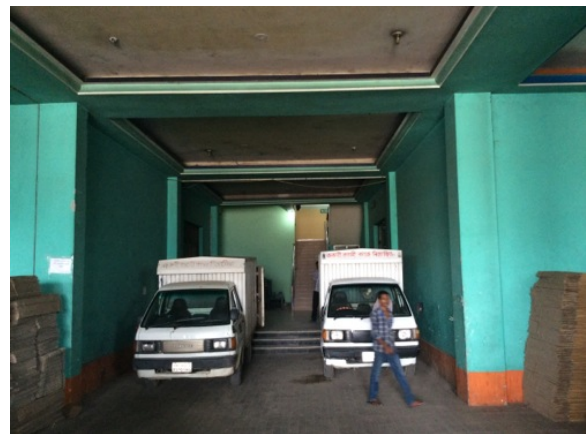
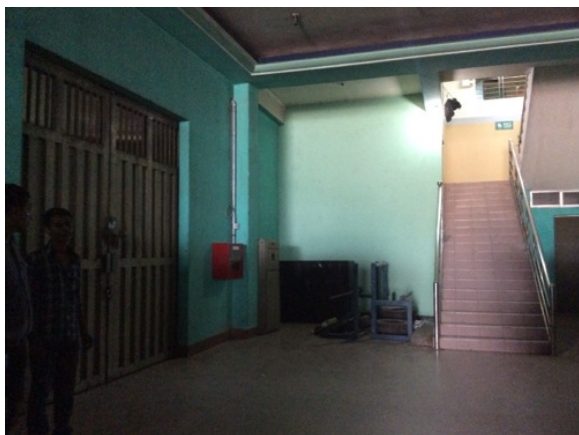
F-12 Egress

Both exit stairs discharge inside the building on the ground floor. Discharge is not separated from parking area, a storeroom, and the generator/transformer room.

Provide 2-hr fire-rated exit passageway leading directly outside (vestibules to separate any storage areas).

Provide sprinkler protection for discharge floor in accordance with NFPA 13.

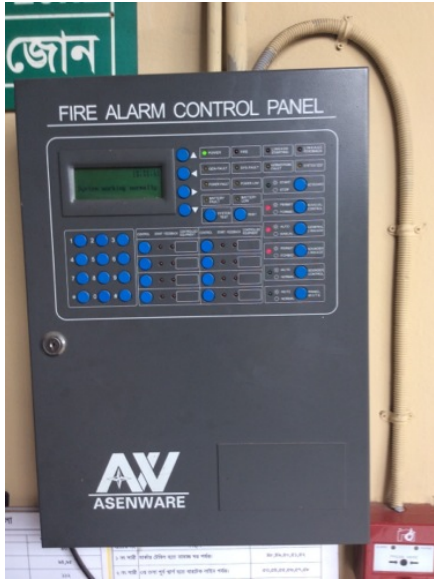
| F-13 | Fire Protection | Inspection, testing, and maintenance for the fire alarm system was not in accordance with NFPA 72. | Inspect, test and maintain the fire alarm system, and keep written records on-site, in accordance with NFPA 72. | Within 3 months |

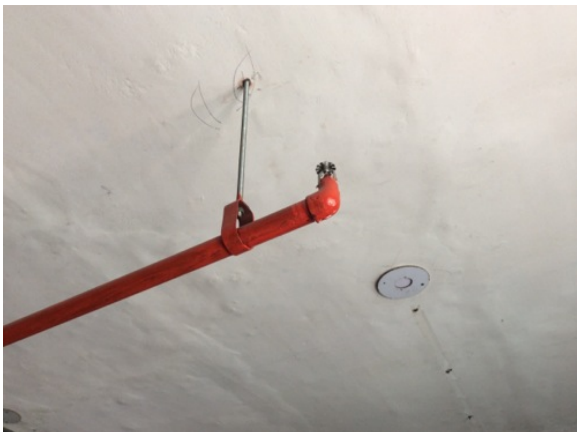
| F-14 | Fire Protection | Inspection, testing, and maintenance of the automatic sprinkler system is not in accordance with NFPA 25. | Inspect, test and maintain the automatic sprinkler system, and keep written records on-site, in accordance with NFPA 25. | Within 3 months |

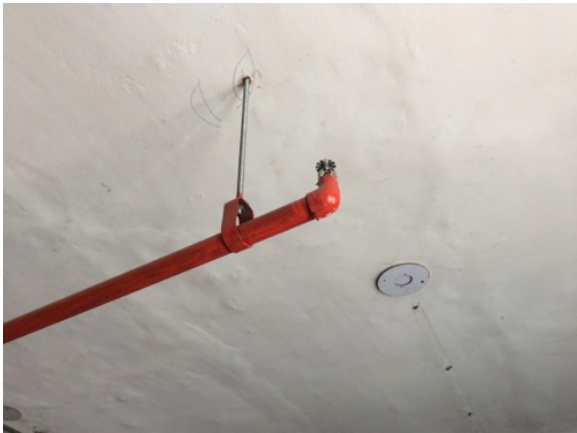
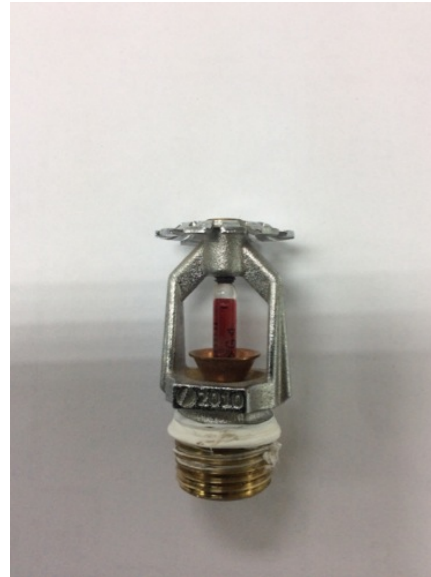
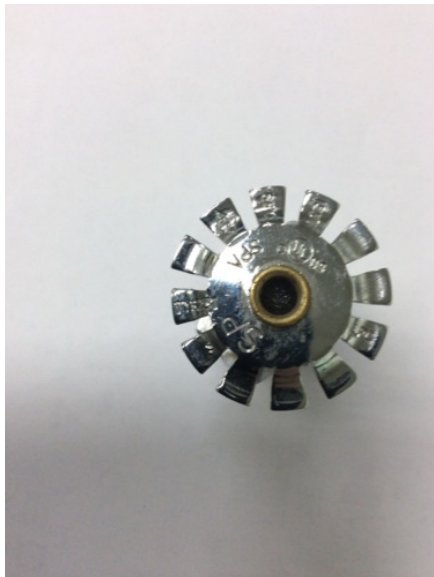
| F-15 | Fire Protection | Sprinkler system is designed for upright sprinkler heads, however pendant type sprinkler heads area installed. | Install upright sprinkler heads in the sprinkler system. | Within 3 months |

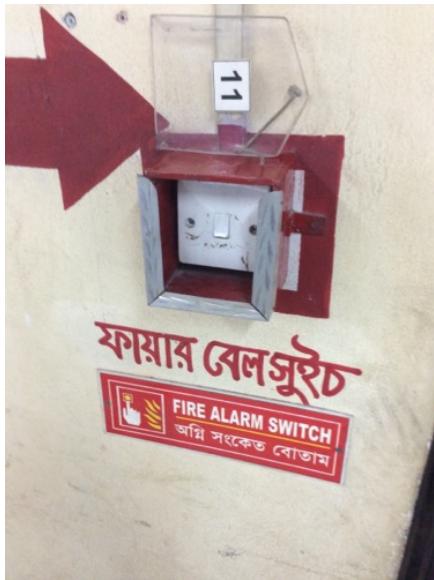
| F-16 | Fire Protection | Antiquated "dead-man" switches connected to a siren are provided on each floor in addition to the manual pull stations connected to the fire alarm panel. | Remove "dead-man" switches from factory floors. | Within 3 months |

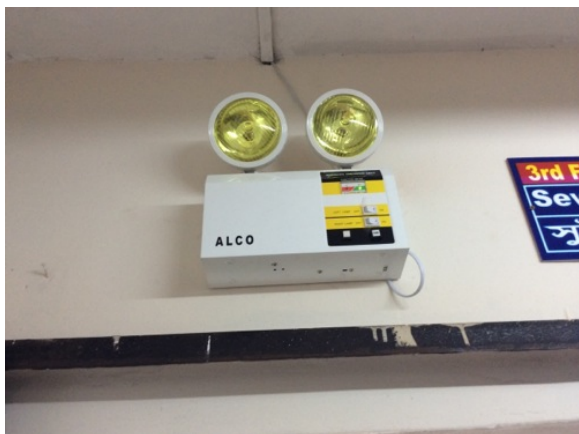
| F-17 | Egress Lighting | Manual on-off switch is provided for all battery backup emergency lighting units. | Remove manual on/off switches from emergency lighting units to prevent them from being switched off. | Within 1 month |

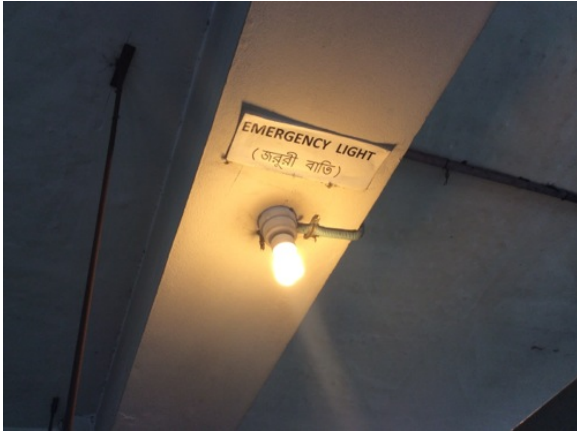
| F-18 | Egress Lighting | Inspection, testing, and maintenance for the emergency lighting system was not in accordance with The ACCORD Standard. | Inspect, test and maintain the emergency lighting system in accordance with The ACCORD standard. Keep written records on-site. | Within 3 months |

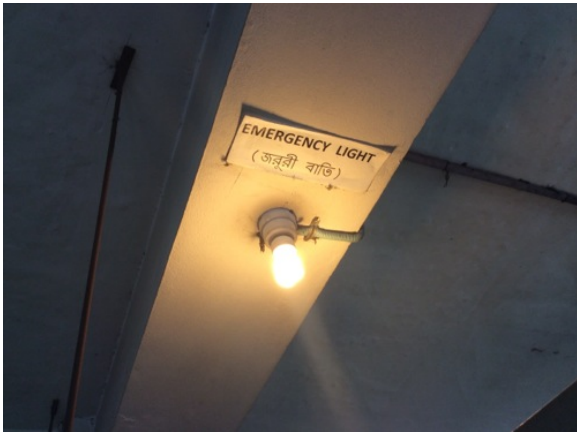
| F-19 | Egress Lighting | Based on the number and location of emergency lights observed, adequate illumination levels are not anticipated along egress routes on all floors. | Test the emergency lighting system on each floor and provide additional emergency fixtures to provide adequate illumination along the means of egress. Provide a minimum illumination of 10 lux at the floor level within exit stairs and exit discharge paths and minimum 2.5 lux along exit access aisles. | Within 3 months |
