INITIAL FIRE SAFETY INSPECTION REPORT

Triple Apparels Ltd (Extension)

RSC ID: 26393

Date: 05-October-2025

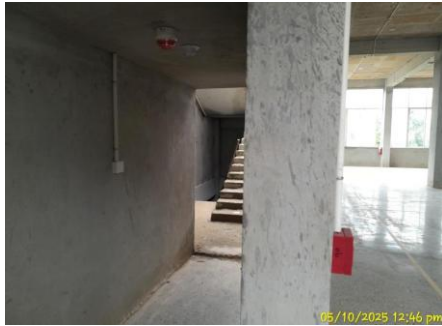
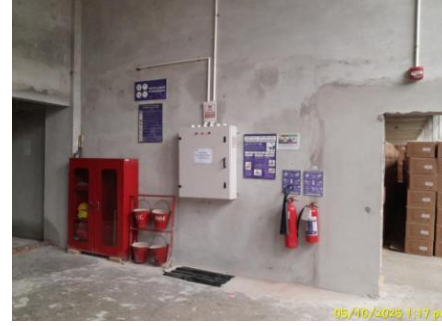
SI No.	Category	Findings	Required Action	Remediation Time Frame
F-01	Means of Egress	<p>The exit stair enclosures are not separated from work areas and other spaces on each floor by fire-rated construction.</p> <p>Location(s): All floors (Warehouse Building).</p>	<p>The exit stair enclosure shall be provided with a minimum 1-hr fire resistance rating for buildings with 3 or fewer stories and a minimum of 2- hr. fire resistance rating for buildings 4 or more stories. Provide 1-hr. fire rated door and seal all penetrations and openings by 1 hr. fire rated fire rated barrier construction for building with 3 or fewer stories. Provide 1.5 hr. fire rated door and seal all penetrations and openings by 2 hr. fire rated fire rated barrier construction for building with 4 or more stories in accordance with section 6.3.1.2 of RSC Technical Guidelines (Standard)¹ V1.0.</p> <p>Provide a fire-resistive rated assembly between the exterior exit stairs and the building up to 10 ft. beyond the end of the stair to achieve the required separation. The rated assembly shall be approved and/or designed by a qualified fire protection engineer. Ensure that the fire doors are self-closing and positive latching and that they are provided with fire exit (panic) hardware where serving production floors. If fire doors are required to be held open for functional reasons, provide automatic closing devices tied to the fire alarm system.</p> <p>Keep proper datasheet & certifications for installed fire doors & accessories on-site for verification. The clearance under the bottom of a door shall be a maximum of 3/4 in. (19 mm).</p>	Within 3 months

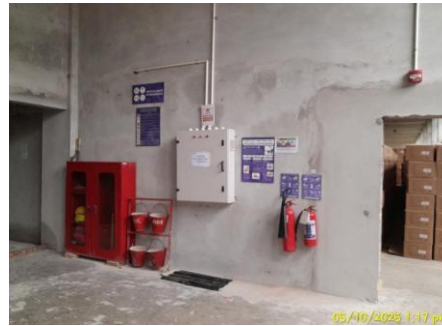
F-02	Means of Egress	<p>Electrical panels were located in the exit stair enclosure.</p> <p>Location: GF, East Stair (Warehouse Building).</p>	<p>Remove and relocate all electrical panels from exit stair enclosures.</p> <p>Or,</p> <p>Provide fire separation with stair enclosure in accordance with section 6.3.1 of RSC Technical Guidelines (Standard)¹ V1.0.</p>	Within 3 months
------	-----------------	---	---	-----------------

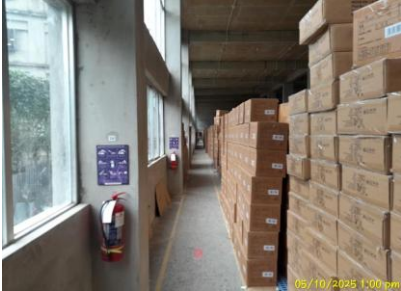
F-03	Means of Egress	<p>Width of aisles is less than 0.9m (36-in.).</p> <p>Location(s): GF (Warehouse Building).</p>	<p>Provide minimum aisle widths of 36-in. Aisles mark shall be clearly visible.</p>	<p>Within 1 month</p>

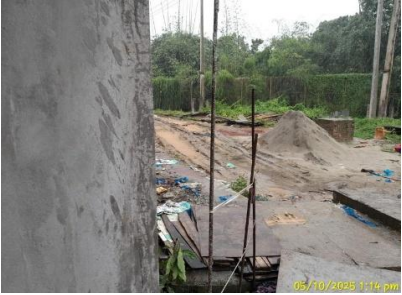
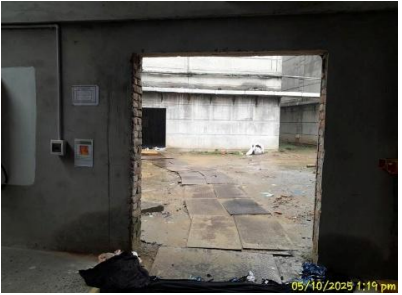
<p>F-04</p>	<p>Means of Egress</p>	<p>Uneven path of travel was observed in the exit discharge path due to construction purposes.</p> <p>Location(s): South & East side (Warehouse Building).</p>	<p>Remove unnecessary items and level exit path to the public way. Means of egress shall be maintained continuously free and clear of all obstructions</p>	<p>Within 3 months</p>
<div style="display: flex; justify-content: space-around;">

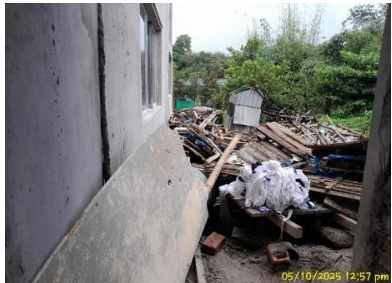
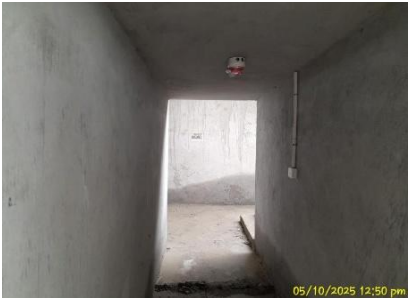
<p>F-05</p>	<p>Means of Egress</p>	<p>A single means of exit has been provided on the first floor of the Interim Construction Building.</p> <p>Location: 1st floor of Warehouse building.</p> <p>Non-compliance: West exit is not in operational condition.</p>	<p>The number of means of egress from any floor, story or portion thereof shall not be less than 2 except where a single exit is permitted by RSC Technical Guideline (Standard), section 6.6.2.</p> <p>Provide additional exit and ensure that the exit doors or means of egress openings are located a distance apart as per RSC Technical Guideline (Standard) section 6.6.6</p>	<p>Within 3 months</p>

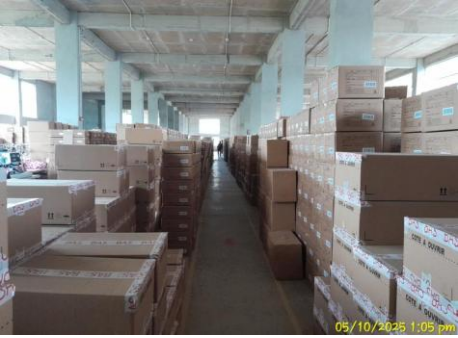
F-08	Means of Egress	<p>Directional signs are not provided where direction of the path of travel to an exit has changed.</p> <p>Location(s): All floors (Warehouse Building).</p>	<p>Illuminated directional signs shall be provided where there is a change in the direction for the path of travel and the direction to an exit is not obvious in accordance with RSC Technical Guidelines (Standard)¹ V1.0 Section 6.11.3.</p>	Within 1 month

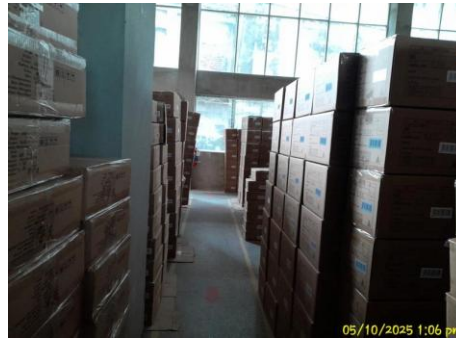
F-09	Means of Egress	<p>Based on the number and location of emergency lights observed, adequate illumination levels are not anticipated along egress routes.</p> <p>Location(s): All floors (Warehouse Building).</p>	<p>Test the emergency lighting system on each floor and provide additional emergency fixtures to provide adequate illumination along the means of egress. Provide a minimum illumination of 10 lux at the floor level within exit stairs and exit discharge paths and minimum 2.5 lux along exit access aisles. Illumination on means of egress shall meet in accordance with RSC Technical Guidelines (Standard)¹ V1.0 Section 10.12.2.</p>	Within 3 months
------	-----------------	---	---	-----------------

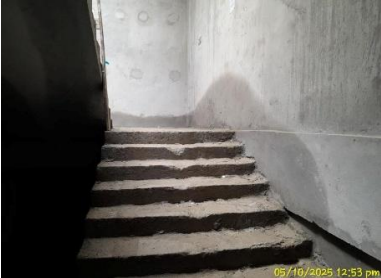
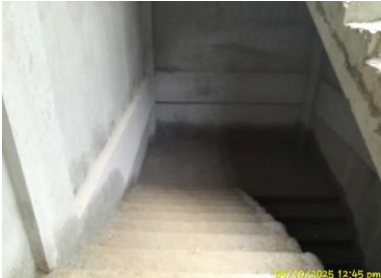
<p>F-10</p>	<p>Means of Egress</p>	<p>Both stair clear widths were found less than 60 in (available: 58 inches each). Location(s): All exit stairs (Warehouse Building).</p>	<p>Stairs shall have a minimum clear width of 60 in for all industrial occupancies as per RSC Technical Guideline (Standard) section 6.5.6.</p>	<p>Within 3 months</p>

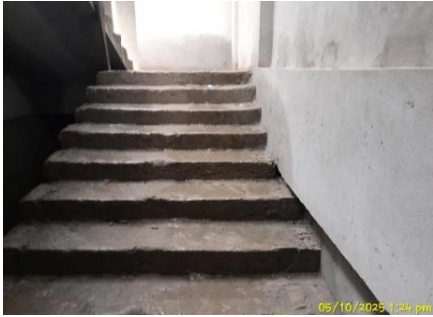
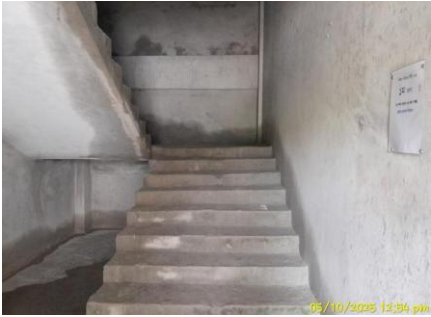
F-11	Means of Egress	<p>Walking surfaces are not uniformly slip-resistant.</p> <p>Location(s): All exit stairs (Warehouse Building).</p>	<p>Walking surfaces, including stairway treads shall be uniformly slip resistant in accordance with RSC Technical Guidelines (Standard)¹ V1.0 Section 6.3.6</p>	Within 3 months

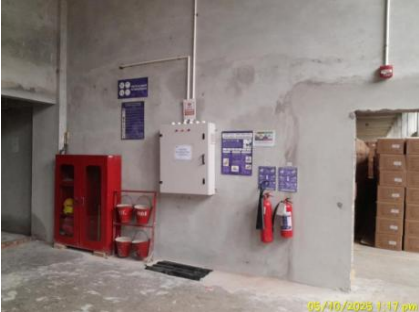
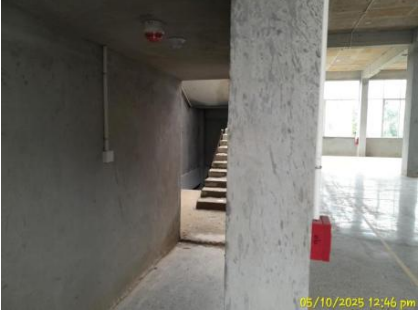
F-12	Means of Egress	<p>Storage area discharges directly into the exit stair enclosures.</p> <p>Location(s): All exit stairs (Warehouse Building).</p>	<p>Openings from exit enclosure to Storage areas shall be provided with a vestibule with fire rated construction and openings in accordance with section 6.14.3 of RSC Technical Guidelines (Standard)¹ V1.0. Provide a min 1-hr fire rated door on the exit stair side and a 1.5 hr. fire rated door on the Store side. Ensure that the fire rating of the vestibule construction matches that of the exit stair enclosure as per RSC Technical Guidelines (Standard)¹ V1.0. section 6.14.3. The minimum width for vestibules shall not be less than 1.1m and length 1.8m.</p>	Within 3 months

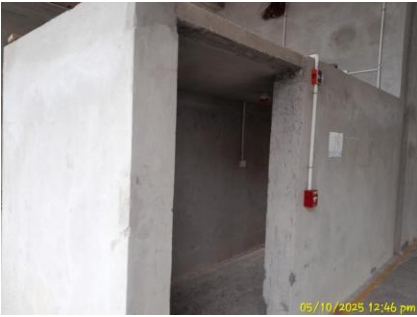
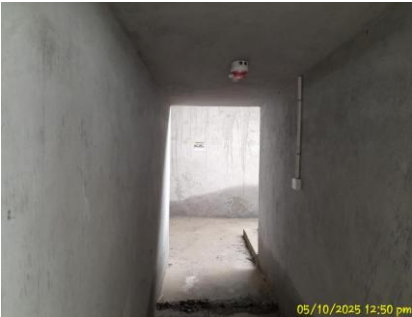
F-15	Means of Egress	<p>Building does not have stair/floor level designation signs at the required locations on all floors.</p> <p>Location(s): All floors (Warehouse Building).</p>	<p>Provide stair designation sign at each floor entrance from the stair to the floor in English and Bengali. Signs shall indicate the name of the stair and the floor level. Signs shall be posted adjacent to the door in accordance with RSC Technical Guidelines (Standard)¹ V1.0 Section 6.9.3.</p>	Within 1 month
F-16	Means of Egress	<p>Exit sign not provided at exit.</p> <p>Location(s): All floors (Warehouse Building).</p>	<p>Lighted exit signs shall be placed at entrance to an exit. Additional directional exit signs shall be placed throughout the facility anywhere the continuation of the egress is not obvious. Lighted exit signs shall be provided with either battery backup or uninterruptable power supply systems and shall be continuously illuminated at all times. Exit Sign shall provide in accordance with RSC Technical Guidelines (Standard)¹ V1.0 Section 6.11.</p>	Within 1 month

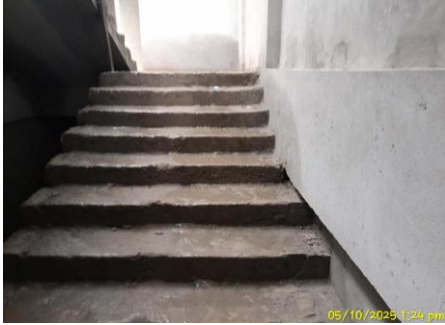
F-17	Means of Egress	<p>Handrails are not provided on both sides of each exit stair on all floors. Having handrails on one side of said staircase may pose a falling hazard during evacuation.</p> <p>Location(s): All exit stairs (Warehouse Building).</p>	<p>Provide handrails on both sides of the exit stair. New handrails shall have a minimum height of 865 mm (34 in.) and a maximum height of 965 mm (38 in.) as measured from the leading edge of the tread. Intermediate handrails shall be provided when the stair width exceeds 2.2 m (87 in.).</p> <p>Open guards shall have intermediate rails or pattern such that a sphere 200 mm (8 in.) in diameter cannot pass through any opening up to a height of 865 mm (34 in.). Handrail shall construct in accordance with RSC Technical Guidelines (Standard)¹ V1.0 Section 6.12.</p>	Within 3 months

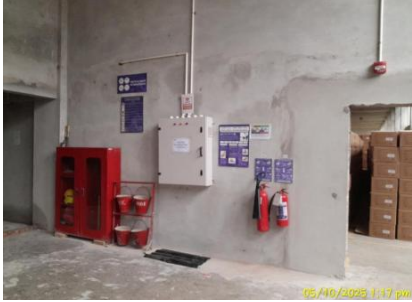
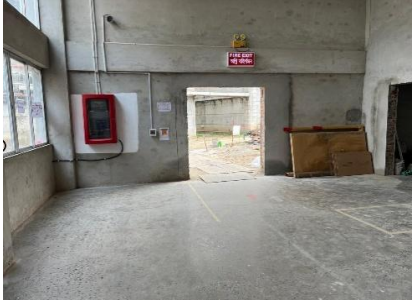
<p>F-18</p>	<p>Fire Rated Construction</p>	<p>Rooms used for storage of combustible materials are not separated from the surrounding existing fire alarm control panel room.</p> <p>Location(s): GF, East Side (Warehouse Building).</p>	<p>Rooms used for storage of combustible materials shall be separated from the surrounding occupancy with a minimum 1 hour construction in accordance with section 3.4.2.1.5 of RSC Technical Guideline (Standard).</p>	<p>Within 3 months</p>
<div style="display: flex; justify-content: space-around;">

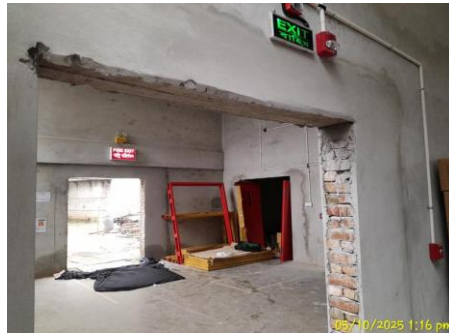
<p>F-19</p>	<p>Fire Rated Construction</p>	<p>Elevator shaft (under installation) opens directly into the exit enclosure, which doesn't comply with RSC Technical Guidelines (Standard), section 6.14.3.</p> <p>Location: East stair enclosure (Warehouse Building).</p>	<p>Provide a minimum 2-hr fire rated elevator shaft to separate it from stair enclosure. No discharge is accepted through elevator shaft. Seal all openings to maintain fire separations.</p>	<p>Within 3 months</p>
--------------------	--------------------------------	--	---	------------------------

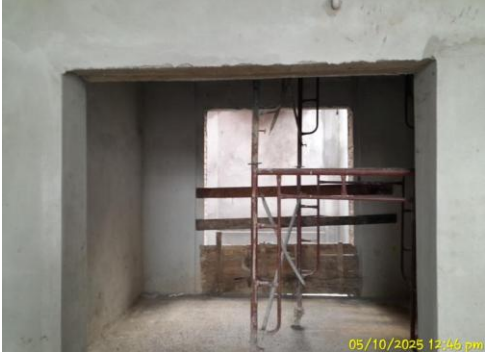
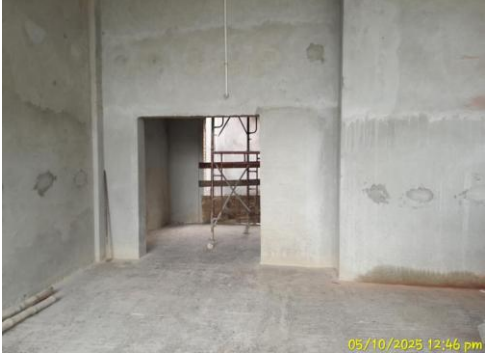
<p>F-20</p>	<p>Fire Rated Construction</p>	<p>Elevator shaft (under installation) opens directly into the production floor without proper fire separation due to unprotected opening.</p> <p>Location: East side (Warehouse Building).</p>	<p>Elevator shaft shall be separated from production area by 2 hours fire rated construction. 2-hr fire barriers shall be protected with minimum 1.5-hr fire protective opening assemblies.</p>	<p>Within 3 months</p>
<div style="display: flex; justify-content: space-around;">

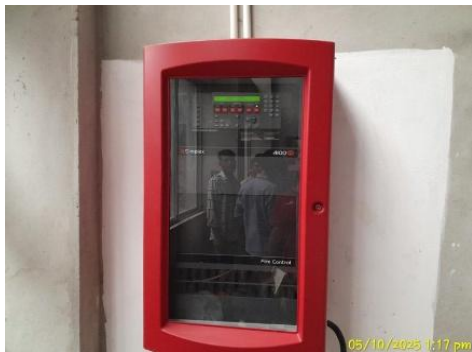
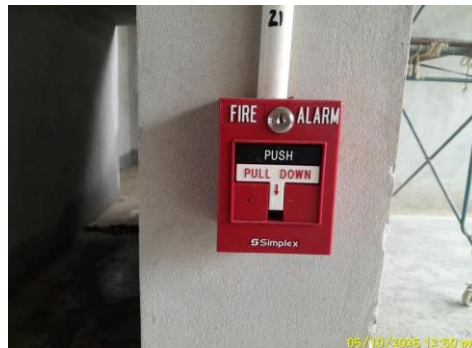
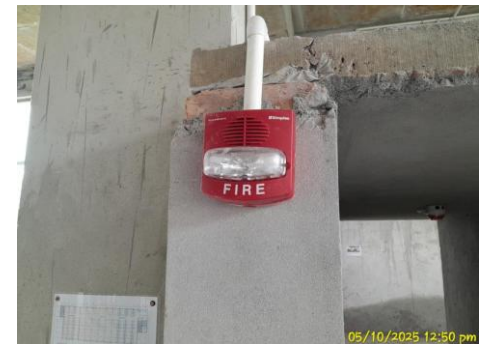
<p>F-22</p>	<p>Fire Alarm & Detection System (FADS)</p>	<p>The factory has installed a fire alarm and detection system that requires a detailed review to confirm compliance with NFPA 72 and RSC Technical Guidelines (Standard).</p> <p>Location(s): Warehouse Building.</p>	<p>Submit the fire alarm and detection system design to RSC for review.</p> <p>Once the design is reviewed, install and modify the fire detection and alarm system throughout the building in accordance with review comment, RSC Technical Guidelines (Standard) and NFPA 72.</p> <p>After installation the owner shall conduct internal testing and commissioning and then contact the RSC for witness of final acceptance testing.</p>	<p>Design within 2 months and modification/ installation with 4 months</p>
--------------------	---	---	---	--
