# **FIRE SAFETY INSPECTION REPORT**

## **RUSSEL APPARELS & EKRAM SWEATER LTD**

**NO.35 MOUZA-KATHALI, BHALUKA, MYMENSING.**

April 29, 2014

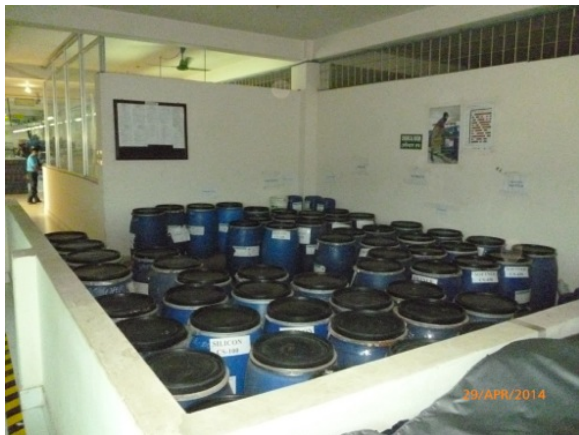
| No. | Category | Finding | Recommendation | Remediation Timeframe |
|---|---|---|---|---|
| F-1 | Fire Rated Construction | Hazardous materials storage area is not separated by fire-rated construction (openings, non-rated doors). | Separate the hazardous materials / flammable liquid storage room by a minimum 2-hr fire-rated construction. Seal and/or protected all openings to maintain the required fire separations. | Within 1 month |

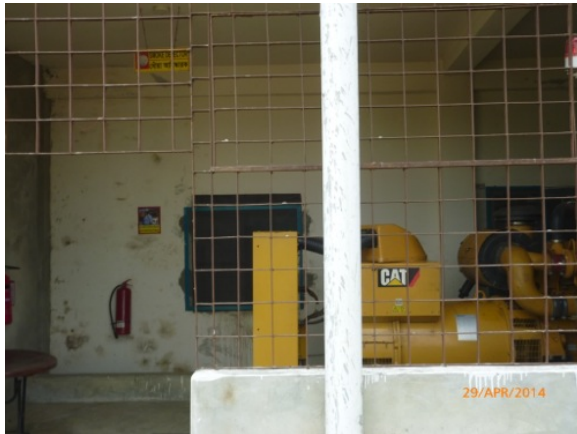
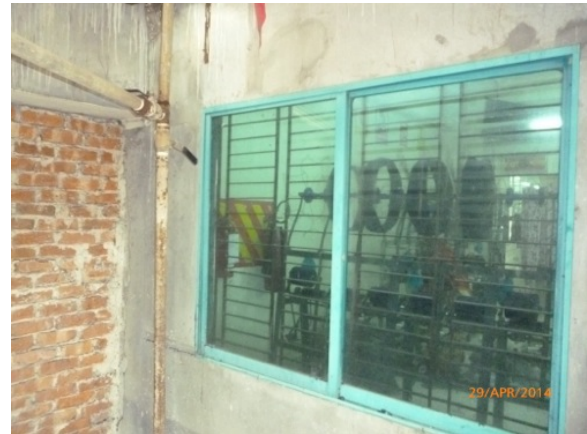
| No. | Category | Finding | Recommendation | Remediation Timeframe |
|---|---|---|---|---|
| F-2 | Fire Rated Construction | The boiler, generator and transformer rooms are not separated by fire-rated construction (window openings, non-rated doors, penetrations). | Separate the boiler, generator and transformer rooms by a minimum 2-hr fire-rated construction. Seal and/or protected all openings to maintain the required fire separations. | Within 3 months |

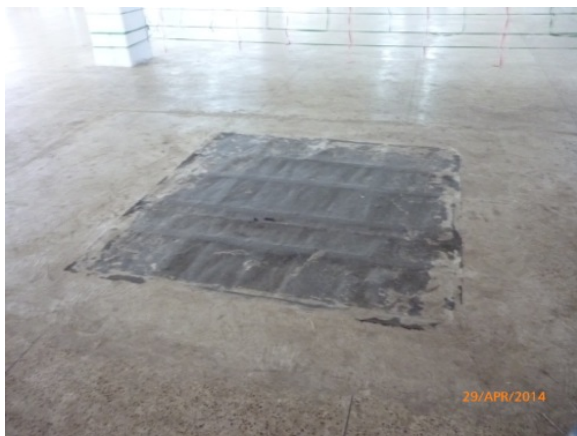
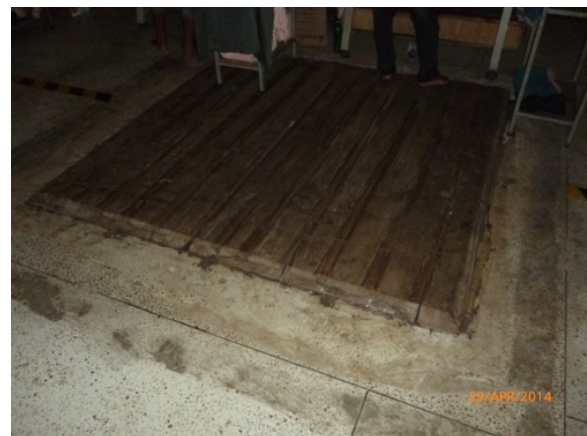
| F-3 | Fire Rated Construction | Unsealed tower crane openings are located in the fire-rated floor/ceiling on assemblies each floor. | Seal all penetrations and openings in floor/ceiling assemblies to maintain the fire separation. | Within 3 months |

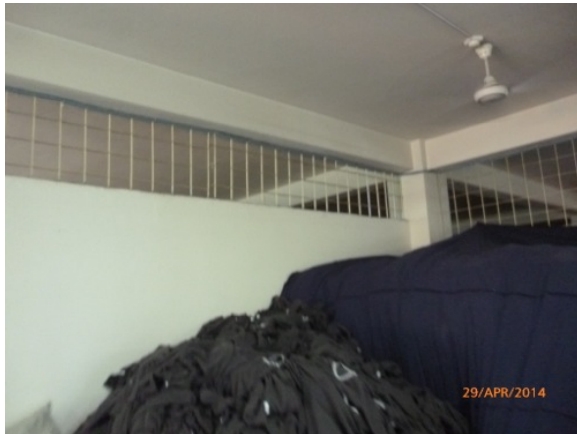
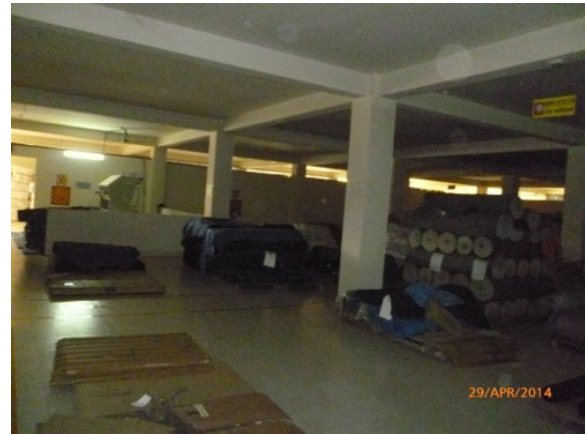
| F-4 | Fire Rated Construction | Yarn storages in ground floor are not separated by fire-rated construction.(Ventilation port opening, Non-fire-rated door.) | Provide dedicated storage rooms separated by minimum 1-hr fire-rated construction. | Within 3 months |

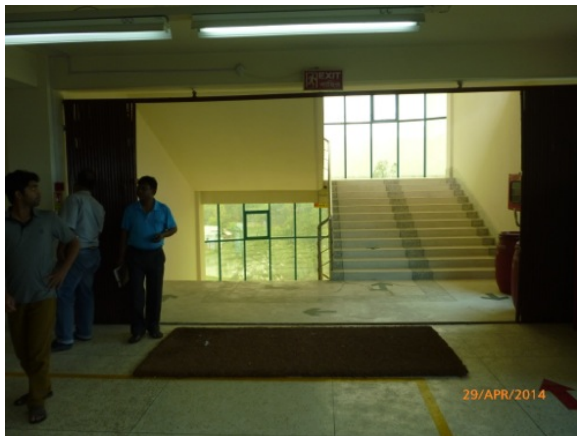
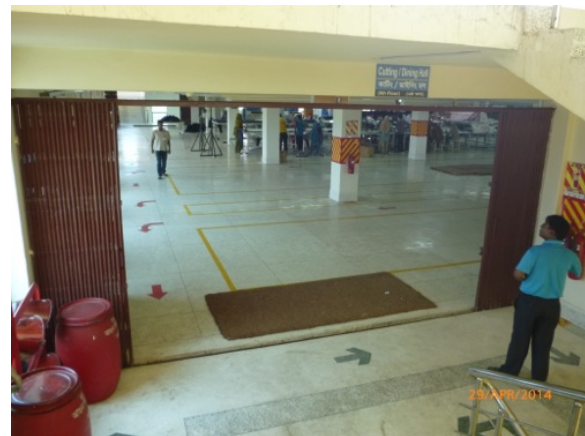
| F-5 | Fire Rated Construction | The exit stairs are not separated from work areas and other spaces on each floor by fire-rated construction. | <p>Provide minimum 1.5-hr fire rated doors and seal all unprotected openings to separate the exit stairs from work areas and other building spaces on all floor levels. Ensure that the fire doors are self-closing and positive latching and that they are provided with fire exit (panic) hardware where serving production floors.</p> <p>If fire doors are required to be held open for functional reasons, provide automatic-closing devices tied to the fire alarm system.</p> | Within 3 months |

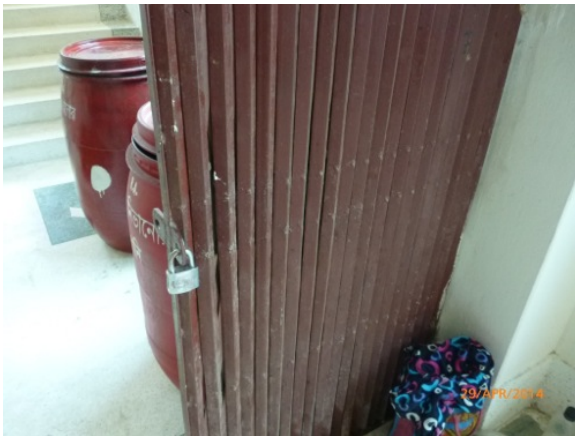
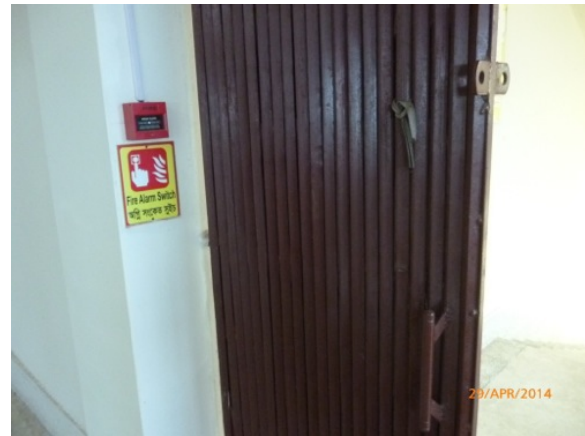
| F-7 | Egress | <p>Egress doors and gates with locking features are provided at building exits, exit stairs and exit discharge.</p> <p>All gates and doors were open and unlocked during the inspection.</p> | <p>Remove locking features from all egress doors and gates.</p> <p>If locks are required for security reasons, utilize special door locking features complying with NFPA 101.</p> | Immediate |

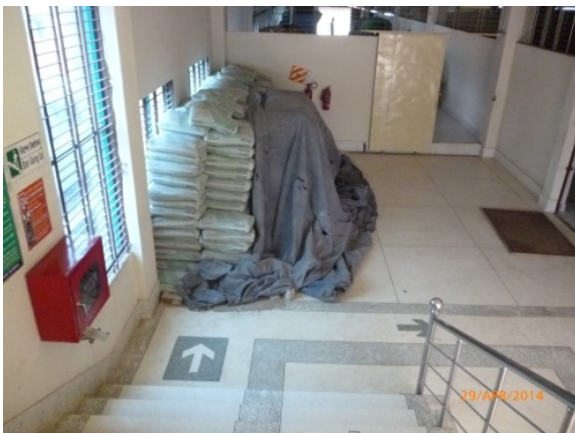
| F-8 | Egress | <p>Storage was located in ground level of NW exit stair.</p> | <p>Remove all storage from exit stairs and egress paths.</p> | Immediate |

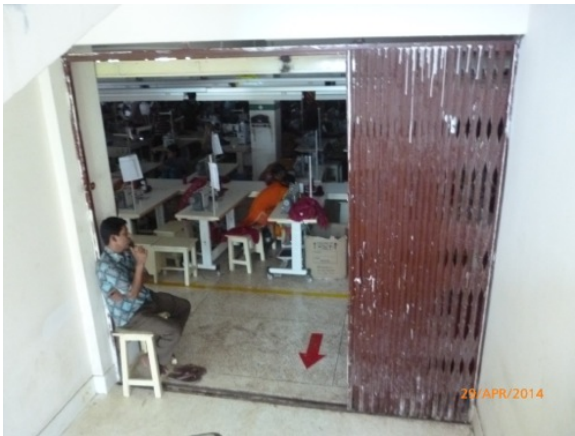
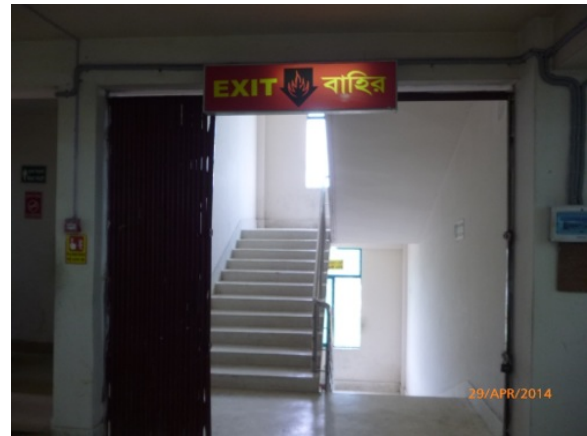
| F-9 | Egress | Collapsible gates and sliding doors are provided at building exits, exit stairs and exit discharge. | <p>Replace all gates and sliding doors along the means of egress with side-hinged, swinging egress doors.</p> <p>If locks are required for security reasons, utilize special door locking features complying with NFPA 101.</p> | Within 1 month |

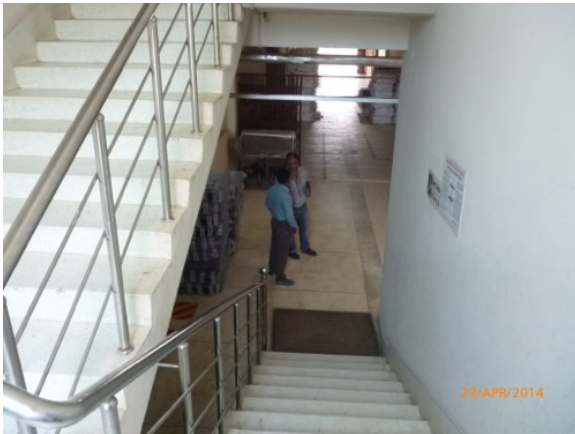
| F-10 | Egress | East exit stair discharge inside the building path way. | <p>Provide 2-hr fire-rated exit passageway leading directly outside (vestibules to separate any storage areas).</p> <p>or</p> <p>Provide sprinkler protection for discharge floor in accordance with NFPA 13.</p> | Within 6 months |

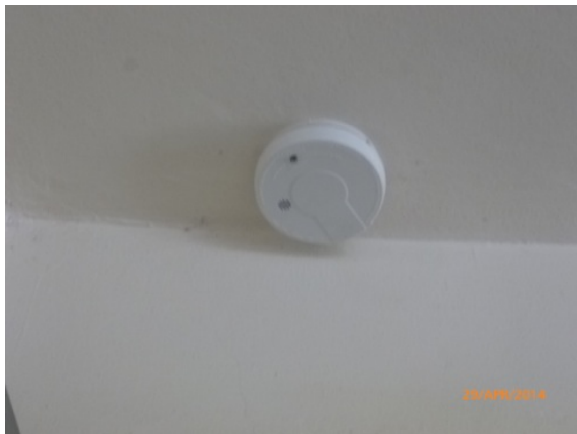
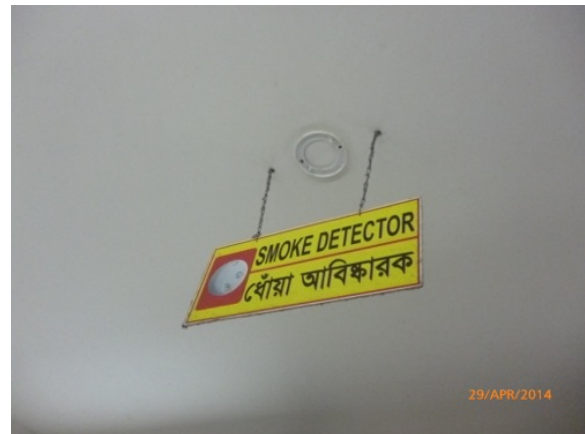
| F-12 | Fire Protection | The building is equipped with single-station smoke alarms. Smoke alarm activation sounds only a local alarm and does not provide automatic fire alarm notification of occupants. | Remove single-station smoke alarms. Provide automatic smoke detection throughout the building, tied into the fire alarm system, in accordance with NFPA 72. | Within 6 months |

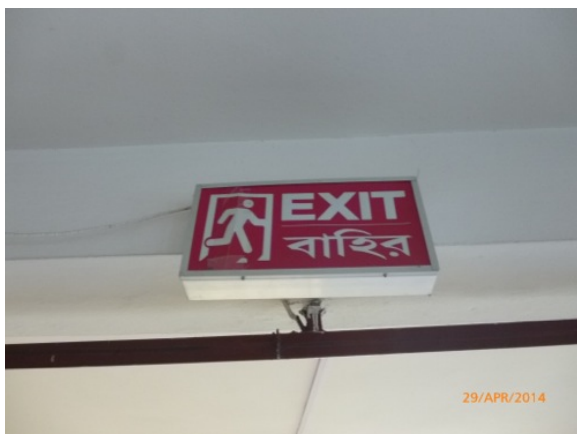
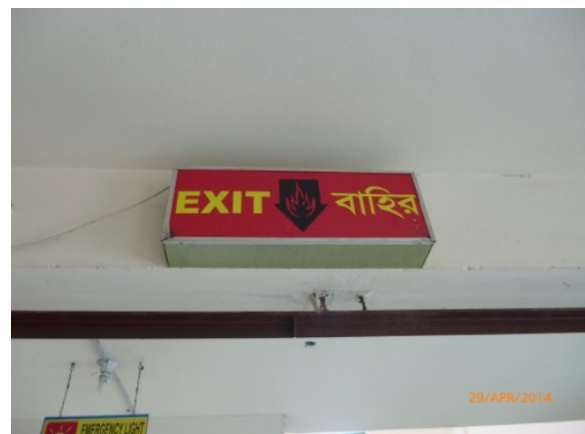
| F-14 | Egress Lighting | Several exit signage not illuminated (burned out, broken). | Regularly inspect all exit signage and replace/install lights as needed to illuminate signs. | Within 3 months |

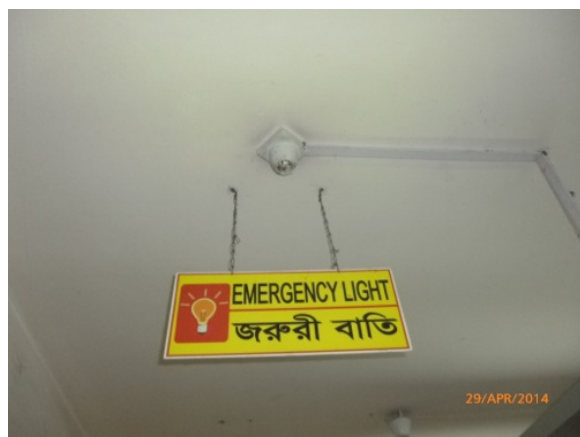
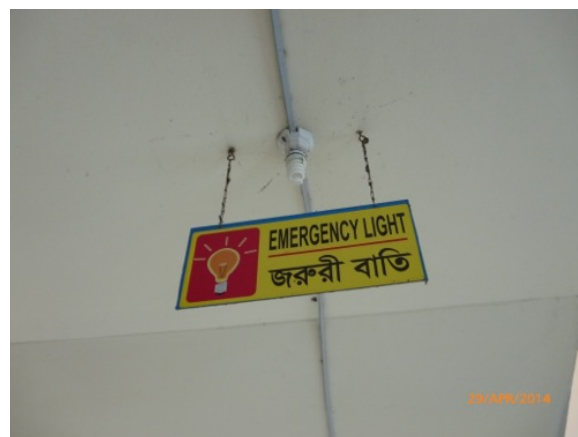
| F-15 | Egress Lighting | Several emergency lighting did not function in test mode (burned out, broken, etc.). | Regularly test the emergency lighting system on each floor and replace/repair lights as needed. | Within 3 months |
