# INITIAL FIRE SAFETY INSPECTION REPORT

**Shipra Fashion Ltd (Extension)**

**RSC ID: 26525**

**Date: 09-December-2025**

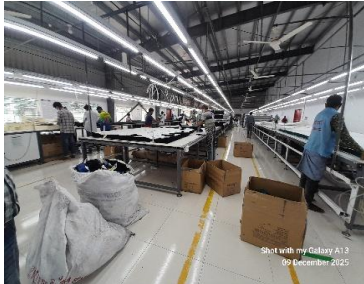
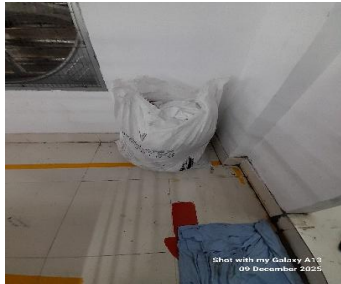
| Sl No. | Category | Findings | Required Action | Remediation Time Frame |
|---|---|---|---|---|
| F-1 | Means of Egress | <p>The egress path along means of egress has interrupted by obstruction/storage/process.</p> <p><b>Location(s): Production Shed.</b></p> | <p>Keep egress paths and stairs clear of storage/obstruction in accordance with section 6.3.9 of RSC Technical Guidelines (Standard)<sup>1</sup> V1.0.</p> <p>Means of egress shall be maintained continuously free and clear of all obstructions or impediments to full instant use in the case of fire or other emergency. No furnishings, decorations, or other objects shall obstruct exits and access to exits. Nothing shall obstruct or impede visibility to exits.</p> | Immediately |

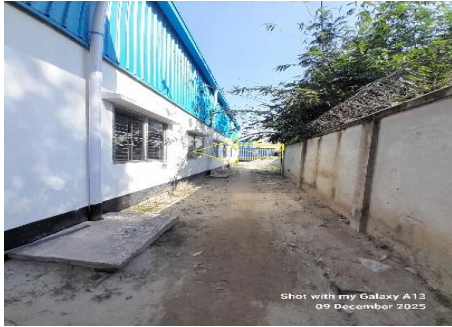
| F-2 | Means of Egress | <p>The egress court [serving south exit] is less than 10 ft wide and is not separated from the building interior which is not in accordance with section 6.17.2 of RSC Technical Guidelines (Standard)<sup>1</sup> V1.0.</p> <p><b>Location(s): South side of the Production Shed.</b></p> | <p>Egress courts less than 3050 mm (10 ft) in width (as measured from the building and the adjacent property line) shall be provided with walls having a 1-hr fire resistance rated construction for a distance of 3050 mm (10 ft) above the floor of the court.</p> <p>Seal all penetrations and openings to the interior of the building along the discharge path, up to a height of 10 ft. to provide a minimum 1-hr fire separation.</p> | Within 3 Months |

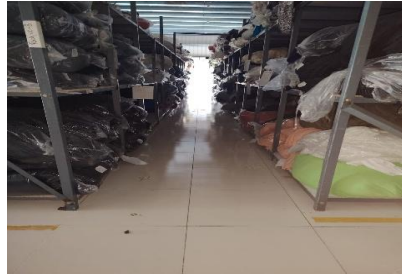
| F-4 | Means of Egress | <p>Aisles were found missing on several locations throughout the building.</p> <p><b>Location(s): Production Shed.</b></p> | <p>Provide minimum aisle widths of 36-in. Aisles mark shall be clearly visible.</p> | Within 1 Month |

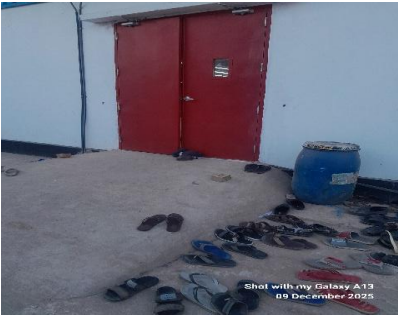
| F-7 | Means of Egress | <p>Uneven walking surface were found and exceed a slope of 1 in 20 in the direction of travel.</p> <p><b>Location(s): East &amp; West side of the Production shed.</b></p> | <p>Walking surfaces shall be mostly level; however, shall not exceed a slope of 1 in 20 in the direction of travel unless meeting the requirements for ramps in 6.10 shall meet the requirements for RSC Technical Guidelines (Standard)<sup>1</sup> V1.0 Section 6.3.4.2.</p> | Within 3 Months |

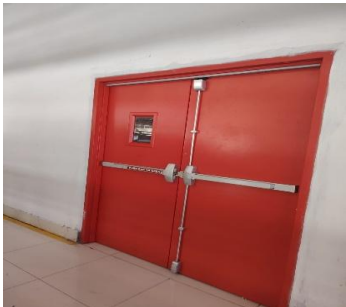
| F-9 | Means of Egress | <p>Exit sign not provided at exit.</p> <p><b>Location(s): Production Shed.</b></p> | <p>Lighted exit signs shall be placed at entrance to an exit. Additional directional exit signs shall be placed throughout the facility anywhere the continuation of the egress is not obvious. Lighted exit signs shall be provided with either battery backup or uninterruptable power supply systems and shall be continuously illuminated at all times. Exit Sign shall provide in accordance with RSC Technical Guidelines (Standard)<sup>1</sup> V1.0 Section 6.11.</p> | Within 1 Month |

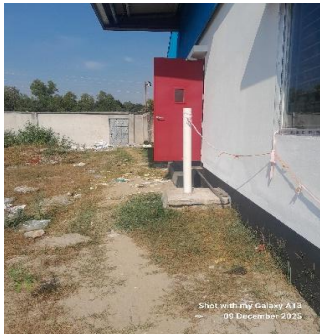
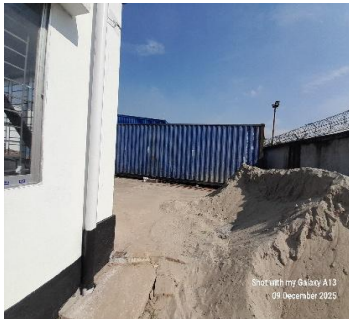
| F-10 | Means of Egress | <p>Uneven path of travel was observed in the exit discharge path due to construction purposes.</p> <p><b>Location(s): South &amp; West side of the Production Shed.</b></p> | <p>Remove unnecessary items and level exit path to the public way. Means of egress shall be maintained continuously free and clear of all obstructions.</p> | Within 3 Months |

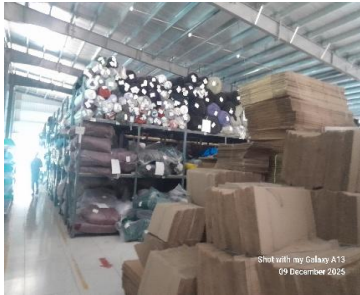
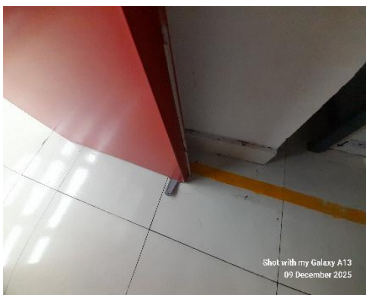
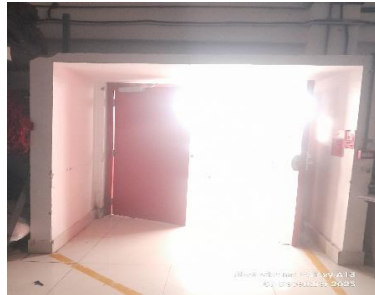
| F-11 | Fire Rated Construction | <p>Rooms used for storage of combustible materials are not separated from the surrounding occupancy(Production).</p> <p><b>Location: Production Shed.</b></p> <p><b>Non-compliance reason: Due to non-Functional fire door &amp; Certificate missing for installed fire door.</b></p> | <p>Rooms used for storage of combustible materials shall be separated from the surrounding occupancy with a minimum 1 hour construction in accordance with section 3.4.2.1.5 of RSC Technical Guideline (Standard).</p> <p>Keep proper datasheet &amp; certifications for installed fire doors &amp; accessories on-site for verification.</p> | Within 3 Months |

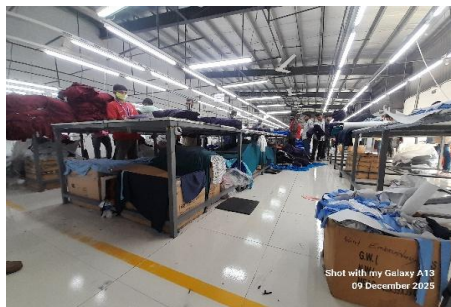
| F-12 | Fire Rated Construction | <p>Storages were found underneath the cutting tables.</p> <p><b>Location(s): Production Shed.</b></p> | <p>Storage underneath the cutting tables shall be kept clear of combustibles at all time, except as provided for miscellaneous storage in accordance with 3.4.2.1.6 or, Where an automatic sprinkler system is installed sprinklers are required to be installed beneath cutting tables greater than 4 ft in width that are used for storage of combustibles.</p> | Within 3 Months |

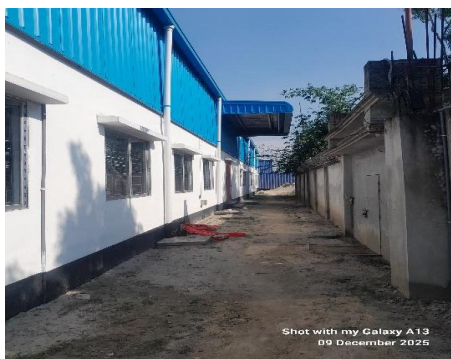
| F-13 | Fire Rated Construction | <p>The required fire separation distance for the (Production Shed) does not comply with the requirements of BNBC 2020.</p> <p><b>Location(s): South side of the Production Shed.</b></p> | <p>The exterior walls shall have a fire resistance and opening protection as specified in BNBC 2020 Part 3 Table 3.2.2 &amp; 3.2.3 and BNBC 2020 Part 3 Section 2.4.1.3.</p> | Within 6 Months |

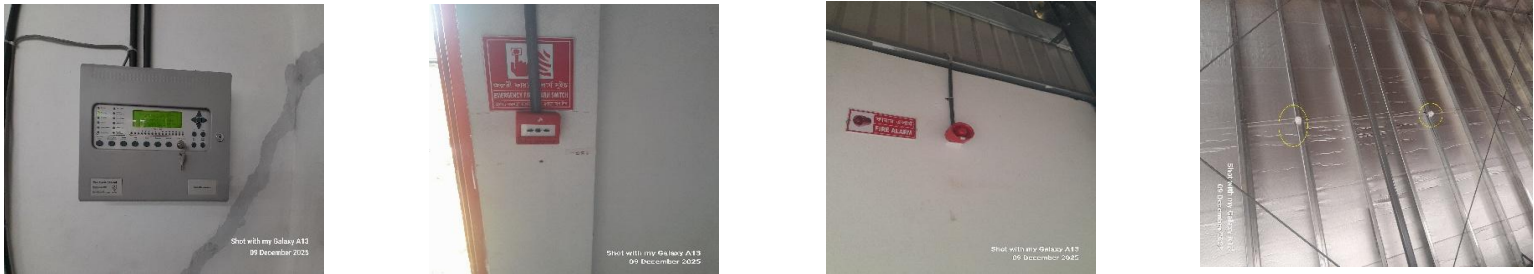
| F-14 | Fire Alarm & Detection System (FADS) | <p>The factory has installed a fire alarm and detection system that requires a detailed review to confirm compliance with NFPA 72 and RSC Technical Guidelines (Standard).</p> <p><b>Location(s): Production Shed.</b></p> | <p>Submit the fire alarm and detection system design to RSC for review.</p> <p>Once the design is reviewed, install and modify the fire detection and alarm system throughout the building in accordance with review comment, RSC Technical Guidelines (Standard) and NFPA 72.</p> <p>After installation the owner shall conduct internal testing and commissioning and then contact the RSC for witness of final acceptance testing.</p> | <p>Design within 2 Months and modification/ installation with 4 Months</p> |

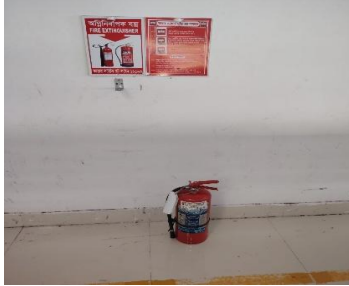
| F-16 | Fire Suppression System (SUPS) | <p>Fire extinguishers were found at several areas but placed on floors.</p> <p><b>Location(s): Production Shed.</b></p> | The bottom of the fire extinguisher and the floor be less than 4 in.(102 mm). As per NFPA 10 section 6.1.3.8.3. | Within 1 Month |
