# INITIAL FIRE SAFETY INSPECTION REPORT

**Liberty Knitwear Ltd. Unit-2 (Extension 3)**

**RSC ID: 26562**

**Date: 23-February-2026**

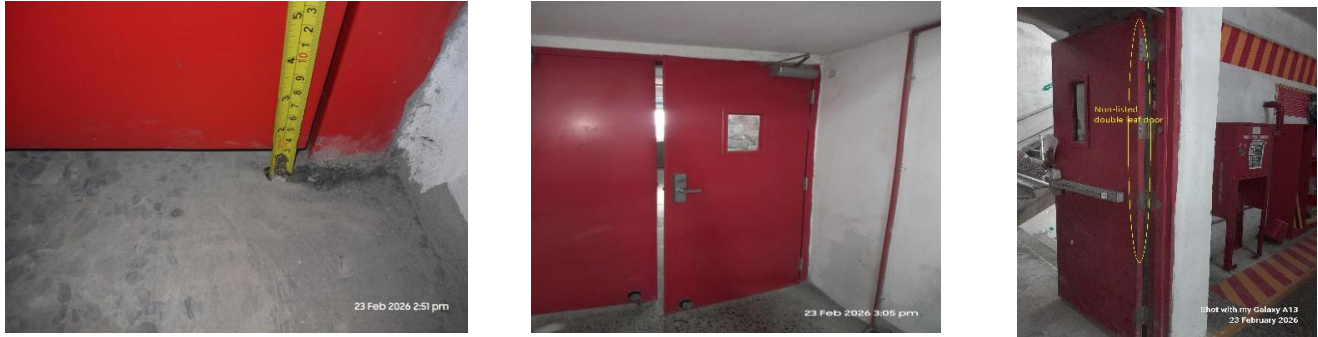
| SI No. | Category | Findings | Required Action | Remediation Time Frame |
|---|---|---|---|---|
| F-01 | Means of Egress | <p>The exit stair enclosures are not separated from work areas and other spaces on each floor by fire-rated construction.</p> <p><b>Location(s): All floors (Generator Power House Building).</b></p> <p><b>Non-Compliance: 1. Fire Door non-functionality,</b></p> <p><b>2. Gap below fire door was more than 19 mm,</b></p> <p><b>3. Non-listed fire door</b></p> <p><b>4. Lack of certificate of installed fire door on site for verification.</b></p> | <p>The exit stair enclosure shall be provided with a minimum of 2- hr. fire resistance rating for buildings 4 or more stories. Provide 1.5 hr. fire rated door and seal all penetrations and openings by 2 hr. fire rated fire rated barrier construction for building with 4 or more stories in accordance with section 6.3.1.2 of RSC Technical Guidelines (Standard)<sup>1</sup> V1.0.</p> <p>Ensure that the fire doors are self-closing and positive latching, and that they are provided with fire exit (panic) hardware where serving production floors. If fire doors are required to be held open for functional reasons, provide automatic closing devices tied to the fire alarm system.</p> <p>Keep proper datasheet &amp; certifications for installed fire doors &amp; accessories on-site for verification. The clearance under the bottom of a door shall be a maximum of 3/4 in. (19 mm).</p> | Within 3 Months |

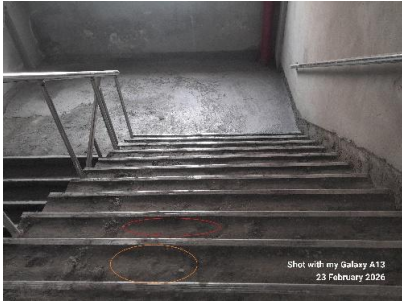
| <b>F-03</b> | Means of Egress | <p>Walking surfaces are not uniformly slip-resistant of the exit stair.</p> <p><b>Location: Exit stair-2 (Generator Power House Building)</b></p> | <p>Walking surfaces, including stairway treads shall be uniformly slip resistant in accordance with RSC Technical Guidelines (Standard)<sup>1</sup> V1.0 Section 6.3.6</p> | Within 3 Months |

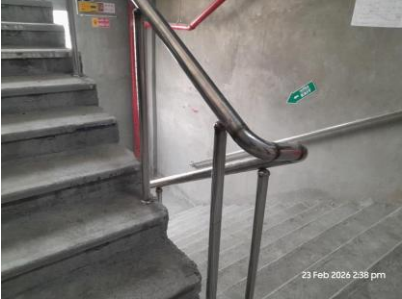
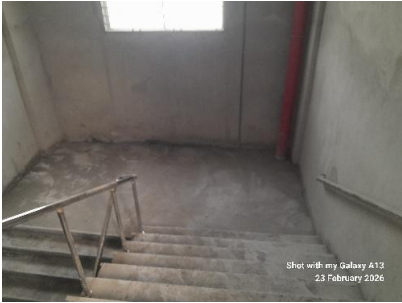
| F-04 | Means of Egress | <p>The guards have gaps that are too large, allowing a sphere 200 mm (8 in.) in diameter to pass through.</p> <p><b>Location: All stairs, Generator Power House Building.</b></p> | <p>Open guards shall have intermediate rails or pattern such that a sphere 200 mm (8 in.) in diameter cannot pass through any opening up to a height of 865 mm (34 in.).</p> | Within 3 Months |

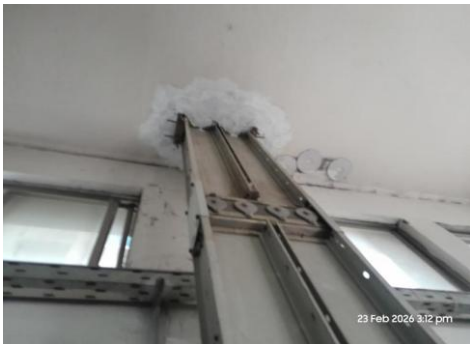
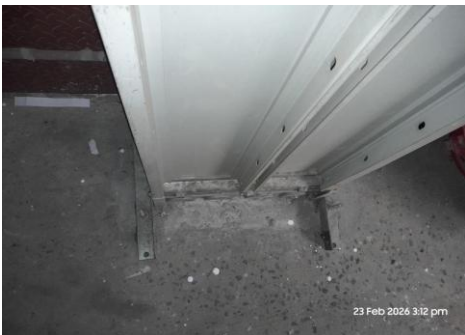
| F-06 | Fire Rated Construction | <p>Penetrations through floor/ceiling assemblies due to BBT are sealed with mortar, but penetration openings exceeding 144 sq in.</p> <p><b>Location(s): All floors (Generator Power House Building).</b></p> | <p>Seal all penetrations and openings in floor/ceiling assemblies by a listed through-penetration fire stop system tested in accordance with ASTM E814 or approved alternative standard to maintain a minimum 3-hr. fire resistance rating. Installation shall be as per the manufacturer's published installation guidelines and the certification authority guideline to ensure the fire-rating in accordance with section 4.7 of RSC Technical Guideline (Standard)</p> <p>Or,</p> <p>Provide a minimum 2-hour fire-rated shaft to separate the penetration from each floor, if required.</p> <p>Keep proper datasheet &amp; certifications for installed fire doors &amp; accessories on-site for verification.</p> <p>Or,</p> <p>Floor penetrations for electrical busbar, cable, metal plumbing pipes, etc., can be protected by concrete, grout, or mortar installed to the full thickness of the floor, if the penetration area is within 144 sq. inches.</p> | Within 3 Months |

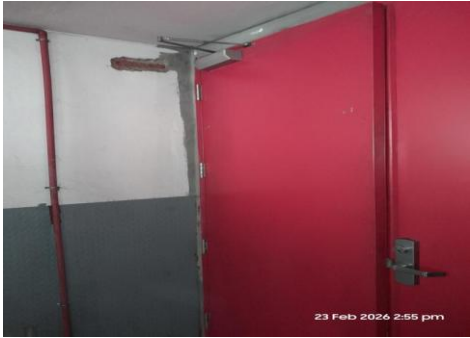
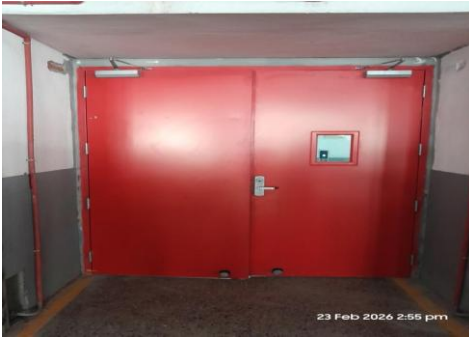
| <b>F-07</b> | Fire Rated Construction | <p>Elevator shafts open directly into the production floor without proper fire separation due to non-functional fire doors.</p> <p><b>Location(s): All floors, Generator Power House Building.</b></p> | <p>Elevator shaft shall be separated from production area by 2 hours fire rated construction. 2-hr fire barriers shall be protected with a minimum 1.5-hr fire protective opening assemblies.</p> <p>Ensure that the fire doors are self-closing and positive latching. If fire doors are required to be held open for functional reasons, provide automatic closing devices tied to the fire alarm system.</p> <p>Keep proper datasheet &amp; certifications for installed fire doors &amp; accessories on-site for verification. The clearance under the bottom of a door shall be a maximum of 3/4 in.</p> | Within 3 Months |

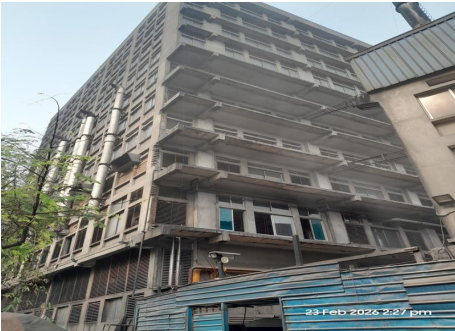
| F-08 | Fire Rated Construction | <p>The required fire separation distance does not comply with the requirements of BNBC 2020.</p> <p><b>Location(s): Generator Power House Building.</b></p> | <p>The exterior walls shall have a fire resistance and opening protection as specified in BNBC 2020 Part 3 Table 3.2.2 &amp; 3.2.3 and BNBC 2020 Part 3 Section 2.4.1.3.</p> | Within 3 Months |

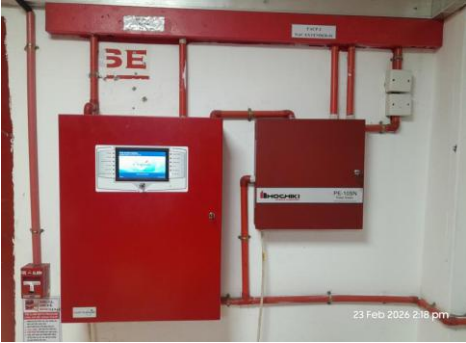
| F-09 | Fire Alarm & Detection System (FADS) | <p>The factory has installed sprinkler based detection system in the main production building. The factory has installed a fire alarm and detection system that requires a detailed review to confirm compliance with NFPA 72 and RSC Technical Guidelines (Standard).</p> <p><b>Location(s): Generator Power House Building.</b></p> | <p>Submit the fire alarm and detection system design to RSC for review.</p> <p>Once the design is reviewed, install and modify the fire detection and alarm system throughout the building in accordance with review comment, RSC Technical Guidelines (Standard) and NFPA 72.</p> <p>After installation the owner shall conduct internal testing and commissioning and then contact the RSC for witness of final acceptance testing.</p> | <p>Design within 2 Month and modification/ installation with 4 Months</p> |

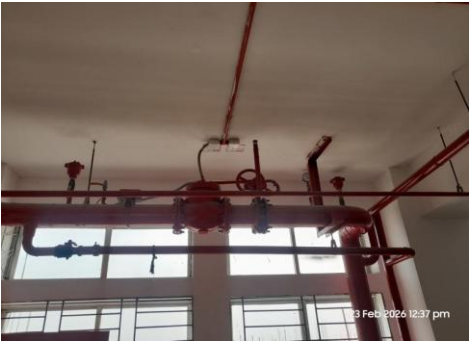
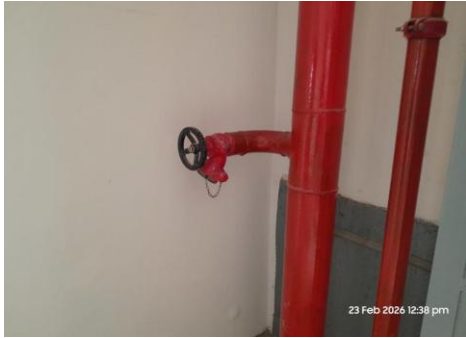
| F-11 | Fire Suppression System (SUPS) | <p>The highest occupied floor of the main building is over 75 feet above grade, mandating a sprinkler system along with a class I standpipe. The factory has installed a sprinkler system with a class III standpipe, requiring a detailed review to ensure compliance with NFPA 13, 14, 20, 22, and 24 and RSC Technical Guidelines (Standard).</p> <p><b>Location(s): Generator Power House Building.</b></p> | <p>Submit the sprinkler system drawing to RSC for review. Once the design is reviewed, install and modify the sprinkler/standpipe system throughout the building in accordance with review comment, RSC Technical guideline (Standard) and NFPA 13,14,20,22 and 24. After installation the owner shall conduct internal testing and commissioning and then contact the RSC for witness of final acceptance testing.</p> <p>(Provide automatic sprinkler protection along with class-I standpipe system throughout the building in accordance with NFPA 13, 14, 20 and 22. Submit design to RSC for review prior installation.)</p> | <p>Design within 2 Month and modification/ installation with 4 Months</p> |

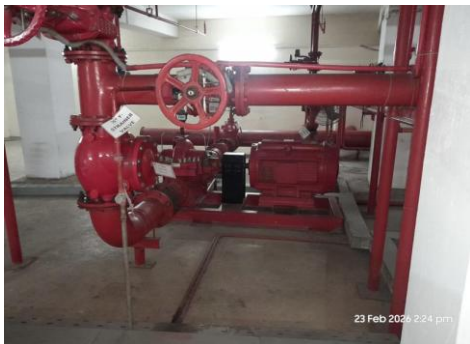
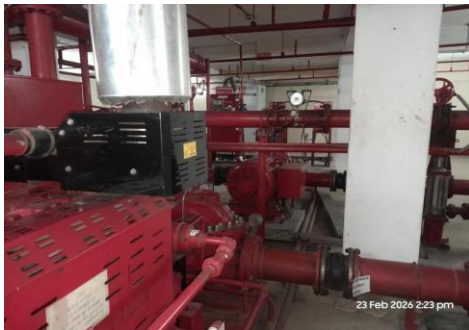
| <b>F-12</b> | Fire Suppression System (SUPS) | <p>Fire pump installation requires detailed review to confirm compliance with NFPA 20 and RSC Technical Guidelines (Standard)<sup>1</sup> V1.0.</p> <p><b>Location(s): All Buildings.</b></p> | <p>Submit as-built drawings, testing records, equipment certification and other relevant documentation to the RSC for review and approval.</p> <p>Submit the standpipe system drawing to RSC for review. Once reviewed, install or modify the standpipe system throughout the building in accordance with RSC Technical Guidelines (Standard)<sup>1</sup> V1.0. and NFPA 14 and 20. The factory management shall contact RSC to conduct the final acceptance testing after the installation, testing &amp; commissioning.</p> | <p>Design within 2 Month and modification/ installation with 4 Months</p> |

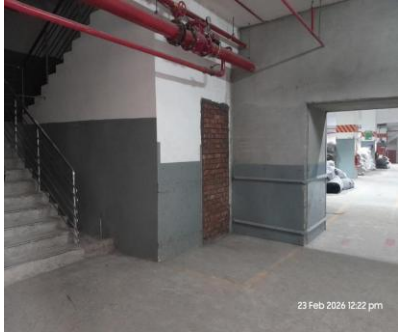
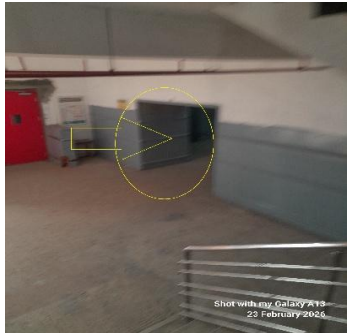
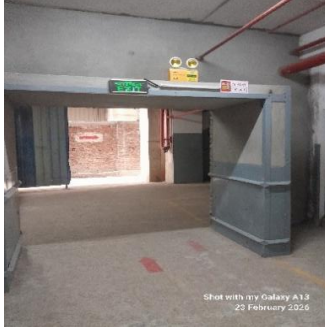
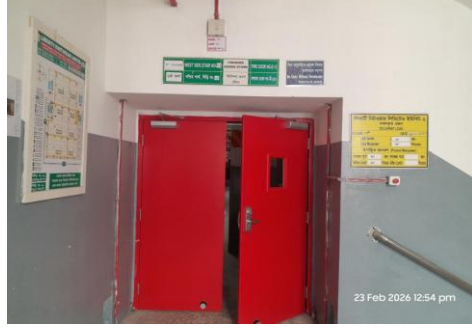
| SI No. | Category | Findings | Required Action | Remediation Time Frame |
|---|---|---|---|---|
| F-13 | Means of Egress | <p>The exit stair enclosures are not separated from work areas and other spaces on each floor by fire-rated construction.</p> <p><b>Location(s): All floors (East Tower Building). Non-Compliance: Unprotected openings, Fire Door non-functionality, Gap below fire door was more than 19 mm, non-listed fire door, etc.</b></p> | <p>The exit stair enclosure shall be provided with a minimum of 2- hr. fire resistance rating for buildings 4 or more stories. Provide 1.5 hr. fire rated door and seal all penetrations and openings by 2 hr. fire rated fire rated barrier construction for building with 4 or more stories in accordance with section 6.3.1.2 of RSC Technical Guidelines (Standard)<sup>1</sup> V1.0.</p> <p>Ensure that the fire doors are self-closing and positive latching, and that they are provided with fire exit (panic) hardware where serving production floors. If fire doors are required to be held open for functional reasons, provide automatic closing devices tied to the fire alarm system.</p> <p>Keep proper datasheet &amp; certifications for installed fire doors &amp; accessories on-site for verification. The clearance under the bottom of a door shall be a maximum of 3/4 in. (19 mm).</p> | Within 3 Months |

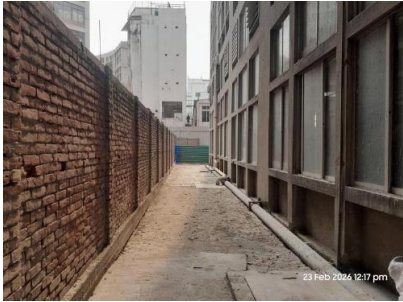
| F-15 | Means of Egress | <p>Uneven path of travel was observed in the exit discharge path due to construction purposes.</p> <p><b>Location(s): East Exit, East Tower Building.</b></p> | <p>Remove unnecessary items and level the exit path to the public way.</p> <p>Means of egress shall be maintained continuously free and clear of all obstructions.</p> | Within 3 Months |

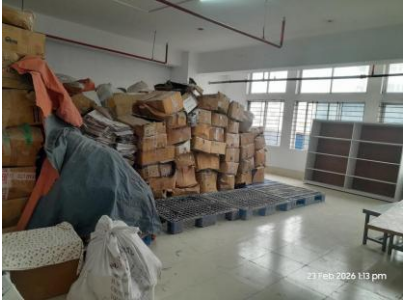
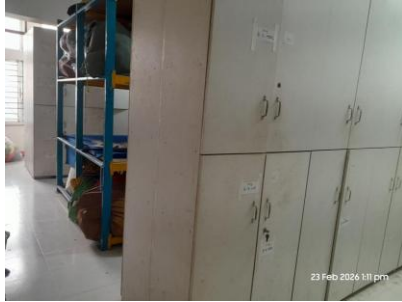
| F-16 | Means of Egress | <p>Aisles were found missing in several locations throughout the building.</p> <p><b>Location(s): Ground floor (Temporary storage portion), Mezzanine floor, East Tower Building.</b></p> | <p>Provide minimum aisle widths of 36-in. Aisles mark shall be clearly visible.</p> | Within 3 Months |

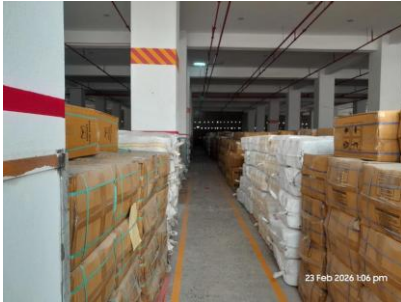
| <b>F-17</b> | Means of Egress | <p>Based on the number and location of emergency lights observed, adequate illumination levels are not anticipated along egress routes.</p> <p><b>Location(s): All floors, (East Tower Building).</b></p> | <p>Test the emergency lighting system on each floor and provide additional emergency fixtures to provide adequate illumination along the means of egress. Provide a minimum illumination of 10 lux at the floor level within exit stairs and exit discharge paths and minimum 2.5 lux along exit access aisles. Illumination on means of egress shall meet in accordance with RSC Technical Guidelines (Standard)<sup>1</sup> V1.0 Section 10.12.2.</p> | Within 3 Months |

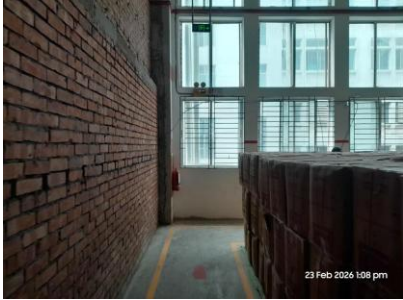
| <b>F-18</b> | Means of Egress | <p>Emergency lights not illuminated during testing (burned out, broken, etc.).</p> <p><b>Location(s): 1st floor, (East Tower Building).</b></p> | <p>Regularly inspect all emergency lighting system as per RSC Technical Guidelines (Standard)<sup>1</sup> section 13.12 and replace/install lights as needed to illuminate signs.</p> | Within 1 Month |

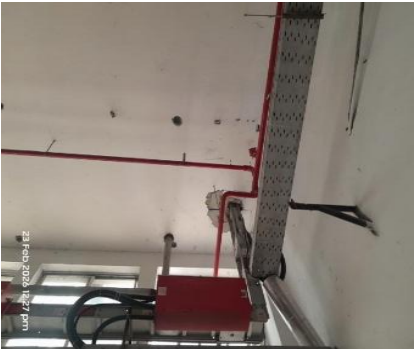
| F-19 | Fire Rated Construction | <p>Penetrations through floor/ceiling assemblies are found unsealed due to BBT.</p> <p><b>Location(s): All floors (East Tower Building).</b></p> | <p>Seal all penetrations and openings in floor/ceiling assemblies by a listed through-penetration fire stop system tested in accordance with ASTM E814 or approved alternative standard to maintain a minimum 3-hr. fire resistance rating. Installation shall be as per the manufacturer's published installation guidelines and the certification authority guideline to ensure the fire-rating in accordance with section 4.7 of RSC Technical Guideline (Standard)</p> <p>Or,</p> <p>Provide a minimum 2-hour fire-rated shaft to separate the penetration from each floor, if required.</p> <p>Keep proper datasheet &amp; certifications for installed fire doors &amp; accessories on-site for verification.</p> | Within 3 Months |

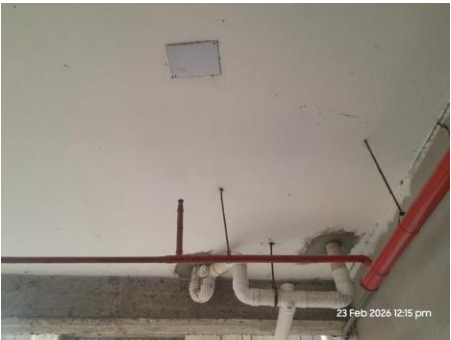
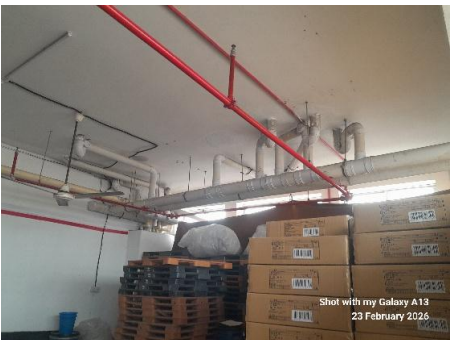
| F-20 | Fire Rated Construction | <p>Penetrations through floor/ceiling assemblies are found unsealed due to plastic plumbing pipes.</p> <p><b>Location(s): All floors (East Tower Building).</b></p> | <p>Seal all penetrations and openings in floor/ceiling assemblies by a listed through-penetration fire stop system tested in accordance with ASTM E814 or approved alternative standard to maintain a minimum 3-hr. fire resistance rating. Installation shall be as per the manufacturer's published installation guidelines and the certification authority guideline to ensure the fire-rating in accordance with section 4.7 of RSC Technical Guideline (Standard)</p> <p>Or,</p> <p>Provide a minimum 2-hour fire-rated shaft to separate the penetration from each floor, if required.</p> <p>Keep proper datasheet &amp; certifications for installed fire doors &amp; accessories on-site for verification.</p> | Within 3 Months |

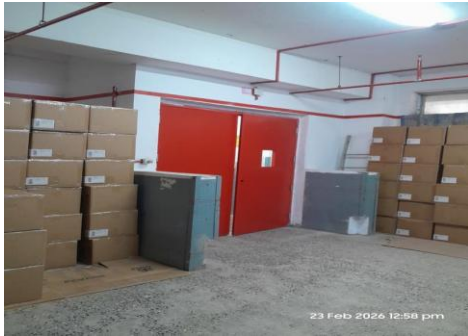
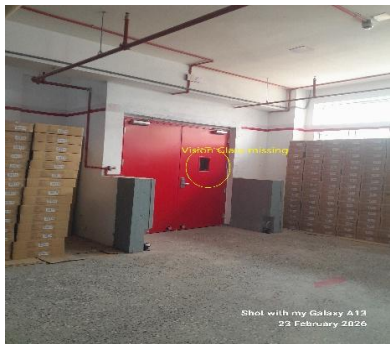
| F-21 | Fire Rated Construction | <p>Elevator shafts open directly into the production floor without proper fire separation due to non-functional fire doors, missing fire door accessories, fire doors held open with external objects, etc.</p> <p><b>Location(s): All floors, East Tower Building.</b></p> | <p>Elevator shaft shall be separated from production area by 2 hours fire rated construction. 2-hr fire barriers shall be protected with a minimum 1.5-hr fire protective opening assemblies.</p> <p>Ensure that the fire doors are self-closing and positive latching. If fire doors are required to be held open for functional reasons, provide automatic closing devices tied to the fire alarm system.</p> <p>Keep proper datasheet &amp; certifications for installed fire doors &amp; accessories on-site for verification. The clearance under the bottom of a door shall be a maximum of 3/4 in.</p> | Within 3 Months |

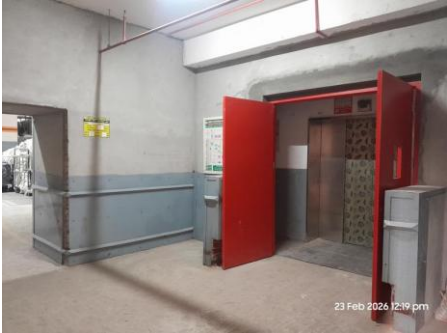
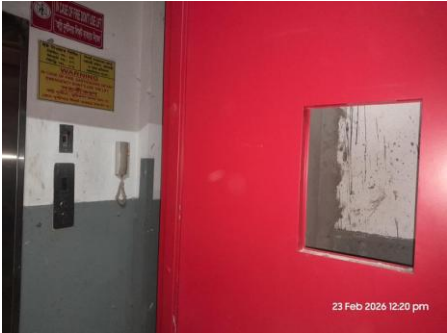
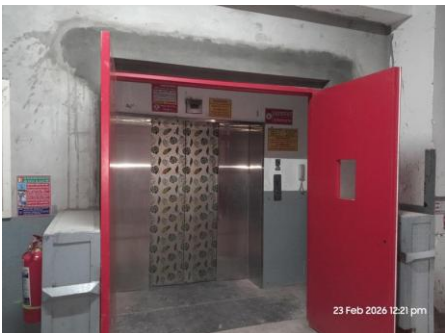
| F-22 | Fire Rated Construction | <p>Elevator shafts open directly into the exit enclosure, which doesn't comply with RSC Technical Guidelines (Standard), section 6.14.3 due to non-functional fire doors, missing fire door accessories, fire doors held open with external objects, etc.</p> <p><b>Location(s): Ground floor, East Tower Building.</b></p> | <p>Provide a minimum 2-hr fire rated elevator shaft to separate it from stair enclosure. No discharge is accepted through elevator shaft. Seal all openings to maintain fire separations.</p> | Within 3 Months |

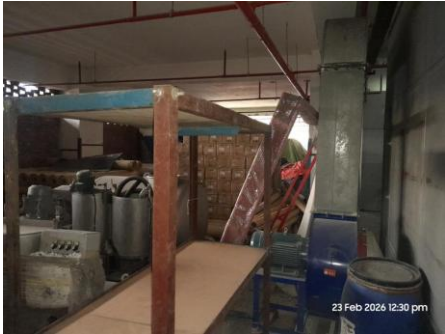
| F-23 | Fire Rated Construction | <p>Rooms used for storage of combustible materials are not separated from the surrounding production areas.</p> <p><b>Location(s): Ground floor, East Tower Building.</b></p> | <p>Rooms used for storage of combustible materials shall be separated from the surrounding occupancy with a minimum 1 hour construction in accordance with section 3.4.2.1.5 of RSC Technical Guideline (Standard).</p> | Within 3 Months |

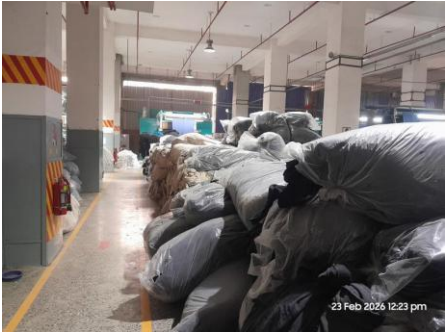
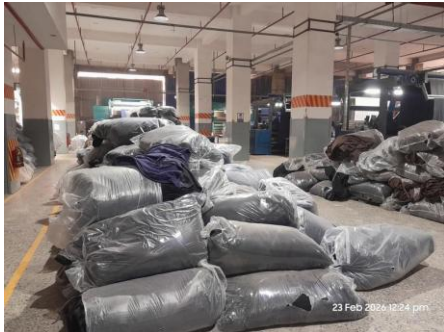
| F-24 | Fire Rated Construction | <p>Areas used for in-process storage of combustible materials are open to the surrounding occupancy.</p> <p><b>Location(s): Ground floor, East Tower Building.</b></p> | <p>Provide defined storage areas and limit the storage arrangement as follows:</p> <p>Maximum height of 2.45 m and maximum area of 23 m<sup>2</sup>, and is separated by a minimum of 3.0 m (10ft) from other storage areas, and they do not exceed 10 percent of the building area of the story in which they occur.</p> <p>or,</p> <p>If sprinkler protected, Maximum height 12 ft (3.66 m) and maximum area of 1000 ft<sup>2</sup> (93 m<sup>2</sup>) and separated by at least 25 ft (7.62 m), and does not constitute more than 10 percent of the building area or 4000 ft<sup>2</sup> (372 m<sup>2</sup>) of the sprinklered area, whichever is greater.</p> <p>or,</p> <p>Enclose the storage area from the surrounding occupancy with a minimum 1-hour construction.</p> | Within 3 Months |

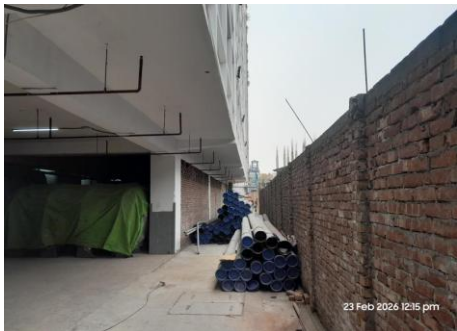
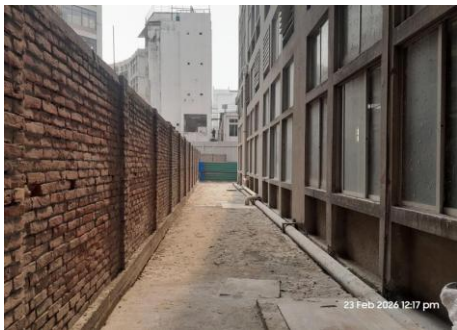
| <b>F-25</b> | Fire Rated Construction | <p>The required fire separation distance does not comply with the requirements of BNBC 2020.</p> <p><b>Location(s): East Tower Building.</b></p> | <p>The exterior walls shall have a fire resistance and opening protection as specified in BNBC 2020 Part 3 Table 3.2.2 &amp; 3.2.3 and BNBC 2020 Part 3 Section 2.4.1.3.</p> | Within 3 Months |

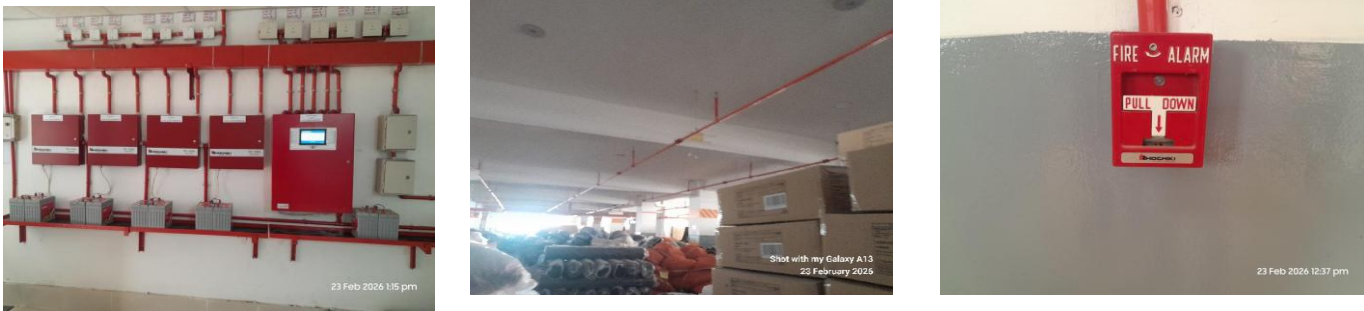
| <b>F-26</b> | Fire Alarm & Detection System (FADS) | <p>The factory has installed sprinkler based detection system in the main production building. The factory has installed a fire alarm and detection system that requires a detailed review to confirm compliance with NFPA 72 and RSC Technical Guidelines (Standard).</p> <p><b>Location(s): East Tower Building.</b></p> | <p>Submit the fire alarm and detection system design to RSC for review.</p> <p>Once the design is reviewed, install and modify the fire detection and alarm system throughout the building in accordance with review comment, RSC Technical Guidelines (Standard) and NFPA 72.</p> <p>After installation the owner shall conduct internal testing and commissioning and then contact the RSC for witness of final acceptance testing.</p> | Design within 2 Month and modification/ installation with 4 Months |

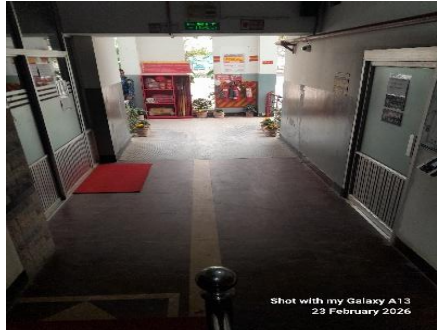
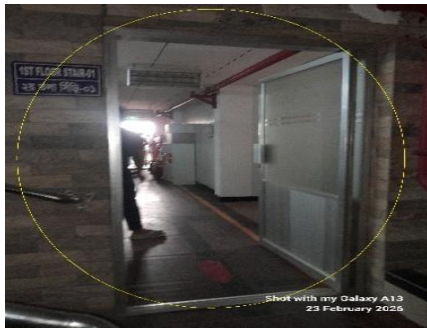
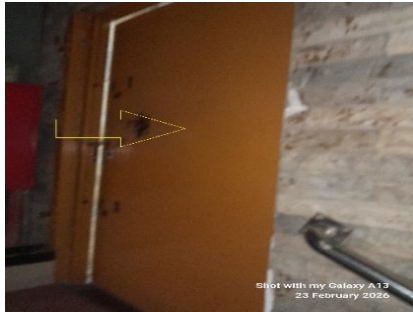
| SI No. | Category | Findings | Required Action | Remediation Time Frame |
|---|---|---|---|---|
| <b>F-29</b> | Means of Egress | <p>The exit stair enclosures are not separated from work areas and other spaces on each floor by fire-rated construction.</p> <p><b>Location(s): All floors (Office Building).</b><br/> <b>Non-Compliance: Unprotected openings &amp; non-rated doors</b></p> | <p>The exit stair enclosure shall be provided with a minimum of 2- hr. fire resistance rating for buildings 4 or more stories. Provide 1.5 hr. fire rated door and seal all penetrations and openings by 2 hr. fire rated fire rated barrier construction for building with 4 or more stories in accordance with section 6.3.1.2 of RSC Technical Guidelines (Standard)<sup>1</sup> V1.0.</p> <p>Ensure that the fire doors are self-closing and positive latching, and that they are provided with fire exit (panic) hardware where serving production floors. If fire doors are required to be held open for functional reasons, provide automatic closing devices tied to the fire alarm system.</p> <p>Keep proper datasheet &amp; certifications for installed fire doors &amp; accessories on-site for verification. The clearance under the bottom of a door shall be a maximum of 3/4 in. (19 mm).</p> | Within 3 Months |

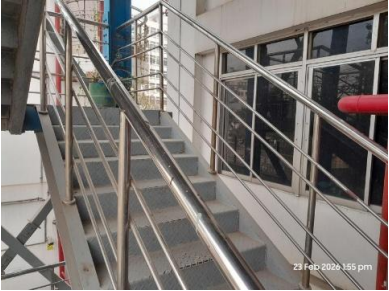
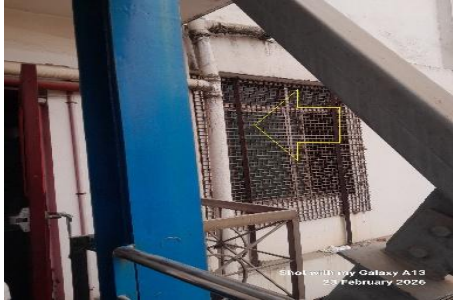
| F-31 | Means of Egress | <p>The exterior exit stair is not separated from the building interior.</p> <p><b>Location(s): North Stair, All floors, (Office Building).</b></p> | <p>Nonrated walls or unprotected openings enclose the exterior of the stairway and the walls or openings are exposed by other parts of the building at an angle of less than 180 degrees (3.14 rad), the building exterior walls within 3050 mm (10 ft) horizontally of a nonrated wall or unprotected opening shall have a fire-resistance rating of not less than 1 hr./ 2 hr. in accordance with section 6.3.1.3 of RSC Technical Guidelines (Standard)<sup>1</sup> V1.0.</p> <p>If fire doors are required to be held open for functional reasons, provide automatic-closing devices tied to the fire alarm system.</p> | Within 3 Months |

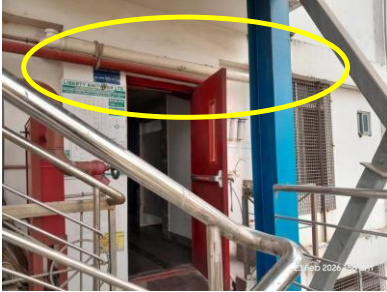
| F-32 | Means of Egress | <p>Unsealed penetrations and openings are located in exit stair enclosures due to plastic pipes.</p> <p><b>Location(s): North Stair, All floors, (Office Building).</b></p> | <p>No other penetration into and through the exit enclosure, except for fire alarm equipment, electrical raceway, required exit doors, sprinkler piping, standpipes, and electrical conduit serving the exit enclosure, is permitted in accordance with section 6.14.4 of RSC Technical Guidelines (Standard) )<sup>1</sup> V1.0. So, relocate the electrical wires/raceways to somewhere else, avoiding the exit enclosure, and seal the created unprotected openings with a minimum of 1.5 hours listed/certified fire-rated materials. Installation shall be as per the manufacturer's published installation guidelines and the certification authority guidelines to ensure the fire-rating. Or seal the penetration by 2-hr masonry construction.</p> | Within 3 Months |

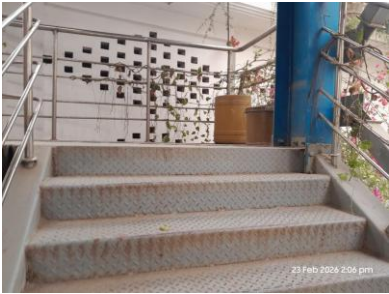
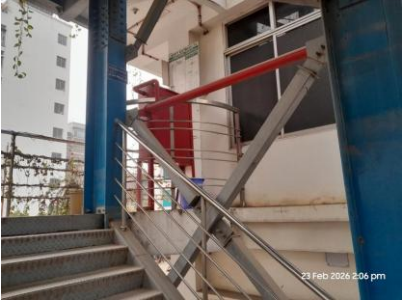
| F-35 | Means of Egress | <p>The exterior exit stair is not separated from the building interior.</p> <p><b>Location(s): East Stair, All floors, (Security Building).</b></p> | <p>Nonrated walls or unprotected openings enclose the exterior of the stairway and the walls or openings are exposed by other parts of the building at an angle of less than 180 degrees (3.14 rad), the building exterior walls within 3050 mm (10 ft) horizontally of a nonrated wall or unprotected opening shall have a fire-resistance rating of not less than 1 hr./ 2 hr. in accordance with section 6.3.1.3 of RSC Technical Guidelines (Standard)<sup>1</sup> V1.0.</p> <p>If fire doors are required to be held open for functional reasons, provide automatic-closing devices tied to the fire alarm system.</p> | Within 3 Months |

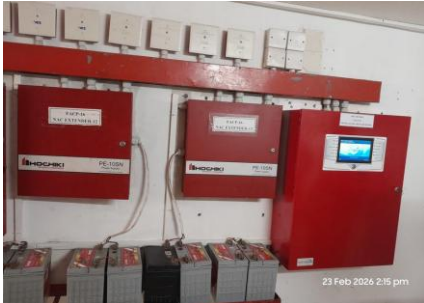
| F-36 | Fire Alarm & Detection System (FADS) | <p>The factory has installed a fire alarm and detection system that requires a detailed review to confirm compliance with NFPA 72 and RSC Technical Guidelines (Standard).</p> <p><b>Location(s): Office Building, Security Building, &amp; Others.</b></p> | <p>Submit the fire alarm and detection system design to RSC for review.</p> <p>Once the design is reviewed, install and modify the fire detection and alarm system throughout the building in accordance with review comment, RSC Technical Guidelines (Standard) and NFPA 72.</p> <p>After installation the owner shall conduct internal testing and commissioning and then contact the RSC for witness of final acceptance testing.</p> | <p>Design within 2 Month and modification/ installation with 4 Months</p> |

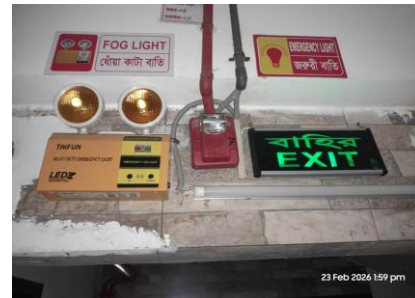
| F-37 | Inspection, Testing & Maintenance (Fire) | <p>Inspection, testing and maintenance for the fire alarm system is not in accordance with NFPA 72.</p> <p><b>Location(s): Office Building, Security Building, &amp; Others.</b></p> | <p>Inspect, test, and maintain the fire alarm system and keep written records on-site, in accordance with NFPA 72 and RSC Technical Guidelines (Standard)<sup>1</sup> V1.0.</p> | <p>Within 1 Month after installation</p> |

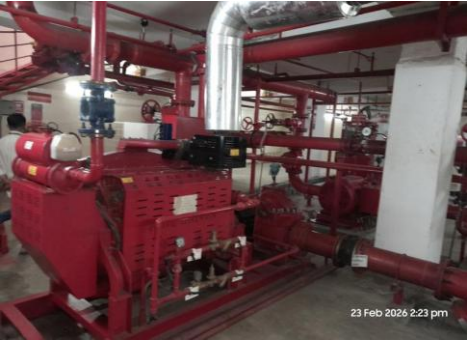
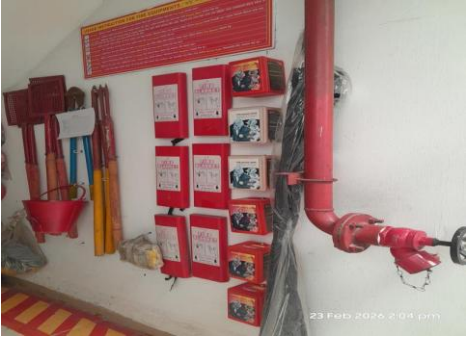
| F-38 | Fire Suppression System (SUPS) | <p>The factory has installed a standpipe &amp; Hose system that requires a detailed review to confirm compliance with NFPA 14,20, 24, and RSC Technical Guidelines (Standard).</p> <p><b>Location(s): Office Building.</b></p> | <p>Submit the standpipe system drawing to RSC for review.</p> <p>Once reviewed, install or modify the standpipe system throughout the building in accordance with RSC Technical Guidelines (Standard)<sup>1</sup> V1.0. and NFPA 14, 20,22 and 24.</p> <p>After installation the owner shall contact the RSC for witness of conducting the final acceptance testing of the standpipe system.</p> | <p>Design within 2 Month and modification/ installation with 4 Months</p> |
