# INITIAL FIRE SAFETY INSPECTION REPORT

**CBM International Ltd.**

**RSC ID: 26534**

**Address: 28, Milkvita Road, Section #07, Mirpur.**

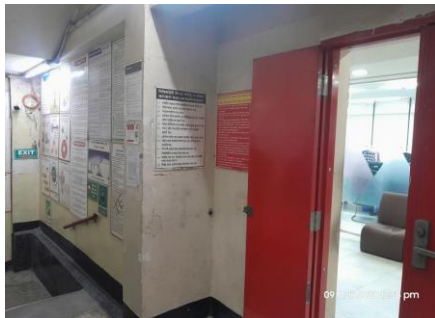
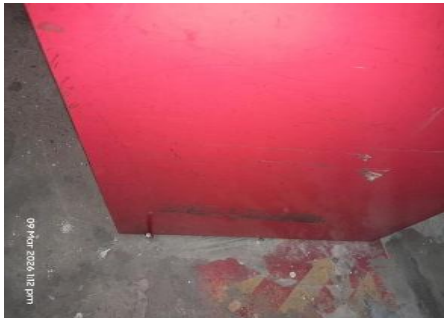
| SI No. | Category | Findings | Required Action | Remediation Time Frame |
|---|---|---|---|---|
| F-1 | Means of Egress | <p>The exit stair enclosures are not separated from work areas and other spaces on each floor by fire-rated construction.</p> <p><b>Location(s): Production Building.</b></p> <p><b>Non-Compliance: Fire door non-functionality, fire door accessories missing, fire doors held open with external object, etc.</b></p> | <p>The exit stair enclosure shall be provided with a minimum of 2- hr. fire resistance rating for buildings 4 or more stories. Provide 1.5 hr. fire rated door and seal all penetrations and openings by 2 hr. fire rated fire rated barrier construction for buildings with 4 or more stories in accordance with section 6.3.1.2 of RSC Technical Guidelines (Standard)<sup>1</sup> V1.0.</p> <p>Provide a fire-resistive rated assembly between the exterior exit stairs and the building up to 10 ft. beyond the end of the stair to achieve the required separation. The rated assembly shall be approved and/or designed by a qualified fire protection engineer.</p> <p>Ensure that the fire doors are self-closing and positive latching, and that they are provided with fire exit (panic) hardware where serving production floors. If fire doors are required to be held open for functional reasons, provide automatic closing devices tied to the fire alarm system.</p> <p>Keep proper datasheet &amp; certifications for installed fire doors &amp; accessories on-site for verification. The clearance under the bottom of a door shall be a maximum of 3/4 in. (19 mm).</p> | Within 3 Months |

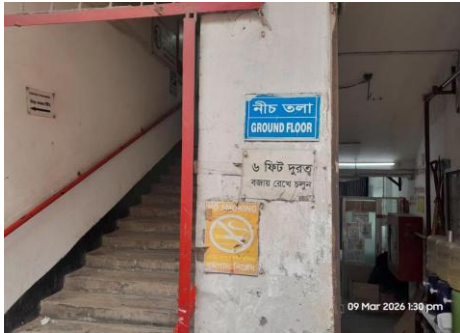
| F-3 | Means of Egress | <p>Unprotected opening within 10 ft horizontal distance from the discharge point where the elevation of the unprotected opening is less than 10 ft.</p> <p><b>Location(s): Ground floor, N-E Stair.</b></p> | <p>Provide protection of unprotected openings within 10 ft horizontal distance from the discharge point where the elevation of the unprotected opening is less than 10 ft. The fire separation rating shall not be less than that of the exit stair enclosure.</p> | Within 3 Months |

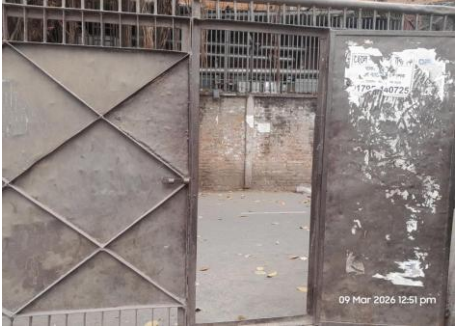
| F-4 | Means of Egress | <p>Doors in the means of egress do not have the required minimum width. (Available Width: 25 inches).</p> <p><b>Location(s): East Main Exit.</b></p> | <p>Doors in a means of egress shall have a minimum width of 0.8 m (32 in.) in accordance with section 6.5.6.1 of RSC Technical Guidelines (Standard)<sup>1</sup> V1.0.</p> | Within 1 Month |

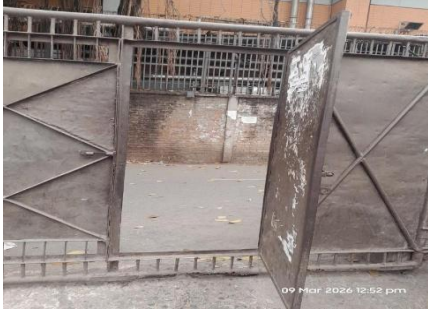
| F-5 | Means of Egress | <p>Egress door serving 50 or more occupants, but does not swing in the direction of egress travel.</p> <p><b>Location(s): East Main Exit.</b></p> | <p>Modify swing direction of egress doors to the direction of egress travel. Doors serving an occupant load of more than 50 shall swing in the direction (out-ward) of egress travel in accordance with section 6.8.1 of RSC Technical Guidelines (Standard)<sup>1</sup> V1.0.</p> | Within 1 Month |

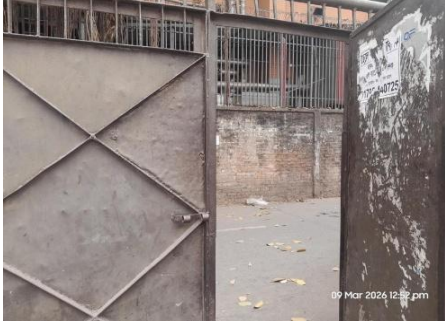
| F-6 | Means of Egress | <p>Headroom measured less than 80 inches (available: 60 inches).</p> <p><b>Location(s): East Main Exit.</b></p> | <p>All means of egress shall have a minimum ceiling height of 2.3 m (7 ft 6 in.) with projections from the ceiling not less than 2.03 m (6 ft 8 in.). The minimum ceiling height shall be maintained for at least 2/3 of the space or room as long as the remaining area shall be not less than 2.03 m (6 ft 8 in.). Headroom on stairs shall not be less than 2.03 m (6 ft 8 in.) as per RSC Technical Guideline (Standard) section of 6.3.3.</p> | Within 3 Months |

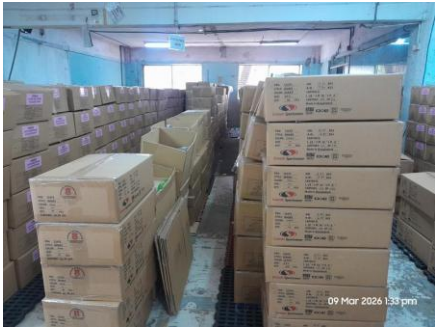
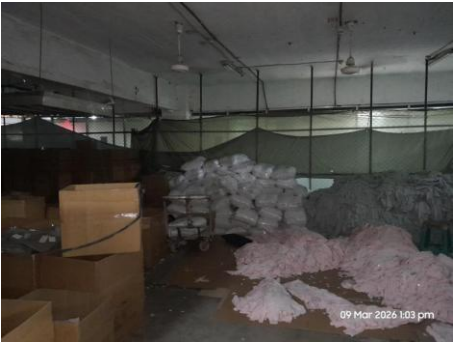
| F-7 | Means of Egress | <p>Aisles were found missing in several locations throughout the building.</p> <p><b>Location(s): 1st floor, Finished Goods Store, Accessories Store, etc. Production Building.</b></p> | <p>Provide minimum aisle widths of 36-in. Aisles mark shall be clearly visible.</p> | <p>Within 1 Month</p> |

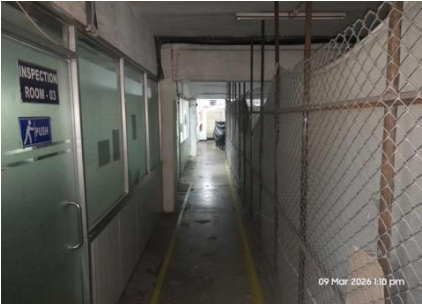
| F-8 | Means of Egress | <p>Directional signs are not provided where the direction of the path of travel to an exit has changed.</p> <p><b>Location(s): All floors, Production Building.</b></p> | <p>Illuminated directional signs shall be provided where there is a change in the direction for the path of travel and the direction to an exit is not obvious in accordance with RSC Technical Guidelines (Standard)<sup>1</sup> V1.0 Section 6.11.3.</p> | Within 1 Month |

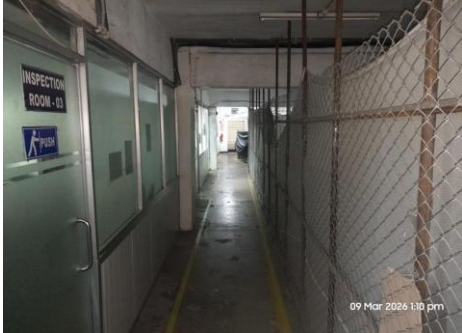
| F-9 | Means of Egress | <p>Based on the number and location of emergency lights observed, adequate illumination levels are not anticipated along egress routes.</p> <p><b>Location(s): All floors, Production Building.</b></p> | <p>Test the emergency lighting system on each floor and provide additional emergency fixtures to provide adequate illumination along the means of egress. Provide a minimum illumination of 10 lux at the floor level within exit stairs and exit discharge paths and minimum 2.5 lux along exit access aisles. Illumination on means of egress shall meet in accordance with RSC Technical Guidelines (Standard)<sup>1</sup> V1.0 Section 10.12.2.</p> | Within 3 Months |

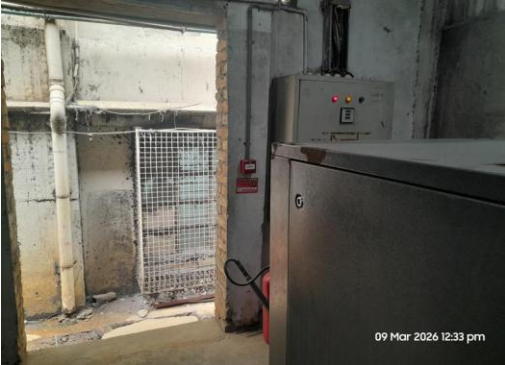
| F-10 | Means of Egress | <p>Exit sign not provided at exit.</p> <p><b>Location(s): Compressor Room.</b></p> | <p>Lighted exit signs shall be placed at entrance to an exit.</p> <p>Additional directional exit signs shall be placed throughout the facility anywhere the continuation of the egress is not obvious.</p> <p>Lighted exit signs shall be provided with either battery backup or uninterruptable power supply systems and shall be continuously illuminated at all times. Exit Sign shall provide in accordance with RSC Technical Guidelines (Standard)<sup>1</sup> V1.0 Section 6.11.</p> | Within 1 Month |

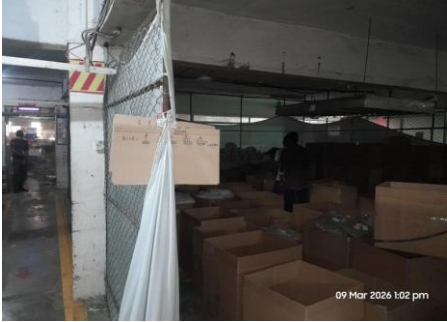
| F-13 | Fire rated construction | <p>Areas used for in-process storage of combustible materials are open to the surrounding occupancy.</p> <p><b>Location(s): 1st &amp; 2nd floors, Production Building.</b></p> | <p>Provide defined storage areas and limit the storage arrangement as follows:</p> <p>Maximum height of 2.45 m, maximum area of 23 m<sup>2</sup>, and is separated by a minimum of 3.0 m (10ft) from other storage areas, and they do not exceed 10 percent of the building area of the story in which they occur.</p> <p>or,</p> <p>Enclose the storage area from the surrounding occupancy with a minimum 1-hour construction.</p> | Within 3 Months |

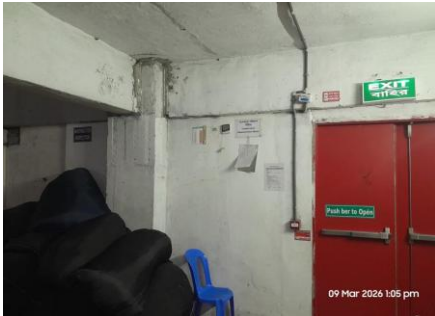
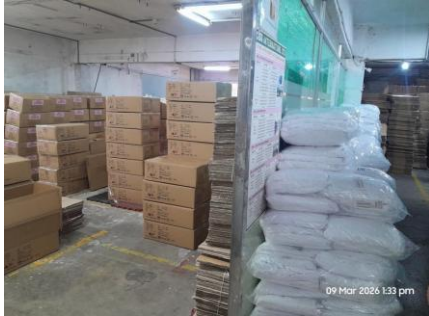
| F-14 | Fire rated construction | <p>Rooms used for the storage of combustible materials are not separated from the surrounding production area due to non-functional doors, penetrations &amp; openings.</p> <p><b>Location(s): 1st floor, Production Building.</b></p> | <p>Rooms used for storage of combustible materials shall be separated from the surrounding occupancy with a minimum 1 hour construction in accordance with section 3.4.2.1.5 of RSC Technical Guideline (Standard).</p> | Within 3 Months |

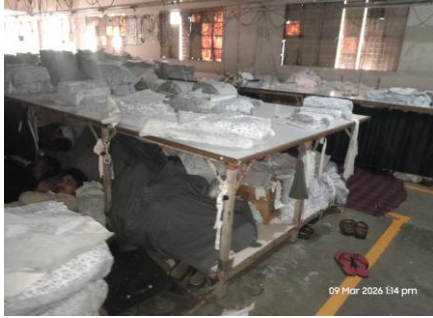
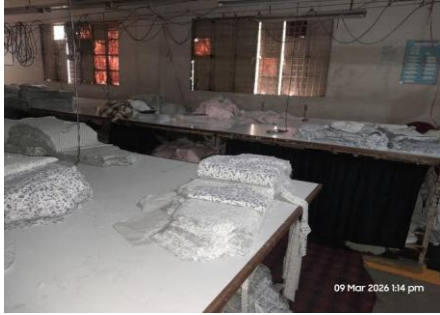
| F-15 | Fire rated construction | <p>Storages were found underneath the cutting tables.</p> <p><b>Location(s): 2nd floor, Production Building.</b></p> | Storage underneath the cutting tables shall be kept clear of combustibles at all times, except as provided for miscellaneous storage in accordance with 3.4.2.1.6. | Within 3 Months |

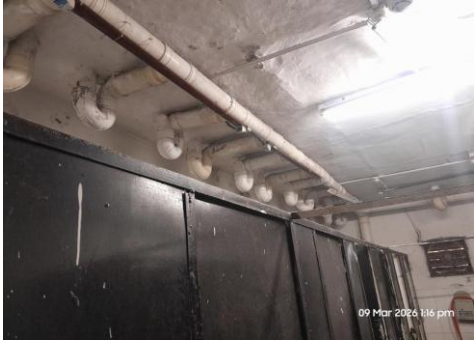
| F-16 | Fire Rated Construction | <p>Penetrations through floor/ceiling assemblies are found unsealed.</p> <p><b>Location(s): Penetrations due to plastic pipes, Production Building.</b></p> | <p>Seal all penetrations and openings in floor/ceiling assemblies by a listed through-penetration fire stop system tested in accordance with ASTM E814 or approved alternative standard to maintain a minimum 3-hr. fire resistance rating. Installation shall be as per the manufacturer's published installation guideline and the certification authority guideline to ensure the fire-rating in accordance with section 4.7 of RSC Technical Guideline (Standard).</p> <p>Or,</p> <p>Provide a minimum 2-hour fire-rated shaft to separate the penetration from each floor if required.</p> | Within 3 Months |

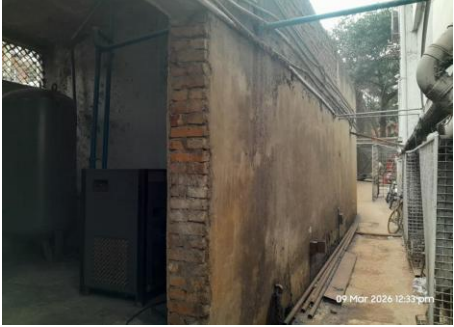
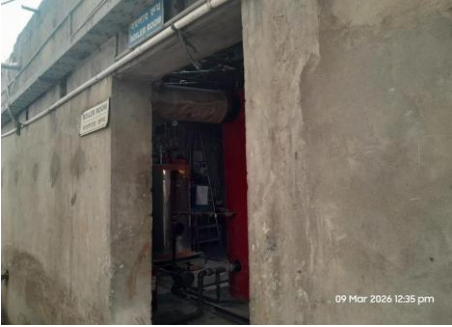
| F-17 | Fire Rated Construction | <p>Boiler &amp; compressor rooms are not properly separated by fire-rated construction from the production building within 10 ft.</p> <p><b>Location(s): CBM Boiler Room, CBM Compressor Room.</b></p> | <p>Boilers or other heat-producing equipment shall be separated from other occupancies by a minimum 1-hr fire-rated construction (wall, floor, slab, etc.). Seal all penetrations and openings (door, window, etc.) should be protected by 0.75-hr (45 min) fire-rated materials to maintain the fire separation if required. All exhaust systems shall discharge to the exterior of the building in a safe location.</p> <p>Or</p> <p>Relocate it to the exterior of the building and maintain a minimum 3m (10 ft.) spatial separation distance from the building. Boiler room separation shall meet section 3.4.2.1.2 of RSC Technical Guideline (Standard) .</p> | Within 3 Months |

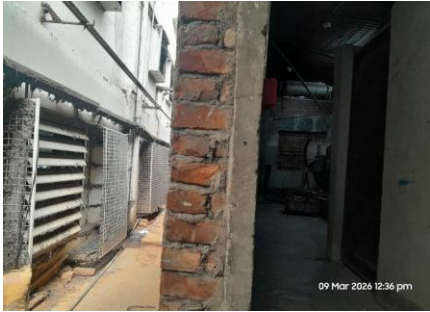
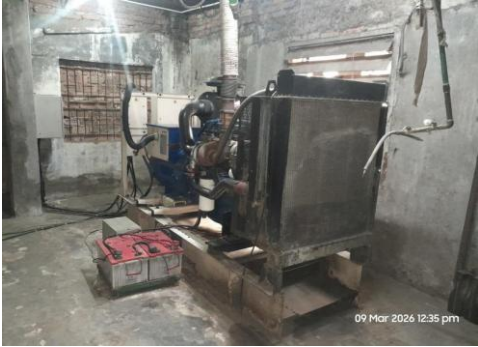
| F-18 | Fire Rated Construction | <p>Generator room is not properly separated by fire-rated construction from the production building within 10 ft.</p> <p><b>Location(s): CBM Generator Room.</b></p> | <p>Generator room shall be separated from other occupancies by a minimum 2-hr fire-rated construction (wall, floor, slab, etc.). Seal all penetrations and openings (door, window, etc.), which should be protected by 1.5-hr fire-rated materials to maintain the fire separation if required. All exhaust systems shall discharge to the exterior of the building in a safe location.</p> <p>Or</p> <p>Relocate it to the exterior of the building and maintain a minimum 3m (10 ft.) spatial separation distance from the building.</p> <p>Generator room separation shall meet section 3.4.2.1.2 of RSC Technical Guideline (Standard).</p> | Within 3 Months |

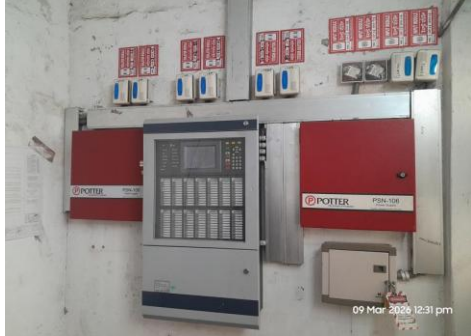
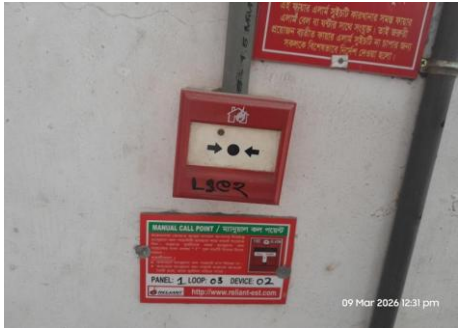
| F-19 | Fire Alarm & Detection System (FADS) | <p>The system installation is complete and functional for the entire building. The system requires to go through the as-built review and T&amp;C process covering both IDs (10905 &amp; 26534) together.</p> <p><b>Note: For details, please check the Fire Alarm and Detection System Overview.</b></p> <p><b>Location(s): All Buildings.</b></p> | <p>Update the as-built design and document for the entire system, covering both IDs (10905 &amp; 26534). The T&amp;C process will be conducted simultaneously after the successful completion of the review for both IDs.</p> | Within 1 Month |

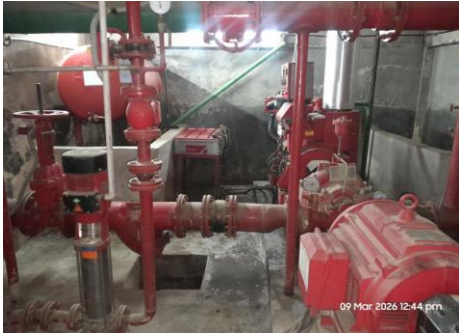
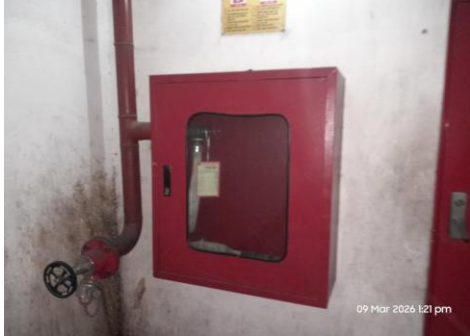
| F-20 | Fire Suppression System (SUPS) | <p>The system installation is complete and functional for the entire building. The system requires to go through the as-built review and T&amp;C process covering both IDs (10905 &amp; 26534) together.</p> <p><b>Note: For details, please check the Standpipe System Overview.</b></p> <p><b>Location(s): Production Building.</b></p> | <p>Update the as-built design and document for the entire system, covering both IDs (10905 &amp; 26534). The T&amp;C process will be conducted simultaneously after the successful completion of the review for both IDs.</p> | Within 1 Month |
