# **FIRE SAFETY INSPECTION REPORT**

## **MAVIS GARMENTS LTD.**

**MOUZA - CHANDANA, CHOWRASTA, JOYDEBPUR,  
GAZIPUR**

March 15, 2014

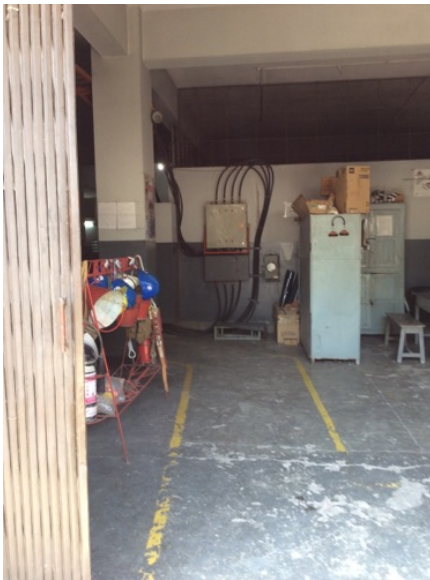
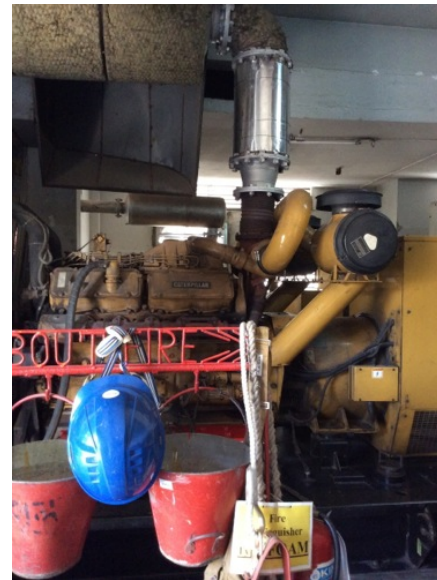
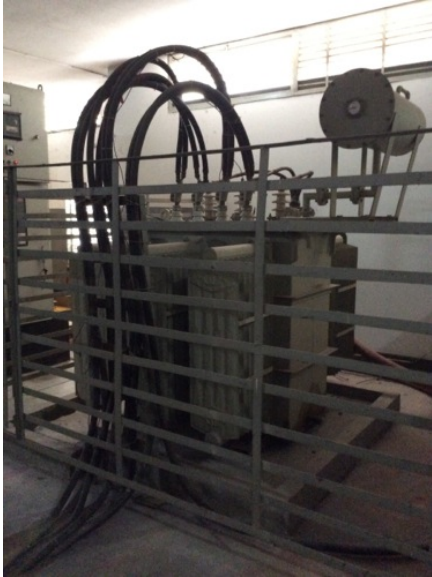
| No. | Category | Finding | Recommendation | Remediation Timeframe |
|---|---|---|---|---|
| F-1 | Fire Rated Construction | The utility room on the ground floor is not separated by fire-rated construction due to openings and no fire-rated doors. | Separate the utility room by a minimum 2-hr fire-rated construction. Seal and/or protected all openings to maintain the required fire separations | Within 3 months |

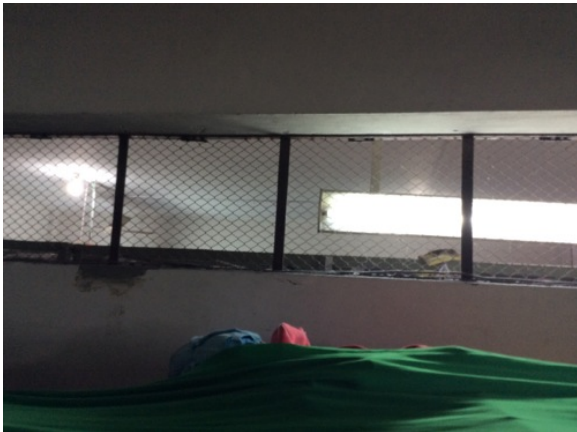
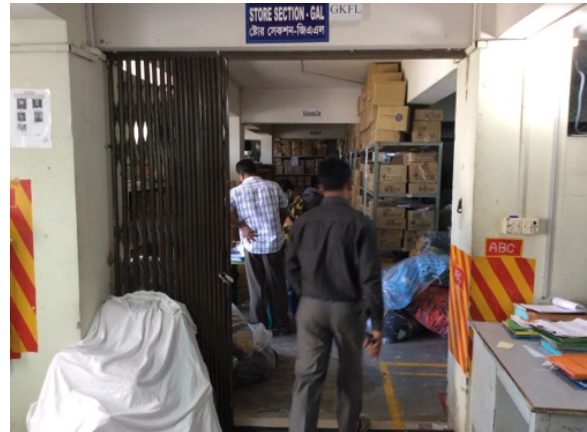
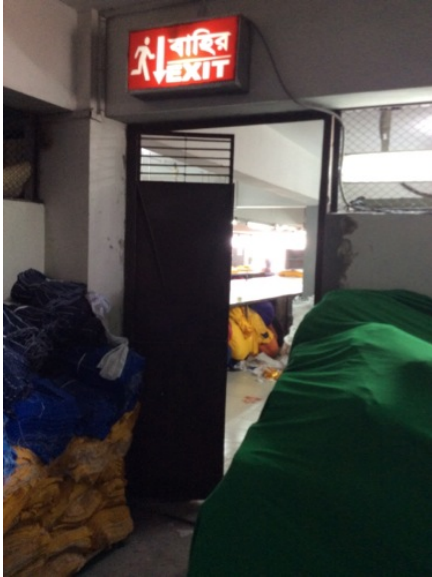
| F-2 | Fire Rated Construction | The storage rooms on the ground and first floors are not separated by fire-rated construction. | Provide dedicated storage rooms separated by minimum 1-hr fire-rated construction. | Within 3 months |

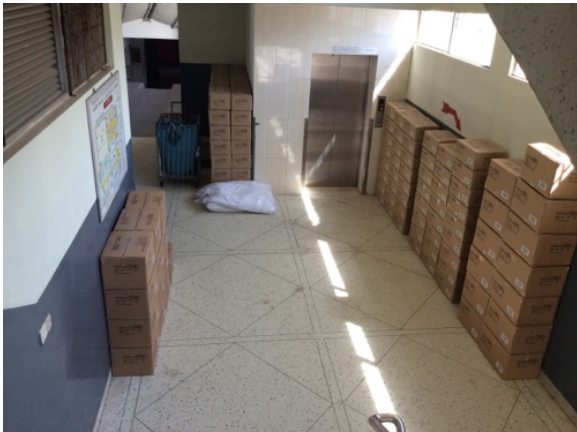
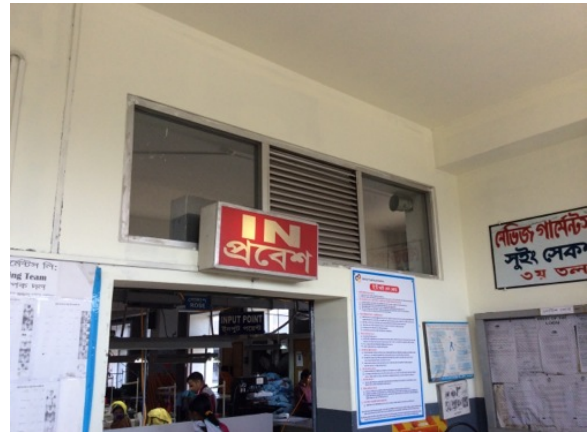
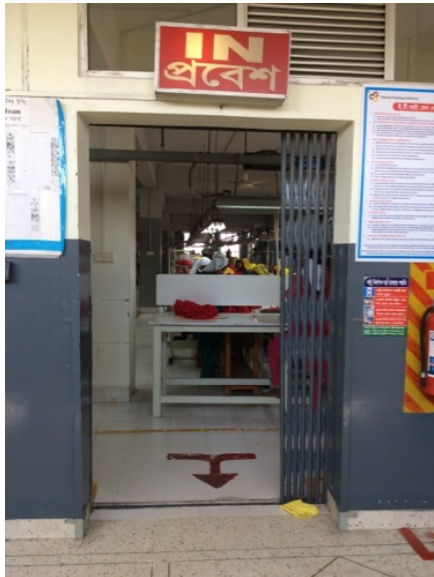
| F-3 | Fire Rated Construction | The exit stairs are not separated from work areas and other spaces on each floor by fire-rated construction. | <p>Provide minimum 1.5-hr fire rated doors and seal all unprotected openings to separate the exit stairs from work areas and other building spaces on all floor levels. Ensure that the fire doors are self-closing and positive latching and that they are provided with fire exit (panic) hardware where serving production floors.</p> <p>If fire doors are required to be held open for functional reasons, provide automatic-closing devices tied to the fire alarm system.</p> | Within 3 months |

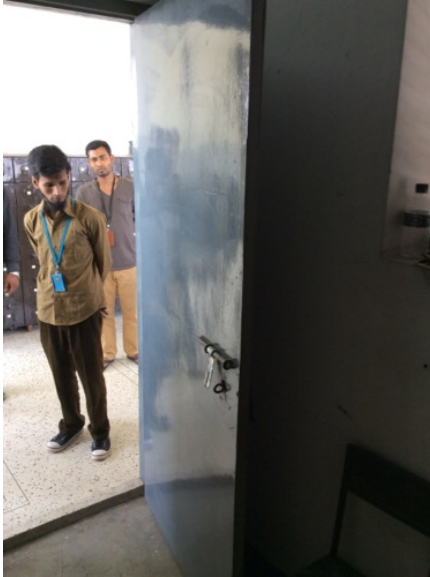
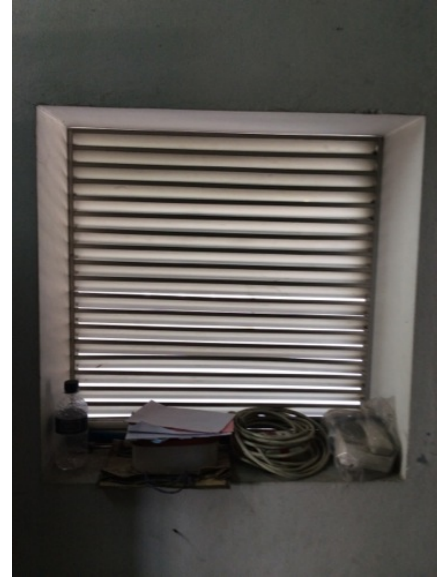
| F-4 | Fire Rated Construction | The elevator machine room on the seventh floor is not separated by fire-rated construction due to openings and a non-rated door. | Separate the elevator machine room by a minimum 2-hr fire-rated construction. Seal and/or protected all openings to maintain the required fire separations | Within 3 months |

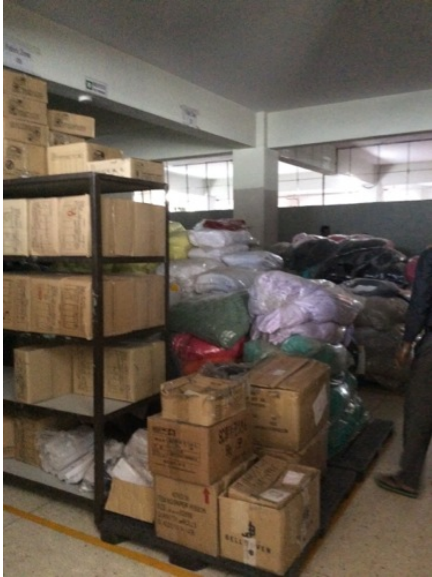
| F-5 | Fire Rated Construction | Areas used for combustible storage on factory floors, specifically the first floor, are not separated by fire-rated construction. | <p>Provide dedicated storage rooms separated by minimum 1-hr fire-rated construction.</p> <p>Where separate storage rooms are not feasible, provide defined storage areas and limit the storage arrangement as follows:</p> <ul style="list-style-type: none"> <li>- Maximum height of 2.4m and maximum area of 23m<sup>2</sup></li> <li>- If sprinkler protected: maximum height of 3.66m and maximum area of 93m<sup>2</sup></li> </ul> <p>Separate areas of unenclosed combustible storage by a minimum clear distance of 3m.</p> | Within 3 months |

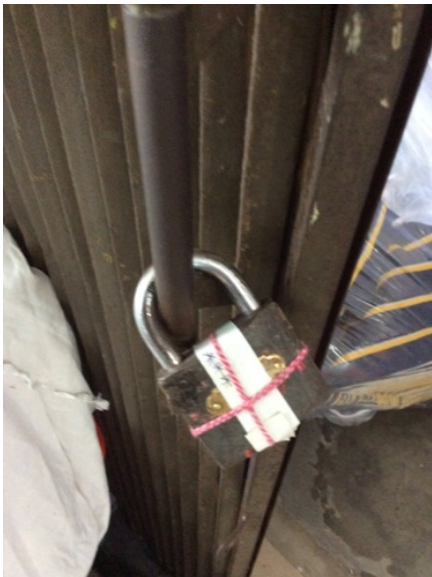
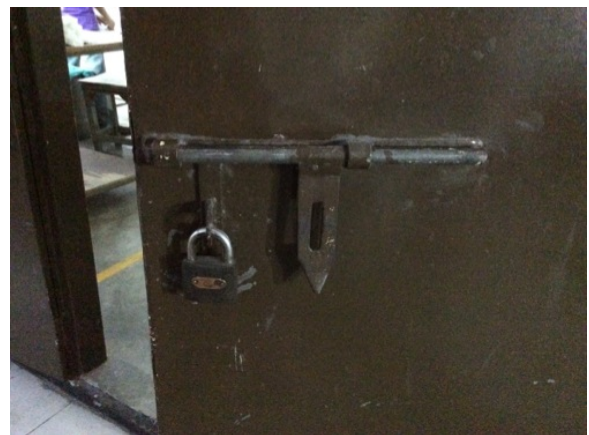
| F-6 | Egress | Egress doors and gates with locking features are provided at building exits, exit stairs, along egress routes, and at exit discharge at various locations throughout the building. All gates/doors were open and unlocked during the inspection. | Remove locking features from all egress doors and gates.<br><br>If locks are required for security reasons, utilize special door locking features complying with NFPA 101. | Immediate |

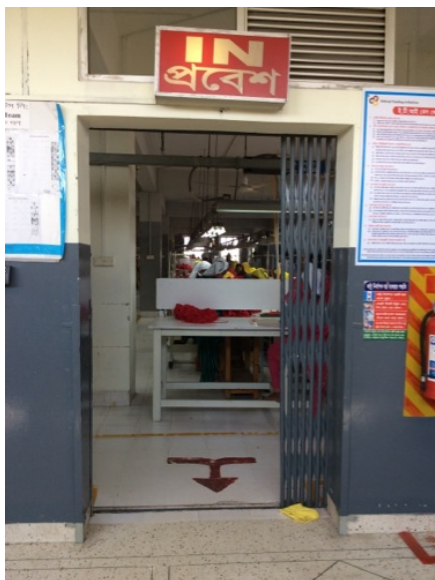
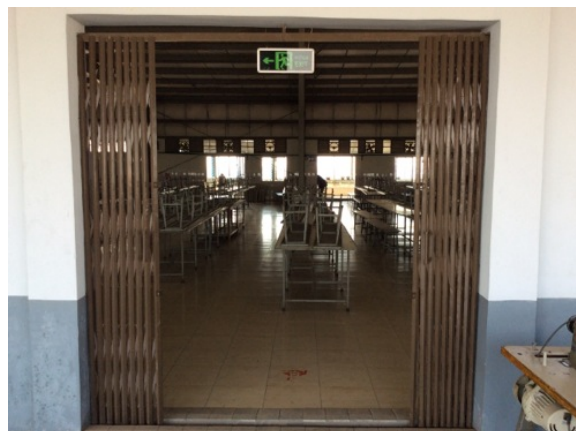
| F-8 | Egress | Collapsible gates are provided at building exits, exit stairs, along egress routes, and at exit discharge at various locations throughout the building. | <p>Replace all gates / sliding doors along the means of egress with side-hinged, swinging egress doors.</p> <p>If locks are required for security reasons, utilize special door locking features complying with NFPA 101.</p> | Within 1 month |

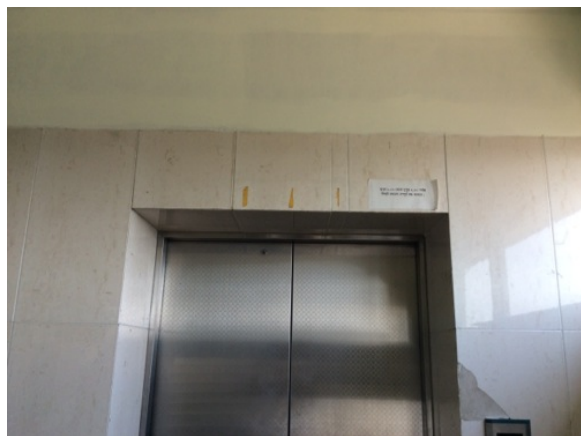
F-9 Egress

Not all elevators have signage stating "If There is a Fire Keep the Lifts Closed."

Provide signage stating "If There is a Fire Keep the Lifts Closed" on the exterior of all elevators.

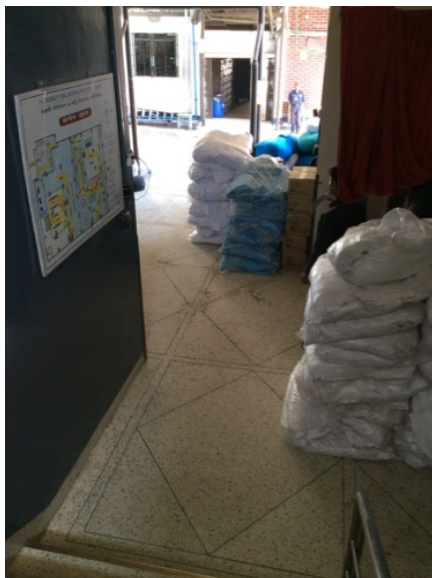
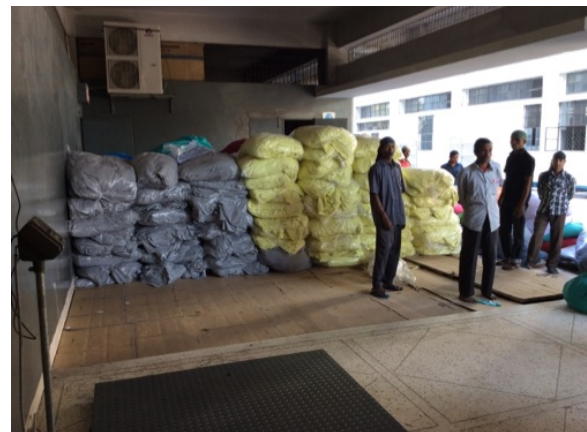
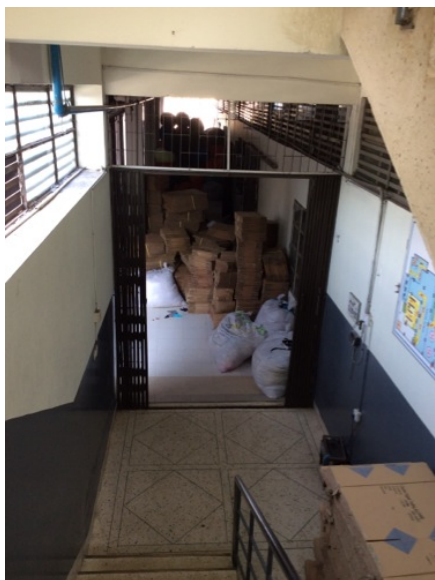
| F-10 | Egress | Both exit stairs discharge inside the building on the ground floor to areas with storage. | <p>East Stair: Provide a 2-hour fire-rated passageway leading directly outside. No storage shall be permitted within passageway.</p> <p>West Stair: Eliminate all storage located along the egress path from the bottom of the stairway to the exit passageway discharge location (uncovered drive north of the building). Modify the west exterior building wall to meet 2-hour fire resistive rating requirement including 90-minute opening protectives. Additionally, provide a vestibule at the west entrance to the storage warehouse such that the vestibule is separated from the storage room by 1 hour construction, and the exit passageway is separated from the vestibule by 2 hour construction.</p> | Within 6 months |

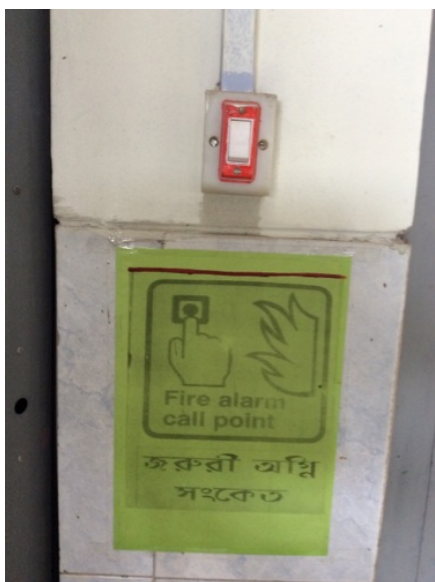
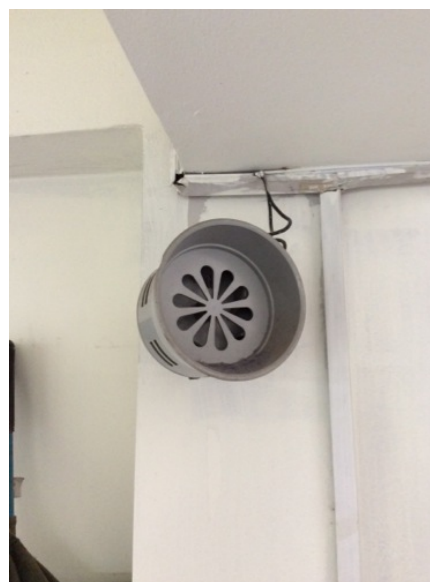
| F-11 | Fire Protection | The fire alarm system is antiquated, not a listed system, and does not provide alarm and notification features consistent with acceptable standards. | Replace the fire alarm system with a new, listed addressable fire alarm system in accordance with NFPA 72. | Design within 4 months, install within 9 months |

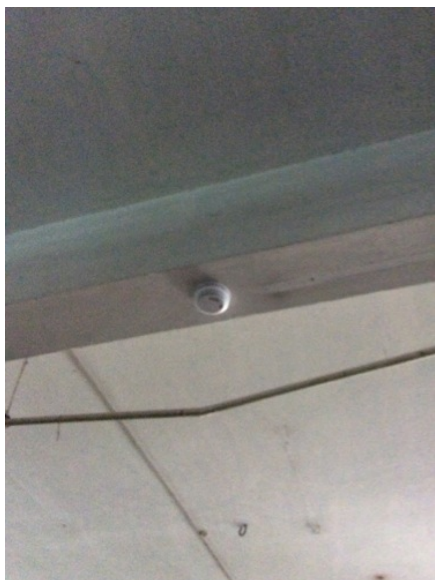
| F-15 | Fire Protection | The building is equipped with single-station smoke alarms. Smoke alarm activation sounds only a local alarm and does not provide automatic fire alarm notification of occupants. | Replace the single-station smoke alarms with automatic smoke detectors tied into the fire alarm system. Configure the fire alarm system to initiate occupant notification upon activation of any two smoke detectors in addition to the manual fire alarm stations. | Within 6 months |
