# **FIRE SAFETY INSPECTION REPORT**

## **MEGHNA KNIT COMPOSITE LTD GILARCHALA, SREEPUR, GAZIPUR**

April 8, 2014

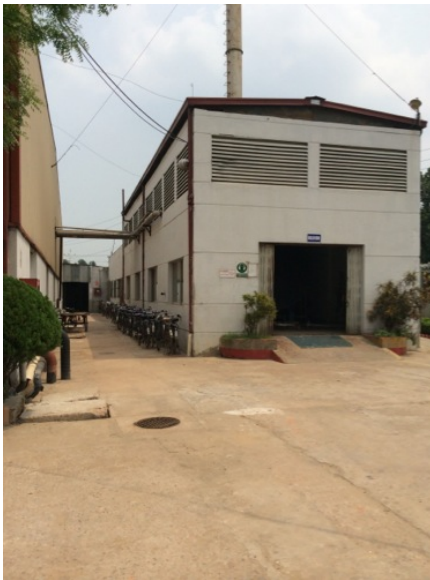
| No. | Category | Finding | Recommendation | Remediation Timeframe |
|---|---|---|---|---|
| F-1 | Fire Rated Construction | The boiler building has unprotected openings less than 10 ft from the adjacent Dyeing section. | Separate the boiler building exterior walls with minimum 2-hr fire-rated construction. Seal and/or protected all openings to maintain the required fire separations | Within 3 months |

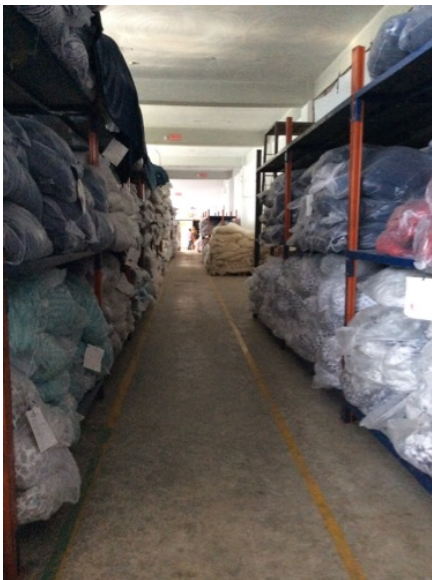
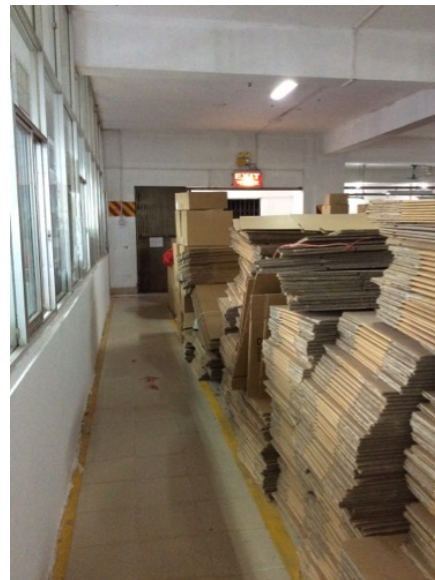
| F-2 | Fire Rated Construction | Areas used for combustible storage are not separated by fire-rated construction. Locations include Levels Ground, 1, 2, 3, 4, and 5. | <p>Provide dedicated storage rooms separated by minimum 1-hr fire-rated construction.</p> <p>Where separate storage rooms are not feasible, provide defined storage areas and limit the storage arrangement as follows:</p> <ul style="list-style-type: none"><li>- Maximum height of 2.4m and maximum area of 23m<sup>2</sup></li><li>- If sprinkler protected: maximum height of 3.66m and maximum area of 93m<sup>2</sup></li></ul> <p>Separate areas of unenclosed combustible storage by a minimum clear distance of 3m.</p> | Within 3 months |

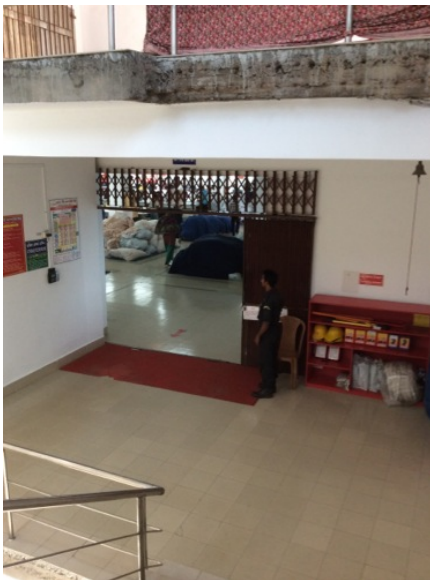
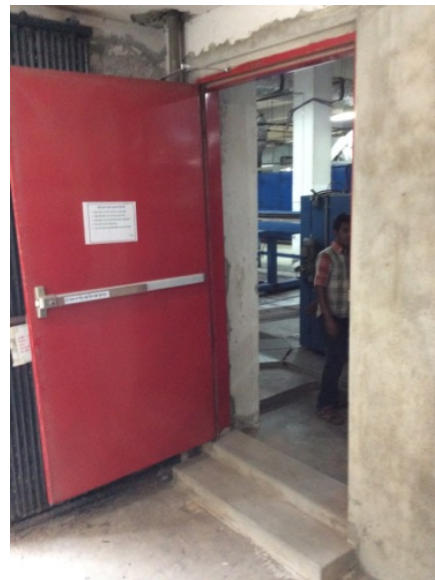
| F-3 | Fire Rated Construction | The north exit stairs are not separated from each floor by fire-rated construction. The south exit stairs are separated by red metal doors for which the factory does not currently have certification demonstrating the doors to be fire doors. | Provide minimum 1.5-hr fire rated doors and seal all unprotected openings to separate the exit stairs from work areas and other building spaces on all floor levels. Ensure that the fire doors are self-closing and positive latching and that they are provided with fire exit (panic) hardware where serving production floors. | Within 3 months |

If fire doors are required to be held open for functional reasons, provide automatic-closing devices tied to the fire alarm system.

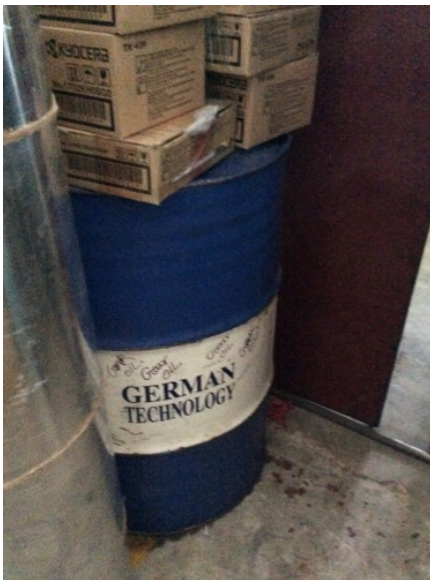
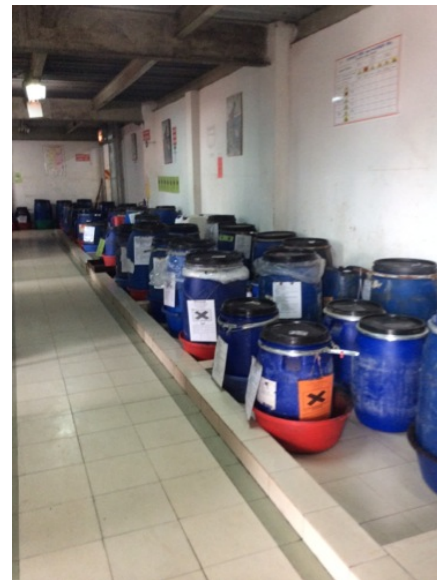
| F-4 | Fire Rated Construction | <p>Hazardous materials / flammable liquid storage areas are not separated by fire-rated construction (openings, non-rated doors, penetrations).</p> <p>Locations:</p> <ul style="list-style-type: none"> <li>-Level 1 Storage Area</li> <li>-Ground Floor Dyeing Section Storage Area</li> <li>-Ground Floor Storage underneath Softeners</li> <li>-Hydrose storage adjacent to Dyeing Section exit access</li> </ul> | Separate the hazardous materials / flammable liquid storage in rooms having minimum 2-hr fire-rated construction. Seal and/or protected all openings to maintain the required fire separations. | Within 3 months |

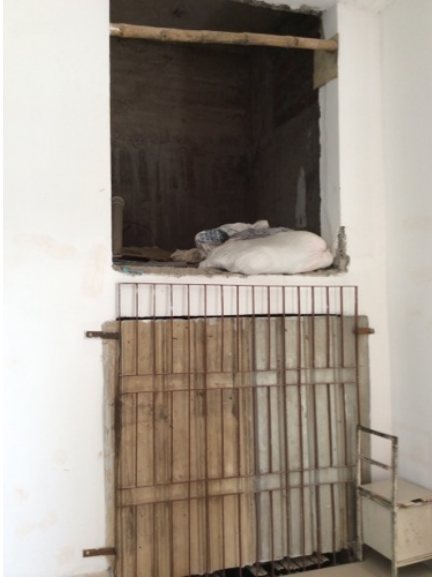
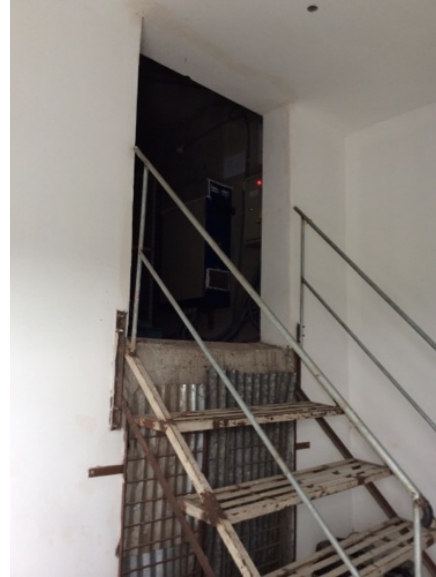
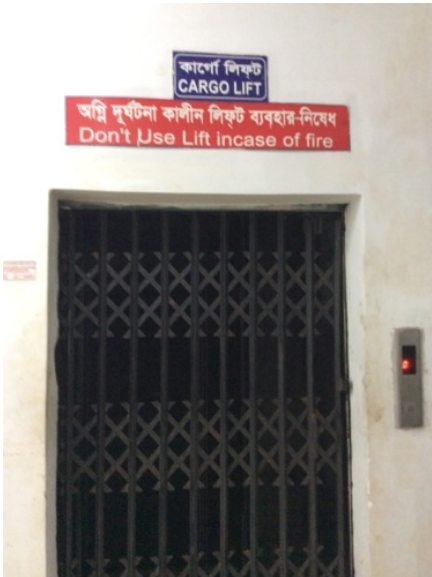
| F-5 | Fire Rated Construction | Elevator shafts (both current and future) have unprotected openings to adjacent stairwells. | Separate the elevator shaft ways and machine rooms with minimum 2-hr fire-rated construction. Seal and/or protected all openings to maintain the required fire separations. | Within 3 months |

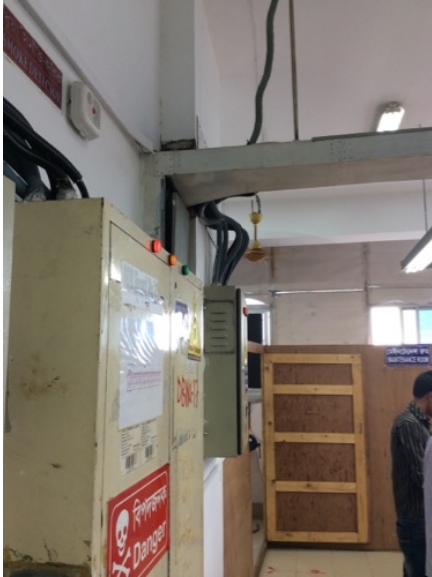
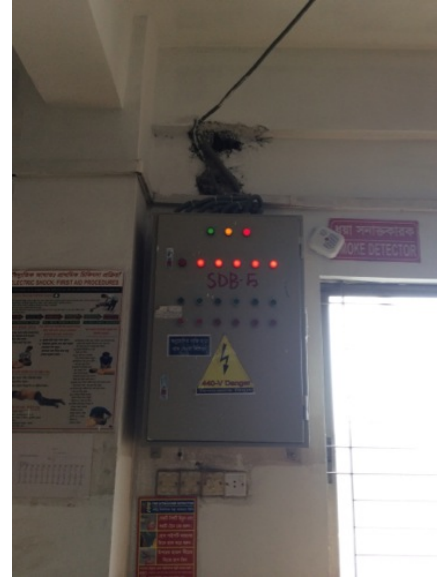
| F-6 | Fire Rated Construction | Utility shafts have unprotected openings to factory floors. | Separate the utility shafts with minimum 2-hr fire-rated construction. Seal and/or protected all openings to maintain the required fire separations. | Within 3 months |

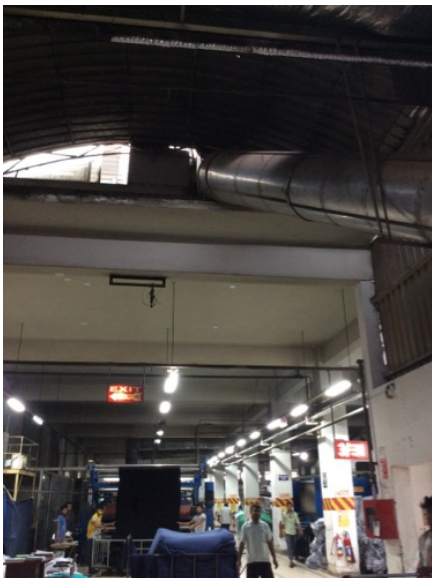
| F-7 | Fire Rated Construction | Unprotected openings are located between Level 1 knitting and Ground floor Dyeing section including a chute for material transfer and vents. | Seal all penetrations and openings in floor/ceiling assemblies to maintain the fire separation. Remove chute. | Within 3 months |

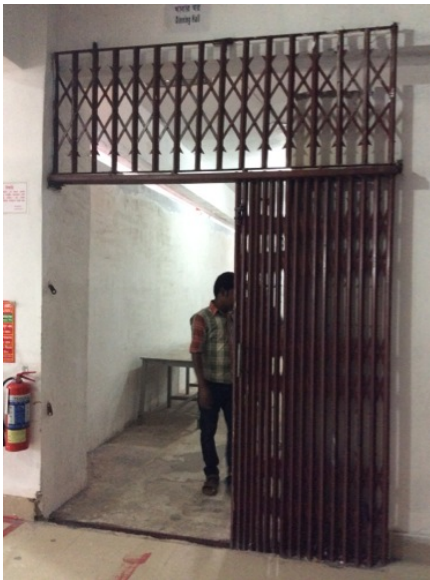
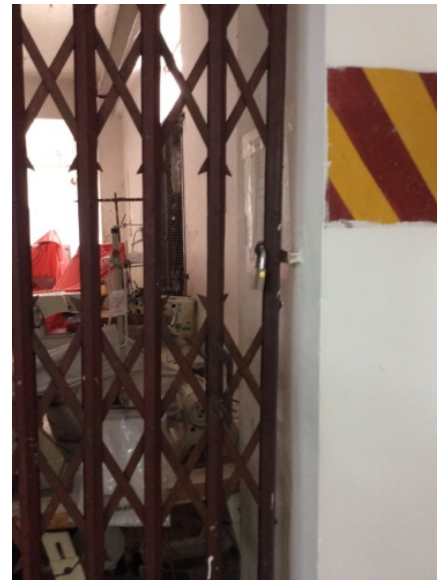
| F-8 | Egress | <p>Egress doors / gates with locking features are provided at building exits, exit stairs, along paths of egress, and means of exit discharge.</p> <p>Most gates/doors within the factory were open and unlocked during the inspection.</p> | <p>Remove locking features from all egress doors / gates that serve the high-rise.</p> <p>If locks are required for security reasons, utilize special door locking features complying with NFPA 101.</p> | Immediate |

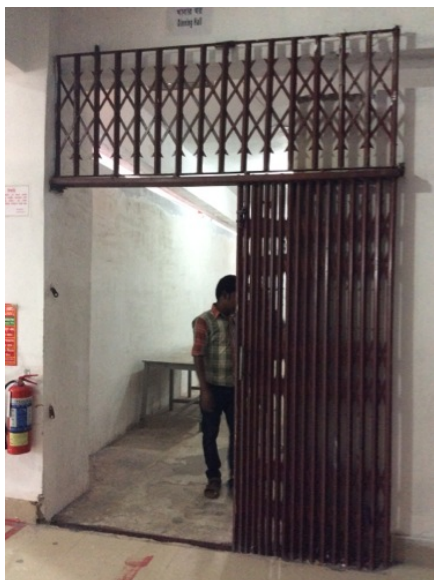
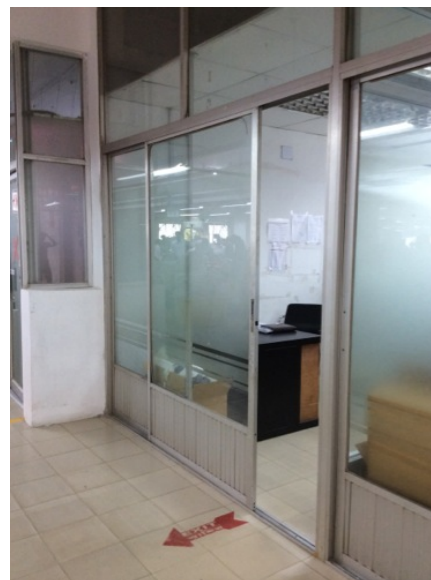
| F-9 | Egress | <p>Collapsible gates / sliding doors are provided at building exits, exit stairs, along egress routes, and means of exit discharge.</p> | <p>Replace all gates / sliding doors along the means of egress with side-hinged, swinging egress doors.</p> <p>If locks are required for security reasons, utilize special door locking features complying with NFPA 101.</p> | Immediate |

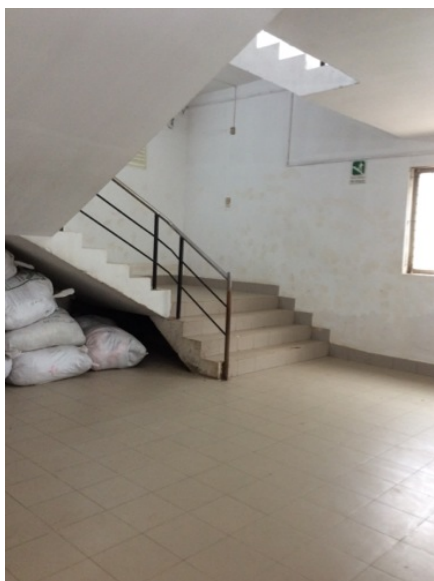
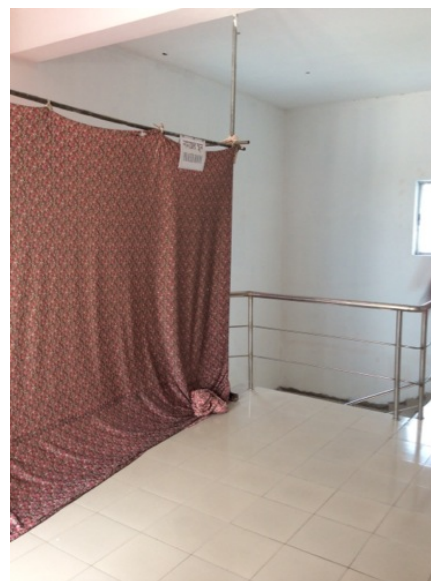
| F-11 | Egress | Storage and assorted combustibles were located in the exit stairs including trash cans, a prayer room, and garment materials. | Remove all storage from exit stairs and egress paths. | Within 3 months |

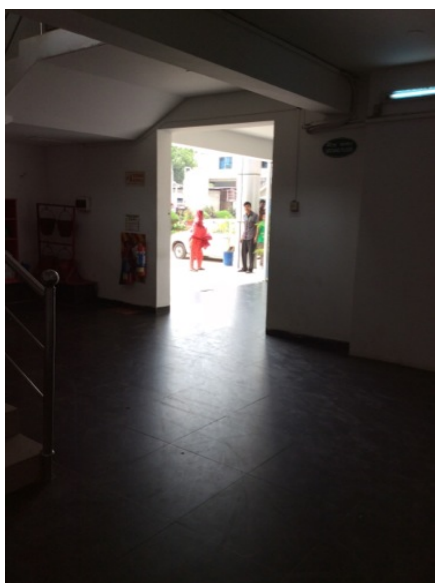
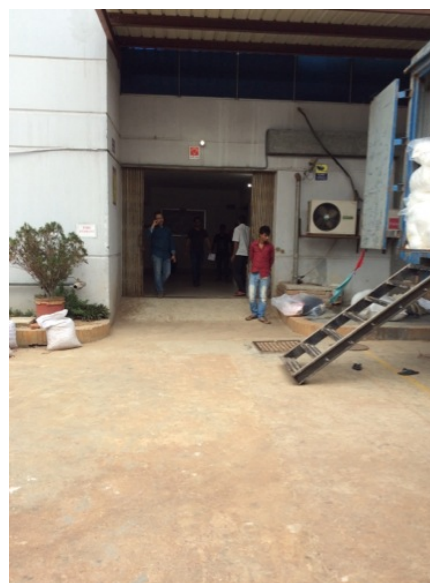
| F-12 | Egress | The northwest and northeast exit stairs discharge through vestibules that also serve as entrances to the Ground Floor area of the building. | Provide 2-hr fire-rated exit passageways from each stairwell leading directly outside. Exit passageway should be separate from Dyeing area entrance. | Within 6 months |

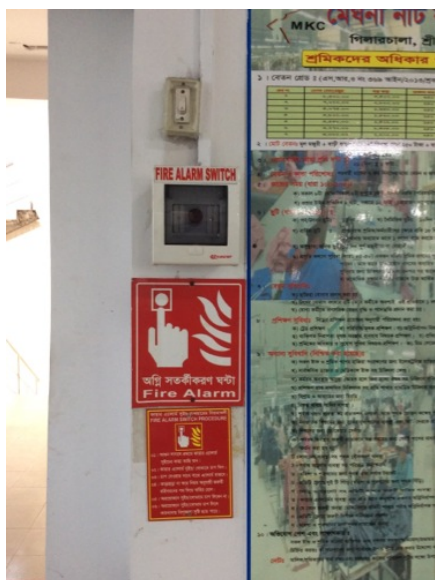
| F-13 | Fire Protection | The fire alarm system is antiquated, not a listed system, and does not provide alarm and notification features consistent with acceptable standards. | Replace the fire alarm system with a new, listed addressable fire alarm system in accordance with NFPA 72. | Design within 4 months, install within 9 months |

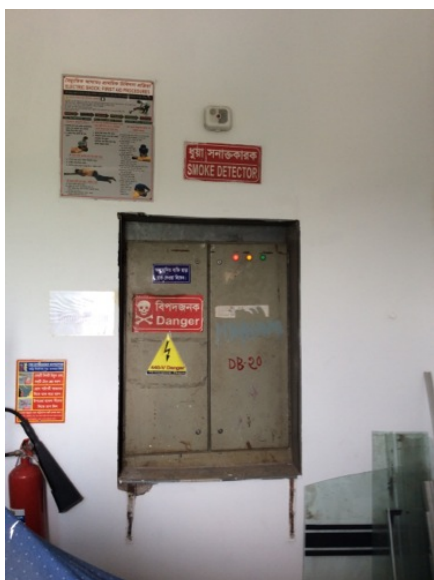
| F-16 | Fire Protection | The building is equipped with single-station smoke alarms. Smoke alarm activation sounds only a local alarm and does not provide automatic fire alarm notification of occupants. | Replace the single-station smoke alarms with automatic smoke detectors tied into the fire alarm system. Configure the fire alarm system to initiate occupant notification upon activation of any two smoke detectors in addition to the manual fire alarm stations. | Within 6 months |
