# **FIRE SAFETY INSPECTION REPORT**

**FGS DENIM WEAR LTD**  
**KATHGORA, ZERABO, ASHULIA, DHAKA**

**ACCORD**  
on Fire and Building Safety in Bangladesh

June 17, 2014

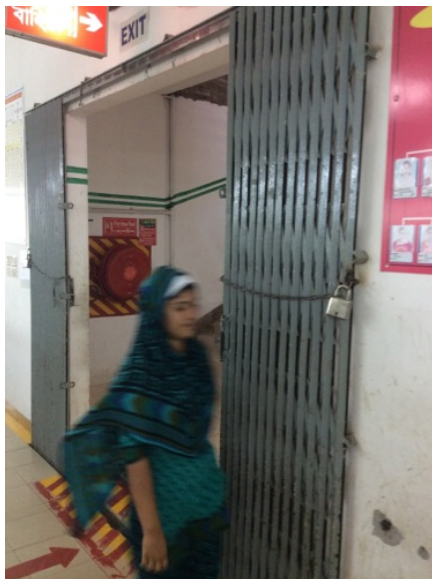
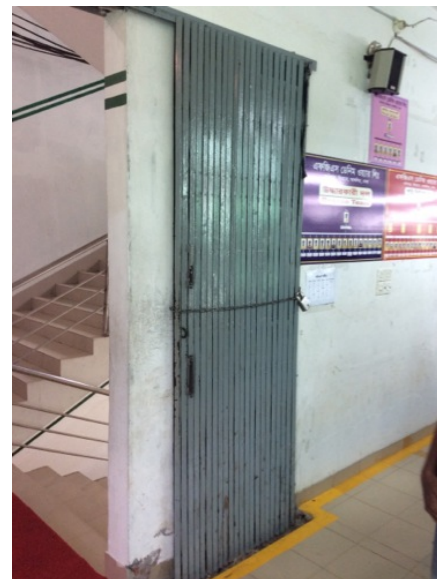
| No. | Category | Finding | Recommendation | Remediation Timeframe |
|---|---|---|---|---|
| F-1 | Fire Rated Construction | The exit stairs are not separated from work areas, on each floor by fire-rated construction. | <p>Provide minimum 1.5-hr fire rated doors and seal all unprotected openings to separate the exit stairs from work areas and other building spaces on all floor levels. Ensure that the fire doors are self-closing and positive latching and that they are provided with fire exit (panic) hardware where serving production floors.</p> <p>If fire doors are required to be held open for functional reasons, provide automatic-closing devices tied to the fire alarm system.</p> | Within 3 months |

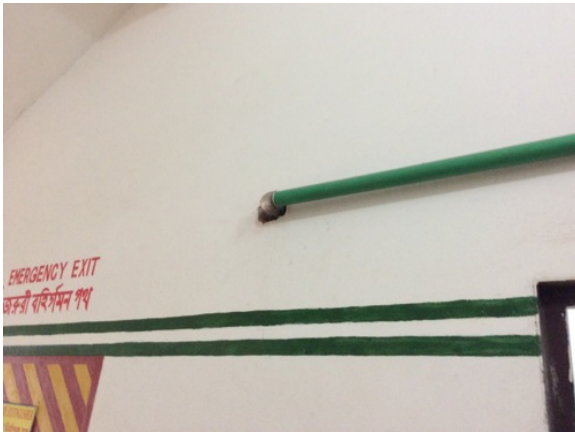
| F-2 | Fire Rated Construction | Unsealed penetrations and openings are located in exit stair enclosures. | Seal all penetrations and openings in exit stair enclosure walls to maintain the fire separation. | Within 3 months |

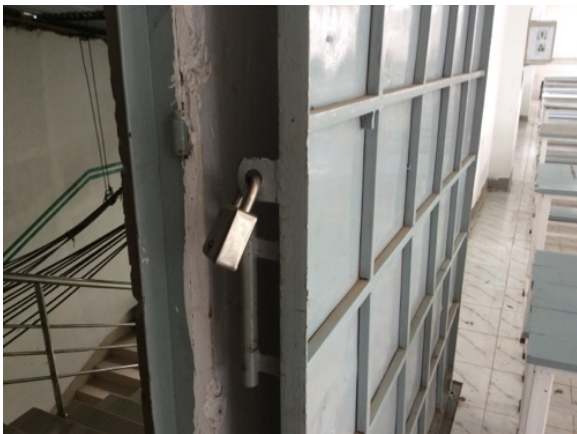
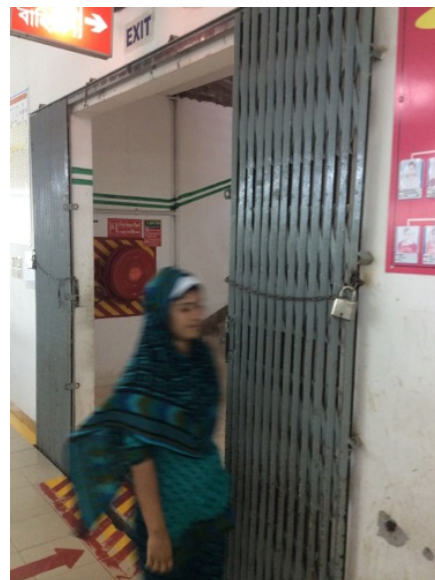
| F-4 | Egress | <p>Egress gates with locking features are provided at most exits.</p> <p>All gates were open and unlocked during the inspection.</p> | <p>Remove locking features from all egress gates.</p> <p>If locks are required for security reasons, utilize special door locking features complying with NFPA 101.</p> | Immediate |

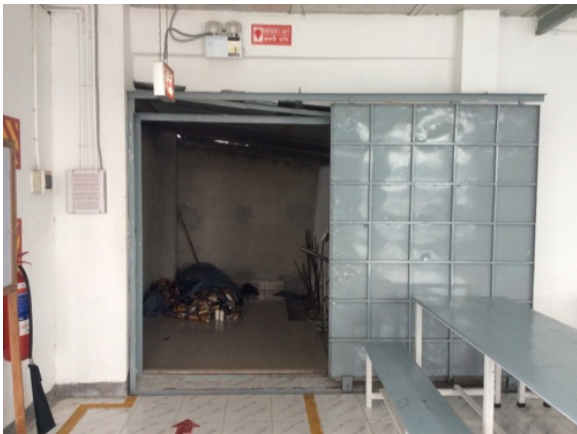
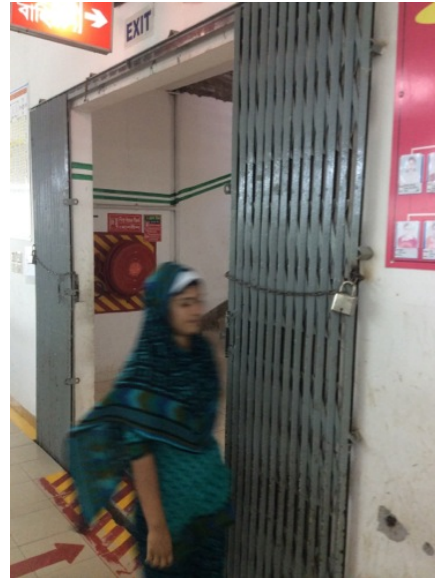
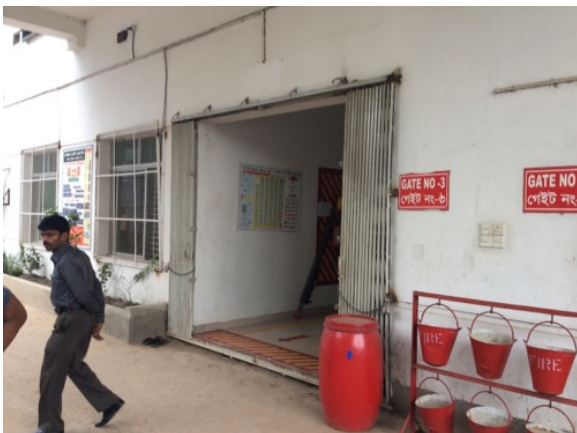
| F-5 | Egress | Collapsible and sliding gates are provided at most building exits, exit stairs, along egress routes and exit discharge. | Replace all collapsible gates along the means of egress with side-hinged, swinging egress doors.<br><br>If locks are required for security reasons, utilize special door locking features complying with NFPA 101. | Within 3 months |

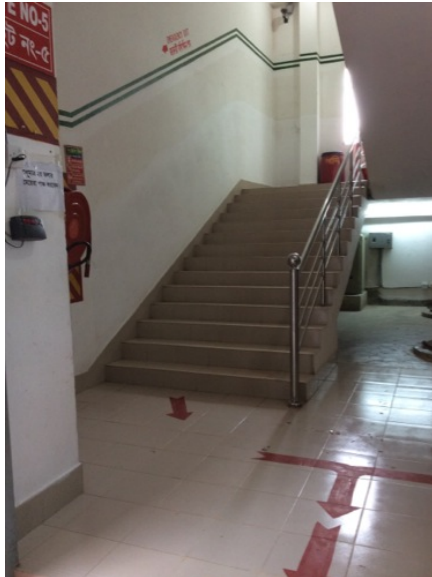
| F-6 | Egress | South exit stair discharge into adjacent building without any separation factory floor. | Modify stair to discharge directly outside. | Within 6 months |

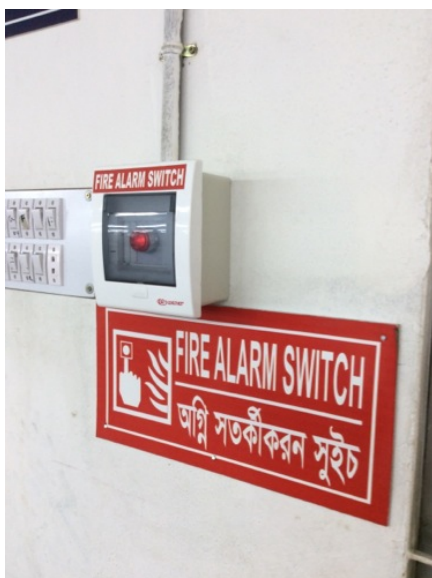
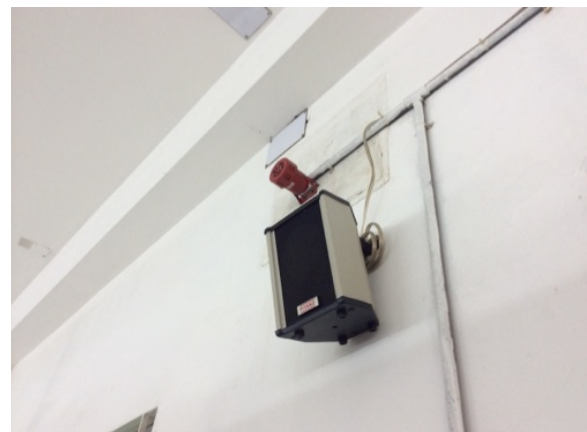
| F-7 | Fire Protection | The fire alarm system is antiquated, not a listed system, and does not provide alarm and notification features consistent with acceptable standards. | Replace the fire alarm system with a new, listed addressable fire alarm system in accordance with NFPA 72. | Design within 4 months, install within 9 months |

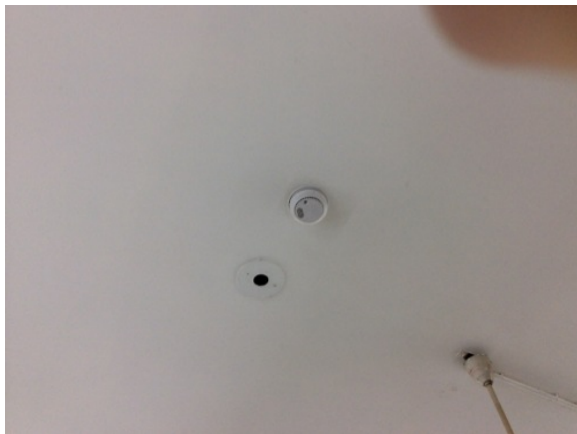
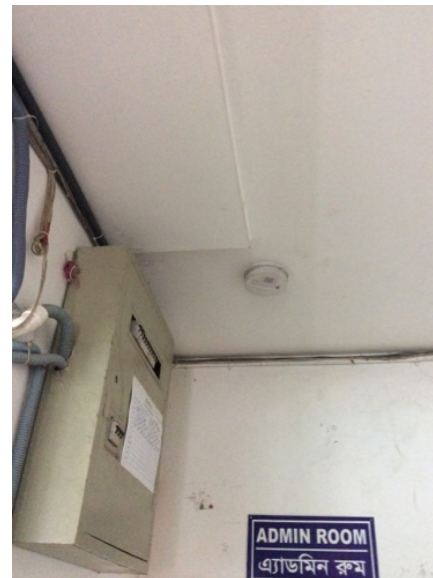
| F-9 | Fire Protection | The building is equipped with single-station smoke alarms. Smoke alarm activation sounds only a local alarm and does not provide automatic fire alarm notification of occupants. | Replace the single-station smoke alarms with automatic smoke detectors tied into the fire alarm system in accordance with NFPA 72. | Within 6 months |

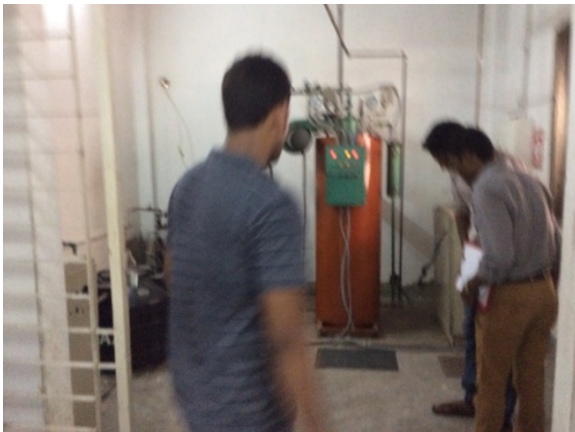
| No. | Category | Finding | Recommendation | Remediation Timeframe |
|---|---|---|---|---|
| F-1 | Fire Rated Construction | The boiler room at the southeast corner of the building is not separated by fire-rated construction due to unprotected openings. | Separate the boiler room by a minimum 2-hr fire-rated construction. Seal and/or protected all openings to maintain the required fire separations. | Within 3 months |

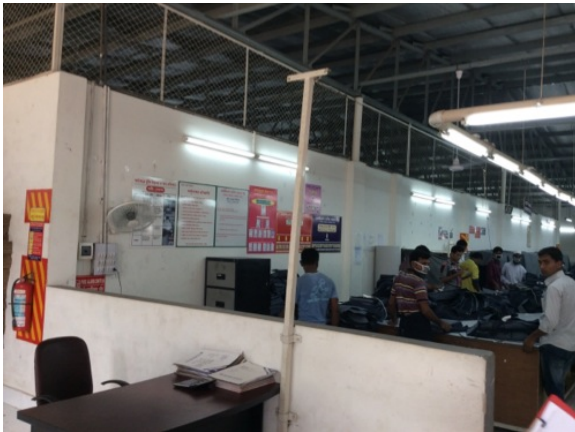
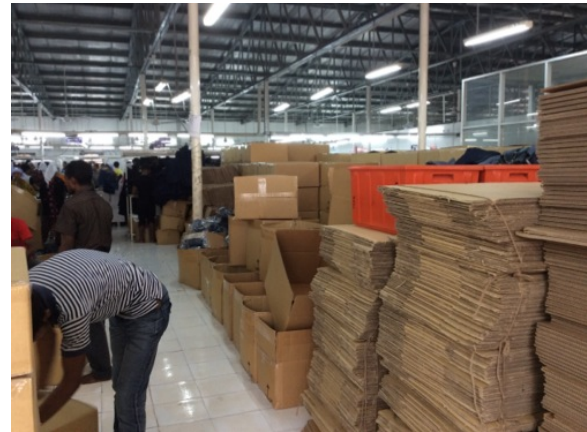
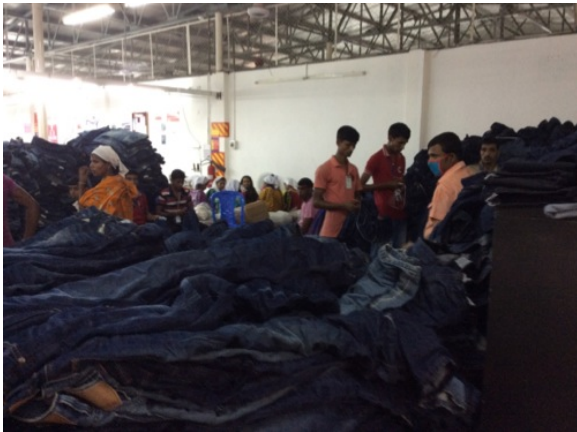
| F-2 | Fire Rated Construction | Areas used for combustible storage throughout the building are not separated by fire-rated construction. | <p>Provide dedicated storage rooms separated by minimum 1-hr fire-rated construction.</p> <p>Where separate storage rooms are not feasible, provide defined storage areas and limit the storage arrangement as follows:</p> <ul style="list-style-type: none"><li>- Maximum height of 2.4m and maximum area of 23m<sup>2</sup></li><li>- If sprinkler protected: maximum height of 3.66m and maximum area of 93m<sup>2</sup></li></ul> <p>Separate areas of unenclosed combustible storage by a minimum clear distance of 3m.</p> | Within 3 months |

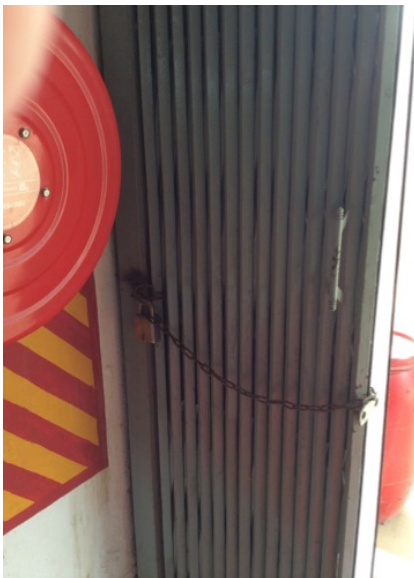
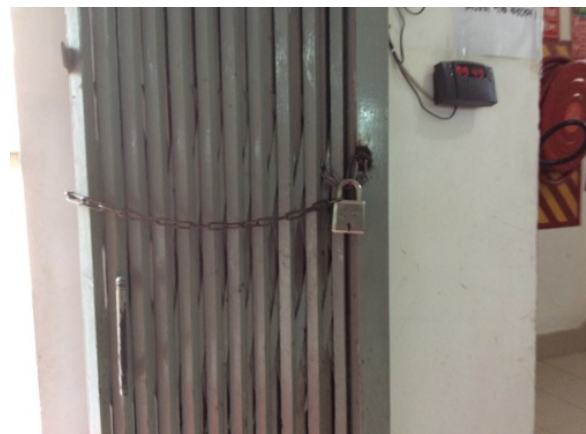
| F-3 | Egress | Egress gates with locking features are provided at most exits.<br><br>All gates were open and unlocked during the inspection. | Remove locking features from all egress gates.<br><br>If locks are required for security reasons, utilize special door locking features complying with NFPA 101. | Immediate |

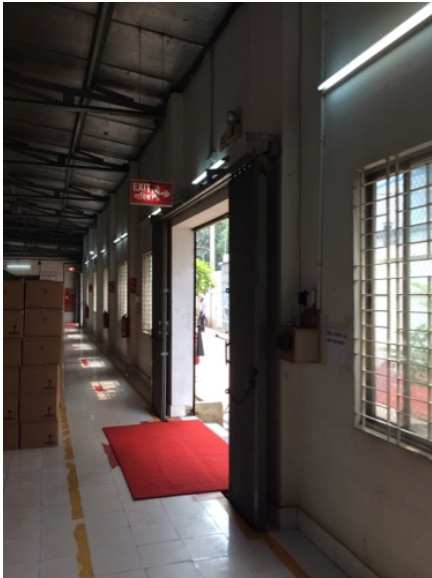
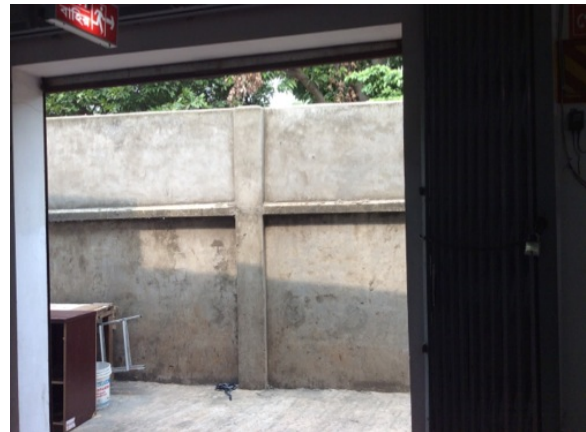
| F-4 | Egress | Collapsible and sliding gates are provided at most building exits. | <p>Replace all collapsible gates along the means of egress with side-hinged, swinging egress doors.</p> <p>If locks are required for security reasons, utilize special door locking features complying with NFPA 101.</p> | Within 3 months |

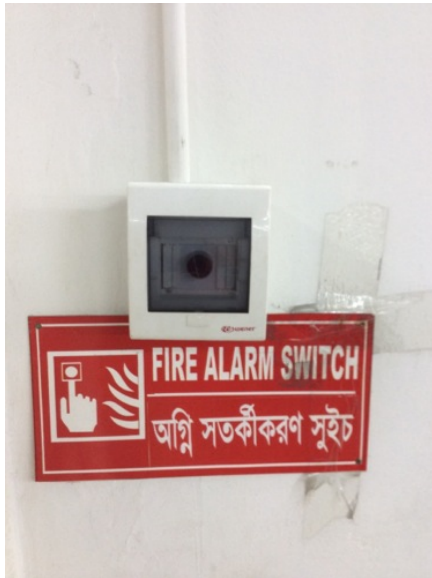
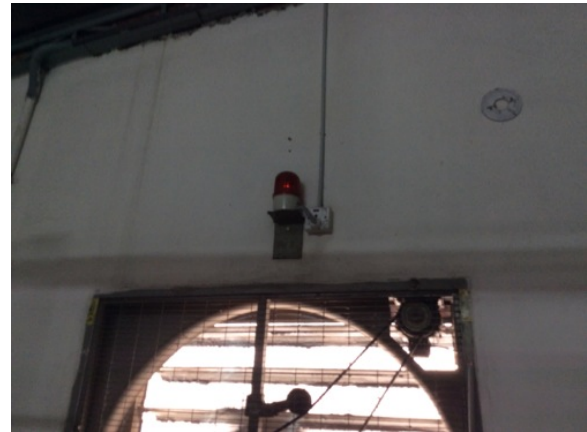
| F-5 | Fire Protection | The fire alarm system is antiquated, not a listed system, and does not provide alarm and notification features consistent with acceptable standards. | Replace the fire alarm system with a new, listed addressable fire alarm system in accordance with NFPA 72. | Design within 4 months, install within 9 months |

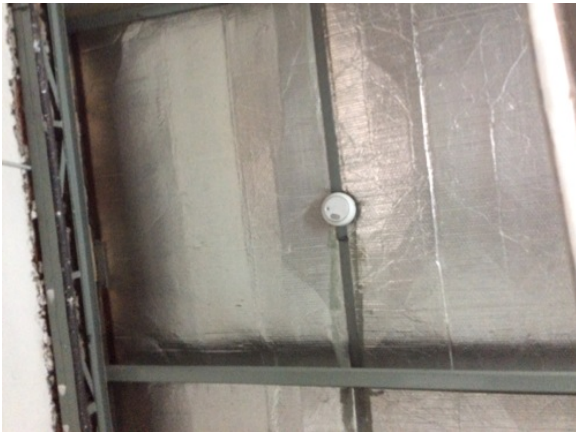
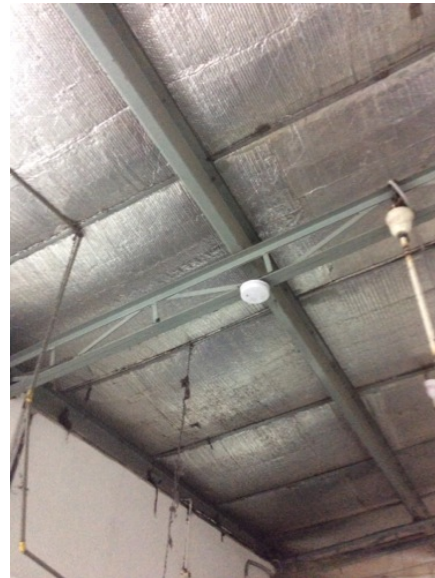
| F-7 | Fire Protection | The building is equipped with single-station smoke alarms. Smoke alarm activation sounds only a local alarm and does not provide automatic fire alarm notification of occupants. | Replace the single-station smoke alarms with automatic smoke detectors tied into the fire alarm system in accordance with NFPA 72. | Within 6 months |
