FIRE SAFETY INSPECTION REPORT

SAVAR SWEATERS LTD.

**GKL SWEATERS COMPLEX, 12P-13P KALURGHAT
HEAVY INDUSTRIAL AREA, CHITTAGONG**

October 31, 2015

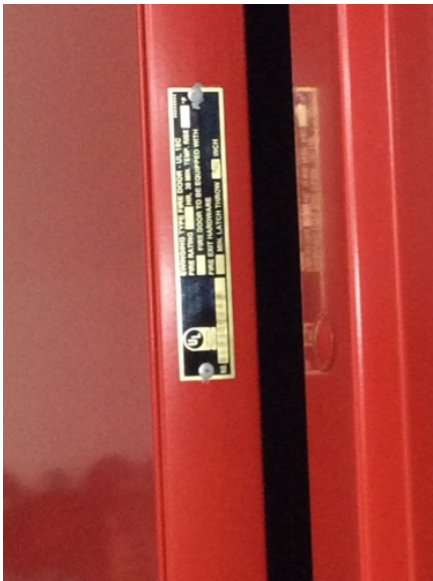
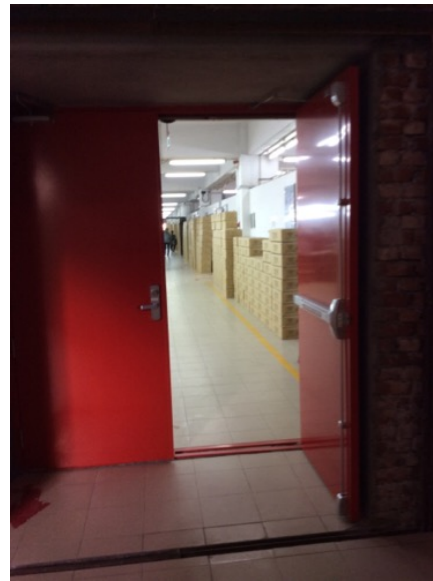
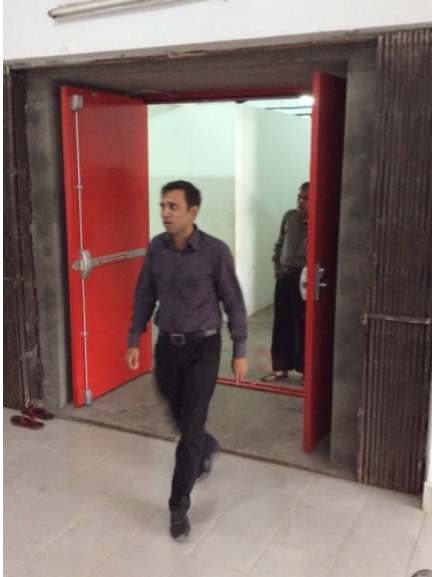
No.	Category	Finding	Recommendation	Remediation Timeframe
F-1	Fire Rated Construction	Proper certification was not available for fire rated doors installed in the factory in the stair-06 & 03 on 1st floor.	Submit proper certifications for installed fire doors to the ACCORD for approval. If not available, or certification is not approved, install new, properly certified fire rated doors in accordance with ACCORD direction.	Immediately

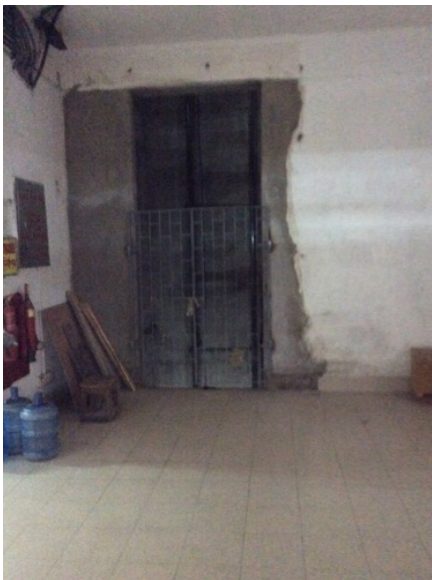
F-2	Fire Rated Construction	The elevator does not have the proper fire rating for the shaft and elevator door.	Provide the proper 2 hr fire rating for the shaft and 1.5 hr fire rating for the elevator door.	Within 3 months
-----	-------------------------	--	---	-----------------

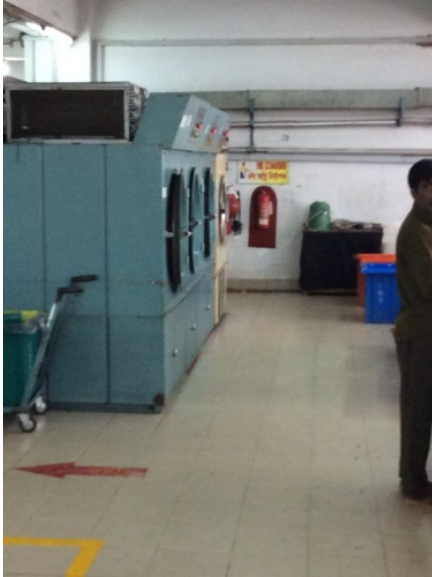
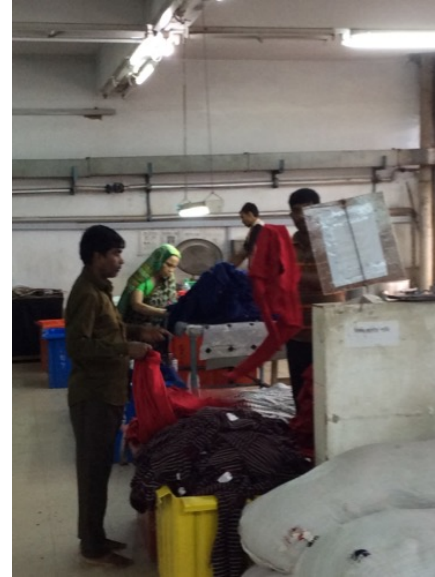
F-3	Fire Rated Construction	The industrial dryers are not separated by fire-rated construction due to openings, non-rated doors, and penetrations on 1st floor.	Separate the industrial dryer area by a minimum 2-hr fire-rated construction. Seal and protect all openings to maintain the required fire separations. Provide proper ventilation and consult with a qualified engineer.	Within 3 months
-----	-------------------------	---	--	-----------------

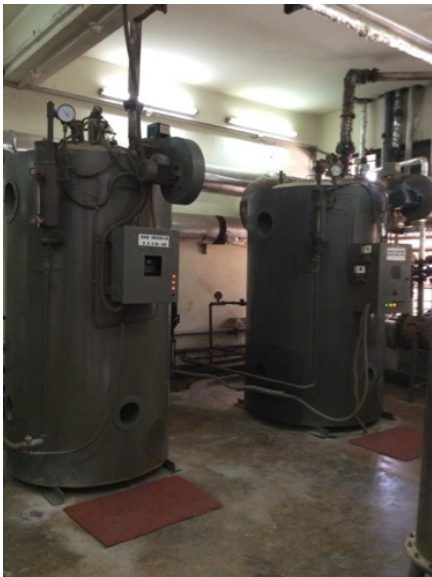
F-4	Fire Rated Construction	The boiler room is not separated by fire-rated construction due to openings, non-rated doors, and penetrations on ground floor.	Separate the boiler room by a minimum 2-hr fire rated construction for high rise. Seal and protect all openings to maintain the required fire separations. Provide proper ventilation and consult a qualified engineer.	Within 3 months
-----	-------------------------	---	---	-----------------

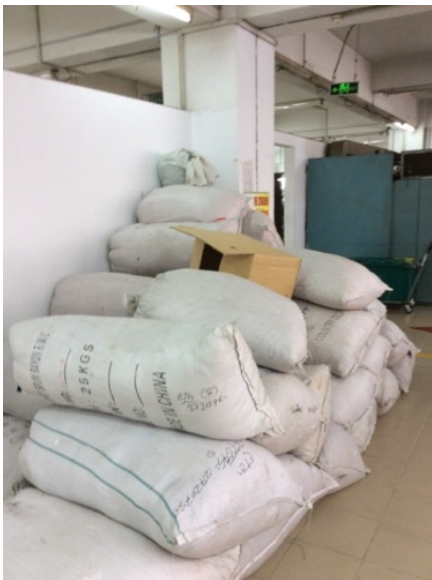
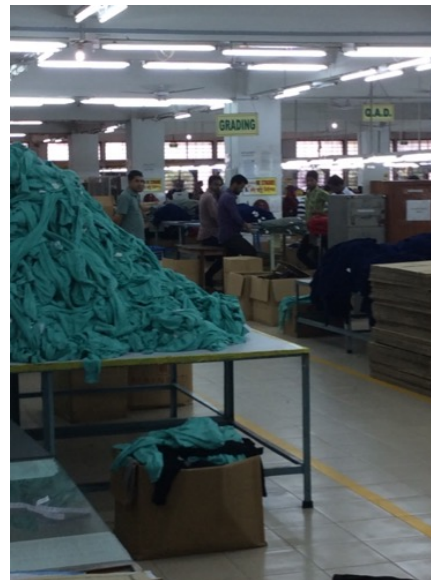
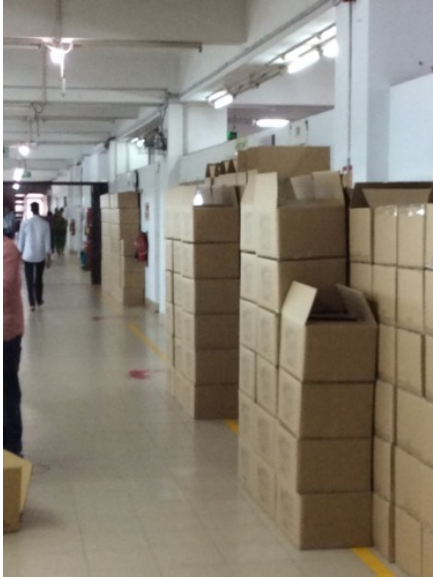
F-5	Fire Rated Construction	Areas used for combustible storage open to the factory are not properly defined and not within limits on 2nd floor.	Provide defined storage areas and limit the storage arrangement as follows: <ul style="list-style-type: none">- Maximum height of 2.45m (8 ft) and maximum area of 23m² (250 ft²) OR <ul style="list-style-type: none">- If sprinkler protected: maximum height of 3.66m (12 ft) and maximum area of 93m² (1000 ft²) AND Separate areas of unenclosed combustible storage by a minimum clear distance of 3m (10 ft).	Within 3 months
-----	-------------------------	---	---	-----------------

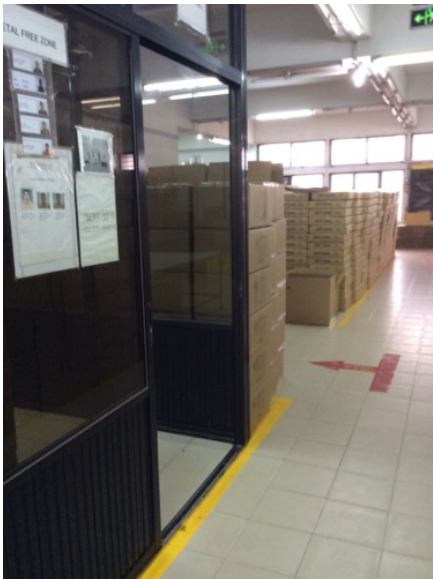
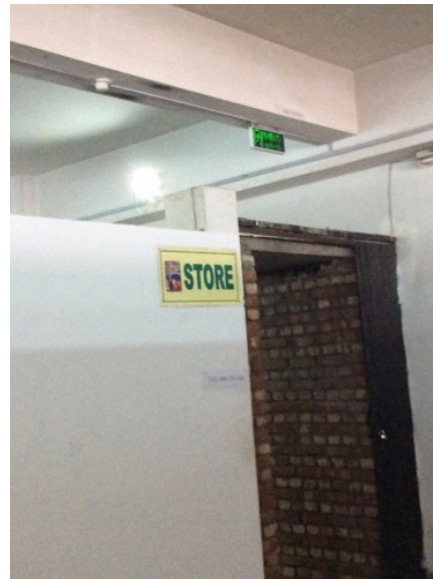
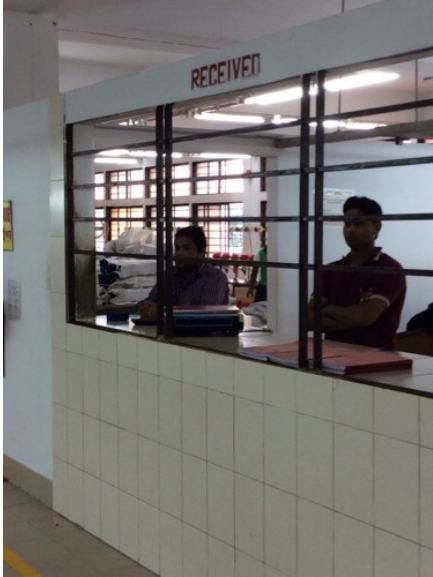
F-6	Fire Rated Construction	Rooms used for combustible storage are not separated by a minimum 1-hr fire-rated construction in store on 2nd, 3rd, and 5th floors.	<p>Provide dedicated storage rooms separated by minimum 1-hr fire-rated construction.</p> <p>Where separate storage rooms are not feasible, provide defined storage areas and limit the storage arrangement as follows:</p> <ul style="list-style-type: none">- Maximum height of 2.45m (8 ft) and maximum area of 23m² (250 ft²) <p>OR</p> <ul style="list-style-type: none">- If sprinkler protected: maximum height of 3.66m (12 ft) and maximum area of 93m² (1000 ft²) <p>AND</p> <p>Separate areas of unenclosed combustible storage by a minimum clear distance of 3m (10ft).</p>	Within 3 months
-----	-------------------------	--	--	-----------------

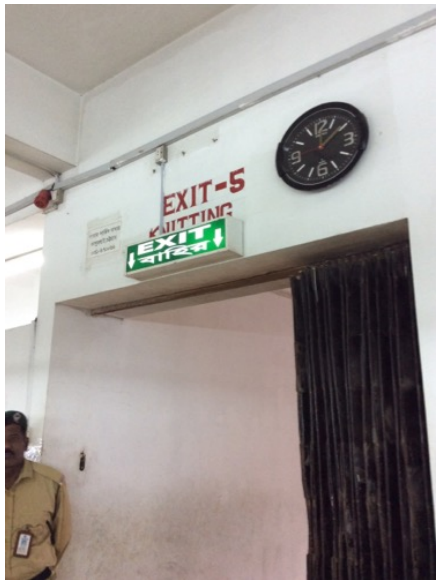
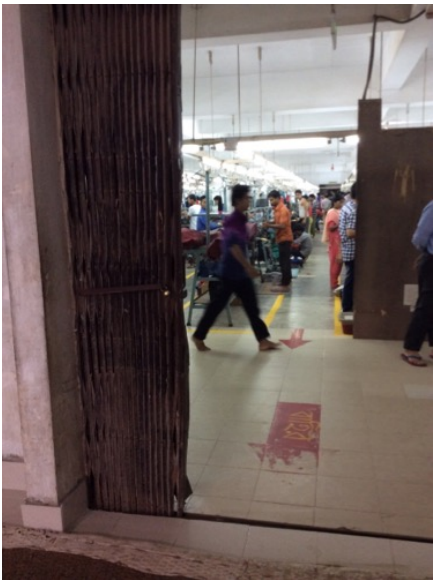
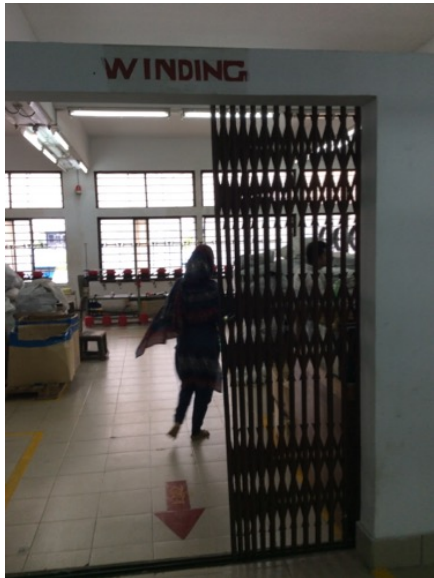
F-7	Fire Rated Construction	Exit stairs are not separated from work areas and other spaces on each floor by fire-rated construction due to unprotected openings and penetrations in stair -03, 04 & 05 on 2nd, 3rd and 5th floors.	Separate the exit stairs from from work areas and other building spaces on all floor levels by minimum 2-hr fire-rated construction. Provide minimum 1.5-hr fire rated doors and seal all unprotected openings and penetrations to maintain the fire separation.	Within 3 months
-----	-------------------------	--	--	-----------------

Ensure that all fire doors are self-closing and positive latching, and are provided with fire exit (panic) hardware where serving production floors or assembly occupancies. If fire doors are required to be held open for functional reasons, provide automatic-closing devices tied to the fire alarm system. Once fire doors are installed, every door in a stair enclosure serving more than 5 stories shall be provided with re-entry unless it meets ACCORD standard 6.8.3.1.

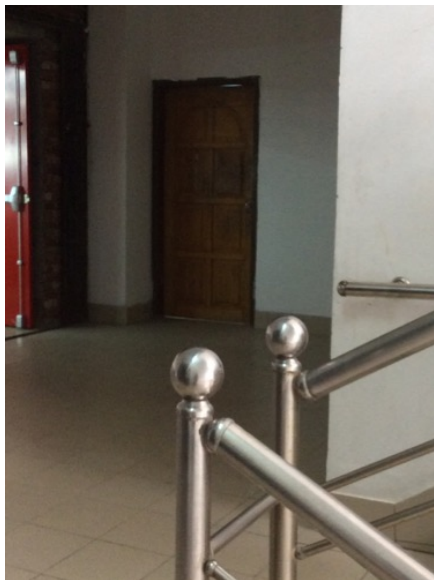
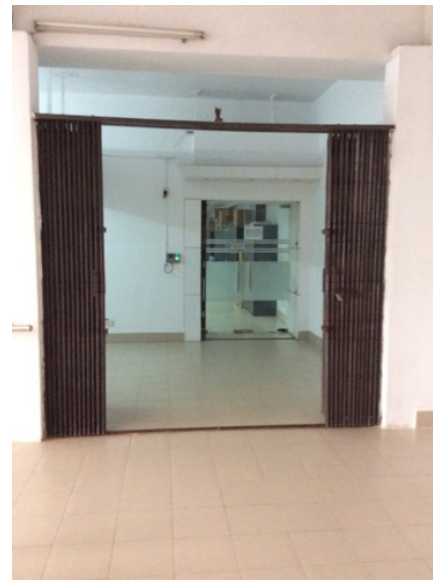
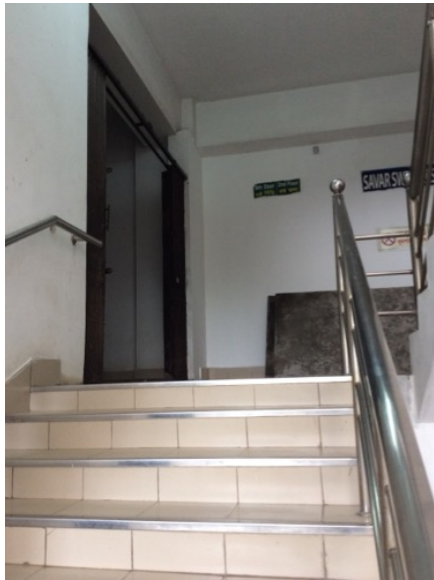
F-8	Fire Rated Construction	Office rooms discharges directly into exit stair enclosure.	Provide a 1.5 hr fire rated door.	Within 3 months
-----	-------------------------	---	-----------------------------------	-----------------

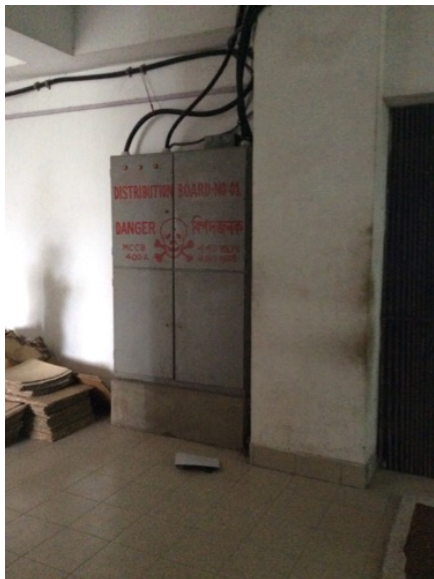
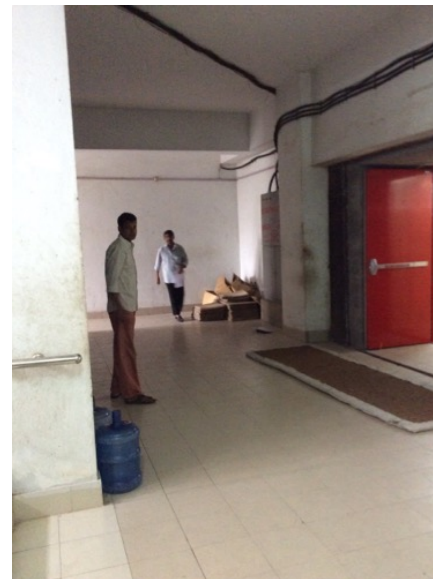
F-9	Fire Rated Construction	Electrical panels were located in the exit stair enclosure.	Remove and re-locate all electrical panels from exit stair enclosures.	Within 3 months
-----	-------------------------	---	--	-----------------

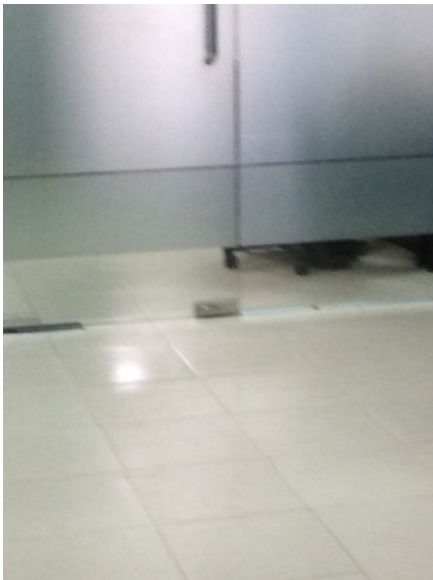
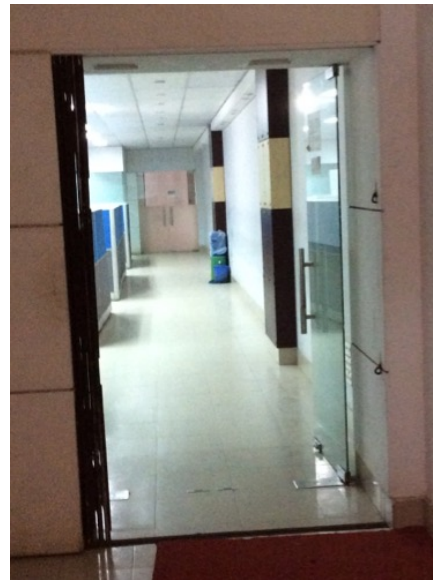
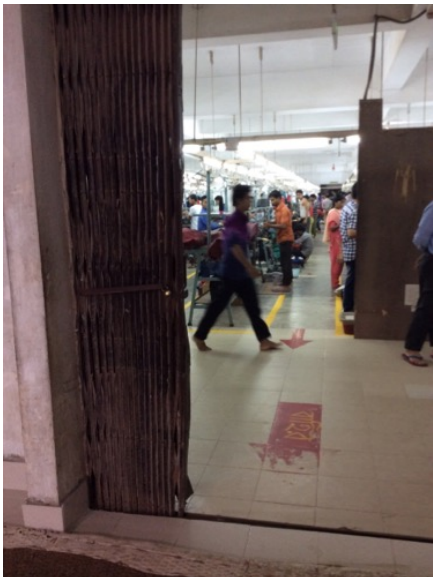
F-10	Egress	Egress doors and gates with locking features are provided at building exits, exit stairs, along egress routes and exit discharge on 2nd, 3rd and 5th floors. All doors and gates were open and unlocked during inspection.	Remove locking features from all egress doors and gates. If locks are required for security reasons, utilize special door locking features complying with ACCORD standard 6.8.2.	Immediately
------	--------	--	---	-------------

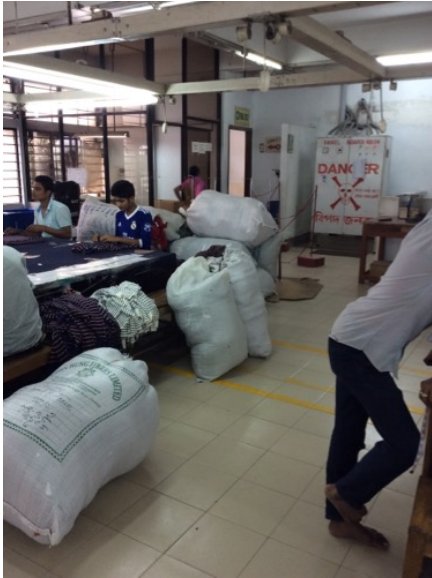
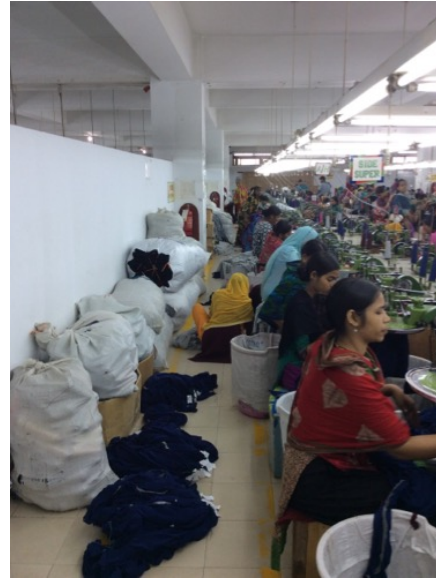
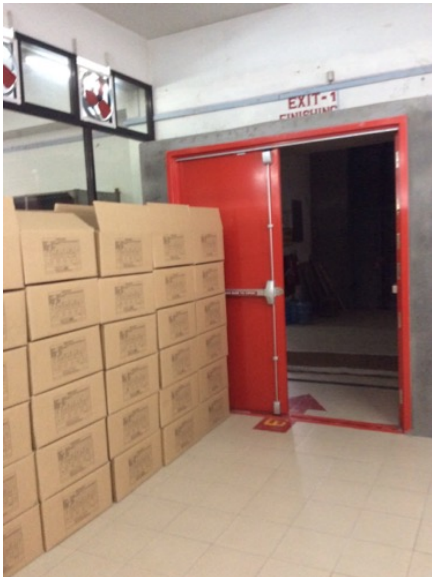
F-11	Egress	Storage was located in the egress path on 2nd and 5th floors.	Keep egress paths and stairs clear of storage.	Immediately
------	--------	---	--	-------------

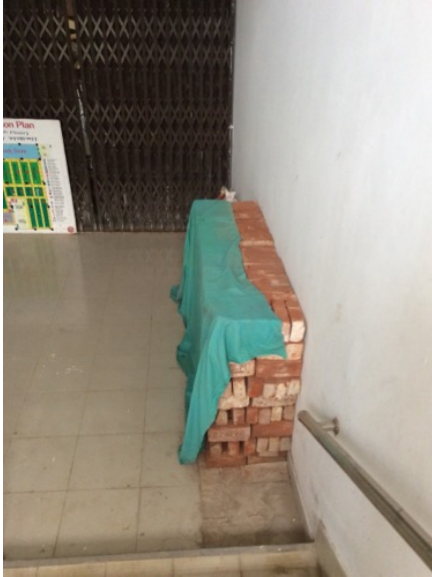
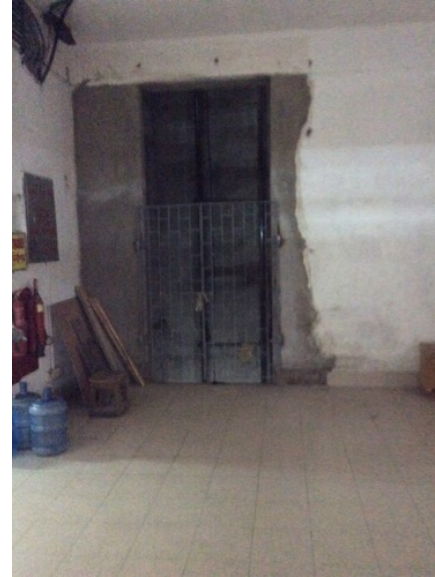
F-12	Egress	Storage was located in the exit stair on 2nd, 3rd and 5th floors	Remove all storage from exit stairs.	Immediately
------	--------	--	--------------------------------------	-------------

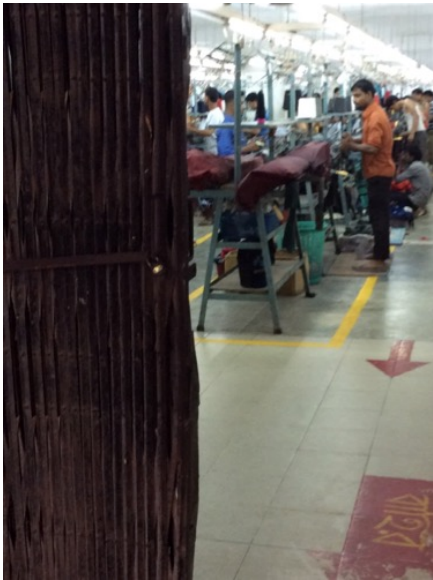
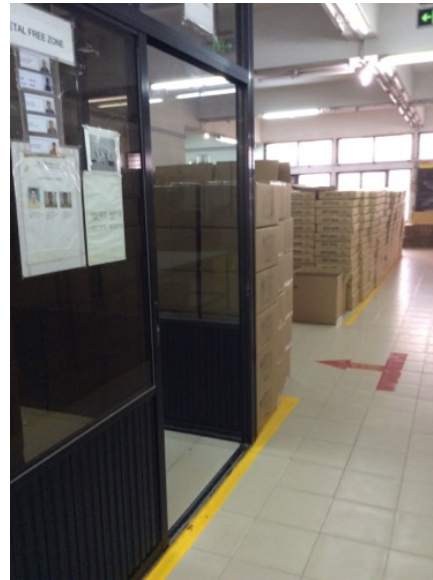
F-13	Egress	Exit capacity is not adequate for the occupant load. on 3rd floor. exit capacity is 1,050 while maximum occupant load is 1,105.	Reduce occupant load immediately to not more than available exit capacity (1,050). AND Provide additional exits in the future to increase exit capacity.	Immediately
F-14	Egress	Collapsible gates and sliding doors are provided at building exits, exit stairs, along egress routes, and exit discharge on 2nd, 3rd and 5th floors.	Replace all gates and sliding doors along the means of egress with side-hinged, swinging egress doors in accordance with ACCORD standard 6.8.1.	Within 1 month

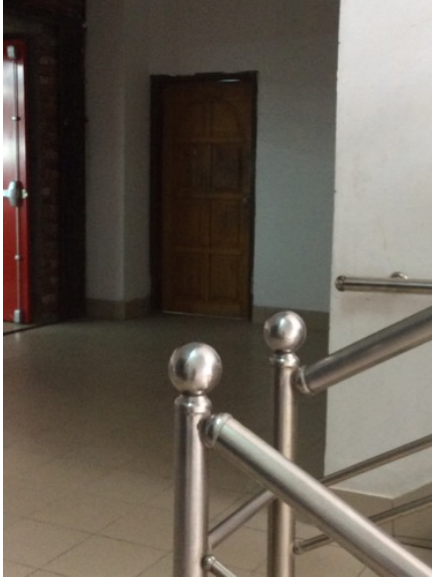
F-15	Egress	Exit stairs serve more than 5 stories and do not have required re-entry provisions on all floors.	Every door in a stair enclosure serving more than 5 stories shall be provided with re-entry unless it meets ACCORD standard 6.8.3.1.	Within 3 months
F-16	Egress	Egress door does not swing in the direction of egress travel in stair 06 on 2nd, 3rd and 5th floors.	Modify the egress door to swing in the direction of egress travel.	Within 3 months

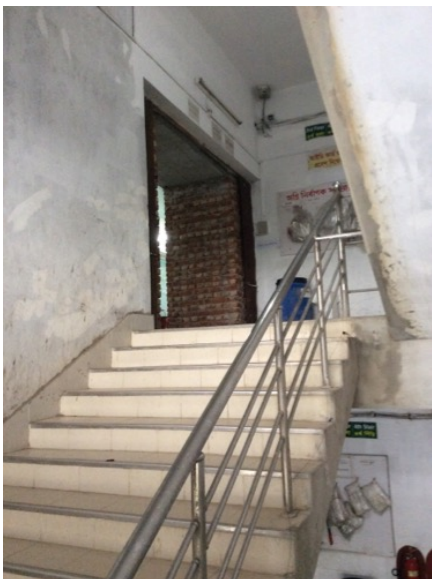
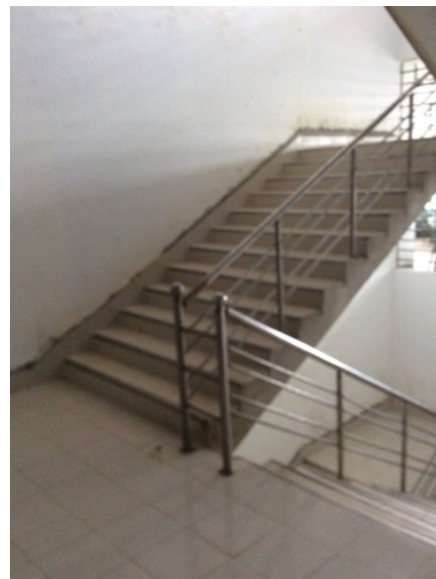
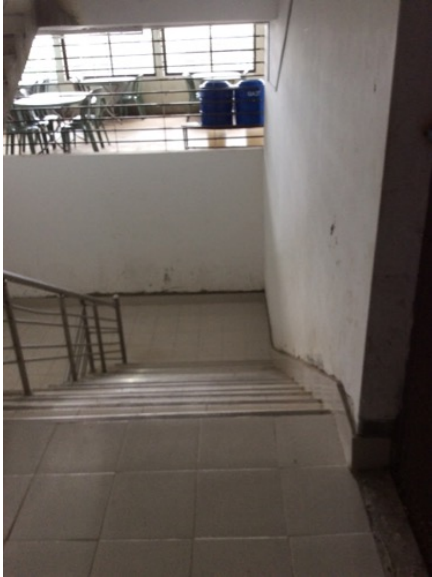
F-17 Egress

Handrails are not provided on both sides of the exit stair 05, 03 & 04 on 2nd, 3rd and 5th floors.

Provide handrails on both sides of the exit stair. New handrails shall have a minimum height of 865 mm (34 in.) and a maximum height of 965 mm (38 in.) as measured from the leading edge of the tread. Intermediate handrails shall be provided when the stair width exceeds 2.2 m (87 in.) .

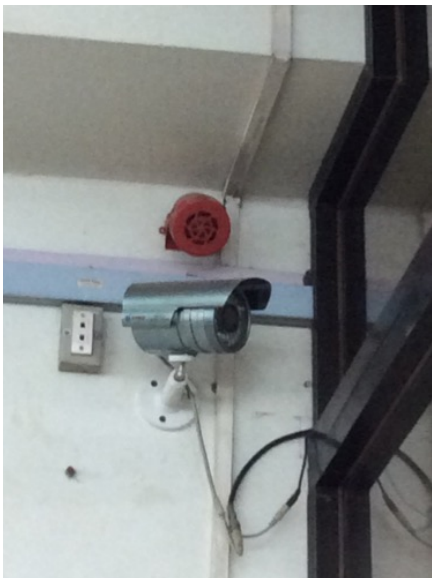
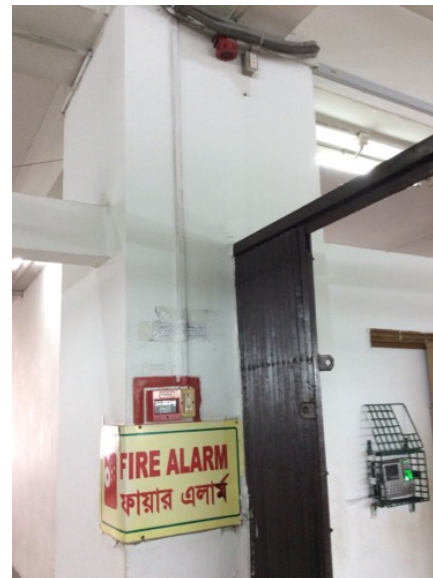
F-18	Fire Protection	The fire alarm system is antiquated, not a listed system and does not provide alarm and notification features consistent with acceptable standards.	Replace the fire alarm system with a new, listed automatic fire alarm system in accordance with NFPA 72 and ACCORD standards.	Design within 4 months, install within 9 months
------	-----------------	---	---	---

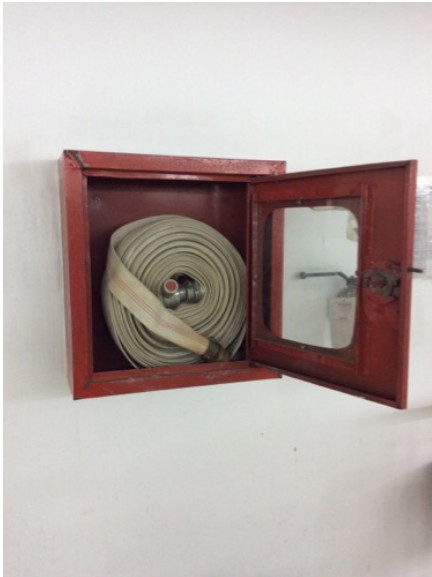
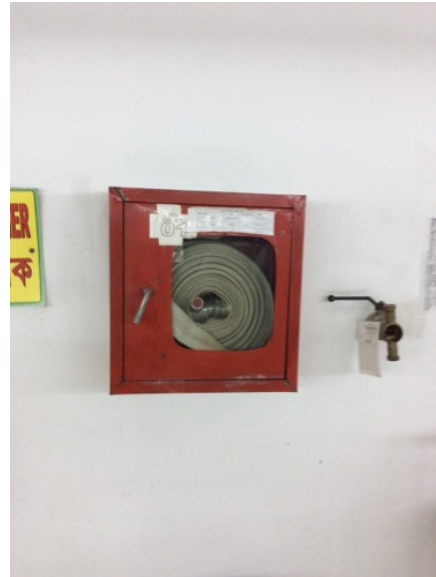
F-24	Fire Protection	Fire pump is not provided and appears to be needed for the standpipe system fire demand.	Provide a fire pump in accordance with NFPA 20 and ACCORD standards, or provide an alternative water supply source capable of meeting the required fire protection demand, subject to ACCORD approval.	Within 6 months
F-25	Fire Protection	Standpipe system is required for the building, which has an occupiable floor 10 m (33 ft) or more above grade.	Install a new class III standpipe system in accordance with ACCORD standard 5.4 and NFPA 14. A class I system shall be permitted in buildings protected throughout by an approved automatic sprinkler system.	Within 6 months

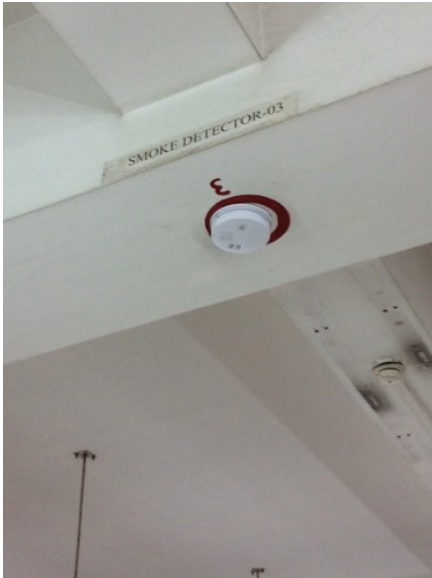
F-27	Fire Protection	The building is equipped with single-station smoke alarms. Smoke alarm activation sounds only a local alarm and does not provide automatic fire alarm notification of occupants.	Remove single-station smoke alarms. Provide automatic smoke detection throughout the building, tied into the fire alarm system, in accordance with NFPA 72 and ACCORD standards.	Within 9 months
------	-----------------	--	--	-----------------

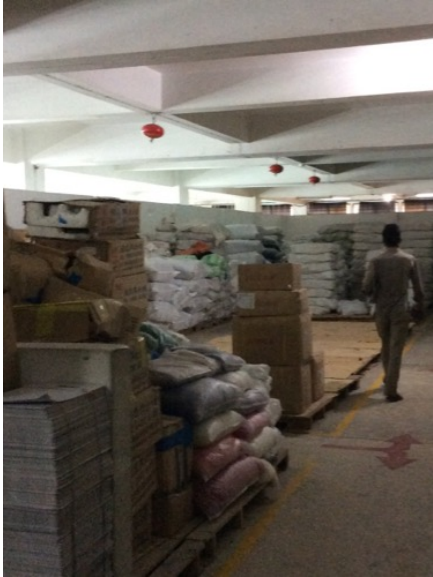
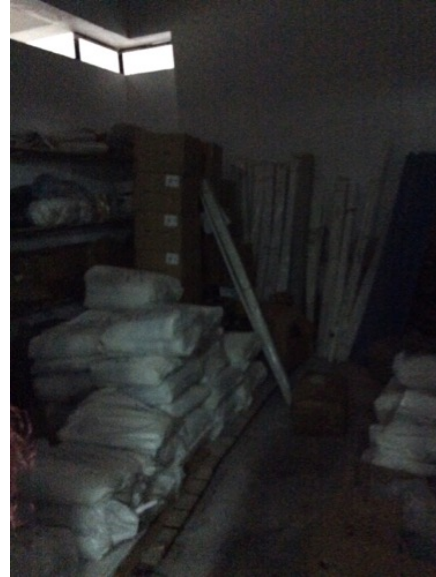
F-29	Egress Lighting	Inspection, testing and maintenance for the emergency lighting system was not in accordance with ACCORD standards.	Inspect, test and maintain the emergency lighting system in the accordance with ACCORD standards. Keep written records on-site.	Within 3 months
F-30	Egress Lighting	Based on the number and location of emergency lights observed, adequate illumination levels are not anticipated along egress routes on 1st floor.	Test the emergency lighting system on each floor and provide additional emergency fixtures to supply adequate illumination along the means of egress. Provide a minimum illumination of 10 lux at the floor level within exit stairs and along exit discharge paths and a minimum 2.5 lux along exit access aisles.	Within 3 months
