# **FIRE SAFETY INSPECTION REPORT**

**IRENE KNITWEAR LTD.**  
**PAITY ROAD, DERMA, 1362, BANGLADESH**

March 3, 2014

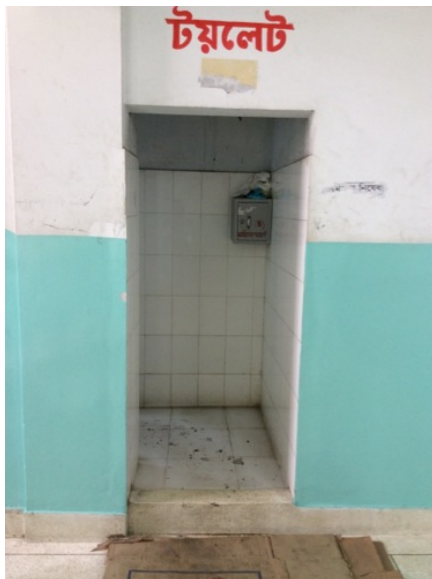
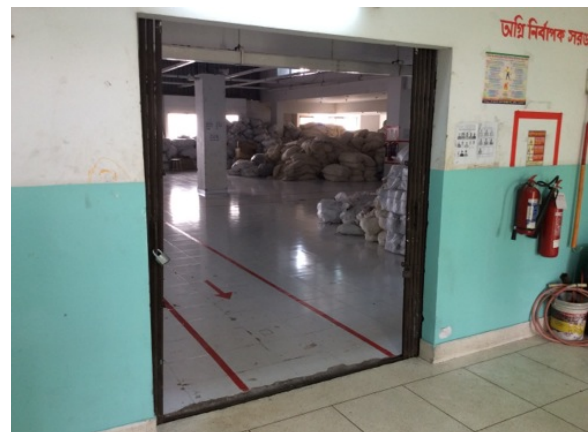
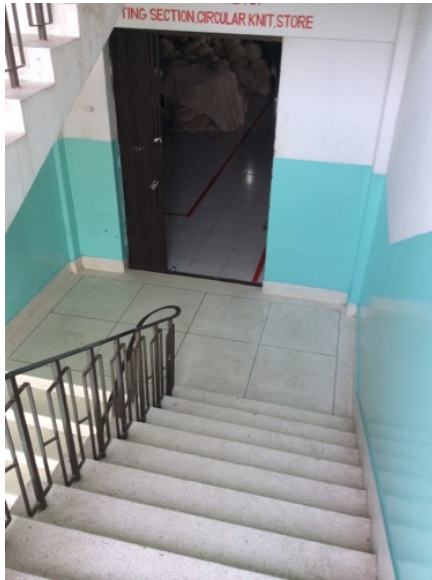
| No. | Category | Finding | Recommendation | Remediation Timeframe |
|---|---|---|---|---|
| F-1 | Fire Rated Construction | The exit stairs are not separated from work areas and other spaces on each floor by fire-rated construction. | <p>Provide minimum 1.5-hr fire rated doors and seal all unprotected openings to separate the exit stairs from work areas and other building spaces on all floor levels. Ensure that the fire doors are self-closing and positive latching and that they are provided with fire exit (panic) hardware where serving production floors.</p> <p>If fire doors are required to be held open for functional reasons, provide automatic-closing devices tied to the fire alarm system.</p> | Within 3 months |

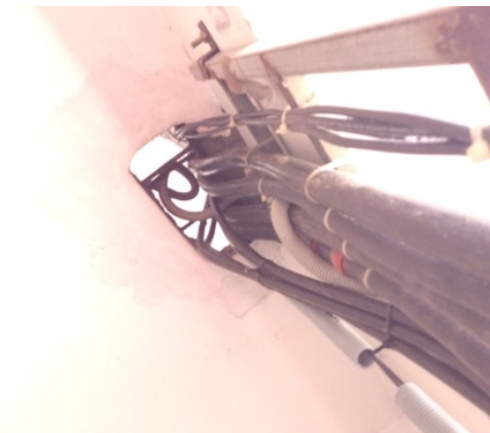
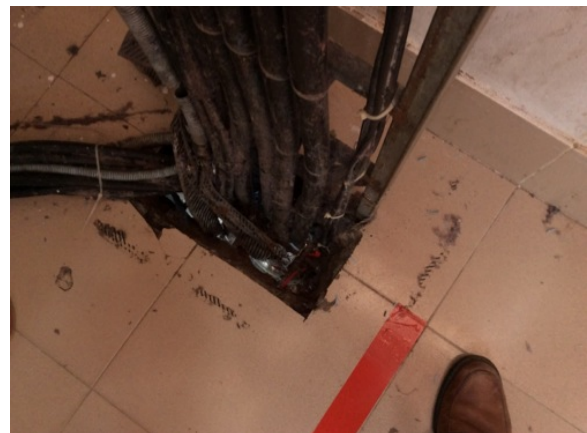
| F-2 | Fire Rated Construction | Unsealed electrical penetrations and openings are located in the fire-rated floor/ceiling assemblies from the fourth floor to the sixth floor next to the west stairwell. | Provide a minimum 2-hr fire-rated shaft to separate the utility risers from each floor level.<br><br>Seal all penetrations and openings in floor/ceiling assemblies to maintain the fire separation. | Within 3 months |

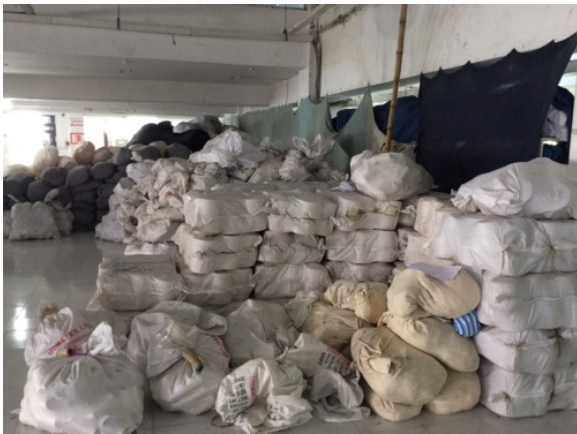
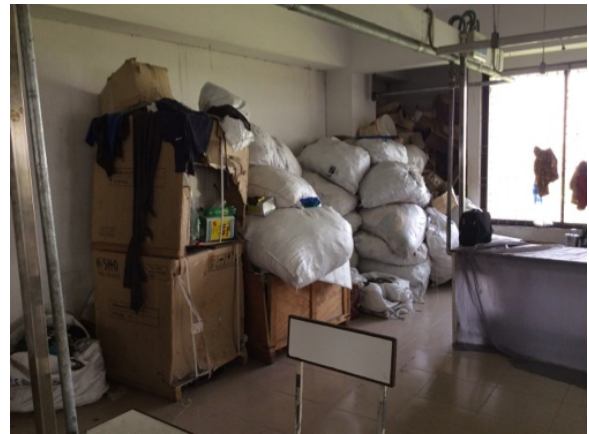
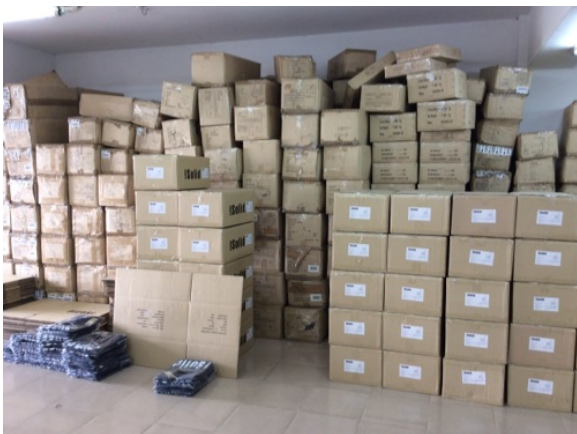
| F-3 | Fire Rated Construction | Areas used for combustible storage on factory floors are not separated by fire-rated construction. | <p>Provide defined storage areas and limit the storage arrangement as follows:</p> <ul style="list-style-type: none"><li>- Maximum height of 2.4m and maximum area of 23m<sup>2</sup></li><li>- If sprinkler protected: maximum height of 3.66m and maximum area of 93m<sup>2</sup></li></ul> <p>Separate areas of unenclosed combustible storage by a minimum clear distance of 3m.</p> | Within 3 months |

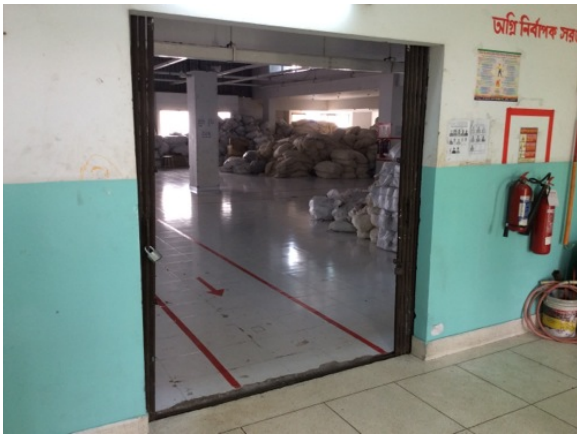
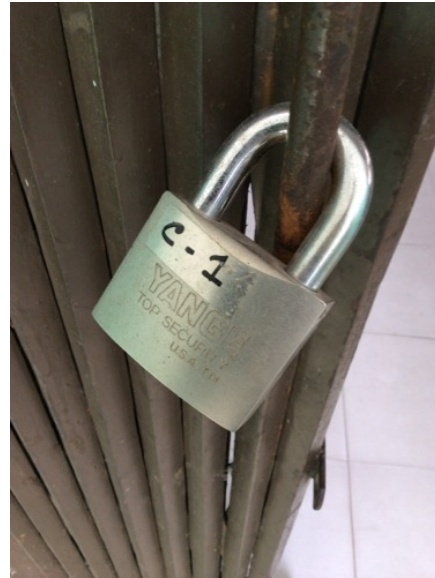
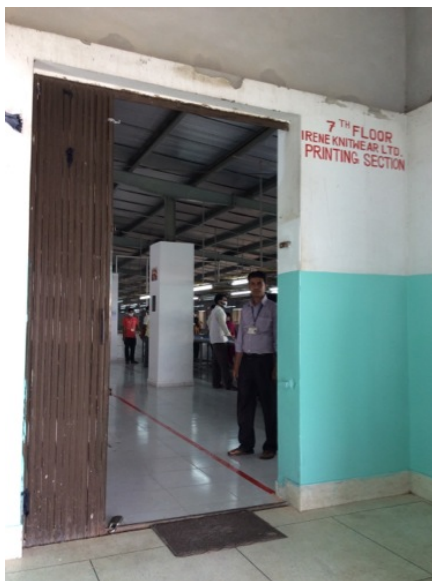
| F-4 | Egress | Egress doors/gates with locking features are provided at building exits, exit stairs, along egress routes, and at exit discharge. All gates/doors were open and unlocked during the inspection. | Remove locking features from all egress doors / gates.<br><br>If locks are required for security reasons, utilize special door locking features complying with NFPA 101. | Immediate |

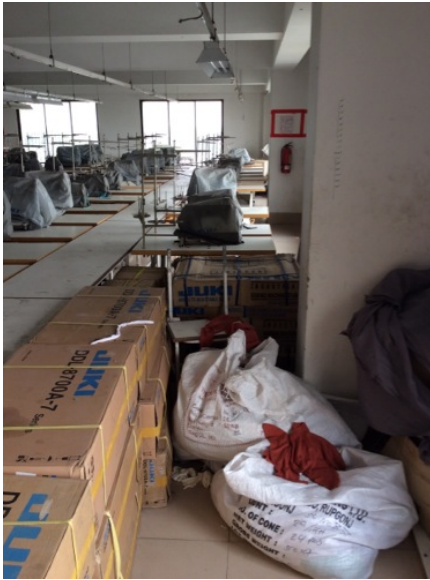
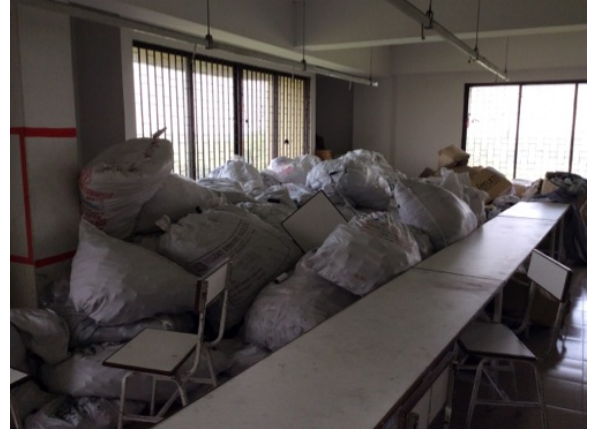
| F-5 | Egress | Storage was located in the egress path on the fifth floor in the northeast and southeast corners. Reportedly this area is currently not being used. | Regardless of vacancy, keep egress paths and stairs clear of storage. | Immediate |

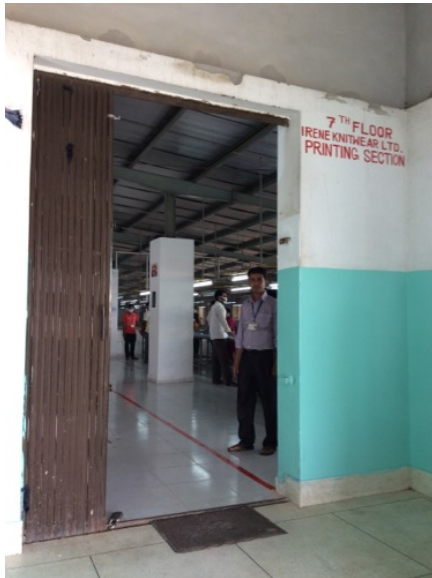
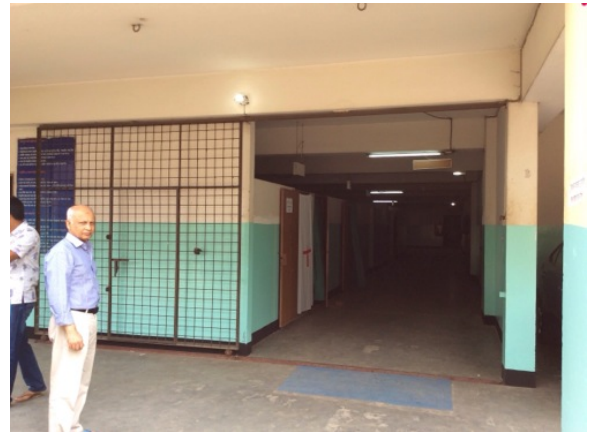
| F-6 | Egress | Collapsible gates and sliding doors are provided at exit stairs on each floor and at the west exit discharge. | Replace all gates / sliding doors along the means of egress with side-hinged, swinging egress doors.<br><br>If locks are required for security reasons, utilize special door locking features complying with NFPA 101. | Within 1 month |

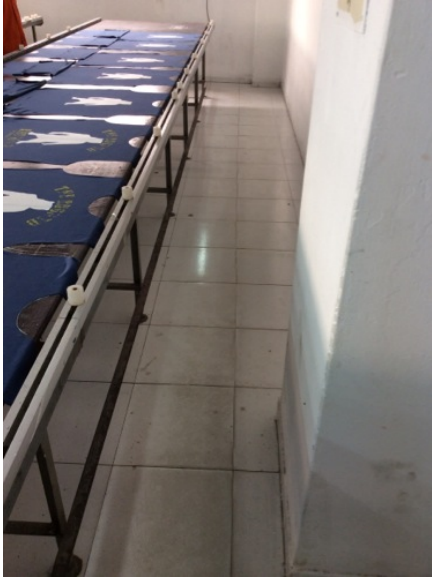
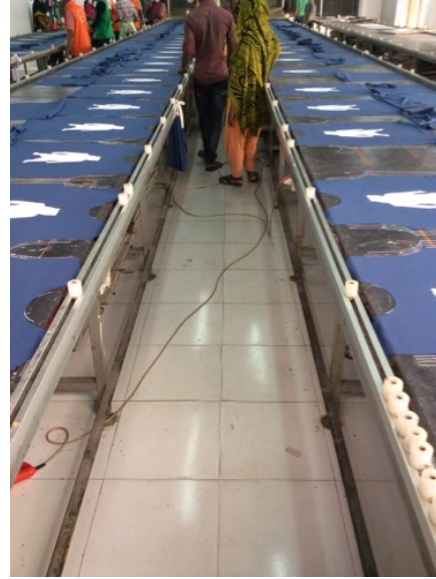
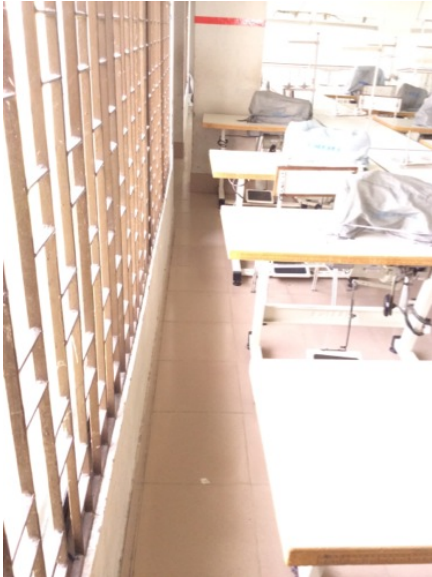
| F-8 | Egress | The width of egress aisles is less than 36-in. in several locations on the fifth, sixth, and seventh (mezzanine) floors. | Provide minimum aisle widths of 36-in. | Within 3 months |

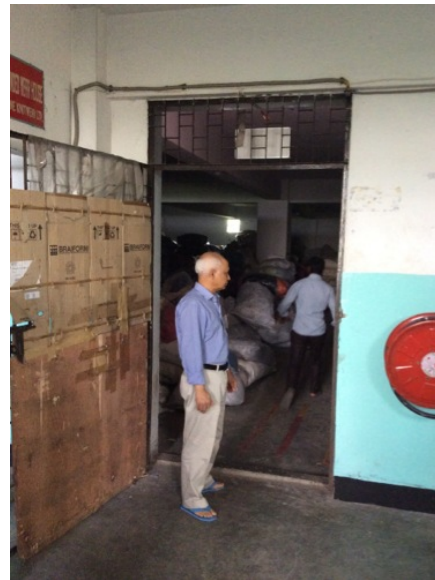
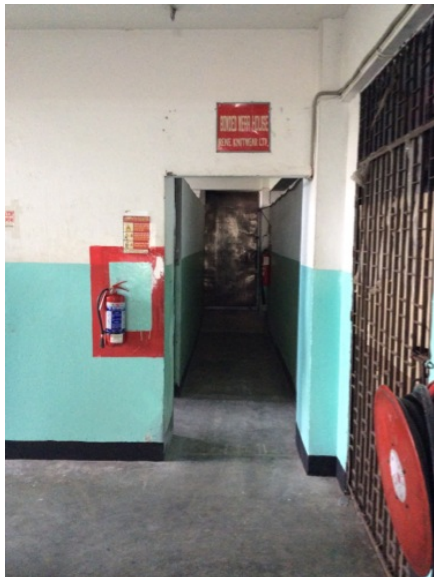
| F-10 | Egress | The north exit stair discharges inside the building on the ground floor adjacent to storage areas. Two exits are available from the point, one exit is through the adjacent dining area and one exit is along the corridor to the west. | Provide sprinkler protection for discharge floor in accordance with NFPA 13. | Within 6 months |

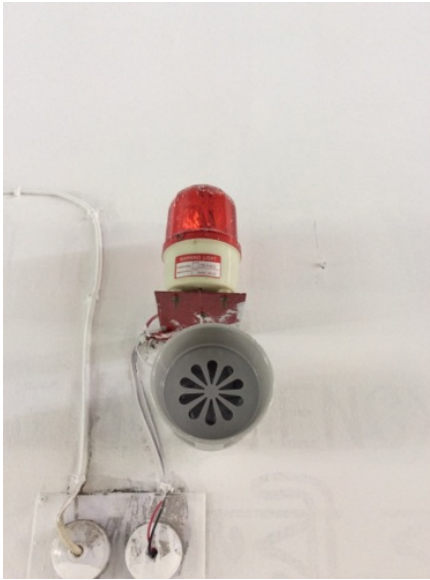
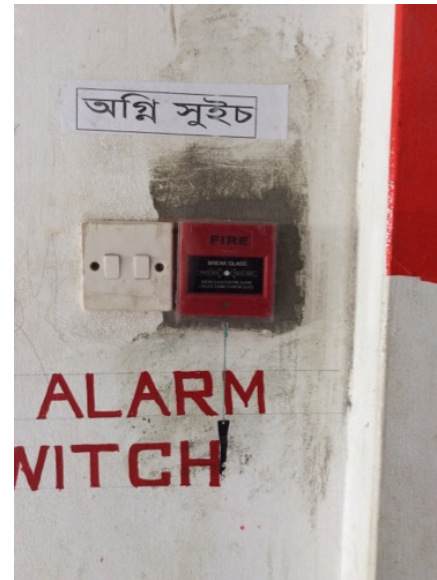
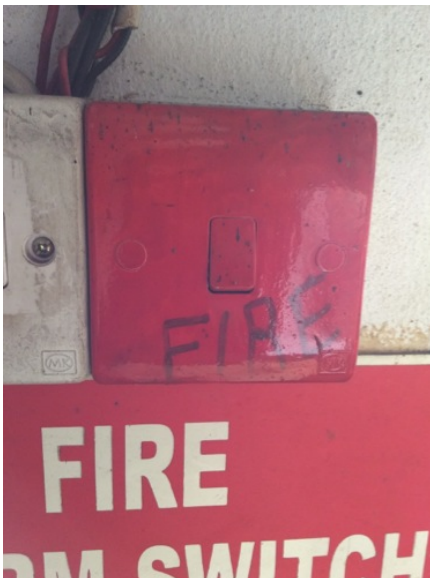
| F-11 | Fire Protection | The fire alarm system is antiquated, not a listed system, and does not provide alarm and notification features consistent with acceptable standards. | Replace the fire alarm system with a new, listed addressable fire alarm system in accordance with NFPA 72. | Design within 4 months, install within 9 months |

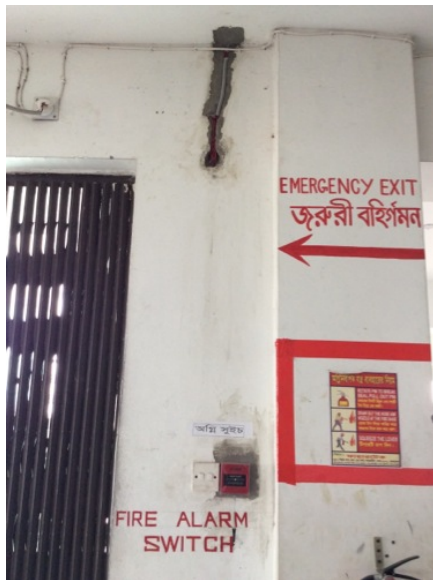
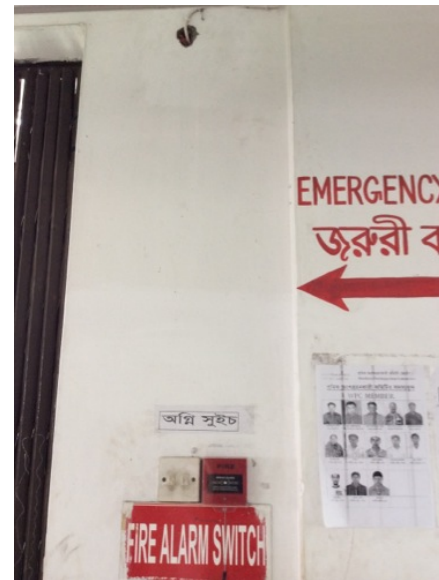
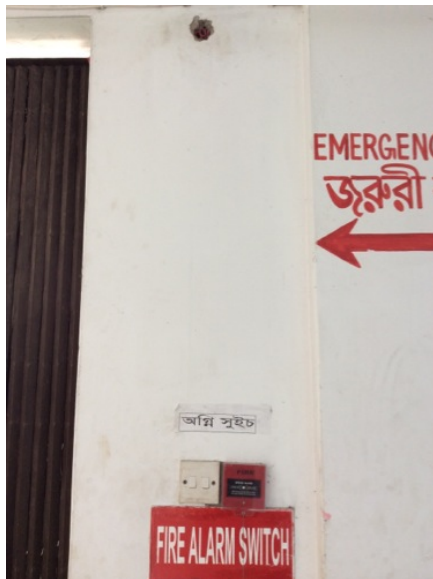
| F-14 | Fire Protection | <p>The fire alarm system does not appear to provide adequate audible notification coverage. A functional test was conducted on the sixth floor and from the rear southeast corner of the winding section the alarm was barely audible. The inadequacy of the fire alarm notification is likely due to the fact that horn units were missing on the fourth, fifth, and sixth floors next to the west stairwell.</p> | <p>Provide additional notification appliances such that the fire alarm system is audible throughout the building in accordance with NFPA 72.</p> | <p>Within 6 months</p> |

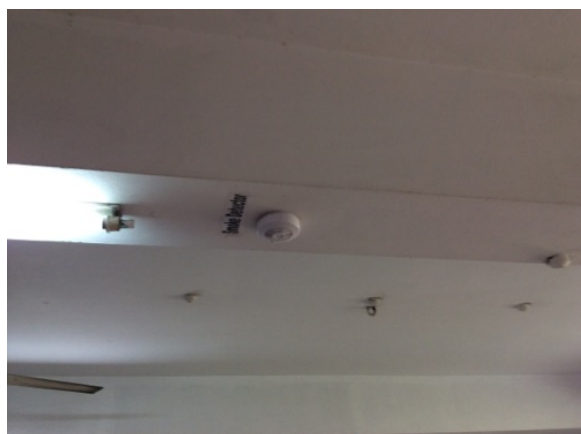
| F-15 | Fire Protection | The building is equipped with single-station smoke alarms. Smoke alarm activation sounds only a local alarm and does not provide automatic fire alarm notification of occupants. | <p>Replace the single-station smoke alarms with automatic smoke detectors tied into the fire alarm system. Based on ceiling configuration, space the detectors in accordance with NFPA 72. Configure the fire alarm system to initiate occupant notification upon activation of any two smoke detectors in addition to the manual fire alarm stations.</p> <p>Alternatively, when complete sprinkler protection is provided throughout a floor with waterflow devices designed to initiate the alarm notification, smoke and fire detection devices can be eliminated throughout the floor.</p> | Within 6 months |

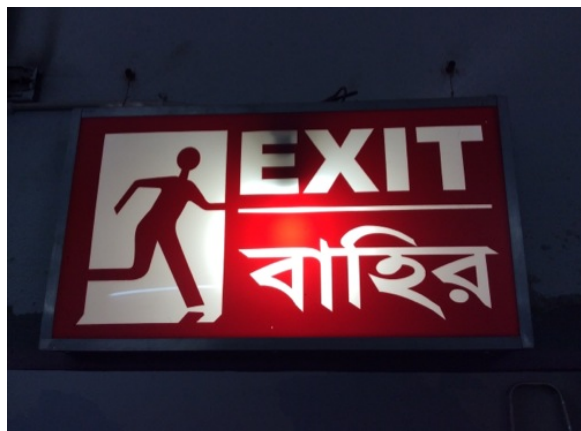
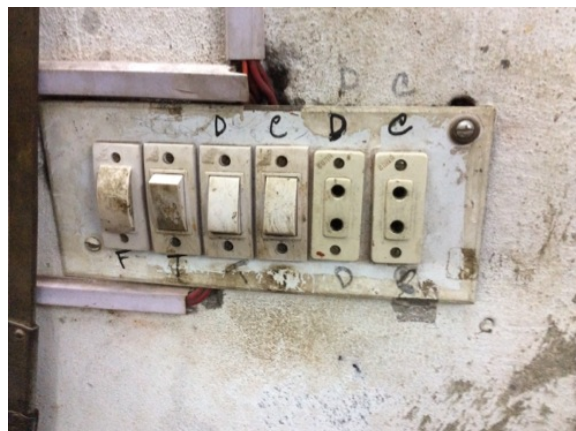
| F-16 | Egress Lighting | Manual on-off switch is provided for exit signage units in several locations throughout the building. | Remove manual on/off switches from exit signage units to prevent them from being switched off. | Within 1 month |
