# **FIRE SAFETY INSPECTION REPORT**

## **HANNAN FASHIONS LTD**

**1153-54, SHAHID SIDDIQUE ROAD, KHAILKUR,  
BOARD BAZAR, GAZIPUR 1704**

April 15, 2014

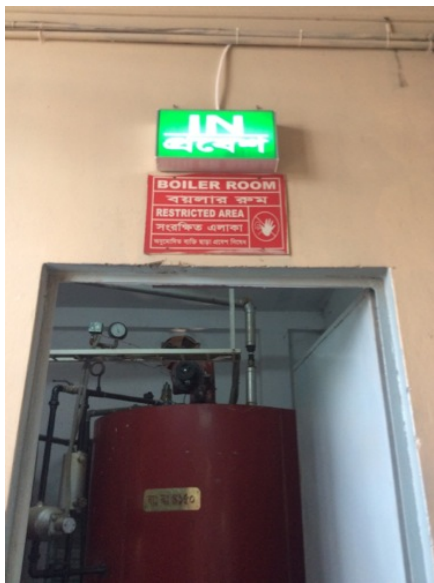
No.	Category	Finding	Recommendation	Remediation Timeframe
F-1	Fire Rated Construction	The ground floor boiler, generator, transformer, and chemical storage sheds have unprotected openings within 30 ft of the factory building.	Separate the boilers, generator, transformer, and chemical storage sheds from adjacent areas by a minimum 2-hr fire-rated construction. Seal and/or protected all openings to maintain the required fire separations.	Within 3 months

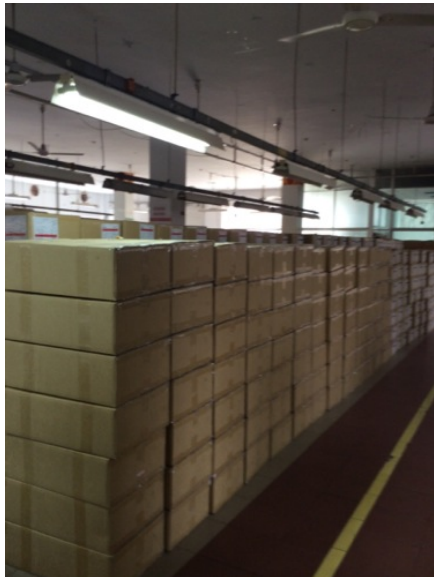
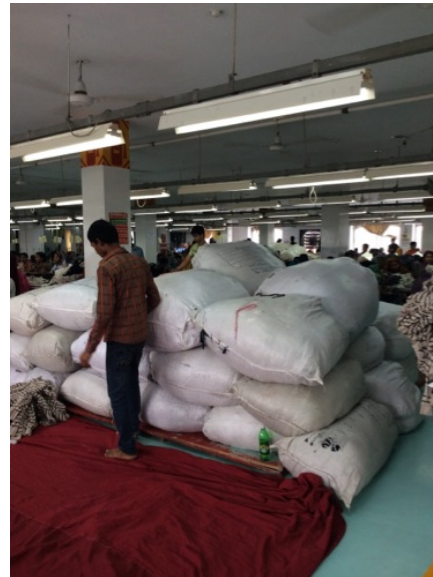
F-2	Fire Rated Construction	<p>Areas used for combustible storage are not separated by fire-rated construction. Locations include the Ground Floor, 1st, 2nd, and 3rd floors.</p>	<p>Provide dedicated storage rooms separated by minimum 1-hr fire-rated construction.</p> <p>Where separate storage rooms are not feasible, provide defined storage areas and limit the storage arrangement as follows:</p> <ul style="list-style-type: none"> <li>- Maximum height of 2.4m and maximum area of 23m<sup>2</sup></li> </ul> <p>Separate areas of unenclosed combustible storage by a minimum clear distance of 3m.</p>	Within 3 months
-----	-------------------------	---	---	-----------------

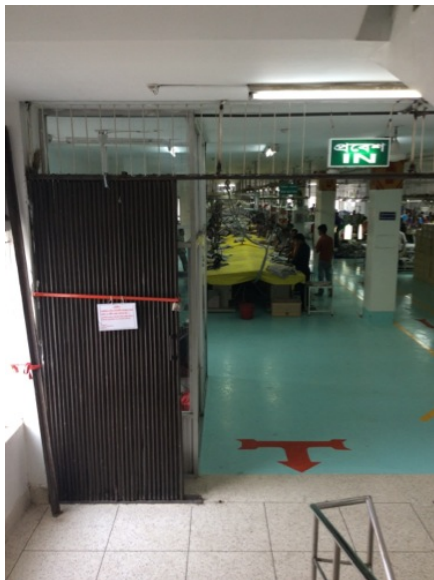
F-3	Fire Rated Construction	The exit stairs are not separated from each floor by fire-rated construction.	<p>Provide minimum 1.5-hr fire rated doors and seal all unprotected openings to separate the exit stairs from work areas and other building spaces on all floor levels. Ensure that the fire doors are self-closing and positive latching and that they are provided with fire exit (panic) hardware where serving production floors.</p>	Within 3 months
-----	-------------------------	---	---	-----------------

If fire doors are required to be held open for functional reasons, provide automatic-closing devices tied to the fire alarm system.

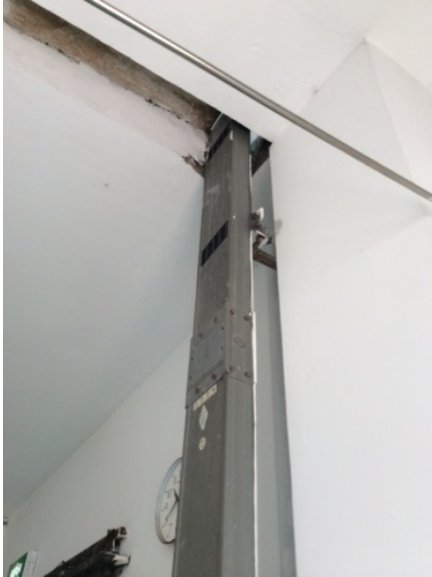
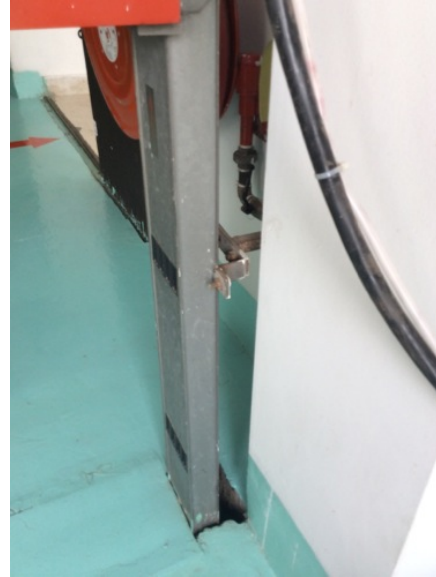
F-4	Fire Rated Construction	Unsealed penetrations and unprotected openings are located in the utility risers.	Provide minimum 1.5-hr fire rated doors and seal all unprotected openings to elevator shafts and utility risers.	Within 3 months
-----	-------------------------	---	--	-----------------

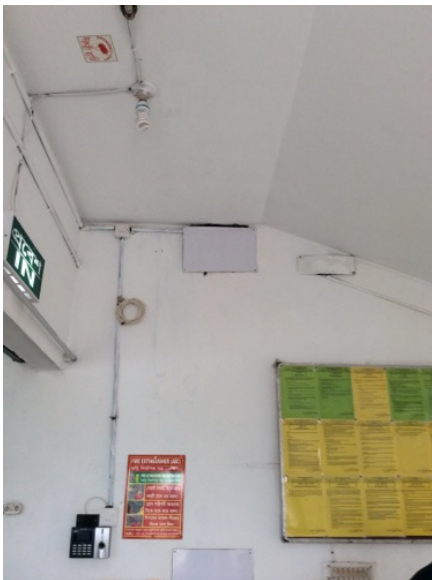
F-5	Fire Rated Construction	Unsealed penetrations and openings are located in exit stair enclosures.	Seal all penetrations and openings in exit stair enclosure walls to maintain the fire separation.	Within 3 months
-----	-------------------------	--	---	-----------------

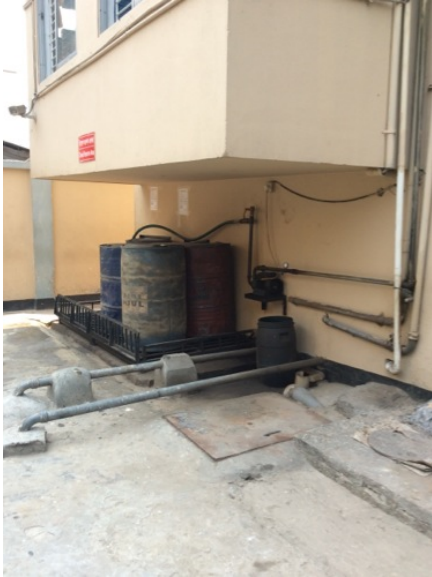
F-6	Fire Rated Construction	Diesel storage area is not separated by fire-rated construction (openings, non-rated doors, penetrations).	Separate the diesel storage area by a minimum 2-hr fire-rated construction. Seal and/or protected all openings to maintain the required fire separations.	Within 3 months
-----	-------------------------	--	---	-----------------

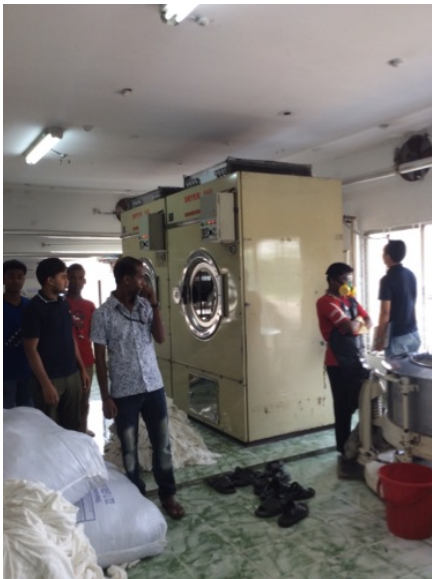
F-7	Fire Rated Construction	The natural gas dryers on the Ground Floor are not separated by fire-rated construction (openings, non-rated doors, penetrations).	Separate the natural gas dryers by a minimum 2-hr fire-rated construction. Seal and/or protected all openings to maintain the required fire separations	Within 3 months
-----	-------------------------	--	---	-----------------

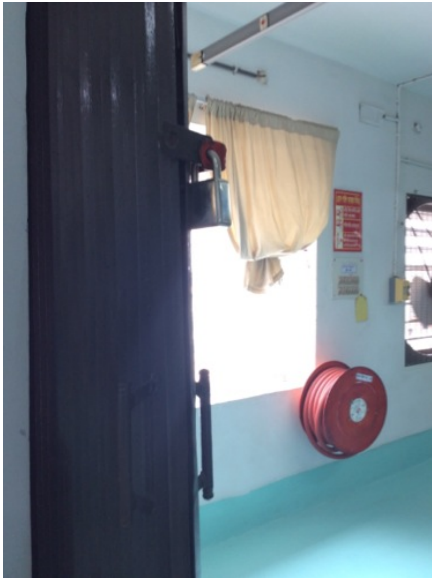
F-8	Egress	<p>Egress doors / gates with locking features are provided at building exits, exit stairs, along egress routes, and means of exit discharge.</p> <p>All gates/doors within the factory were open and unlocked during the inspection.</p>	<p>Remove locking features from all egress doors / gates that serve the high-rise.</p> <p>If locks are required for security reasons, utilize special door locking features complying with NFPA 101.</p>	Immediate
-----	--------	--	--	-----------

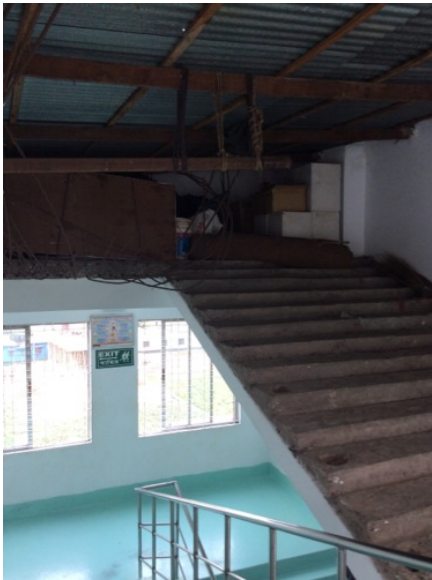
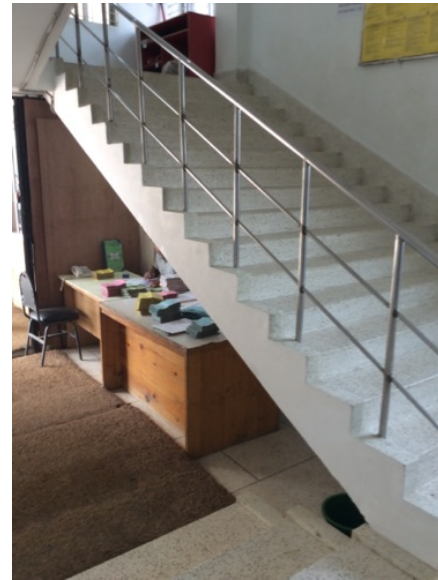
F-9	Egress	<p>Storage was located in the exit stairs.</p>	<p>Remove all storage from exit stairs and egress paths.</p>	Immediate
-----	--------	--	--	-----------

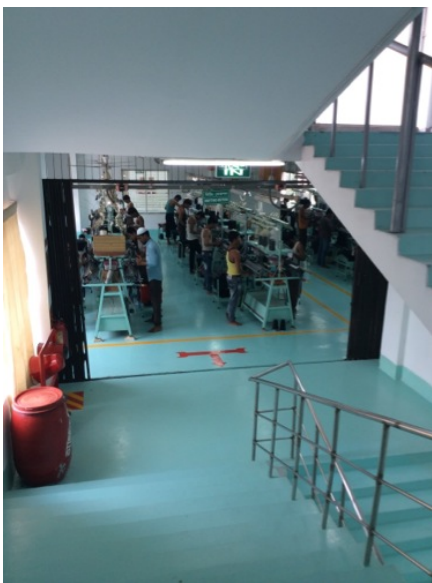
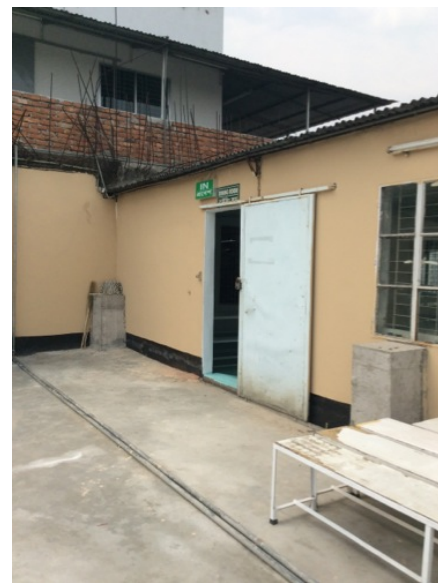
F-10 Egress

Collapsible gates / sliding doors are provided at building exits, exit stairs, along egress routes, and means of exit discharge.

Replace all gates / sliding doors along the means of egress with side-hinged, swinging egress doors.

If locks are required for security reasons, utilize special door locking features complying with NFPA 101.

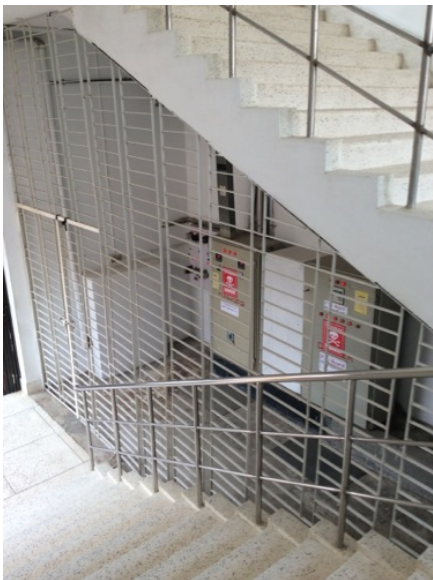
F-12	Egress	Electrical panels are located in the exit stairs.	Remove all electrical equipment from the exit stair that does not specifically serve the stair.	Within 3 months
------	--------	---	---	-----------------

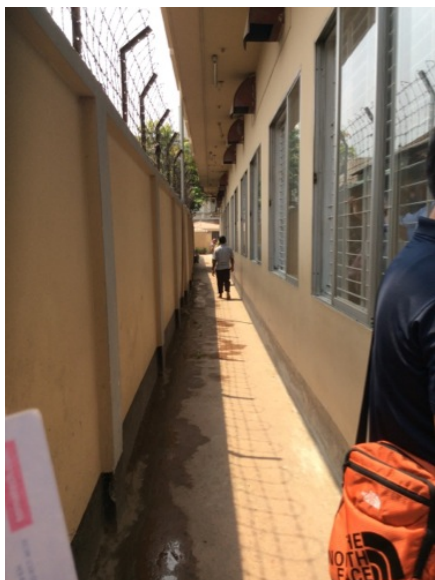
F-13	Egress	Egress court is less than 10 ft wide.	Separate the interior of the building from the exit path by 1-hr fire rated construction up to a height of 10 ft above grade.	Within 3 months
------	--------	---------------------------------------	---	-----------------

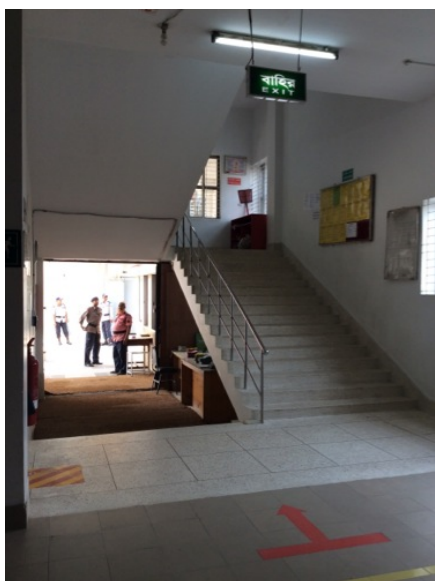
F-14	Egress	The west exit stairs discharge inside the building.	Provide a 2-hr fire-rated exit passageway from the exit stairs leading directly outside.	Within 6 months
------	--------	---	--	-----------------

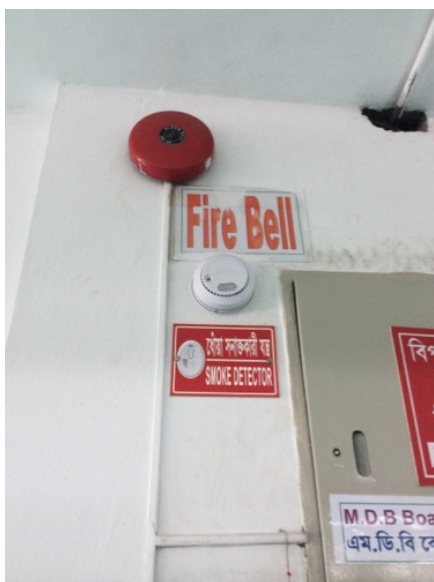
F-16	Fire Protection	The fire alarm system is not a listed system, does not provide full coverage smoke detection, and does not provide alarm and notification features consistent with acceptable standards.	Replace the fire alarm system with a new, listed addressable fire alarm system in accordance with NFPA 72.	Design within 4 months, install within 9 months
F-17	Fire Protection	Testing and maintenance records for the fire alarm system were not available.	Inspect, test and maintain the fire alarm system, and keep written records on-site, in accordance with NFPA 72.	Within 3 months
F-18	Fire Protection	The building is equipped with single-station smoke alarms. Smoke alarm activation sounds only a local alarm and does not provide automatic fire alarm notification of occupants.	Replace the single-station smoke alarms with automatic smoke detectors throughout the building that are tied into the fire alarm system. Configure the fire alarm system to initiate occupant notification upon activation of any two smoke detectors in addition to the manual fire alarm stations.	Within 6 months
