FIRE SAFETY INSPECTION REPORT

NEXUS FASHION LTD

VOGRA, JOYDEBPUR

ACCORD
on Fire and Building Safety in Bangladesh

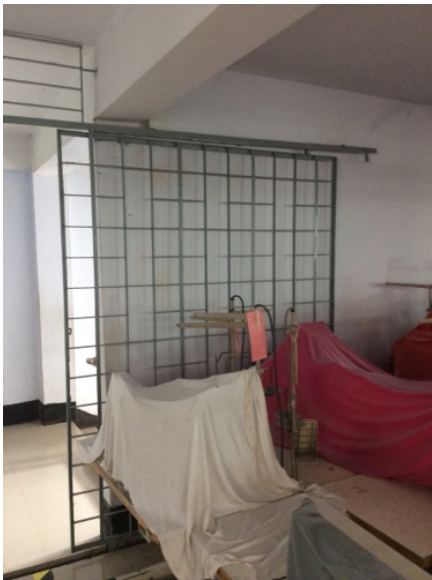
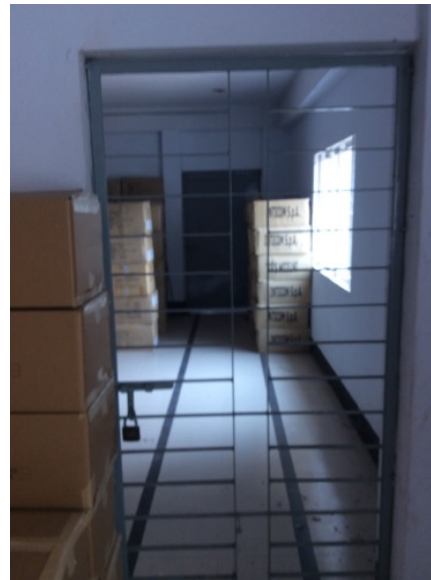
No.	Category	Finding	Recommendation	Remediation Timeframe
F-1	Fire Rated Construction	Areas used for combustible storage are not separated by fire- rated construction.	<p>Provide dedicated storage rooms separated by minimum 1-hr fire-rated construction.</p> <p>Where separate storage rooms are not feasible, provide defined storage areas and limit the storage arrangement as follows:</p> <ul style="list-style-type: none"> - Maximum height of 2.4m and maximum area of 23m² - If sprinkler protected: maximum height of 3.66m and maximum area of 93m² <p>Separate areas of unenclosed combustible storage by a minimum clear distance of 3m.</p>	Within 3 months

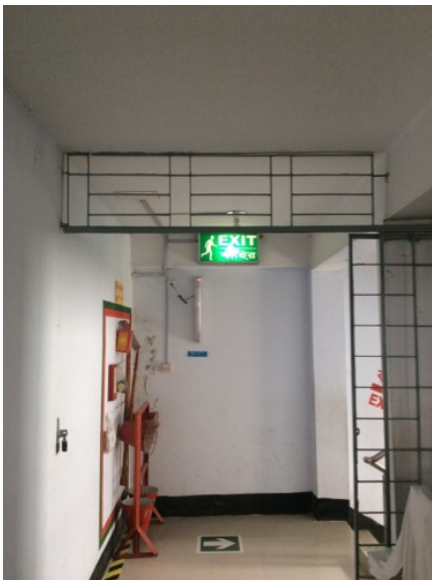
F-2	Fire Rated Construction	The exit stairs are not separated from work areas, other spaces on each floor by fire-rated construction.	Provide minimum 1.5-hr fire rated doors and seal all unprotected openings to separate the exit stairs from work areas and other building spaces on all floor levels. Ensure that the fire doors are self-closing and positive latching and that they are provided with fire exit (panic) hardware where serving production floors. If fire doors are required to be held open for functional reasons, provide automatic-closing devices tied to the fire alarm system.	Within 3 months
-----	-------------------------	---	---	-----------------

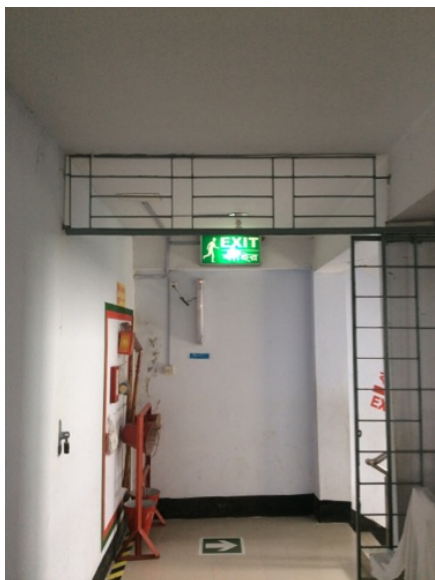
F-3	Fire Rated Construction	Unsealed penetrations and openings are located in exit stair enclosures.	Seal all penetrations and openings in exit stair enclosure walls to maintain the fire separation.	Within 3 months
-----	-------------------------	--	---	-----------------

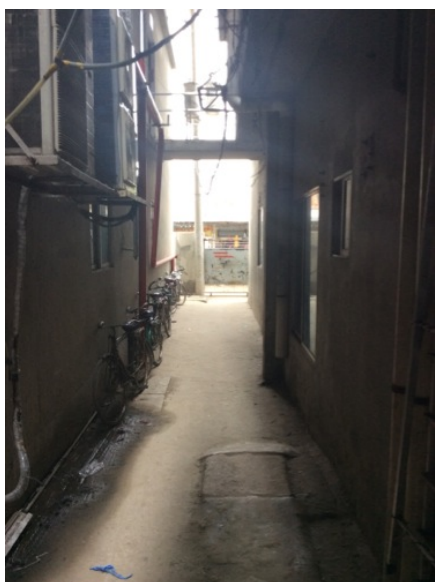
F-4	Fire Rated Construction	Uncovered discharge path to assembly point, with less than 10 ft. building separation, has unprotected openings at a height of less than 10 ft.	Seal all penetrations and openings to the interior of the building, up to a height of 10 ft., to maintain the fire separation. Alternately, provide 1-hr fire-rated separation up to a height of 10 ft.	Within 3 months
-----	-------------------------	---	---	-----------------

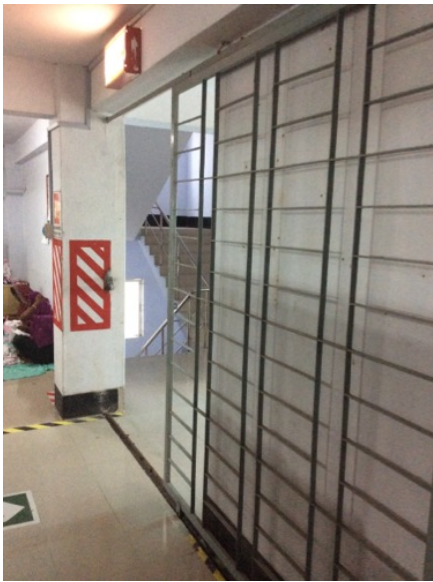
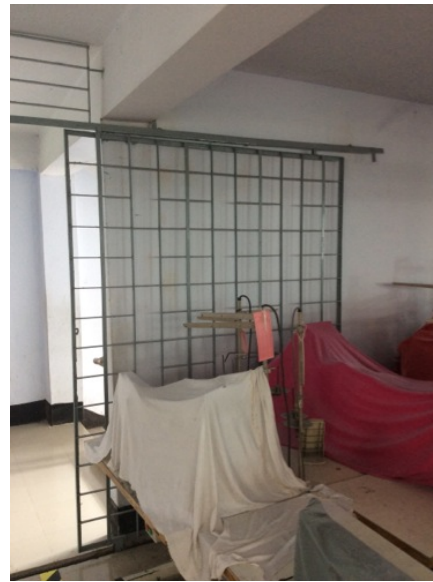
F-5	Egress	Egress doors & gates with locking features are provided at building exits, exit stairs, along egress routes, exit discharge. throughout all floors of the factory. All other gates/doors were open and unlocked during the inspection.	Remove locking features from all egress doors / gates. If locks are required for security reasons, utilize special door locking features complying with NFPA 101.	Immediate
-----	--------	--	--	-----------

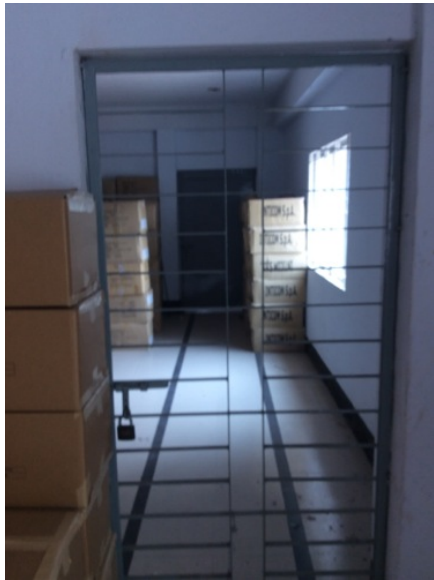
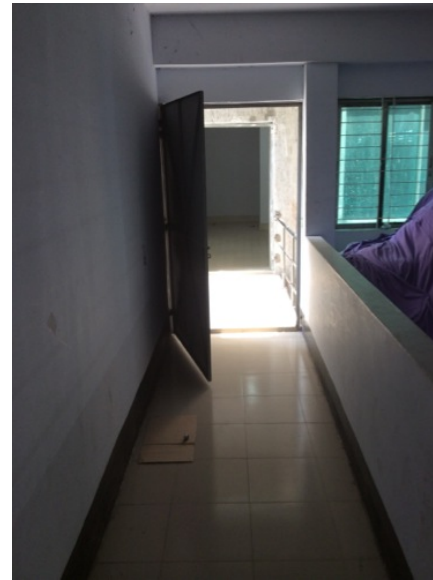
F-6	Egress	Collapsible gates & sliding doors are provided at main building exits and along egress routes.	Replace all gates / sliding doors along the means of egress with side-hinged, swinging egress doors. If locks are required for security reasons, utilize special door locking features complying with NFPA 101.	Within 1 month
-----	--------	--	--	----------------

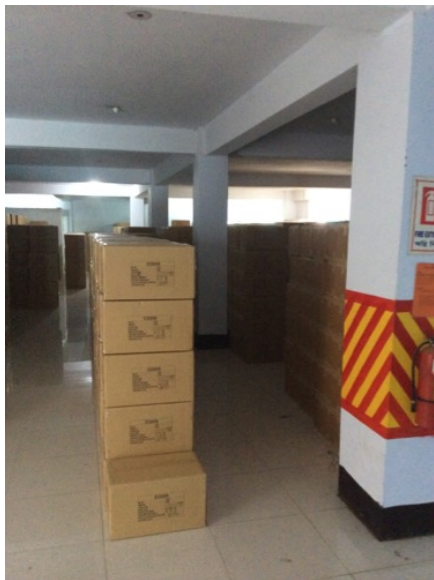
F-7	Egress	The width of egress aisles is less than 36-in on the first floor storage area.	Provide minimum aisle widths of 36-in.	Within 3 months
-----	--------	--	--	-----------------

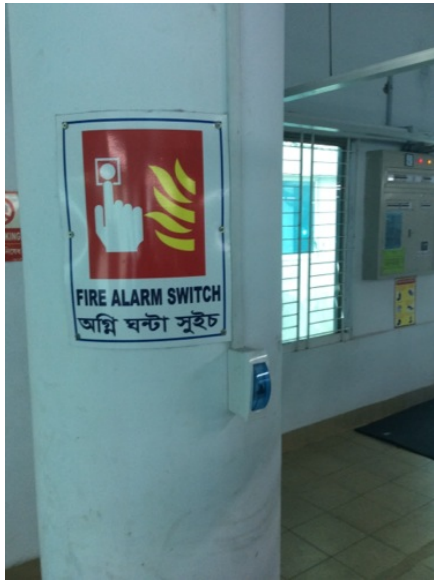
F-8	Fire Protection	The fire alarm system is antiquated, not a listed system, and does not provide alarm and notification features consistent with acceptable standards.	Replace the fire alarm system with a new, listed addressable fire alarm system in accordance with NFPA 72.	Design within 4 months, install within 9 months
-----	-----------------	--	--	---

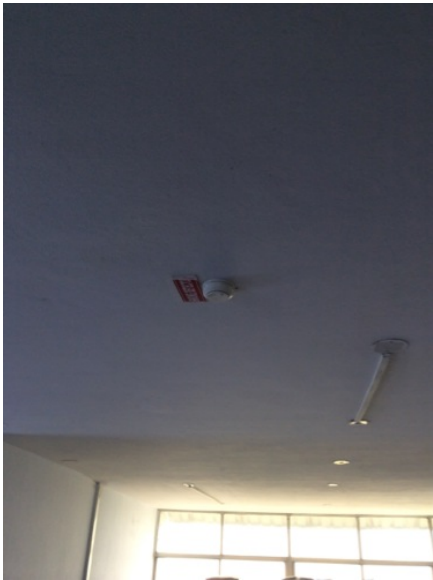
F-9	Fire Protection	Inspection, testing, and maintenance for the fire alarm system were not in accordance with NFPA 72.	Inspect, test and maintain the fire alarm system, and keep written records on-site, in accordance with NFPA 72.	Within 3 months
F-10	Fire Protection	The building is equipped with single-station smoke alarms. Smoke alarm activation sounds only a local alarm and does not provide automatic fire alarm notification of occupants.	Remove single-station smoke alarms. Provide automatic smoke detection throughout the building in accordance with NFPA 72.	Within 6 months

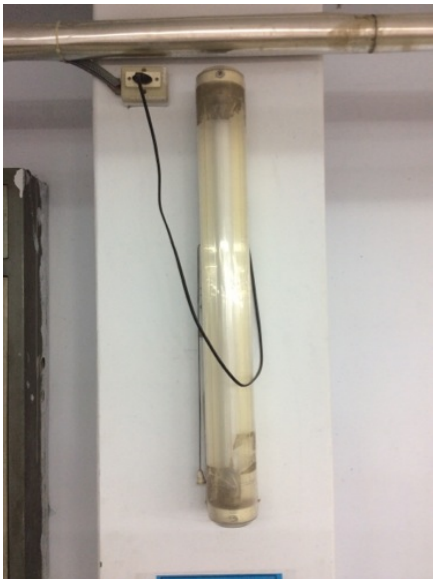
F-11	Egress Lighting	Manual on-off switch is provided for emergency lighting / exit signage units on all floors of the factory.	Remove manual on/off switches from emergency lighting / exit signage units to prevent them from being switched off.	Within 1 month
------	-----------------	--	---	----------------
