# **FIRE SAFETY INSPECTION REPORT**

## **DEKKO READYWEARS LTD**

**PLOT -M1, ROAD - 7, PALLABI, MIRPUR, DHAKA  
PALLABI PLAZA**

March 8, 2014

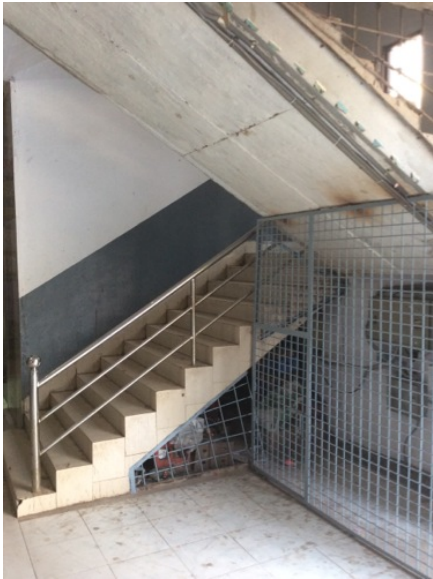
| No. | Category | Finding | Recommendation | Remediation Timeframe |
|---|---|---|---|---|
| F-1 | Fire Rated Construction | Electrical supply is located under East most facing stairwell at landing area is not separated by fire-rated construction openings, non-rated doors and penetrations all present. | Separate the electrical supply room by a minimum 2-hr fire-rated construction. Seal and/or protected all openings to maintain the required fire separations. | Within 3 months |

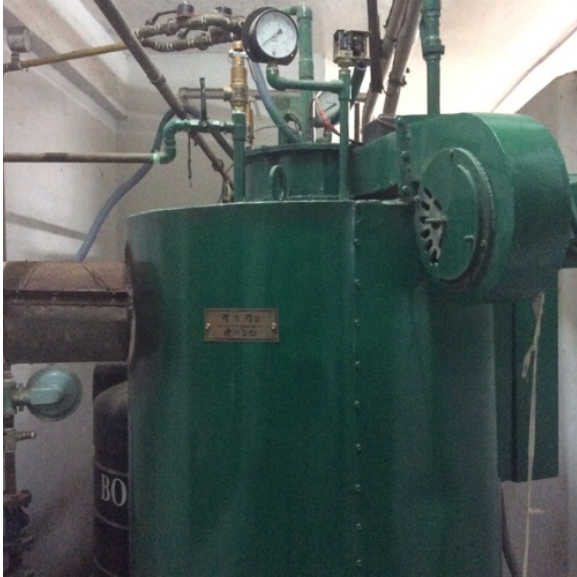
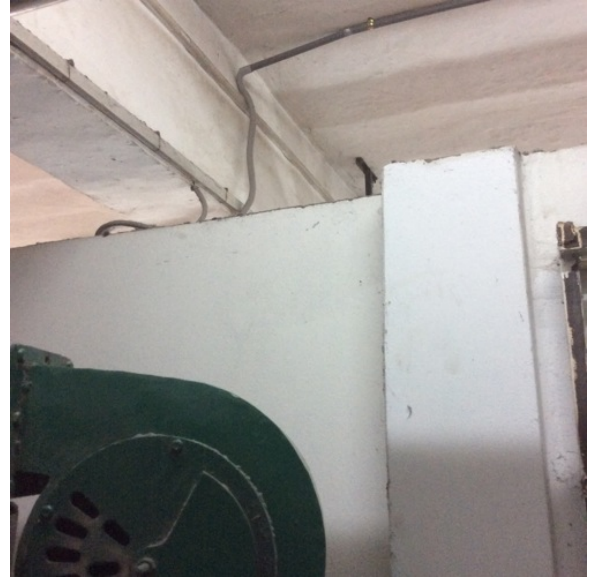
| No. | Category | Finding | Recommendation | Remediation Timeframe |
|---|---|---|---|---|
| F-2 | Fire Rated Construction | The boiler room on the third floor is not separated by fire-rated construction openings, non-rated doors and penetrations all present. | Separate the boiler room by a minimum 2-hr fire-rated construction. Seal and/or protected all openings to maintain the required fire separations | Within 3 months |

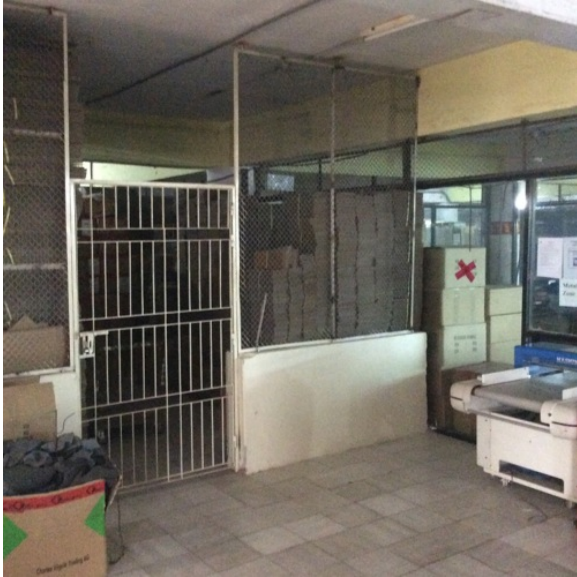
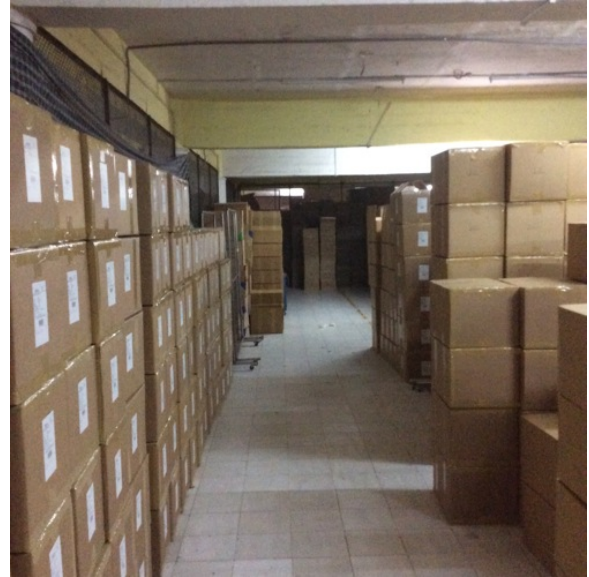
| F-3 | Fire Rated Construction | 5th floor storage areas used for combustible storage is not separated by fire-rated construction. | <p>Provide dedicated storage rooms separated by minimum 1-hr fire-rated construction.</p> <p>Where separate storage rooms are not feasible, provide defined storage areas and limit the storage arrangement as follows:</p> <ul style="list-style-type: none"> <li>- Maximum height of 2.4m and maximum area of 23m<sup>2</sup></li> <li>- If sprinkler protected: maximum height of 3.66m and maximum area of 93m<sup>2</sup></li> </ul> <p>Separate areas of unenclosed combustible storage by a minimum clear distance of 3m.</p> | Within 3 months |

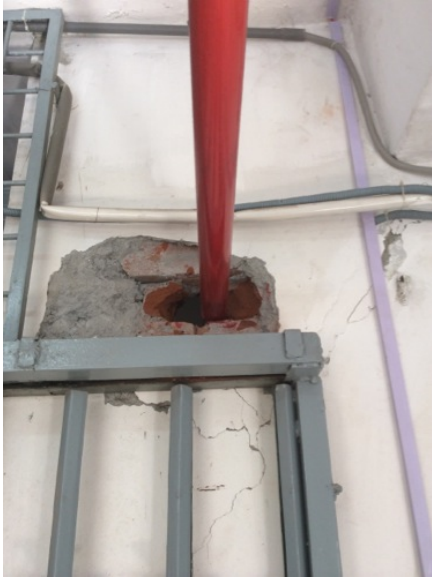
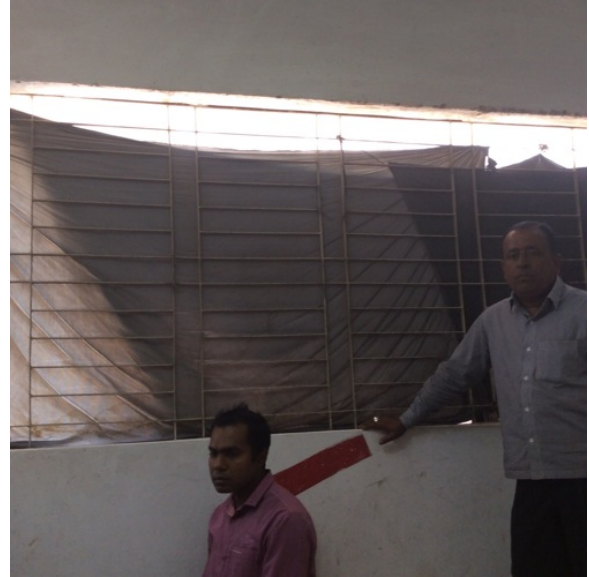
| F-4 | Fire Rated Construction | The exit stairs are not separated from work areas on each floor by fire-rated construction. | <p>Provide minimum 1.5-hr fire rated doors and seal all unprotected openings to separate the exit stairs from work areas and other building spaces on all floor levels. Ensure that the fire doors are self-closing and positive latching and that they are provided with fire exit (panic) hardware where serving production floors.</p> <p>If fire doors are required to be held open for functional reasons, provide automatic-closing devices tied to the fire alarm system.</p> | Within 3 months |

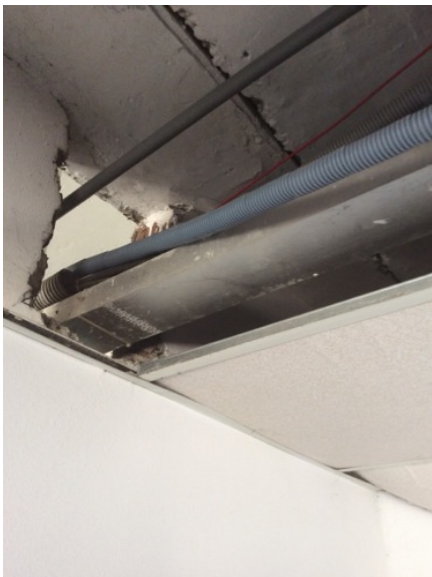
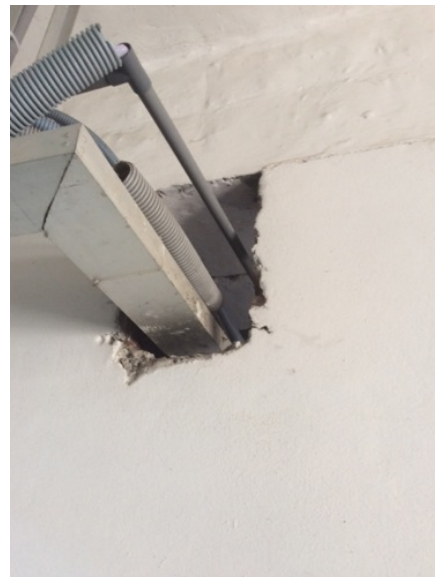
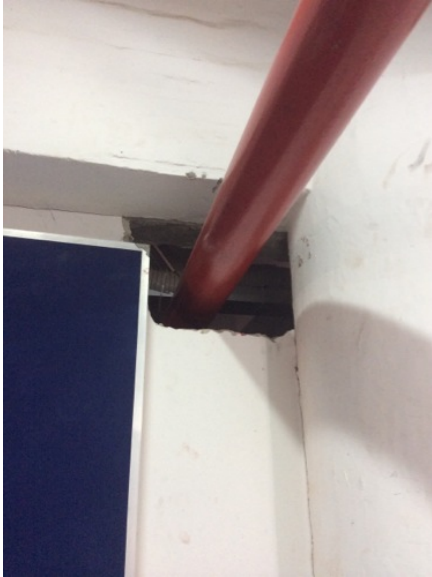
| F-5 | Fire Rated Construction | Unsealed penetrations and openings are located in the fire-rated floor/ceiling assemblies. | Provide a minimum 2-hr fire-rated shaft to separate the utility risers from each floor level. | Within 3 months |

| | | | Seal all penetrations and openings in floor/ceiling assemblies to maintain the fire separation. | |

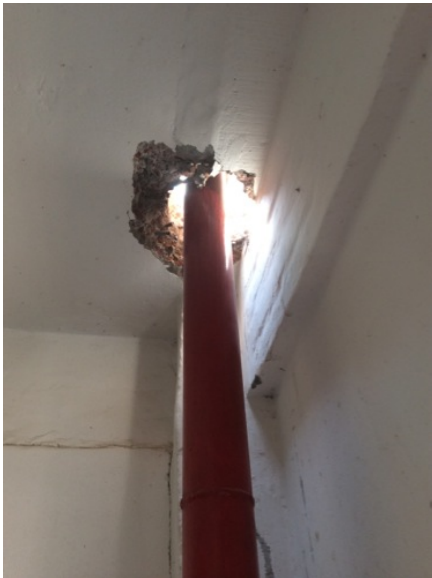
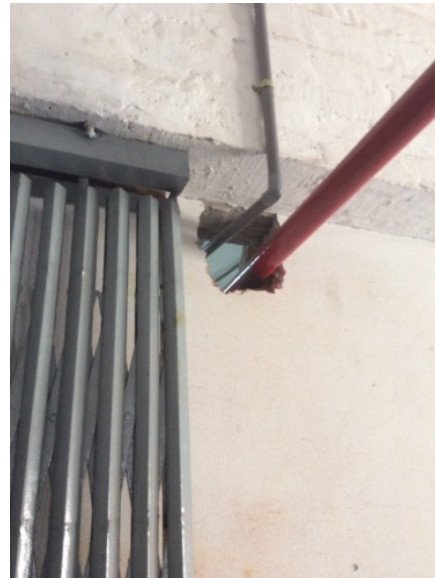
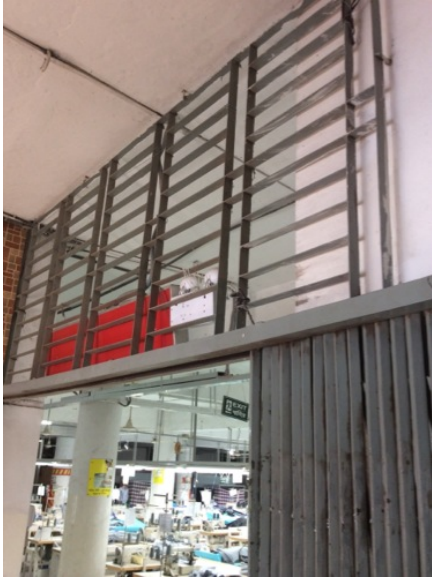
| F-6 | Fire Rated Construction | Unsealed penetrations and openings are located in exit stair enclosures. | Seal all penetrations and openings in exit stair enclosure walls to maintain the fire separation. | Within 3 months |

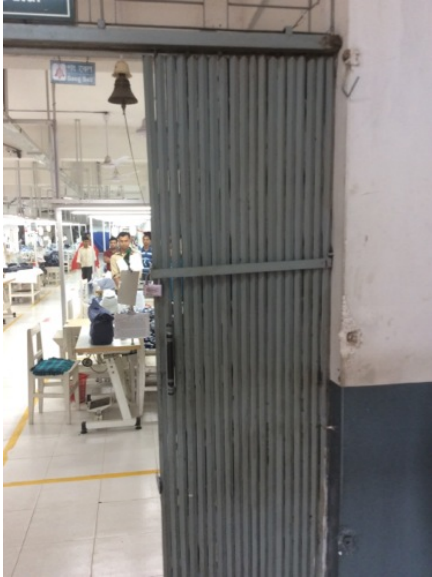
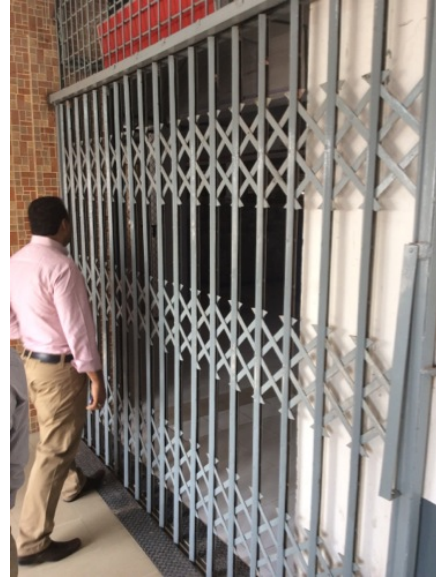
| F-7 | Egress | <p>Egress doors gates with locking features are provided at building exits, exit stairs, along egress routes and exit discharge.</p> <p>Steel sliding gated doors where present on all egress points from floor plates, first floor landings, main egress doors and all storage doors. All doors were unlocked during inspection</p> | <p>Remove locking features from all egress doors / gates.</p> <p>If locks are required for security reasons, utilize special door locking features complying with NFPA 101.</p> | Immediate |

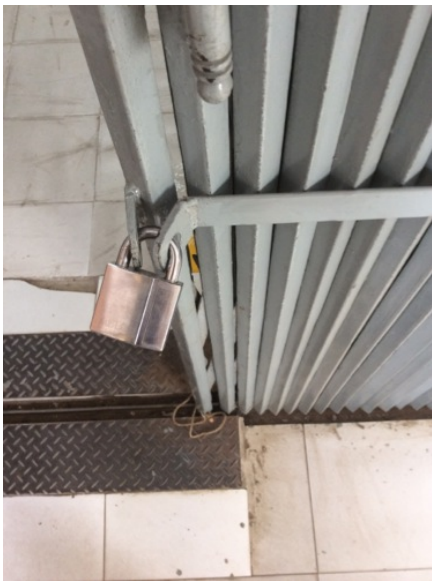
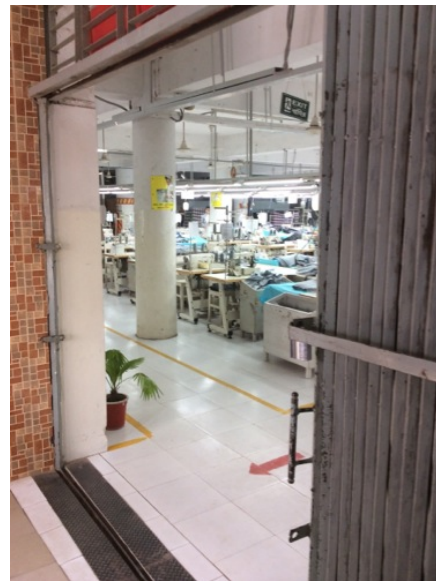
**F-8 Egress**

Collapsible gates sliding doors are provided at all building exits, exit stairs, along egress routes and exit discharges.

Replace all gates / sliding doors along the means of egress with side-hinged, swinging egress doors.

If locks are required for security reasons, utilize special door locking features complying with NFPA 101.

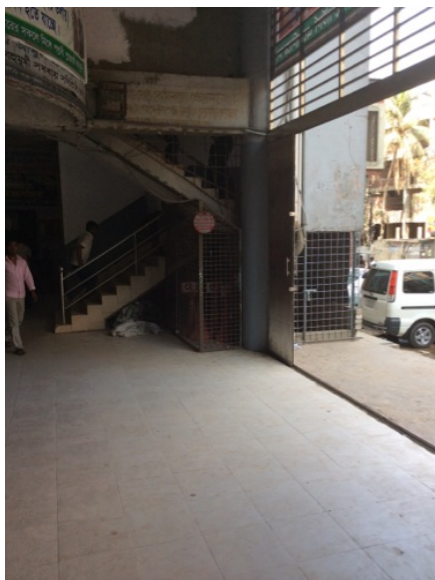
| F-10 | Egress | East most stairwells exit stair discharges to inside the building. | Specify appropriate upgrade based on conditions:<br>- Provide 2-hr fire-rated exit passageway leading directly outside (vestibules to separate any storage areas). | Within 3 months |

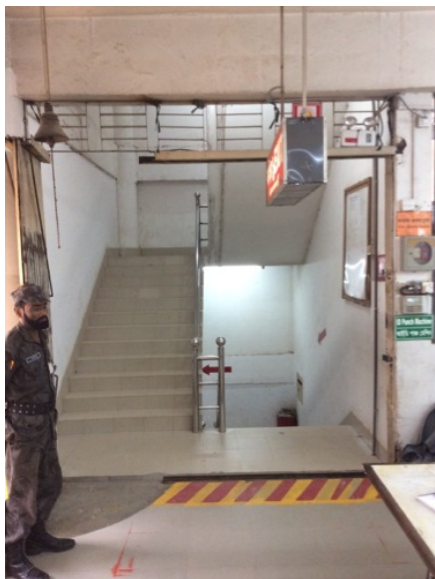
| F-11 | Egress | Exit stair door serving 50 or more occupants does not swing in the direction of egress travel. | Modify the egress door to swing in the direction of egress travel. | Within 3 months |

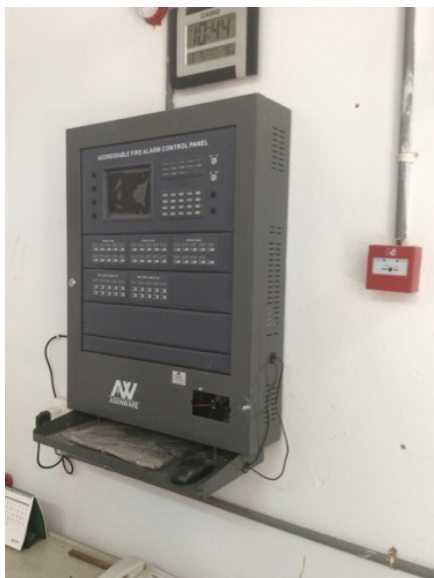
| F-12 | Fire Protection | The fire alarm system is antiquated, not a listed system, and does not provide alarm and notification features consistent with acceptable standards. | Replace the fire alarm system with a new, listed addressable fire alarm system in accordance with NFPA 72. | Design within 4 months, install within 9 months |

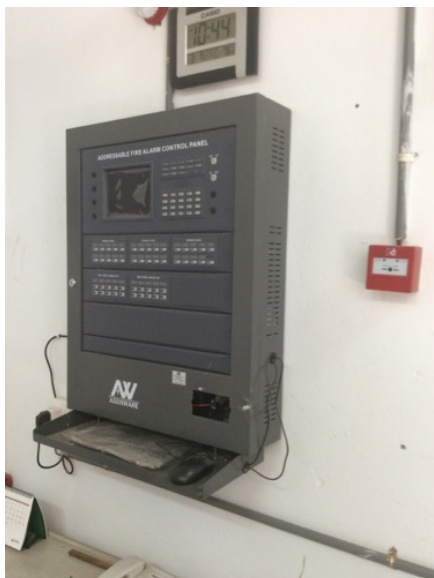
| F-14 | Fire Protection | Inspection, testing, and maintenance records for the fire alarm system were not available. | Inspect, test and maintain the fire alarm system, and keep written records on-site, in accordance with NFPA 72. | Within 3 months |

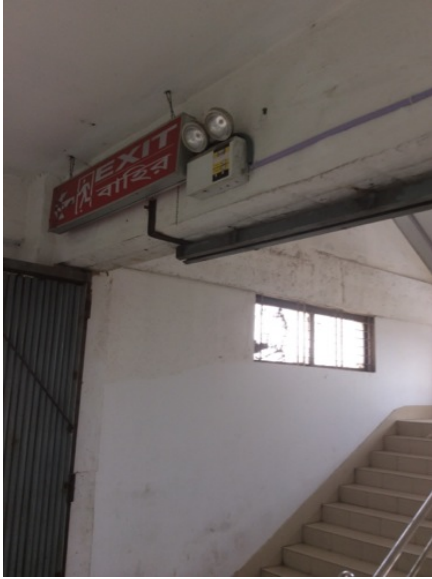
| F-15 | Egress Lighting | Emergency lighting did not function in test mode (burned out, broken, etc.). | Regularly test the emergency lighting system on each floor and replace/repair lights as needed. | Within 1 month |
| | | A number of emergency lights were burnt out when tested, it should be noted compliance team began to correct non lit bulbs at time of inspection, Emergency lighting maintenance schedule should be in place with weekly/monthly checks. | | |
