# **FIRE SAFETY INSPECTION REPORT**

## **ORNATE KNIT GARMENTS INDUSTRIES LTD**

**ACCORD**  
on Fire and Building Safety in Bangladesh

March 25, 2014

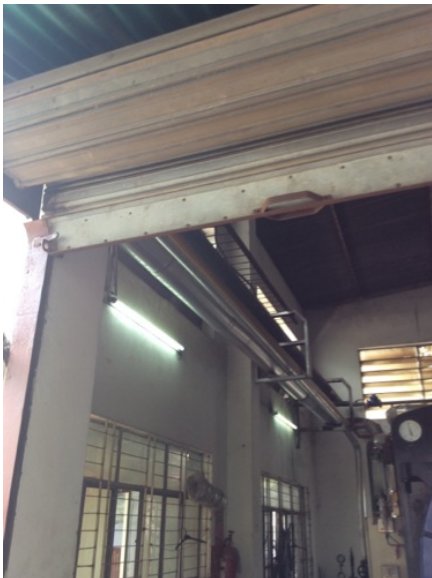
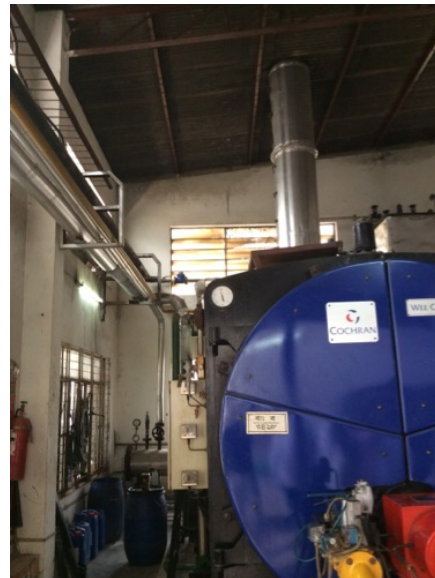
| No. | Category | Finding | Recommendation | Remediation Timeframe |
|---|---|---|---|---|
| F-1 | Fire Rated Construction | The boiler /generator room is not separated by fire-rated construction. Openings, non-rated doors and penetrations are open to safe egress routes. | Separate the boiler / generator room by a minimum 2-hr fire-rated construction. Seal and/or protected all openings to maintain the required fire separations | Within 1 month |

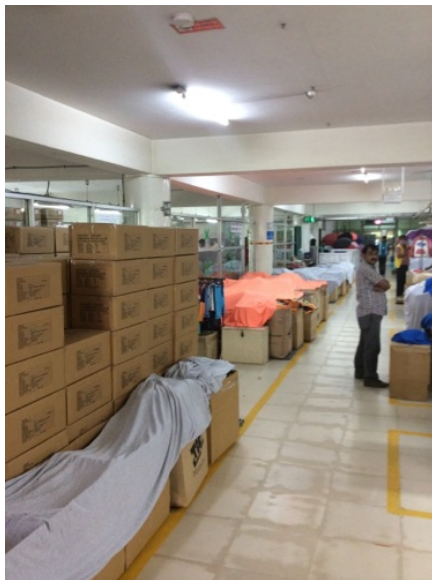
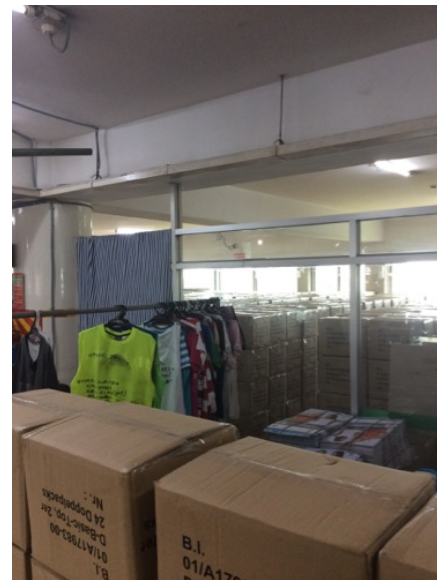
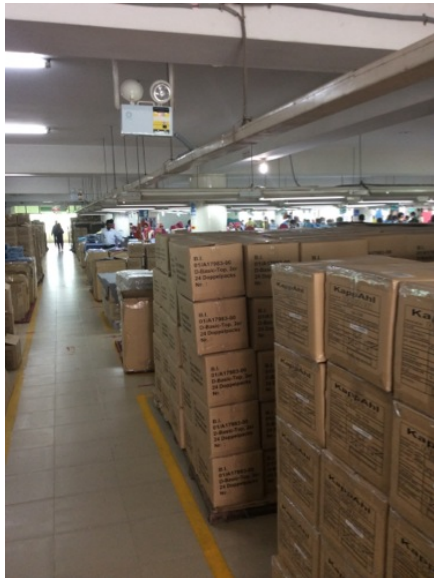
| F-2 | Fire Rated Construction | Areas used for combustible storage are not separated by fire-rated construction. Half height walling, non rated fire doors and combustible storage open to the first floor. | <p>Provide dedicated storage rooms separated by minimum 1-hr fire-rated construction.</p> <p>Where separate storage rooms are not feasible, provide defined storage areas and limit the storage arrangement as follows:</p> <ul style="list-style-type: none"><li>- Maximum height of 2.4m and maximum area of 23m<sup>2</sup></li><li>- If sprinkler protected: maximum height of 3.66m and maximum area of 93m<sup>2</sup></li></ul> <p>Separate areas of unenclosed combustible storage by a minimum clear distance of 3m.</p> | Within 3 months |

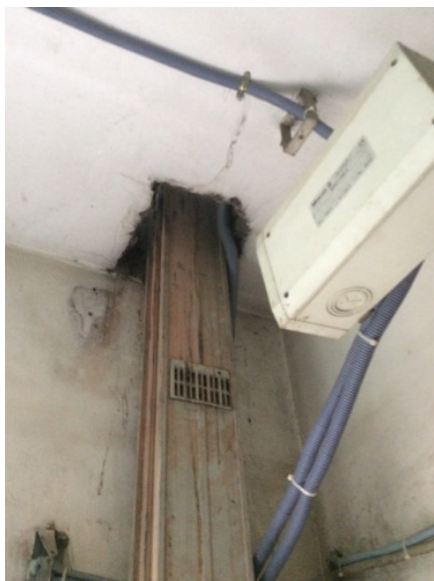
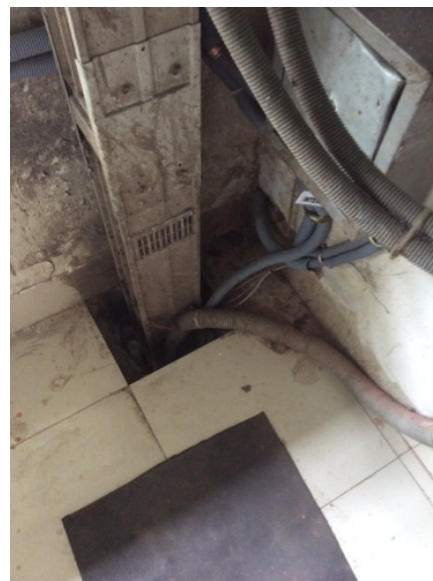
| F-3 | Fire Rated Construction | Unsealed penetrations and openings are located in the fire-rated floor/ceiling assemblies, Electrical shaft open to all Textown occupied floors. | Provide a minimum 2-hr fire-rated shaft to separate the utility risers from each floor level.<br><br>Seal all penetrations and openings in floor/ceiling assemblies to maintain the fire separation. | Within 3 months |

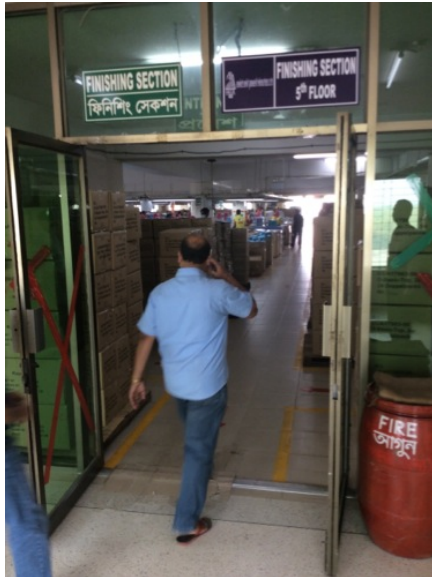
| F-4 | Fire Rated Construction | Unsealed penetrations and openings are located in exit stair enclosures. | Seal all penetrations and openings in exit stair enclosure walls to maintain the fire separation. | Within 3 months |

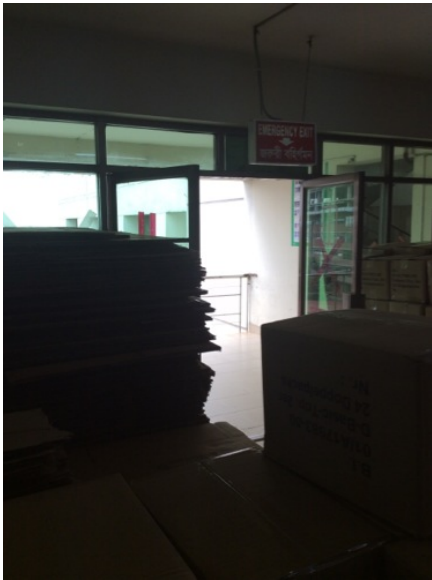
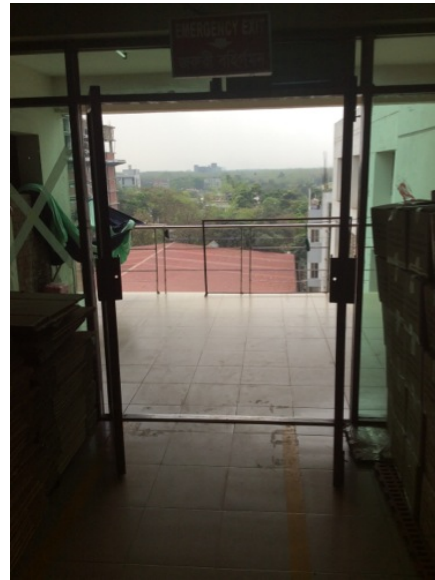
| F-5 | Fire Rated Construction | The exit stairs are not separated from work areas, other spaces on each floor by fire-rated construction. | <p>Provide minimum 1.5-hr fire rated doors and seal all unprotected openings to separate the exit stairs from work areas and other building spaces on all floor levels. Ensure that the fire doors are self-closing and positive latching and that they are provided with fire exit (panic) hardware where serving production floors.</p> <p>If fire doors are required to be held open for functional reasons, provide automatic-closing devices tied to the fire alarm system.</p> | Within 3 months |

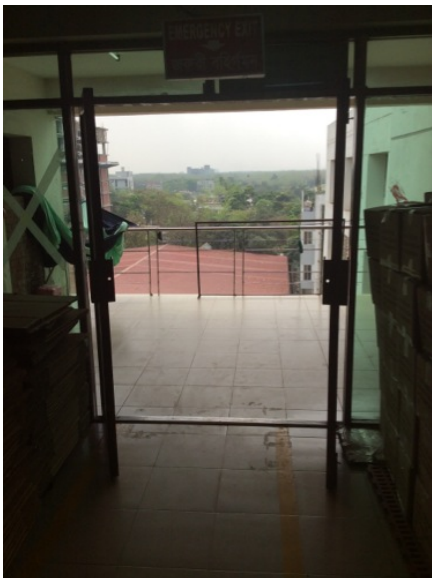
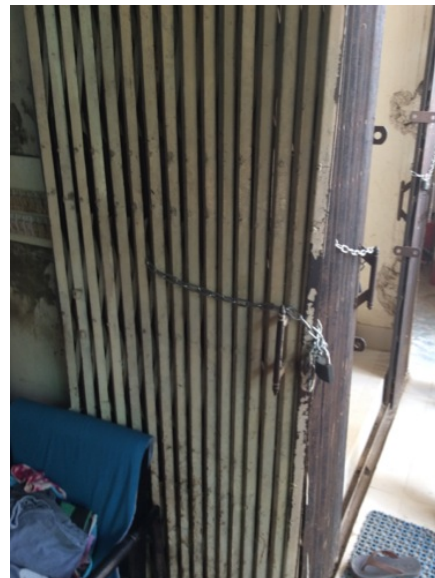
| F-6 | Egress | Egress doors / gates with locking features are provided at all building exits, exit stairs, along egress routes and exit discharge. All doors were open and unlocked during the inspection | Remove locking features from all egress doors / gates.<br><br>If locks are required for security reasons, utilize special door locking features complying with NFPA 101. | Immediate |

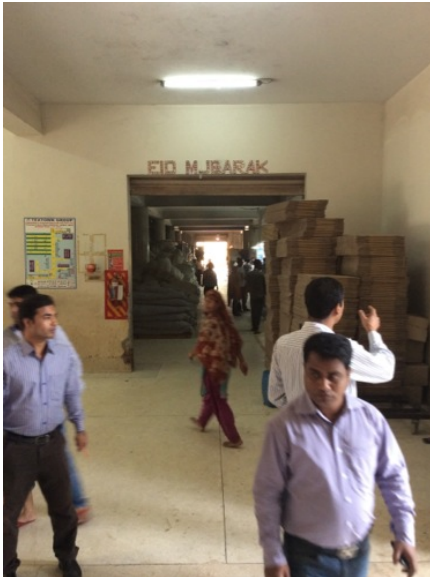
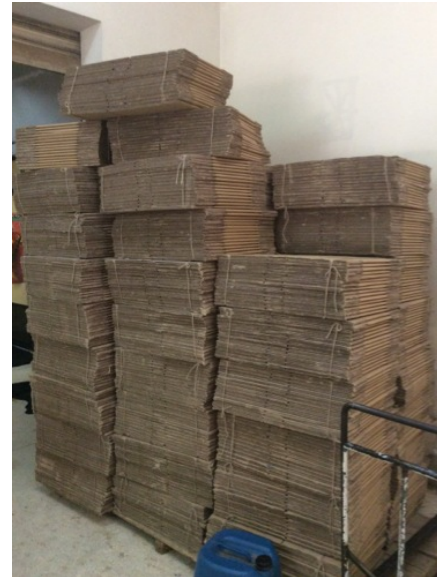
| F-7 | Egress | Storage was located in the egress path at ground level adjacent with the dying shed egress point. | Keep egress paths and stairs clear of storage. | Immediate |

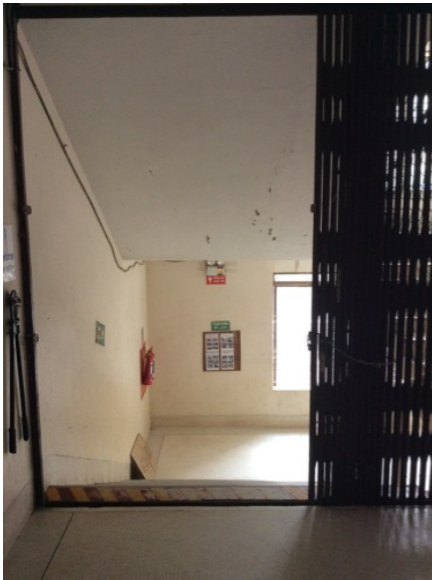
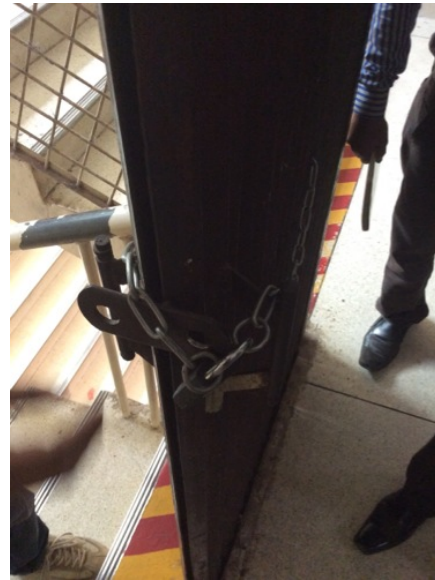
| F-9 | Egress | Collapsible gates / sliding doors are provided at building exits, exit stairs, along egress routes and main exit discharge throughout Building1. | <p>Replace all gates / sliding doors along the means of egress with side-hinged, swinging egress doors.</p> <p>If locks are required for security reasons, utilize special door locking features complying with NFPA 101.</p> | Within 1 month |

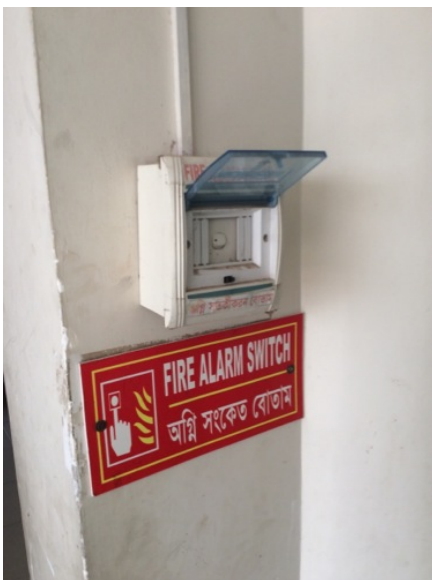
| F-10 | Fire Protection | The fire alarm system is antiquated, not a listed system, and does not provide alarm and notification features consistent with acceptable standards. | Replace the fire alarm system with a new, listed addressable fire alarm system in accordance with NFPA 72. | Design within 4 months, install within 9 months |

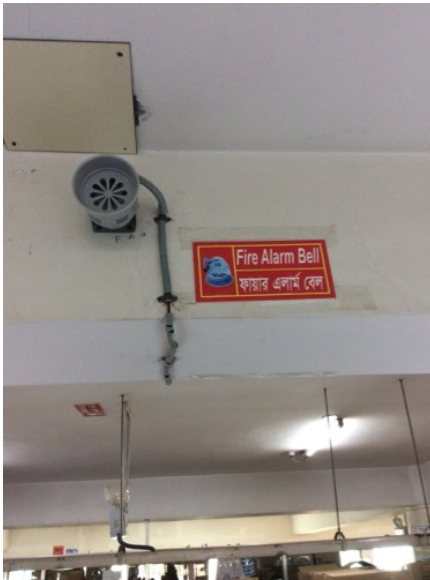
| F-12 | Fire Protection | The fire alarm system does not appear to provide adequate audible notification coverage due to the type of production on each floor a greater amount of decibels is required. | Provide additional notification appliances such that the fire alarm system is audible throughout the building in accordance with NFPA 72. | Within 6 months |

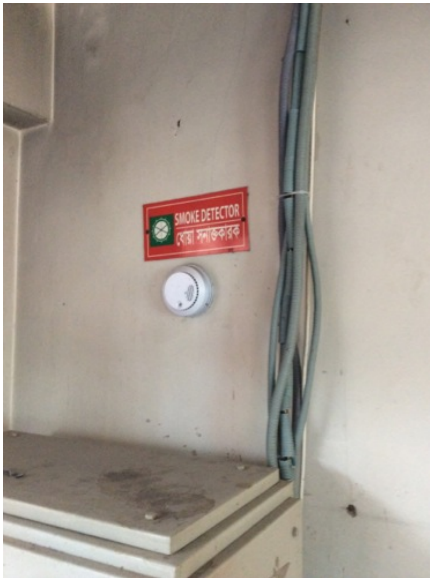
| F-13 | Fire Protection | The building is equipped with single-station smoke alarms. Smoke alarm activation sounds only a local alarm and does not provide automatic fire alarm notification of occupants. | Remove single-station smoke alarms. Provide automatic smoke detection throughout the building, tied into the fire alarm system, in accordance with NFPA 72. | Within 6 months |

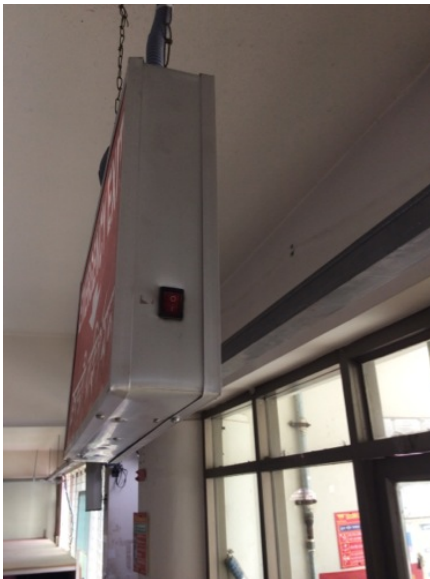
| F-14 | Egress Lighting | Manual on-off switch is provided for emergency lighting / exit signage units on all floors . | Remove manual on/off switches from emergency lighting / exit signage units to prevent them from being switched off. | Within 1 month |

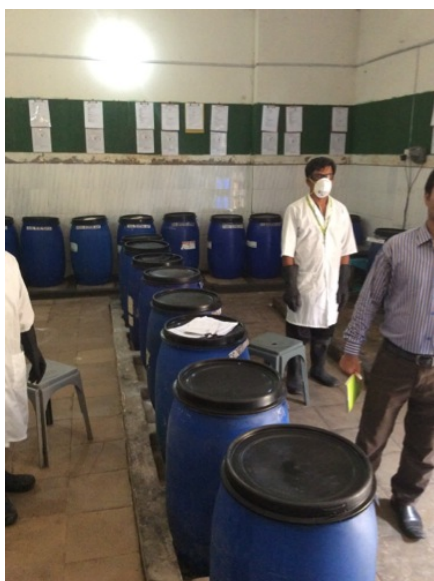
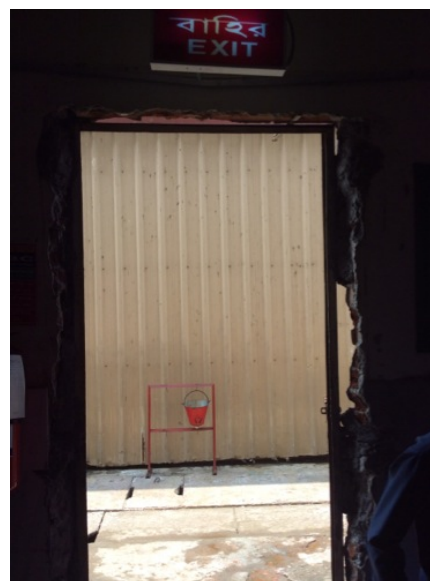
| F-1 | Fire Rated Construction | Hazardous materials and flammable liquid storage area is not separated by fire-rated construction. Chemical store does not have the required fire rated construction door assembly, penetration to walling present. | Separate the hazardous materials / flammable liquid storage room by a minimum 2-hr fire-rated construction. Seal and/or protected all openings to maintain the required fire separations. | Within 3 months |

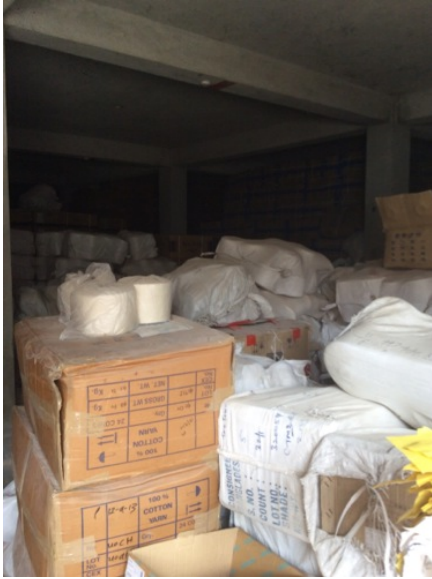
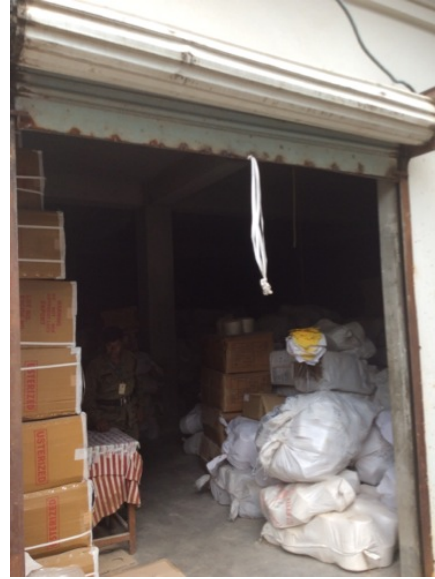
| F-2 | Fire Rated Construction | Areas used for combustible storage on the ground floor are not separated by fire-rated construction, roller shutters are used for entry to and from the storage space. | Provide dedicated storage rooms separated by minimum 1-hr fire-rated construction. | Within 3 months |

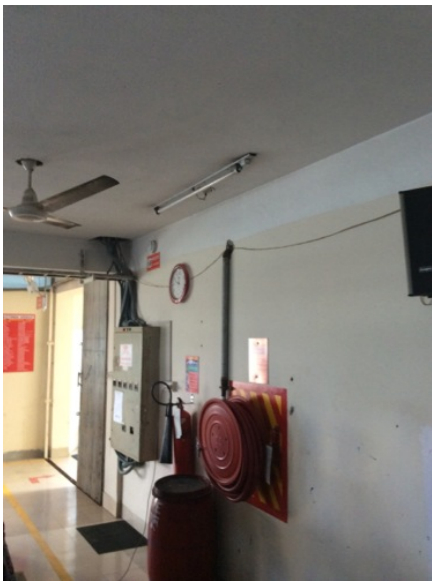
| F-3 | Fire Rated Construction | Unsealed penetrations and openings are located in the fire-rated floor/ceiling assemblies. | Provide a minimum 2-hr fire-rated shaft to separate the utility risers from each floor level. | Within 3 months |

| | | | Seal all penetrations and openings in floor/ceiling assemblies to maintain the fire separation. | |

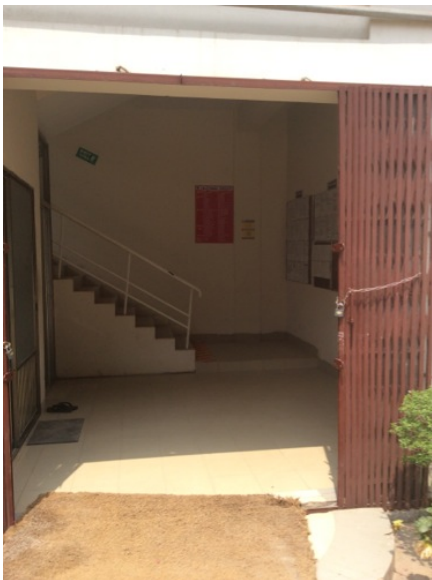
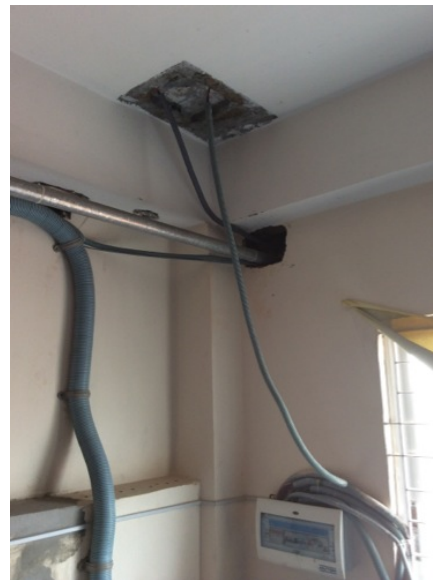
| F-4 | Fire Rated Construction | <p>The exit stairs are not separated from work areas, other spaces on each floor by fire-rated construction.</p> <p>Steel gated sliding doors are present on each floor.</p> | <p>Provide minimum 1.5-hr fire rated doors and seal all unprotected openings to separate the exit stairs from work areas and other building spaces on all floor levels.</p> <p>Ensure that the fire doors are self-closing and positive latching and that they are provided with fire exit (panic) hardware where serving production floors.</p> <p>If fire doors are required to be held open for functional reasons, provide automatic-closing devices tied to the fire alarm system.</p> | Within 3 months |

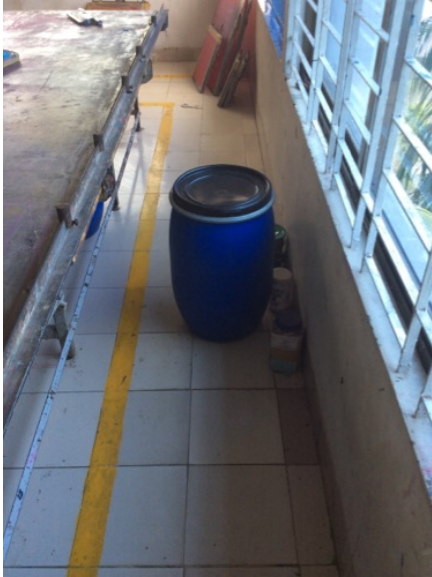
| F-5 | Egress | <p>Storage was located in the egress path on the Third floor.</p> | <p>Keep egress paths and stairs clear of storage.</p> | Immediate |

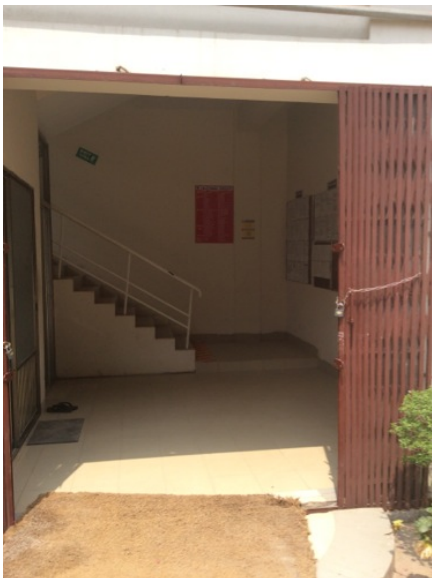
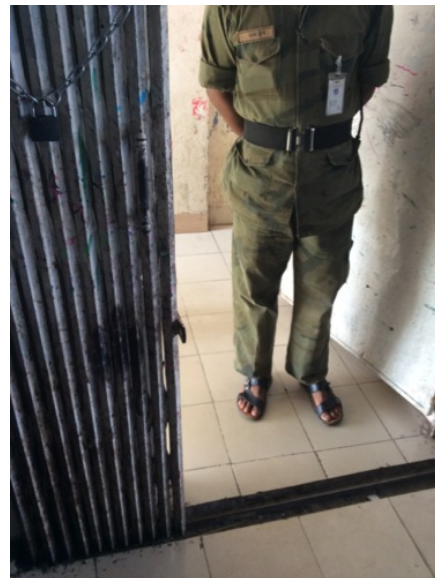
| F-6 | Egress | Egress doors gates with locking features are provided at building exits and main exit discharge. All gates/doors were open and unlocked during the inspection. | Remove locking features from all egress doors / gates.<br><br>If locks are required for security reasons, utilize special door locking features complying with NFPA 101. | Immediate |

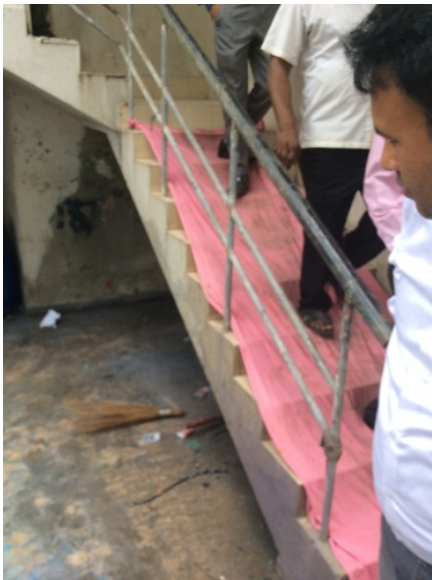
| F-7 | Egress | Fabric material has been fixed to stair risers and treads creating tripping and slipping hazard at the rear exit stairwell to the ground floor. | Remove fabric from stair treads. | Immediate |

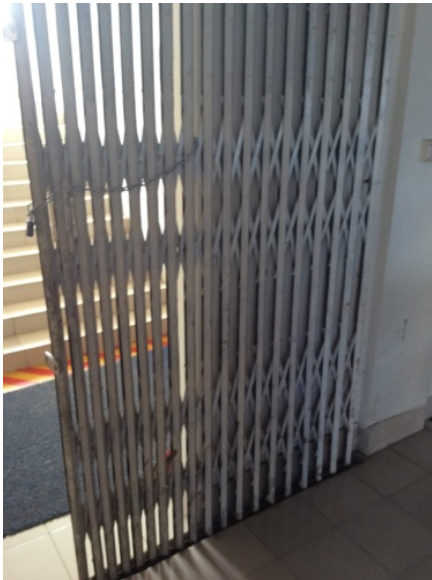
| F-8 | Egress | Collapsible gates / sliding doors are provided at building exits and main exit discharge points. | Replace all gates / sliding doors along the means of egress with side-hinged, swinging egress doors.<br><br>If locks are required for security reasons, utilize special door locking features complying with NFPA 101. | Within 1 month |

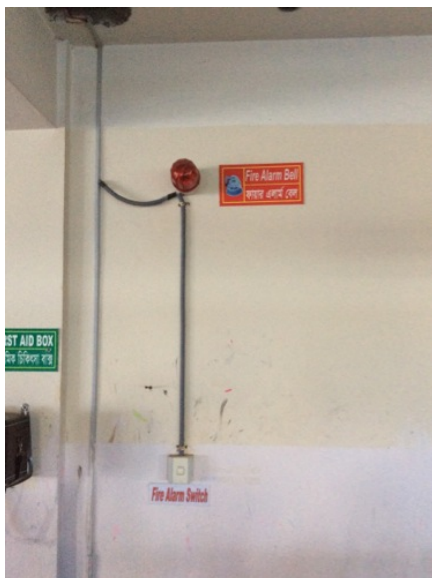
| F-9 | Fire Protection | The fire alarm system is antiquated, not a listed system, and does not provide alarm and notification features consistent with acceptable standards. | Replace the fire alarm system with a new, listed addressable fire alarm system in accordance with NFPA 72. | Design within 4 months, install within 9 months |

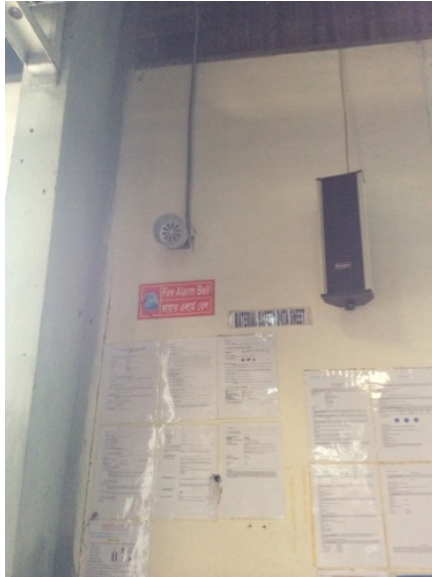
| F-10 | Fire Protection | Activation of the fire alarm system by a manual fire alarm station provides automatic occupant notification only on the floor of alarm and not throughout the building. | Configure the fire alarm system to initiate automatic occupant notification on all floor levels to facilitate whole-building evacuation upon any manual fire alarm station activation. | Within 1 months |

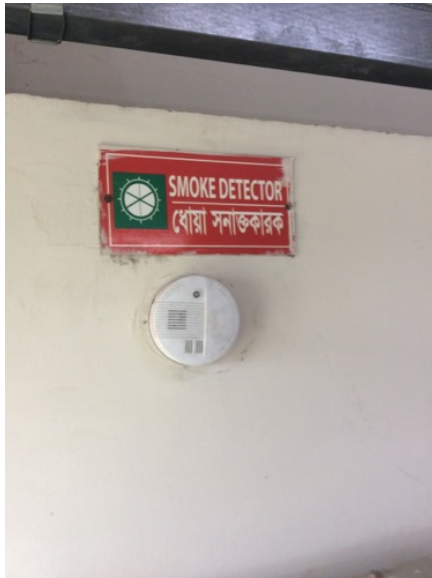
| F-12 | Fire Protection | The building is equipped with single-station smoke alarms. Smoke alarm activation sounds only a local alarm and does not provide automatic fire alarm notification of occupants. | Remove single-station smoke alarms. Provide automatic smoke detection throughout the building, tied into the fire alarm system, in accordance with NFPA 72. | Within 6 months |

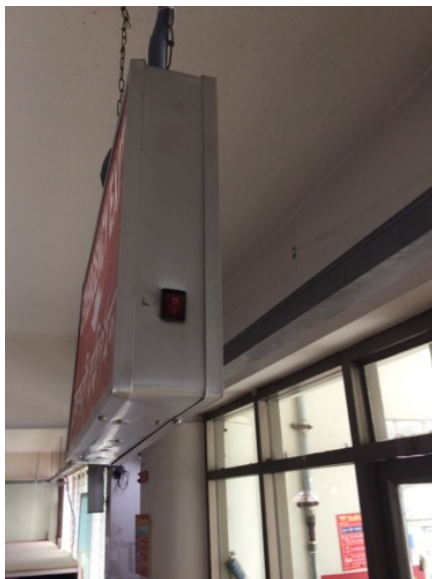
| F-13 | Egress Lighting | Manual on-off switch is provided for emergency lighting / exit signage units throughout the factory floors. | Remove manual on/off switches from emergency lighting / exit signage units to prevent them from being switched off. | Within 1 month |

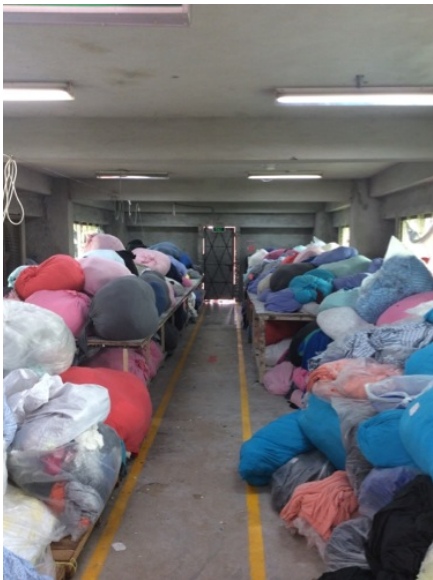
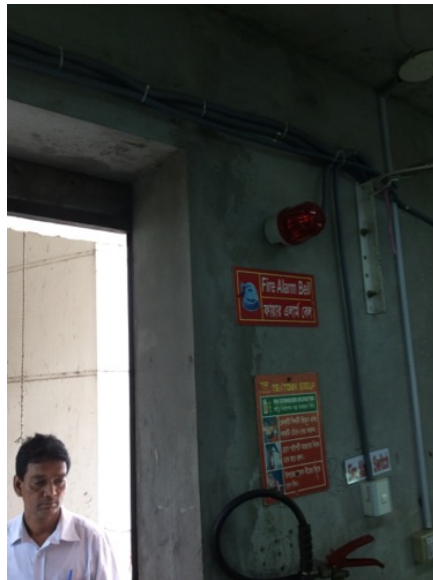
| No. | Category | Finding | Recommendation | Remediation Timeframe |
|---|---|---|---|---|
| F-1 | Fire Rated Construction | Areas used for combustible storage are not separated by fire-rated construction on the third floor, both exit doors are non fire rated. | Provide dedicated storage rooms separated by minimum 1-hr fire-rated construction. | Within 3 months |

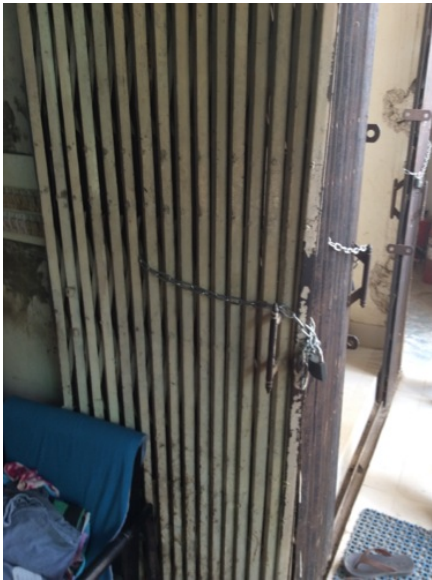
| No. | Category | Finding | Recommendation | Remediation Timeframe |
|---|---|---|---|---|
| F-2 | Egress | Egress doors and gates with locking features are provided at all building exits, exit stairs, along egress routes and main exit discharge. The doors were open and unlocked during the inspection. | Remove locking features from all egress doors / gates.<br><br>If locks are required for security reasons, utilize special door locking features complying with NFPA 101. | Immediate |

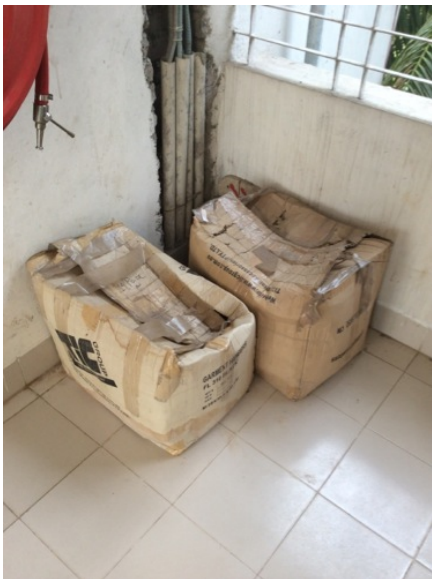
| F-3 | Egress | Storage was located throughout the exit stair. | Remove all storage from exit stairs and egress paths. | Immediate |

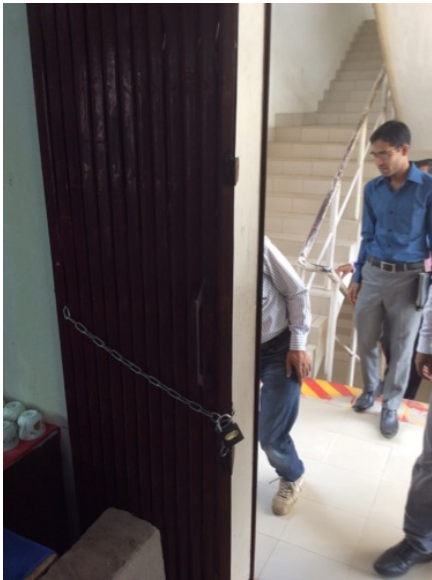
| F-4 | Egress | Collapsible gates/ sliding doors are provided at all building exits, exit stairs, along egress routes and main exit discharge. | Replace all gates / sliding doors along the means of egress with side-hinged, swinging egress doors.<br><br>If locks are required for security reasons, utilize special door locking features complying with NFPA 101. | Within 1 month |

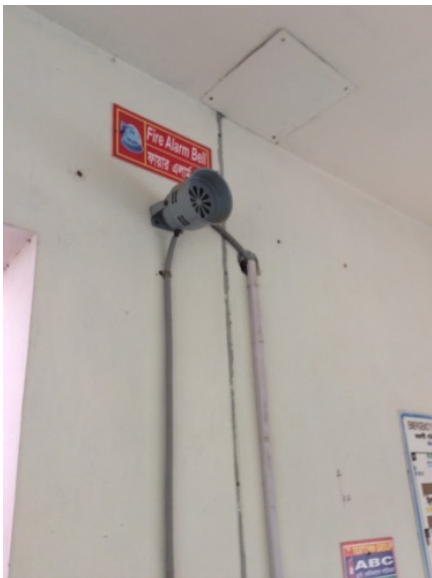
| F-5 | Fire Protection | The fire alarm system is antiquated, not a listed system, and does not provide alarm and notification features consistent with acceptable standards. | Replace the fire alarm system with a new, listed addressable fire alarm system in accordance with NFPA 72. | Design within 4 months, install within 9 months |

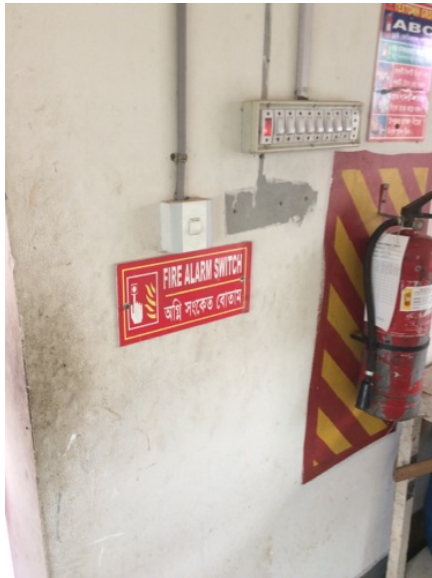
| F-6 | Fire Protection | Inspection, testing, and maintenance of the fire alarm system is not in accordance with NFPA 72. | Inspect, test and maintain the fire alarm system, and keep written records on-site, in accordance with NFPA 72. | Within 3 months |

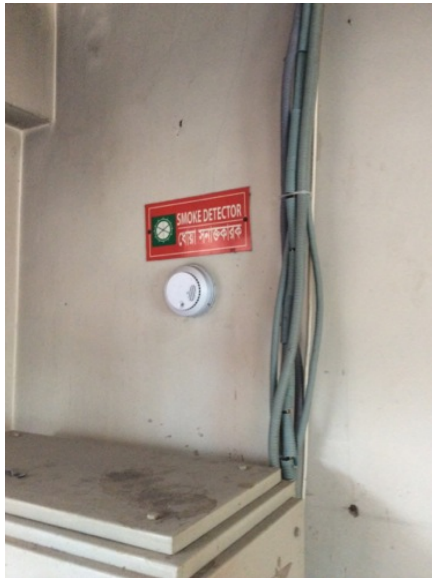
| F-8 | Fire Protection | The building is equipped with single-station smoke alarms. Smoke alarm activation sounds only a local alarm and does not provide automatic fire alarm notification of occupants. | Remove single-station smoke alarms. Provide automatic smoke detection throughout the building, tied into the fire alarm system, in accordance with NFPA 72. | Within 6 months |

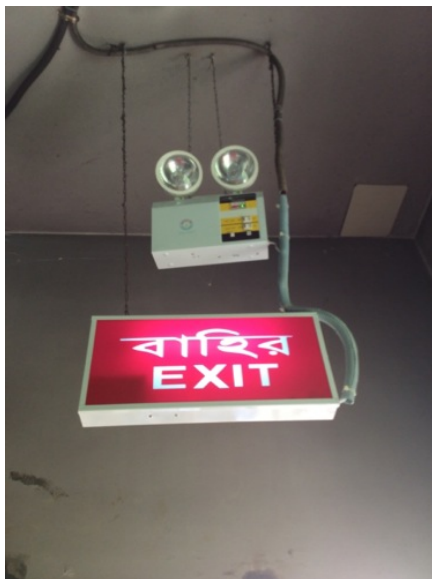
| F-9 | Egress Lighting | Manual on-off switch is provided for emergency lighting / exit signage units in this building. | Remove manual on/off switches from emergency lighting / exit signage units to prevent them from being switched off. | Within 1 month |

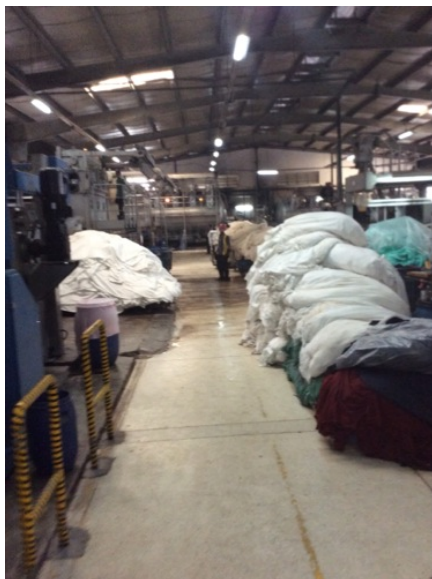
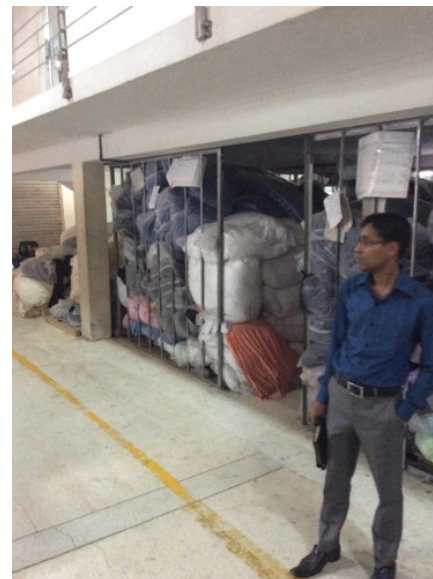
| No. | Category | Finding | Recommendation | Remediation Timeframe |
|---|---|---|---|---|
| F-1 | Fire Rated Construction | Areas used for combustible storage are not separated by fire-rated construction on the ground floor, Large storage area with non adequate fire rated separation. Storage open throughout the ground floor being processed in large quantities. | <p>Provide dedicated storage rooms separated by minimum 1-hr fire-rated construction.</p> <p>Where separate storage rooms are not feasible, provide defined storage areas and limit the storage arrangement as follows:</p> <ul style="list-style-type: none"> <li>- Maximum height of 2.4m and maximum area of 23m<sup>2</sup></li> <li>- If sprinkler protected: maximum height of 3.66m and maximum area of 93m<sup>2</sup></li> </ul> <p>Separate areas of unenclosed combustible storage by a minimum clear distance of 3m.</p> | Within 3 months |

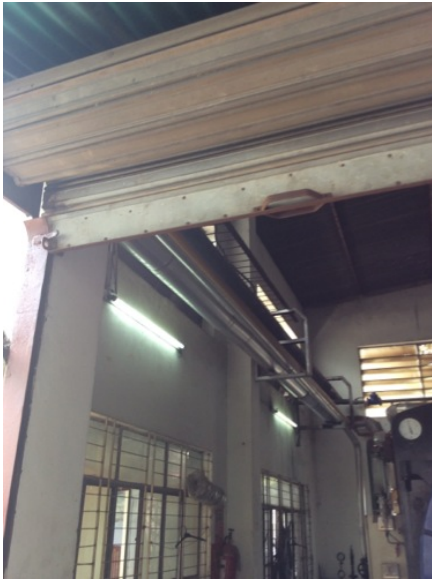
| F-2 | Egress | Roller shutters with locking features are provided at building exits. All roller shutters were open and unlocked during the inspection. | Remove locking features from all egress doors / gates.<br><br>If locks are required for security reasons, utilize special door locking features complying with NFPA 101. | Immediate |

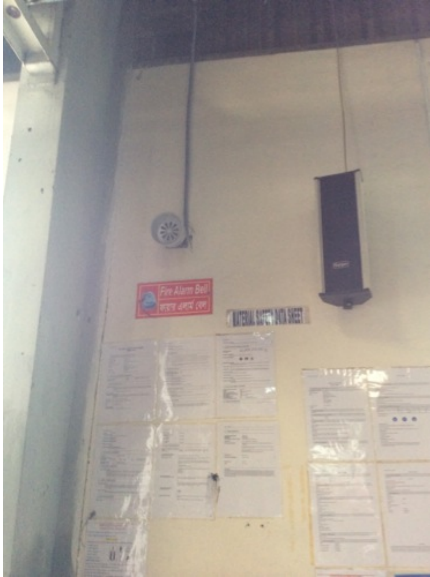
| F-3 | Fire Protection | The fire alarm system is antiquated, not a listed system, and does not provide alarm and notification features consistent with acceptable standards. | Replace the fire alarm system with a new, listed addressable fire alarm system in accordance with NFPA 72. | Design within 4 months, install within 9 months |

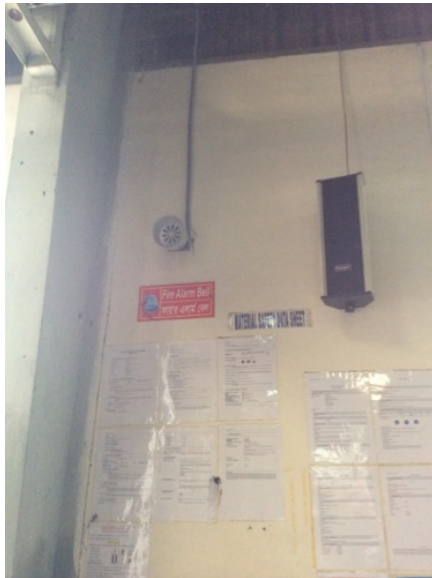
| F-5 | Fire Protection | The fire alarm system at present does not appear to provide adequate audible notification coverage required for the decibel levels the production on this factory floor creates. | Provide additional notification appliances such that the fire alarm system is audible throughout the building in accordance with NFPA 72. | Within 6 months |

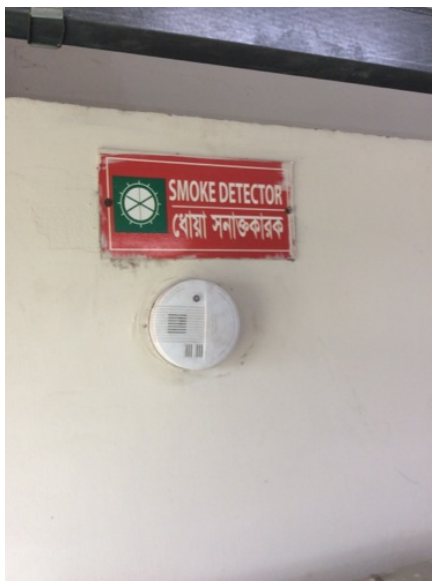
| F-6 | Fire Protection | The building is equipped with single-station smoke alarms. Smoke alarm activation sounds only a local alarm and does not provide automatic fire alarm notification of occupants. | Remove single-station smoke alarms. Provide automatic smoke detection throughout the building, tied into the fire alarm system, in accordance with NFPA 72. | Within 6 months |

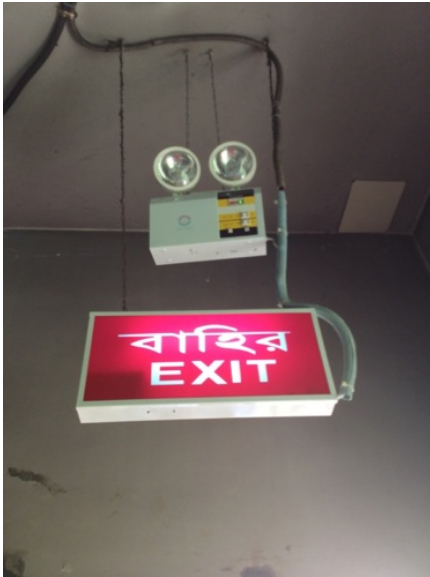
| F-7 | Egress Lighting | Manual on-off switch is provided for emergency lighting / exit signage units on the ground and mezzanine level of this shed building. | Remove manual on/off switches from emergency lighting / exit signage units to prevent them from being switched off. | Within 1 month |

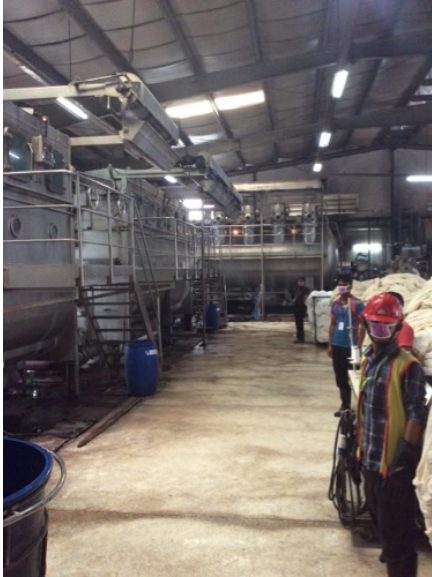
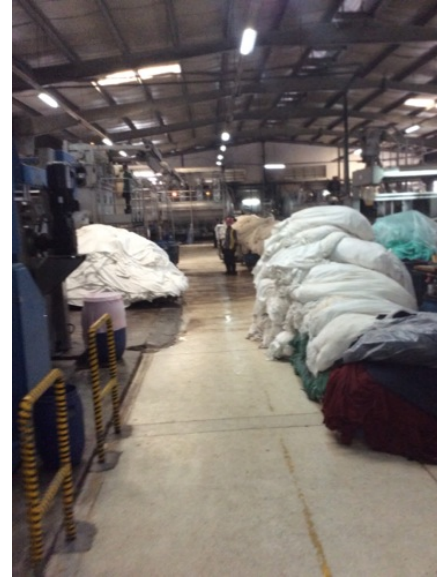
| F-8 | Egress Lighting | Based on the number and location of emergency lights observed, adequate illumination levels are not anticipated along egress routes at ground floor level. | Test the emergency lighting system on each floor and provide additional emergency fixtures to provide adequate illumination along the means of egress. Provide a minimum illumination of 10 lux at the floor level within exit stairs and exit discharge paths and minimum 2.5 lux along exit access aisles. | Within 3 months |
