# **FIRE SAFETY INSPECTION REPORT**

## **PARKVIEW DRESSES LTD.**

**OLD-30/2, NEW-111, DARAIL, SATAISH, TONGI**

June 9, 2014

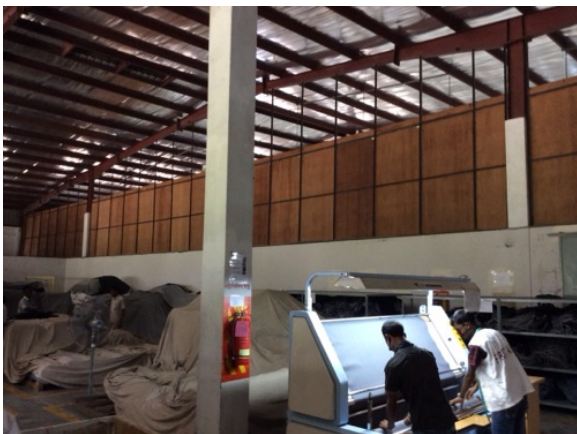
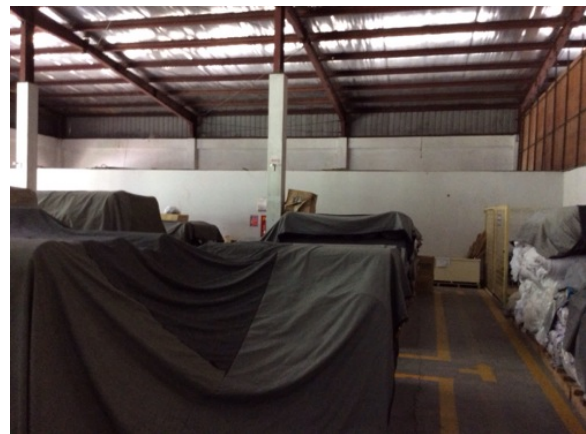
F-1	Fire Rated Construction	The dedicated storage area was not separated from the adjacent working working areas (Cutting section and Office zone) by means of fire rated construction (non-rated door and unprotected openings)	Provide dedicated storage rooms separated by minimum 1-hr fire-rated construction.	Within 3 months
-----	----------------------------	--	--	-----------------

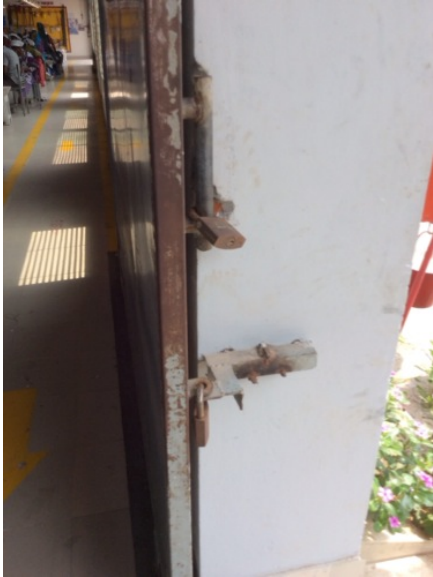
F-2	Egress	Egress doors / gates with locking features are provided along egress routes and at all building exits	Remove locking features from all egress doors / gates.  If locks are required for security reasons, utilize special door locking features complying with NFPA 101.	Immediate
-----	--------	---	--	-----------

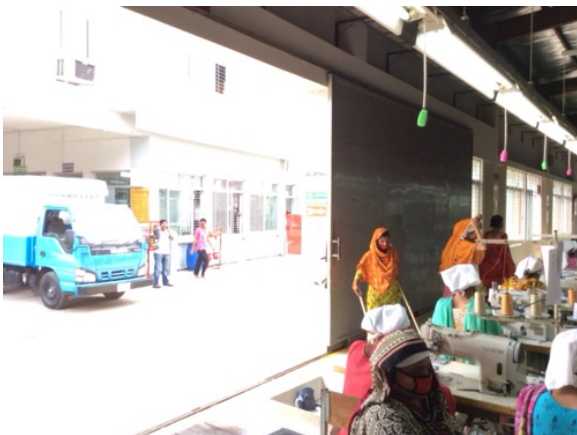
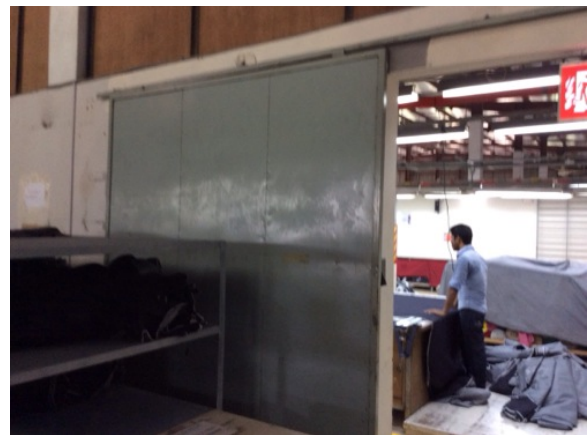
F-3	Egress	Collapsible gates and sliding doors are provided along egress routes and at all building exits	Replace all gates / sliding doors along the means of egress with side-hinged, swinging egress doors.  If locks are required for security reasons, utilize special door locking features complying with NFPA 101.	Within 1 month
-----	--------	--	--	----------------

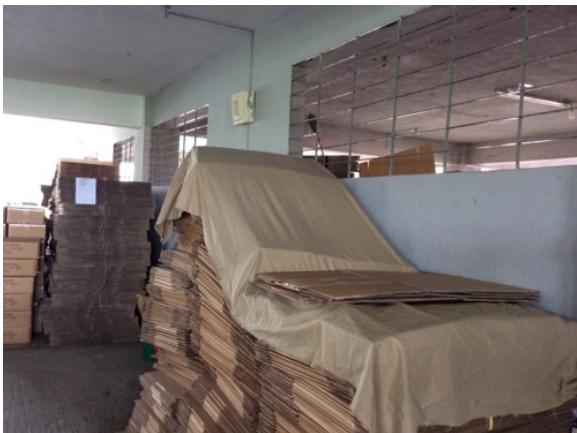
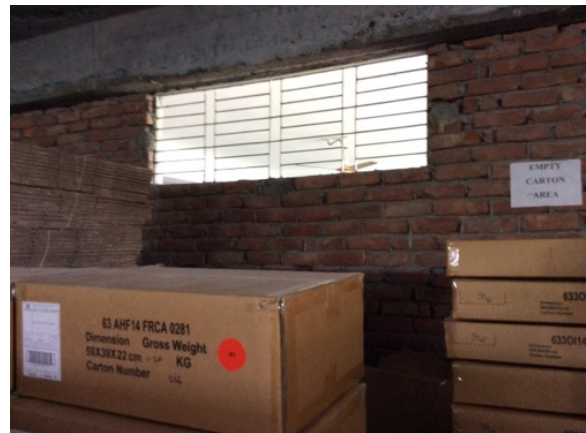
F-1	Fire Rated Construction	The dedicated storage areas on the 1st floor was not separated from the dining area by means of fire rated construction (non-rated door and unprotected openings).	Provide dedicated storage rooms separated by minimum 1-hr fire-rated construction.	Within 3 months
-----	-------------------------	--	--	-----------------

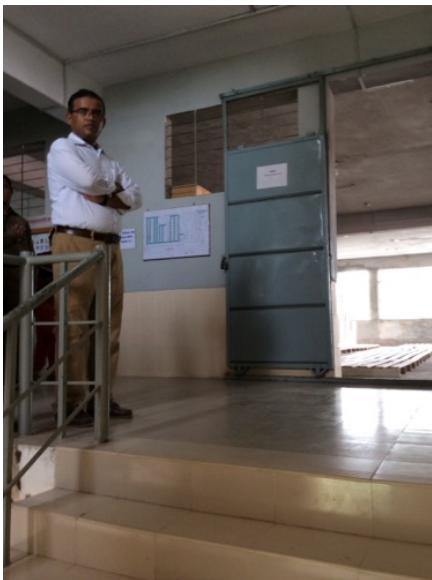
F-2	Fire Rated Construction	The exit stairs are not separated from work areas on each floor by fire-rated construction.	Provide minimum 1.5-hr fire rated doors and seal all unprotected openings to separate the exit stairs from work areas and other building spaces on all floor levels. Ensure that the fire doors are self-closing and positive latching and that they are provided with fire exit (panic) hardware where serving production floors.  If fire doors are required to be held open for functional reasons, provide automatic-closing devices tied to the fire alarm system.	Within 3 months
-----	-------------------------	---	---	-----------------

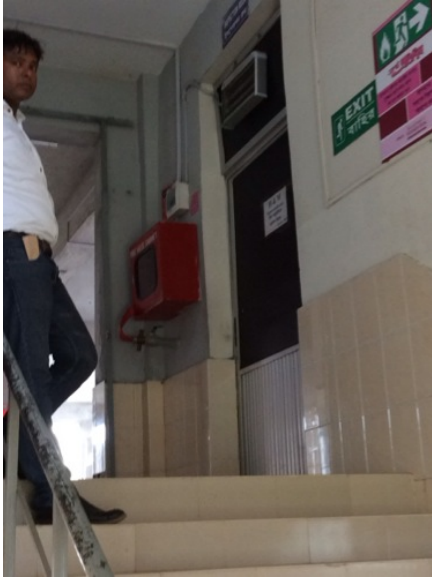
F-3	Fire Rated Construction	Unsealed penetrations and openings are located in both the exit stair enclosures on the 1st floor.	Seal all penetrations and openings in exit stair enclosure walls to maintain the fire separation.	Within 3 months
-----	-------------------------	--	---	-----------------

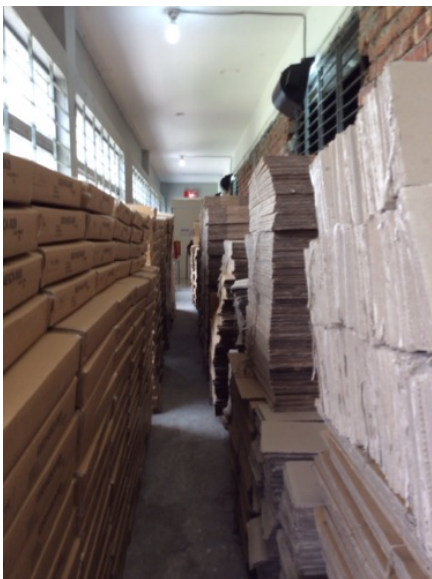
F-4	Egress	Egress doors / gates with locking features are provided at all exit stairs and exit discharge.	Remove locking features from all egress doors / gates.  If locks are required for security reasons, utilize special door locking features complying with NFPA 101.	Immediate
F-5	Egress	Storage was located in the egress pathway leading to the southern exit stair on the 1st floor.	Keep egress paths and stairs clear of storage.	Immediate

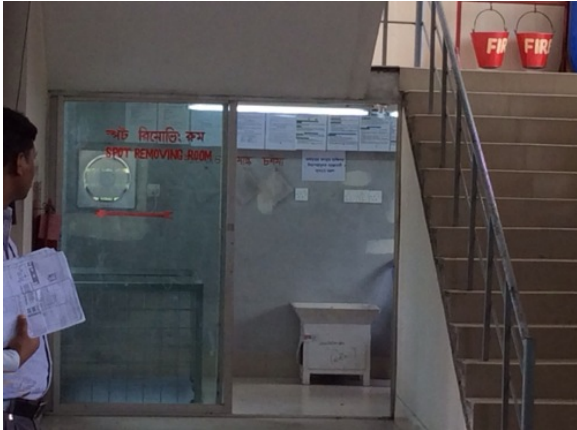
F-6	Egress	Storage was located inside the southern exit stair enclosure on the ground floor.	Remove all storage from exit stairs and egress paths.	Immediate
-----	--------	---	---	-----------

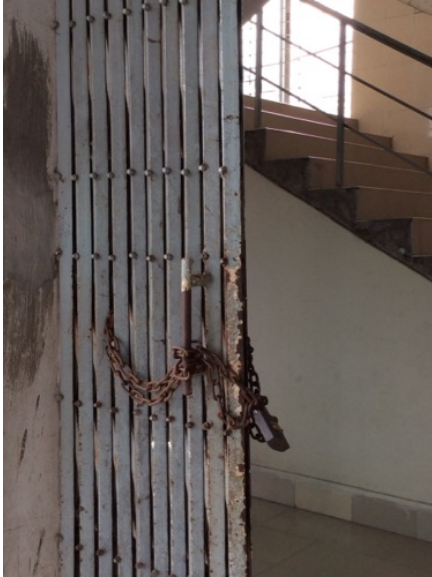
F-7	Egress	Collapsible gates / sliding doors are provided at all exit stairs and exit discharges.	Replace all gates / sliding doors along the means of egress with side-hinged, swinging egress doors.  If locks are required for security reasons, utilize special door locking features complying with NFPA 101.	Within 1 month
-----	--------	--	--	----------------

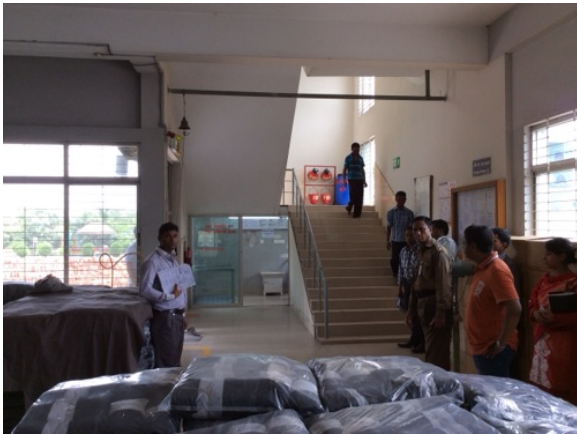
F-8	Egress	The southern exit stairs discharge inside the building.	Provide 2-hr fire-rated exit passageway leading directly outside (vestibules to separate any storage areas).	Within 6 months
-----	--------	---	--	-----------------
