# **FIRE SAFETY INSPECTION REPORT**

**DIGANTA SWEATERS LTD.  
NAOUJOOR, TANGAIL ROAD, CHANDANA  
CHOWRASTA GAZIPUR**

**ACCORD**  
on Fire and Building Safety in Bangladesh

March 30, 2014

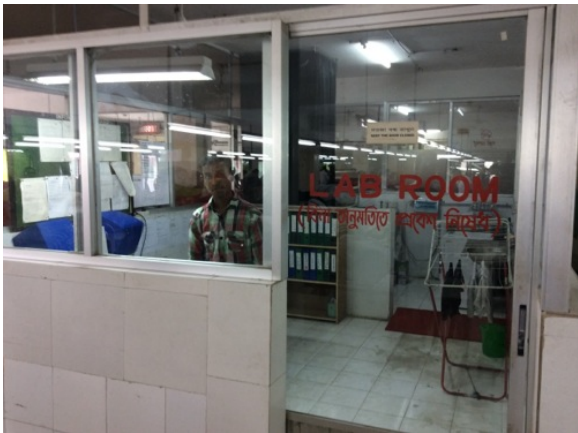
| No. | Category | Finding | Recommendation | Remediation Timeframe |
|---|---|---|---|---|
| F-1 | Fire Rated Construction | <p>Hazardous materials area is not separated by fire-rated construction (openings, non-rated doors, penetrations).</p> <p>There is a lab on the second floor that is not separated from the working floor area.</p> | <p>Separate the hazardous materials / flammable liquid storage room by a minimum 2-hr fire-rated construction. Seal and/or protected all openings to maintain the required fire separations.</p> | Within 3 months |

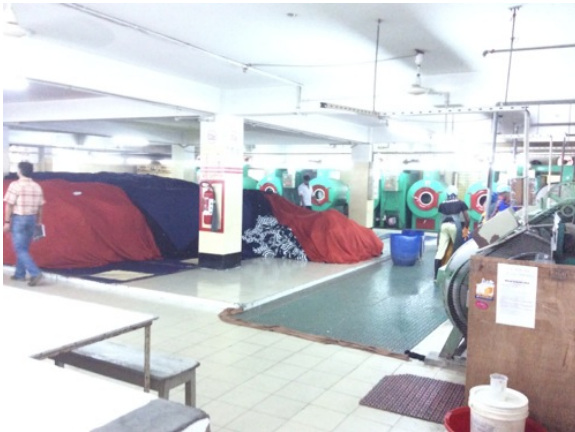
| No. | Category | Finding | Recommendation | Remediation Timeframe |
|---|---|---|---|---|
| F-2 | Fire Rated Construction | <p>The industrial dryers are not separated by fire-rated construction (openings, non-rated doors, penetrations).</p> <p>Located on the second floor.</p> | <p>Separate the industrial dryers by a minimum 2-hr fire-rated construction. Seal and/or protected all openings to maintain the required fire separations</p> | Within 3 months |

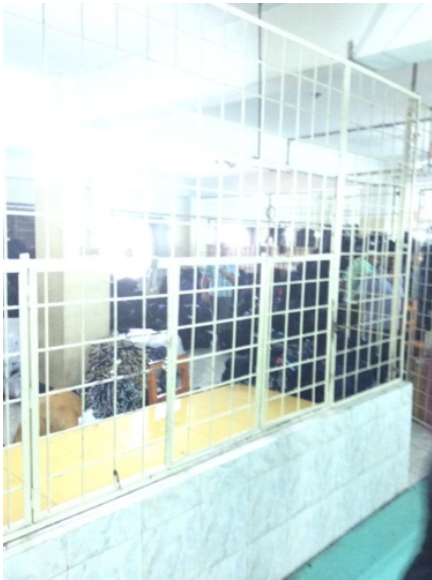
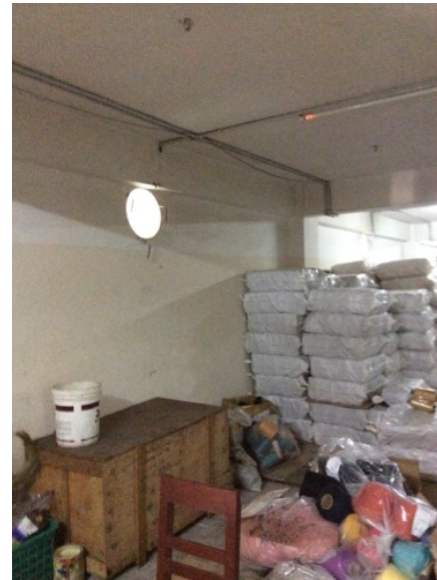
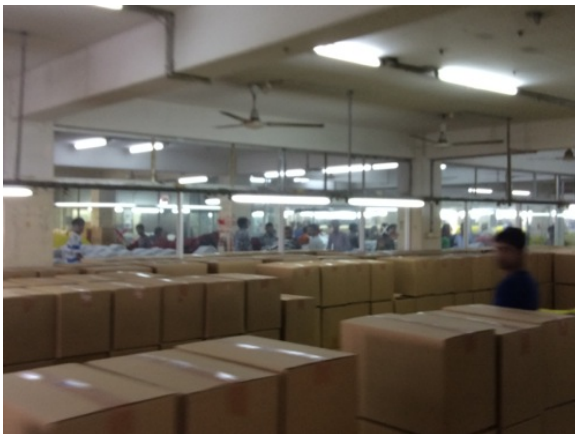
| F-3 | Fire Rated Construction | <p>Areas used for combustible storage are not separated by fire-rated construction.</p> <p>All Floors</p> | <p>Provide dedicated storage rooms separated by minimum 1-hr fire-rated construction.</p> <p>Where separate storage rooms are not feasible, provide defined storage areas and limit the storage arrangement as follows:</p> <ul style="list-style-type: none"> <li>- Maximum height of 2.4m and maximum area of 23m<sup>2</sup></li> <li>- If sprinkler protected: maximum height of 3.66m and maximum area of 93m<sup>2</sup></li> </ul> <p>Separate areas of unenclosed combustible storage by a minimum clear distance of 3m.</p> | Within 3 months |

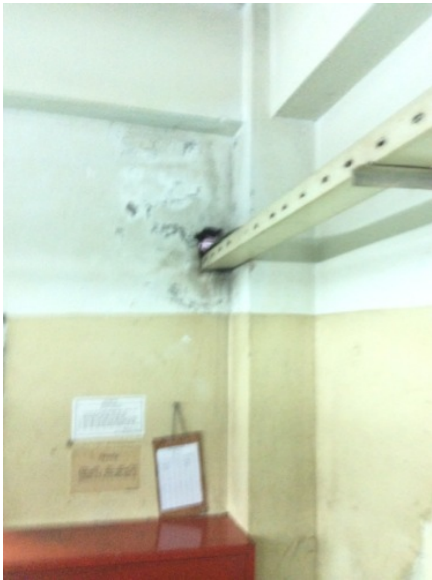
| F-4 | Fire Rated Construction | Unsealed penetrations and openings are located in the fire-rated floor/ceiling assemblies. | Provide a minimum 2-hr fire-rated shaft to separate the utility risers from each floor level.<br><br>Seal all penetrations and openings in floor/ceiling assemblies to maintain the fire separation. | Within 3 months |

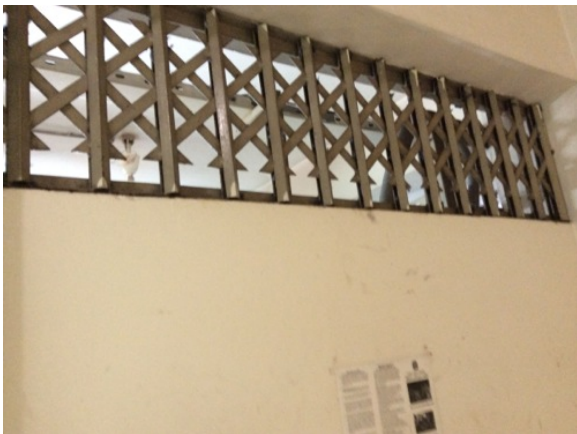
| F-5 | Fire Rated Construction | Unsealed penetrations and openings are located in exit stair enclosures. | Seal all penetrations and openings in exit stair enclosure walls to maintain the fire separation. | Within 3 months |

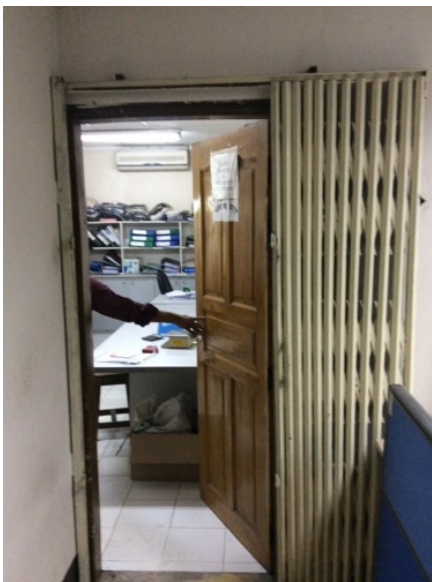
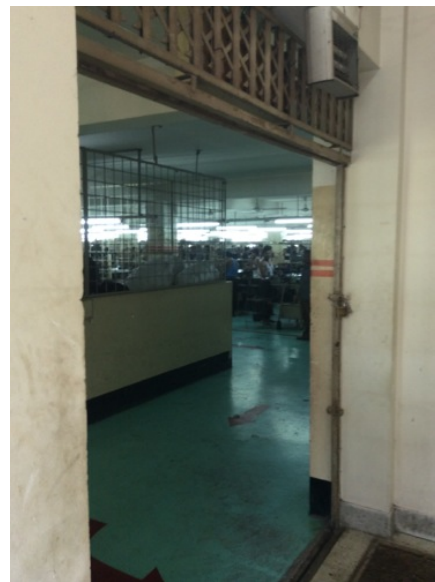
| F-6 | Egress | <p>Egress doors / gates with locking features are provided at building exits, exit stairs, along egress routes and exit discharge.</p> <p>All floors had locks on egress gates. Most of the gates were open but there were a few that we found locked up.</p> | <p>Remove locking features from all egress doors / gates.</p> <p>If locks are required for security reasons, utilize special door locking features complying with NFPA 101.</p> | Immediate |

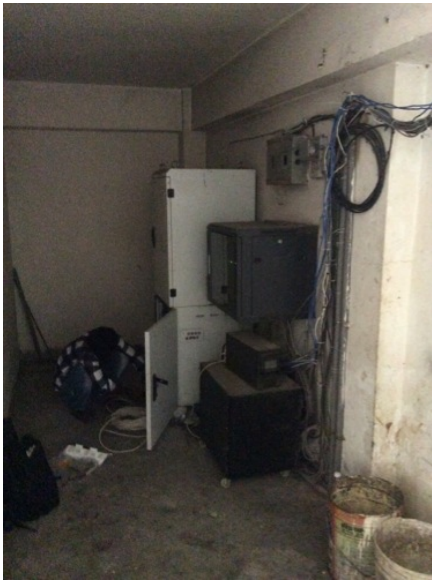
| F-7 | Egress | <p>Storage was located in the SW exit stair at the top and small item through out all exit stairs..</p> | <p>Remove all storage from exit stairs and egress paths.</p> | Immediate |

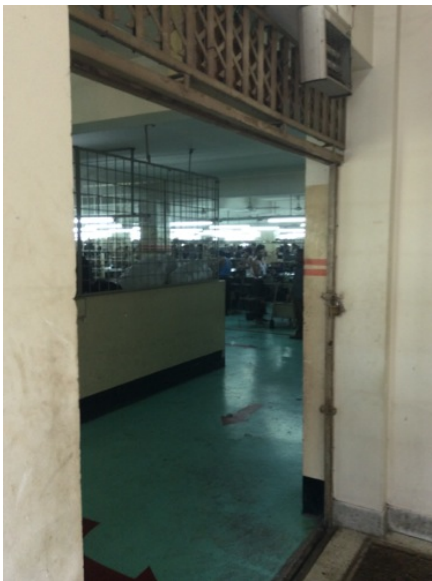
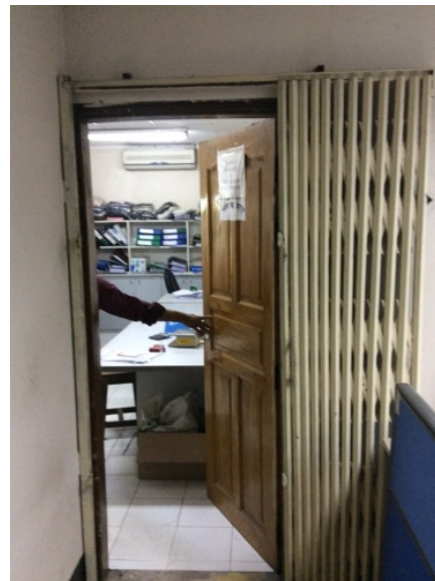
| F-8 | Egress | <p>Collapsible gates / sliding doors are provided at building exits, exit stairs, along egress routes and exit discharge.</p> <p>Located at all exit stairs/</p> | <p>Replace all gates / sliding doors along the means of egress with side-hinged, swinging egress doors.</p> <p>If locks are required for security reasons, utilize special door locking features complying with NFPA 101.</p> | <p>Within 1 month</p> |

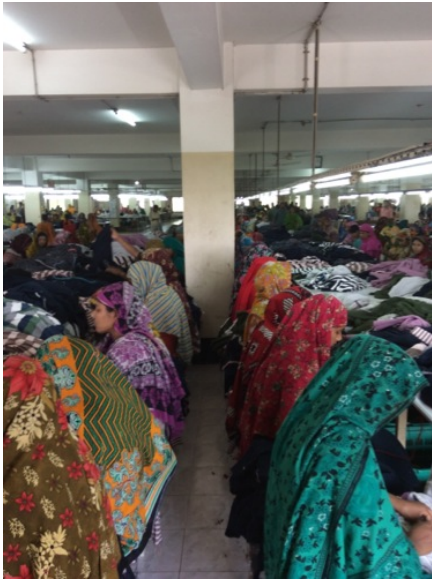
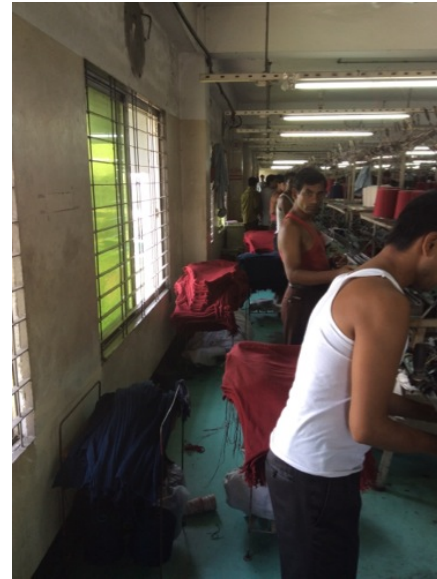
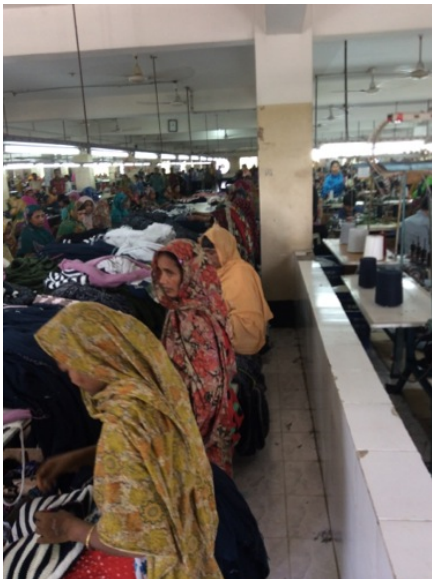
| F-9 | Egress | The width of egress aisles is less than 36-in. | Provide minimum aisle widths of 36-in. | Within 3 months |

Locations:

3rd, 4th and 5th floor.

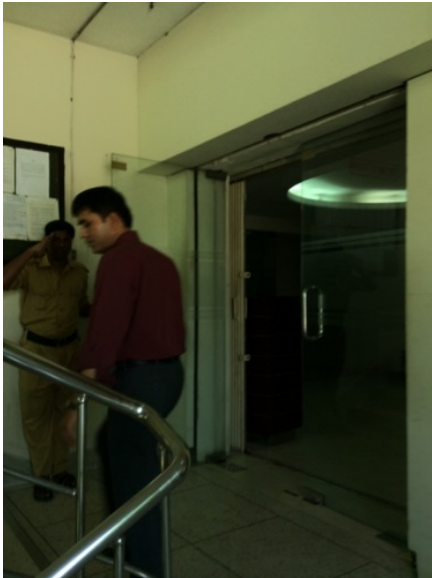
| F-10 | Egress | Exit stair door does not swing in the direction of egress travel.<br><br>Location:<br><br>1st floor NE stair. | Modify the egress door to swing in the direction of egress travel. | Within 3 months |

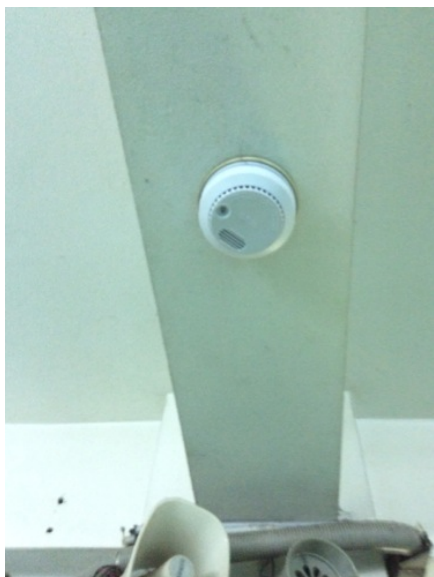
| F-14 | Fire Protection | The building is equipped with single-station smoke alarms. Smoke alarm activation sounds only a local alarm and does not provide automatic fire alarm notification of occupants. | Replace the single-station smoke alarms with automatic smoke detectors tied into the fire alarm system. Configure the fire alarm system to initiate occupant notification upon activation of any two smoke detectors in addition to the manual fire alarm stations. | Within 6 months |

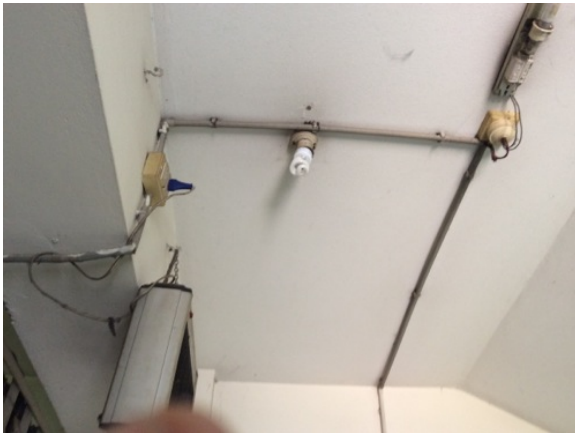
| F-17 | Egress Lighting | Emergency lighting did not function in test mode (burned out, broken, etc.).<br><br>Through out building. | Regularly test the emergency lighting system on each floor and replace/repair lights as needed. | Within 3 months |

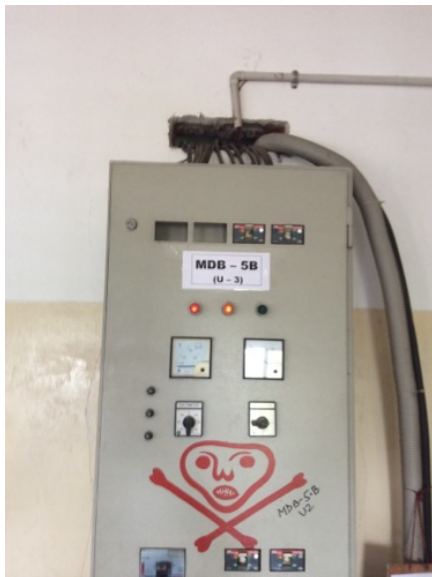
| No. | Category | Finding | Recommendation | Remediation Timeframe |
|---|---|---|---|---|
| F-1 | Fire Rated Construction | Unsealed penetrations and openings are located in the fire-rated floor/ceiling assemblies. | Provide a minimum 2-hr fire-rated shaft to separate the utility risers from each floor level.<br><br>Seal all penetrations and openings in floor/ceiling assemblies to maintain the fire separation. | Within 3 months |

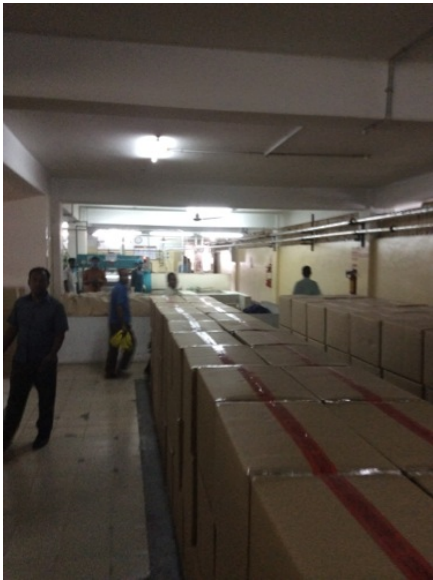
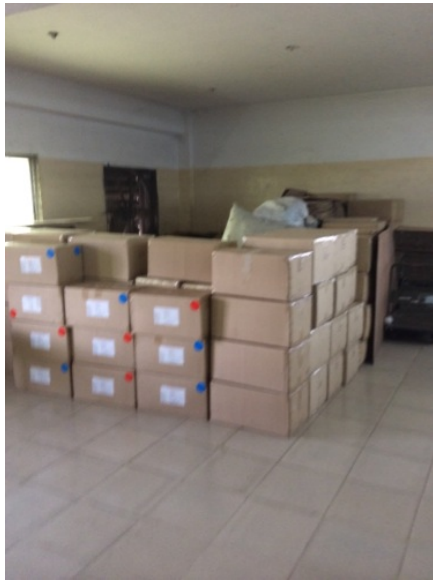
| F-2 | Fire Rated Construction | <p>Areas used for combustible storage are not separated by fire-rated construction.</p> <p>All Floors.</p> | <p>Provide dedicated storage rooms separated by minimum 1-hr fire-rated construction.</p> <p>Where separate storage rooms are not feasible, provide defined storage areas and limit the storage arrangement as follows:</p> <ul style="list-style-type: none"> <li>- Maximum height of 2.4m and maximum area of 23m<sup>2</sup></li> <li>- If sprinkler protected: maximum height of 3.66m and maximum area of 93m<sup>2</sup></li> </ul> <p>Separate areas of unenclosed combustible storage by a minimum clear distance of 3m.</p> | Within 3 months |

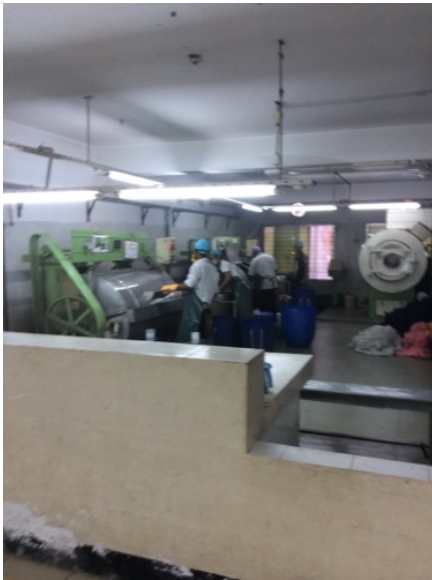
| F-3 | Fire Rated Construction | <p>Hazardous materials area is not separated by fire-rated construction (openings, non-rated doors, penetrations).</p> <p>Located on multiple floors.</p> | <p>Separate the hazardous materials storage room by a minimum 2-hr fire-rated construction. Seal and/or protected all openings to maintain the required fire separations.</p> | Within 3 months |

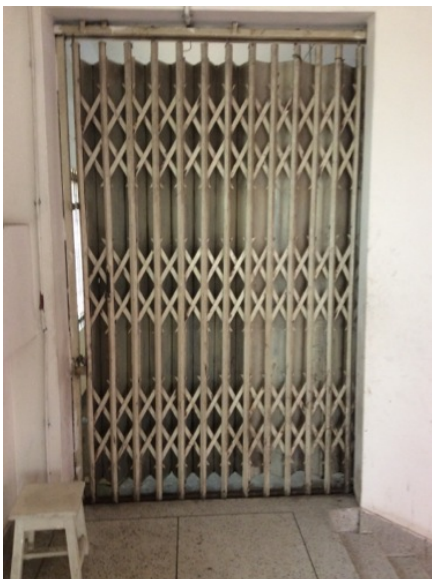
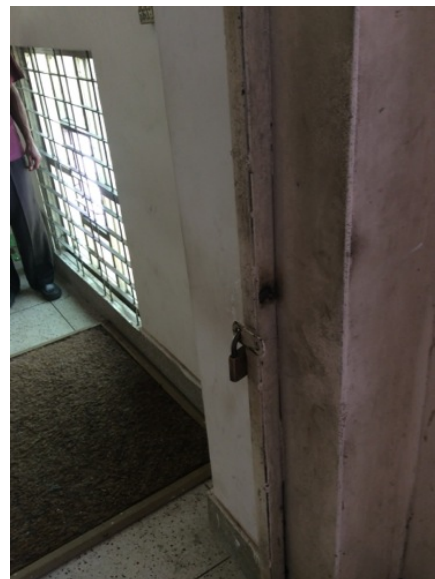
| F-4 | Egress | <p>Egress doors / gates with locking features are provided at building exits, exit stairs, along egress routes and exit discharge.</p> <p>All exit locations and most gates were open during inspection, but some were closed.</p> | <p>Remove locking features from all egress doors / gates.</p> <p>If locks are required for security reasons, utilize special door locking features complying with NFPA 101.</p> | Immediate |

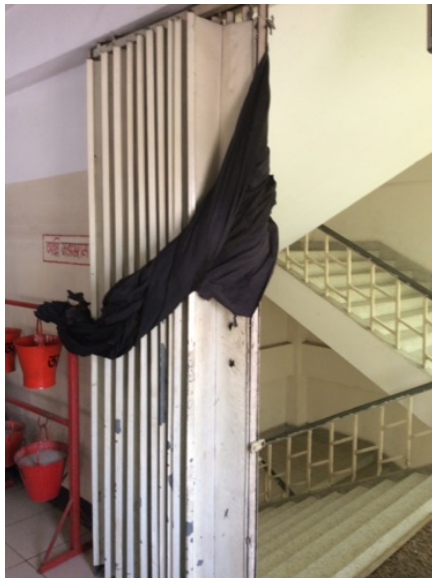
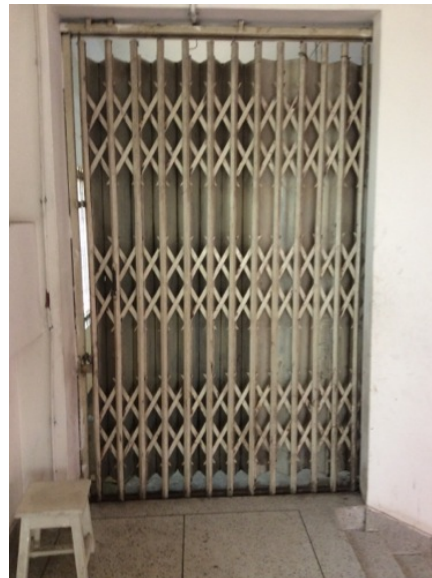
| F-5 | Egress | <p>Collapsible gates / sliding doors are provided at building exits, exit stairs, along egress routes and exit discharge.</p> <p>At all exit locations.</p> | <p>Replace all gates / sliding doors along the means of egress with side-hinged, swinging egress doors.</p> <p>If locks are required for security reasons, utilize special door locking features complying with NFPA 101.</p> | Within 1 month | |

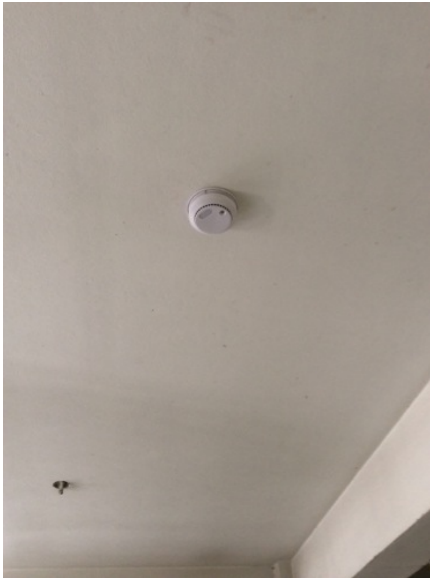
| F-8 | Fire Protection | The building is equipped with single-station smoke alarms. Smoke alarm activation sounds only a local alarm and does not provide automatic fire alarm notification of occupants. | Replace the single-station smoke alarms with automatic smoke detectors tied into the fire alarm system. Configure the fire alarm system to initiate occupant notification upon activation of any two smoke detectors in addition to the manual fire alarm stations. | Within 6 months |

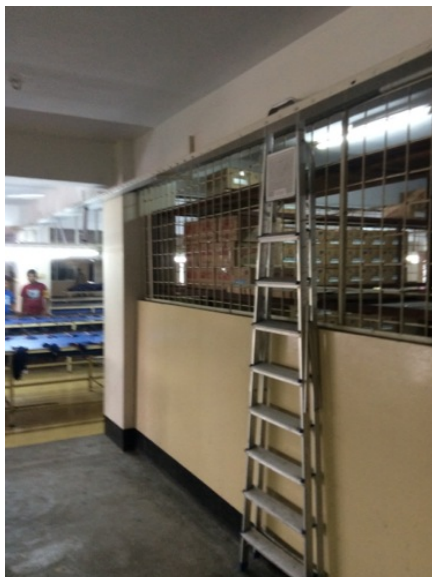
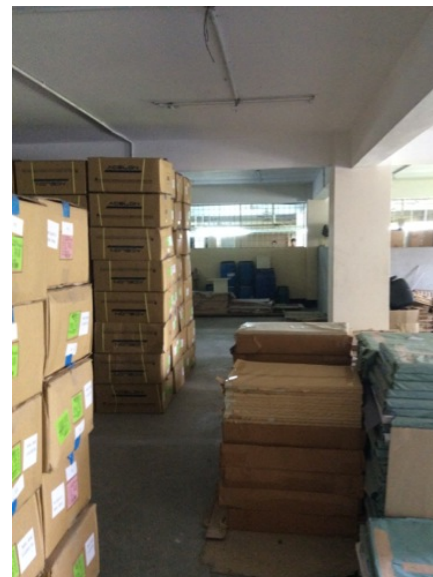
| No. | Category | Finding | Recommendation | Remediation Timeframe |
|---|---|---|---|---|
| F-1 | Fire Rated Construction | <p>Areas used for combustible storage are not separated by fire-rated construction.</p> <p>Location:<br/>First Floor</p> | <p>Provide dedicated storage rooms separated by minimum 1-hr fire-rated construction.</p> <p>Where separate storage rooms are not feasible, provide defined storage areas and limit the storage arrangement as follows:</p> <ul style="list-style-type: none"> <li>- Maximum height of 2.4m and maximum area of 23m<sup>2</sup></li> <li>- If sprinkler protected: maximum height of 3.66m and maximum area of 93m<sup>2</sup></li> </ul> <p>Separate areas of unenclosed combustible storage by a minimum clear distance of 3m.</p> | Within 3 months |

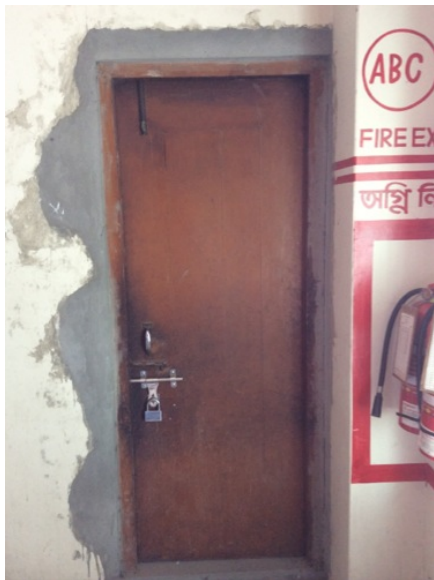
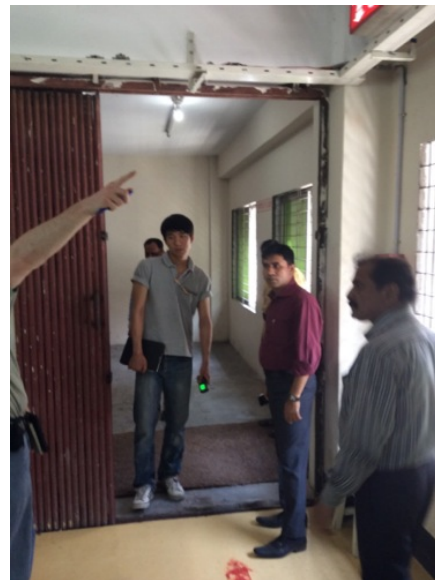
| F-2 | Fire Rated Construction | The exit stairs are not separated from work areas and other spaces on each floor by fire-rated construction. | Provide minimum 1.5-hr fire rated doors and seal all unprotected openings to separate the exit stairs from work areas and other building spaces on all floor levels. Ensure that the fire doors are self-closing and positive latching and that they are provided with fire exit (panic) hardware where serving production floors.<br><br>If fire doors are required to be held open for functional reasons, provide automatic-closing devices tied to the fire alarm system. | Within 3 months |

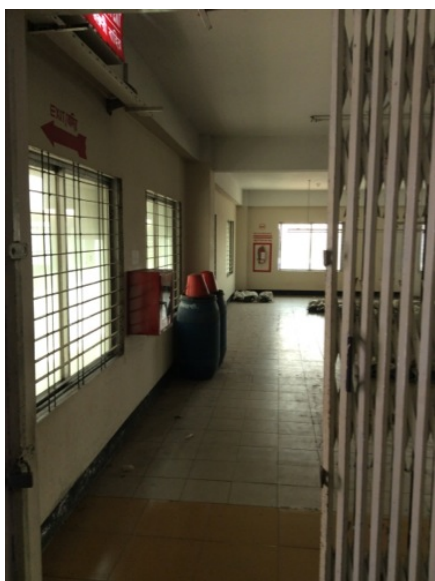
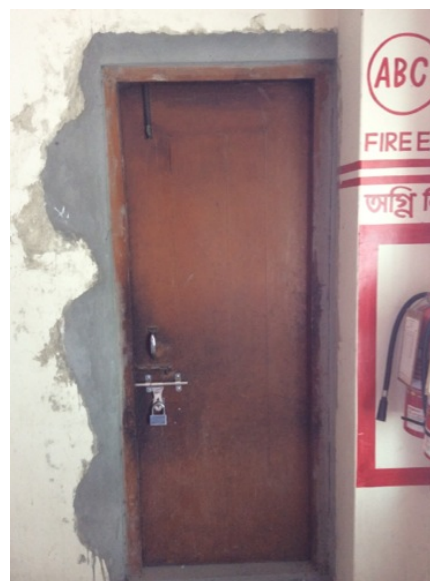
| F-3 | Egress | Egress doors / gates with locking features are provided at building exits, exit stairs, along egress routes, and exit discharge. | Remove locking features from all egress doors / gates.<br><br>If locks are required for security reasons, utilize special door locking features complying with NFPA 101. | Immediate |

These were located on all floors.

Doors were open and unlocked during the inspection.

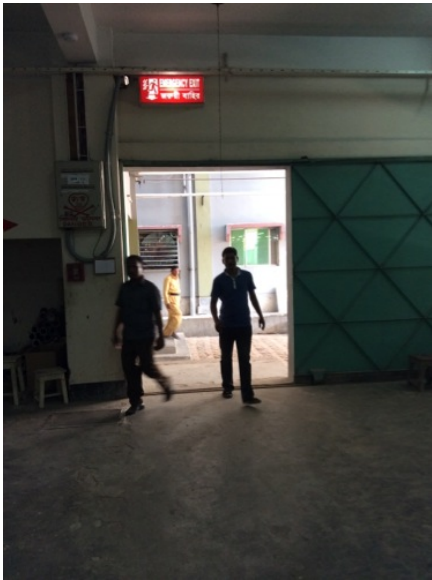
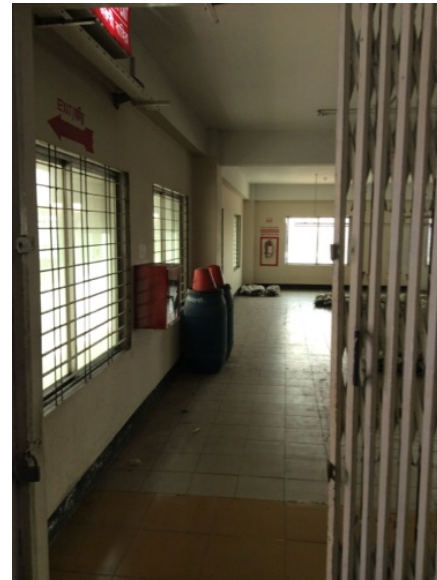
| F-4 | Egress | Collapsible gates / sliding doors are provided at building exits, exit stairs, along egress routes, and exit discharge.<br><br>Located on all floors. | Replace all gates / sliding doors along the means of egress with side-hinged, swinging egress doors.<br><br>If locks are required for security reasons, utilize special door locking features complying with NFPA 101. | Within 1 month |

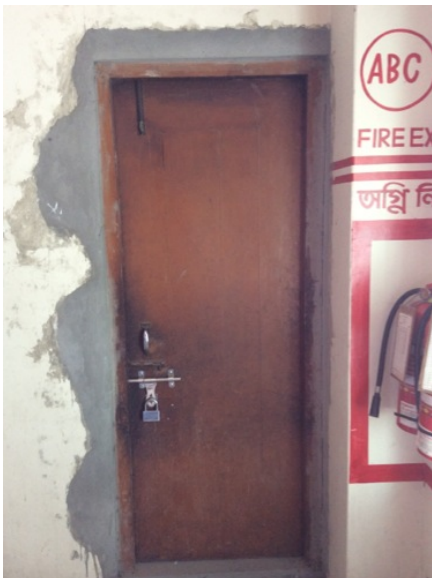
| F-5 | Egress | Exit stair door does not swing in the direction of egress travel. | Modify the egress door to swing in the direction of egress travel. | Within 3 months |
| Location: | | | | |
| South Stairwell landing on the first floor. | | | | |
