# FIRE SAFETY INSPECTION REPORT

## HOPLUN APPARELS LTD.-(UNIT-2)

ACCORD ID: 12447

Inspected By: Md. Dalower Hossain & Md. Anayet Hossain  
Date: June 09, 2016

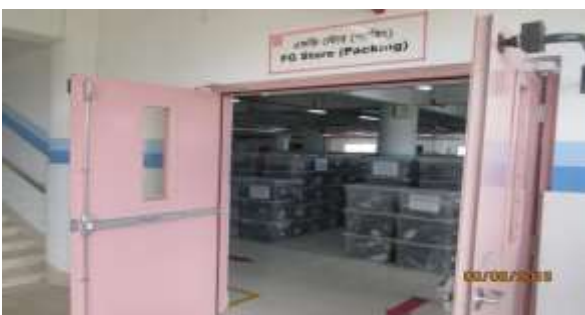
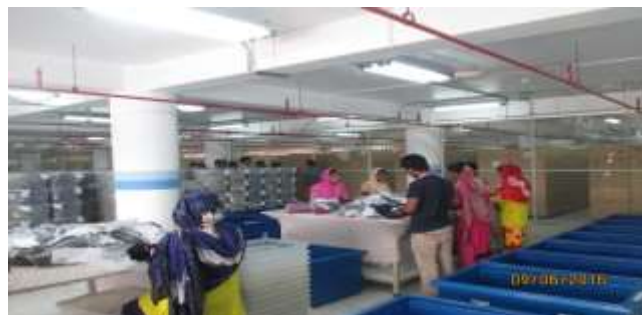
SI No.	Category	Finding	Required Action	Remediation Time Frame
1	Fire Rated Construction	Rooms used for storage of combustible materials are not separated from the surrounding occupancy/areas by fire rated construction. Location: Various floor.	Rooms used for storage of combustible materials shall be separated from the surrounding occupancy with a minimum 1 hour construction. Seal all penetrations and openings in floor/ceiling (full thickness of the floor/ceiling) assemblies by fire rated	Within 03 Months

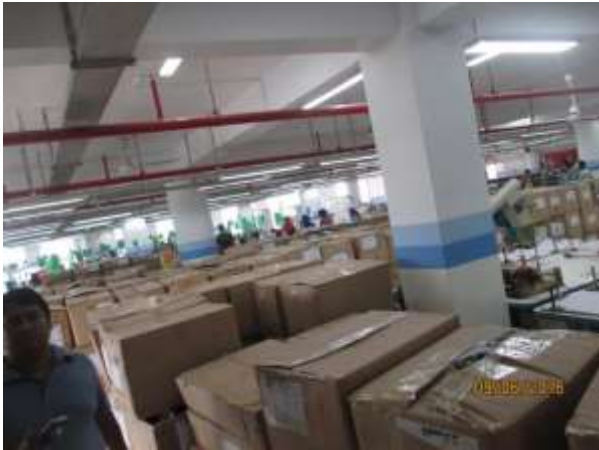
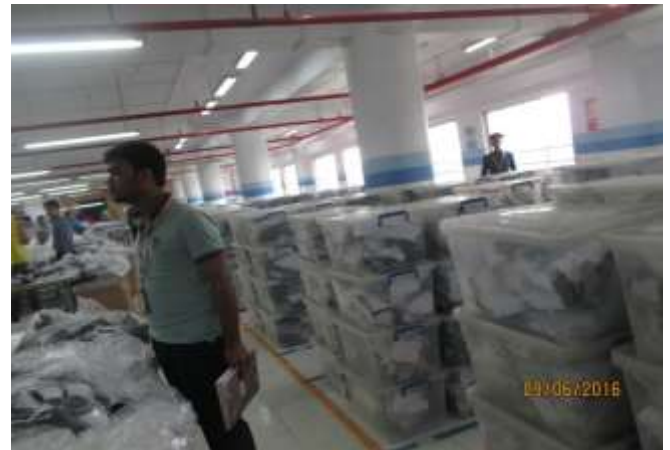
2	Fire Rated Construction	<p>Areas used for in-process storage of combustible materials are open to the surrounding occupancy. Location: Various Floor.</p>	<p>Provide defined storage areas and limit the storage arrangement as follows:-</p> <ol style="list-style-type: none"> <li><b>1. General Condition:</b> Maximum height of 2.4m and maximum area of 23m<sup>2</sup>. Separate areas of unenclosed combustible storage by a minimum clear distance of 3m.</li> <li><b>2. If sprinkler protected:</b> maximum height of 3.66m and maximum area of 93m<sup>2</sup>. Separate areas of unenclosed combustible storage by a minimum clear distance of 3m. or</li> <li><b>3. Enclose the storage area from the surrounding occupancy with a minimum 1 hour construction.</b></li> </ol>	Within 03 Months
---	-------------------------	---	--	------------------

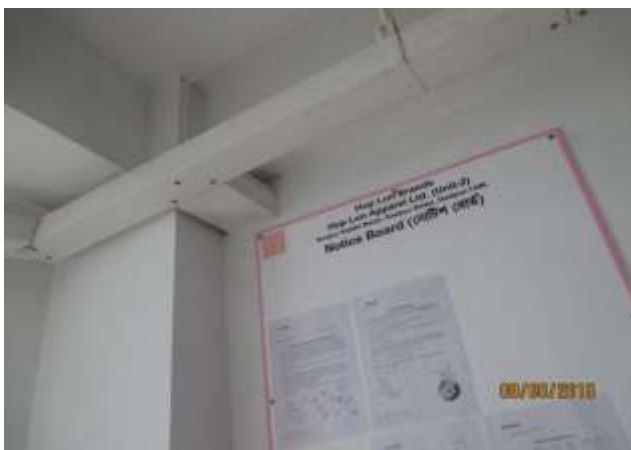
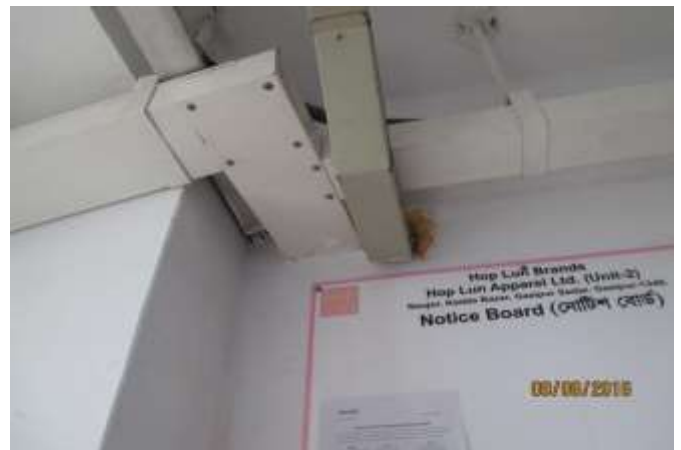
3	Fire Rated Construction	<p>Unsealed penetrations and openings are located to exit stair. Location: exit stair-2 in all floors.</p>	<p>Seal all penetrations and openings in the wall of exit enclosure walls (full thickness of the wall) by fire rated materials to maintain the required fire rating.</p>	Within 01 Month
---	-------------------------	--	--	-----------------

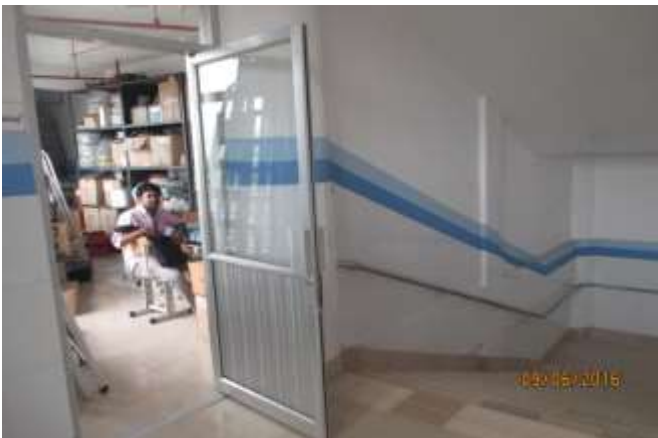
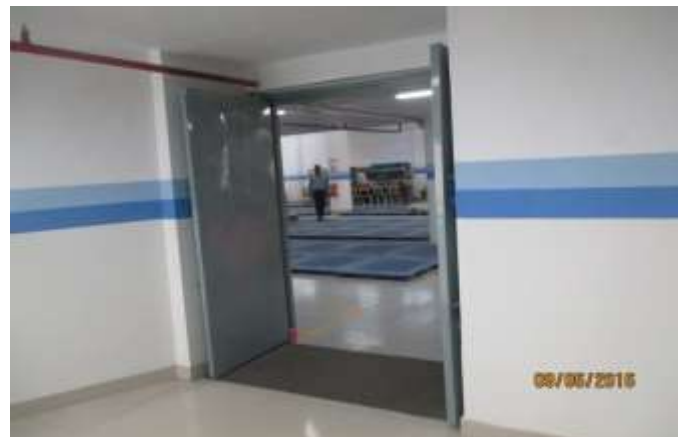
4	Fire Rated Construction	<p>The exit stairs are not separated from [work areas, other spaces] on each floor by fire rated construction.</p> <p>Location: All Floor.</p>	<p>Provide minimum 1.5-hr fire rated doors and seal all unprotected openings to separate the exit stairs from work areas and other building spaces on all floor levels. Ensure that the fire rated doors are self-closing and positive latching and that they are provided with fire exit (panic) hardware where serving production floors.</p> <p>If fire rated doors are required to be held open for functional reasons, provide automatic closing devices tied to the fire alarm system.</p> <p>Once fire doors are installed, every door in a stair enclosure serving more than 5 stories shall be provided with re-entry unless it meets ACCORD standard 6.8.3.1</p>	Within 03 Months
---	-------------------------	--	--	------------------

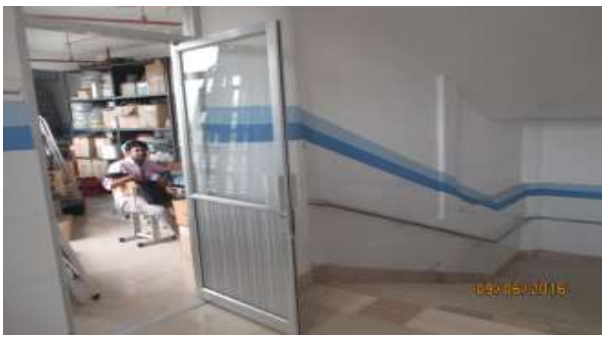
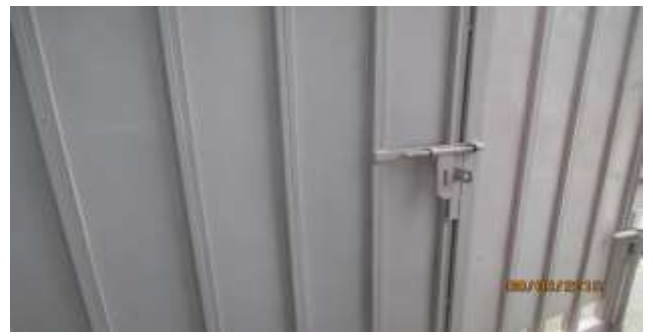
5	Egress	<p>Doors along means of egress are provided with non compliant locking system.</p>	<ol style="list-style-type: none"> <li>1. Remove all non compliant locking features from egress doors.</li> <li>2. If locks are required for security reasons, utilize special door locking features complying with NFPA 101.</li> <li>3. Doors may be locked where the latch and lock are disengaged with one motion where the occupant load does not exceed 49 persons.</li> <li>4. Doors may be provided with locking hardware from the ingress side provided that a panic bar is installed on any door with an occupant load exceeding 49 persons.</li> </ol>	Immediate
---	--------	--	---	-----------

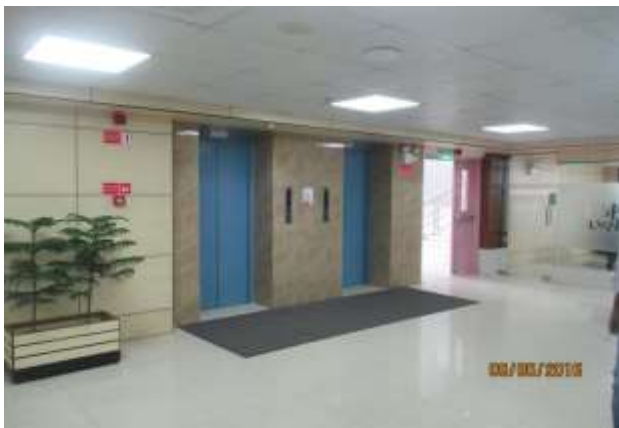
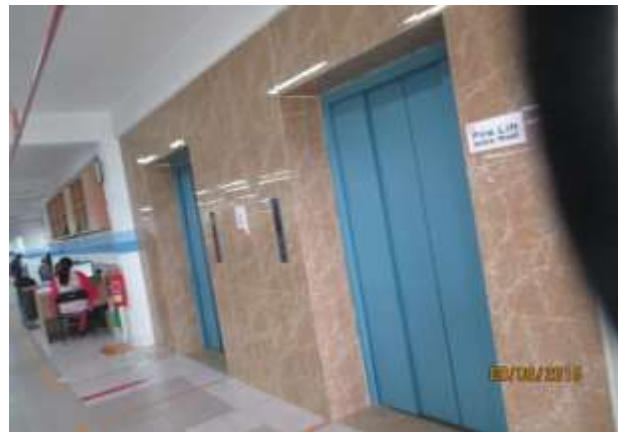
6	Egress	The elevator [all floors] discharges inside the production floor. [Unsealed penetrations & openings]	Provide a minimum 2-hr fire rated construction to separate the elevator shaft from each floor level. Seal all penetrations and openings in floors/ceiling assemblies to maintain the fire separation.	Within 03 Month
---	--------	--	---	-----------------

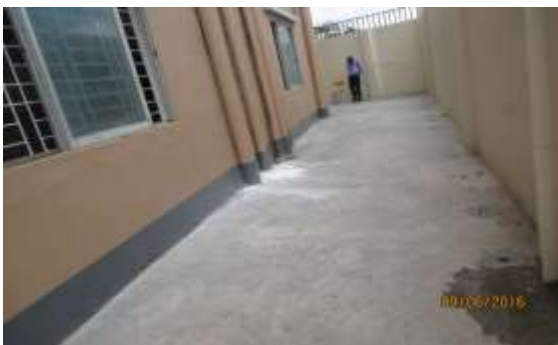
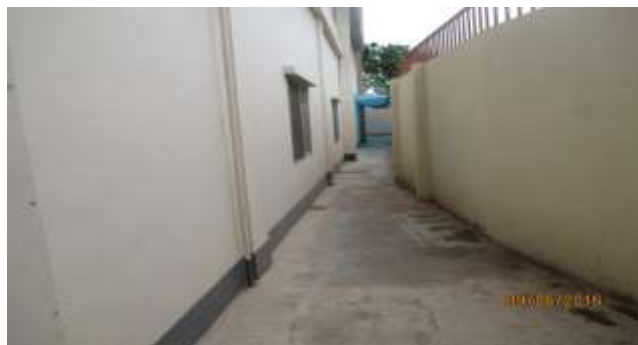
7	Unprotected Exterior Discharge Path	The exit discharge path [rear exit] is less than 10 ft wide and is not separated from the building interior.	Seal all penetrations and openings to the interior of the building along the discharge path, up to a height of 10 ft., to provide a minimum 1-hr fire separation. Alternatively, provide a second remote discharge path to the public way (only include this if feasible).	Within 03 Month
---	-------------------------------------	--	--	-----------------

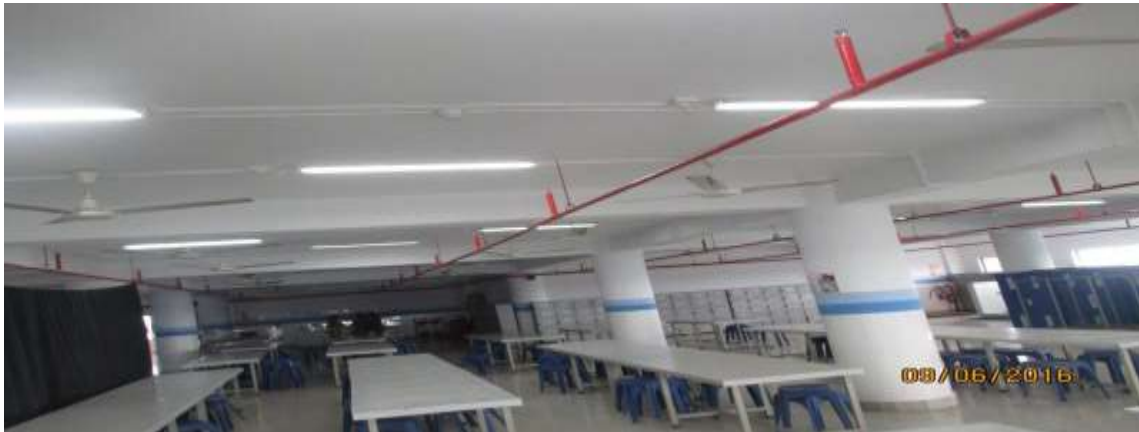
8	Dining Area	Dinning area has not been separated from working areas ( other surrounding). Location: 6th Floor.	Provide a minimum 2-hr fire rated construction to separate the dinning area. Seal all penetrations and openings in floors/ceiling assemblies to maintain the fire separation.	Within 03 Months
---	-------------	--	--	------------------

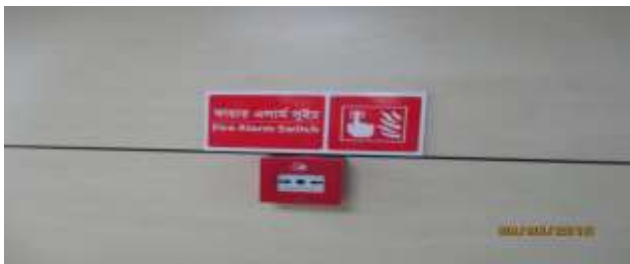
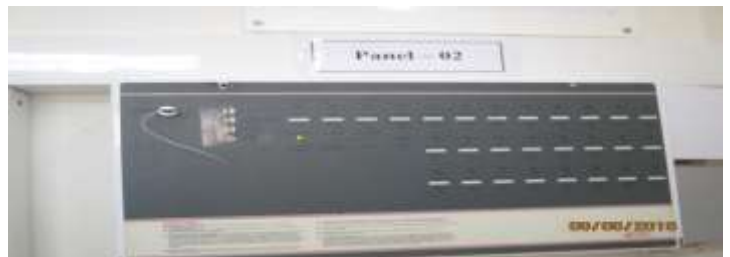
9	Fire Alarm & Detection System	The existing fire alarm system is not a listed system and does not provide automatic alarm and notification features consistent with acceptable standards.	Replace the fire alarm system with a new, listed addressable fire alarm system in accordance with NFPA 72.	Design Within 04 Months & Installation Within 09 Months
---	-------------------------------	--	--	---

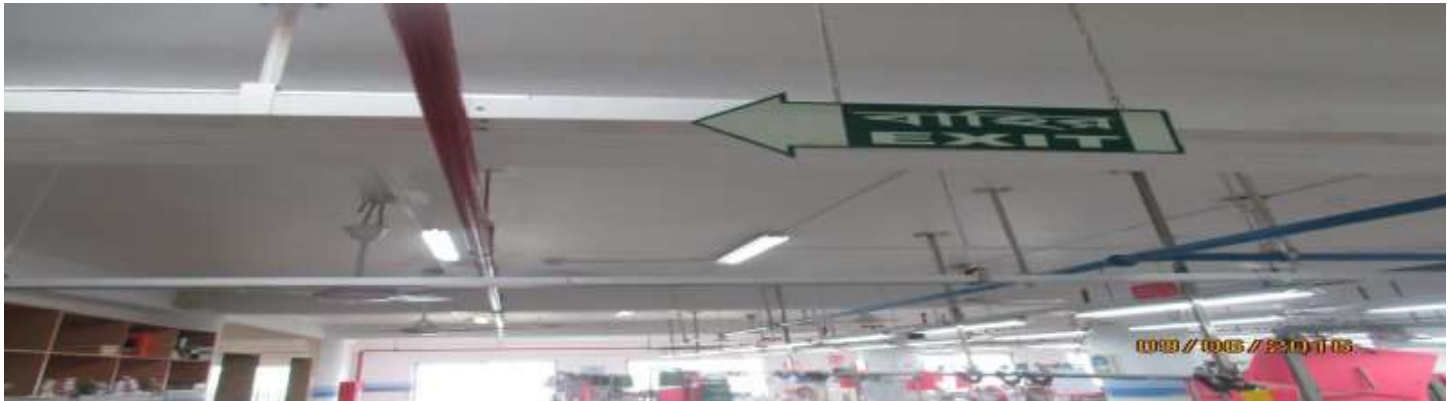
12	Egress Lighting	Emergency Light & Exit signage is not illuminated during testing (burned out, broken, etc.).	Regularly inspect all exit signage as per Accord standard and replace/install lights as needed to illuminate signs.	Within 01 Months
----	-----------------	--	---	------------------
