FIRE SAFETY INSPECTION REPORT

**ANUPAM HOSIERY INDUSTRY (PVT) LTD.
VULTA, RUPGONJ**

ACCORD
on Fire and Building Safety in Bangladesh

June 30, 2014

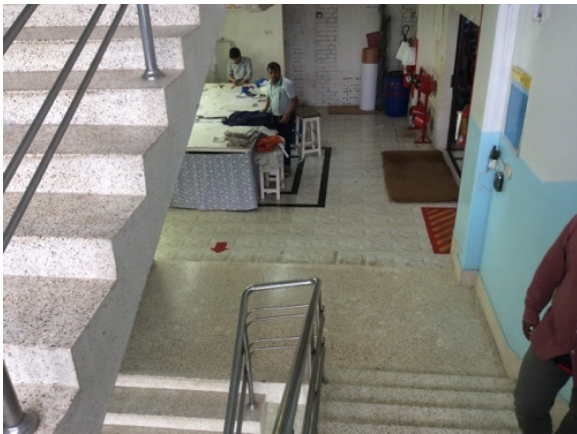
No.	Category	Finding	Recommendation	Remediation Timeframe
F-1	Fire Rated Construction	The exit stairs are not separated from work areas, and other spaces on each floor by fire-rated construction. This was reflected throughout the building on all floors.	<p>Provide minimum 1.5-hr fire rated doors and seal all unprotected openings to separate the exit stairs from work areas and other building spaces on all floor levels. Ensure that the fire doors are self-closing and positive latching and that they are provided with fire exit (panic) hardware where serving production floors.</p> <p>If fire doors are required to be held open for functional reasons, provide automatic-closing devices tied to the fire alarm system.</p>	Within 3 months

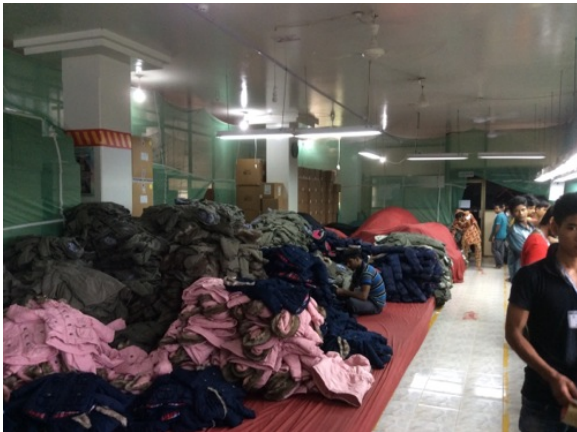
F-2	Fire Rated Construction	Areas used for combustible storage on the first, second and third floors are not separated by fire-rated construction.	<p>Provide dedicated storage rooms separated by minimum 1-hr fire-rated construction.</p> <p>Where separate storage rooms are not feasible, provide defined storage areas and limit the storage arrangement as follows:</p> <ul style="list-style-type: none"> - Maximum height of 2.4m and maximum area of 23m² - If sprinkler protected: maximum height of 3.66m and maximum area of 93m² <p>Separate areas of unenclosed combustible storage by a minimum clear distance of 3m.</p>	Within 3 months
-----	-------------------------	--	--	-----------------

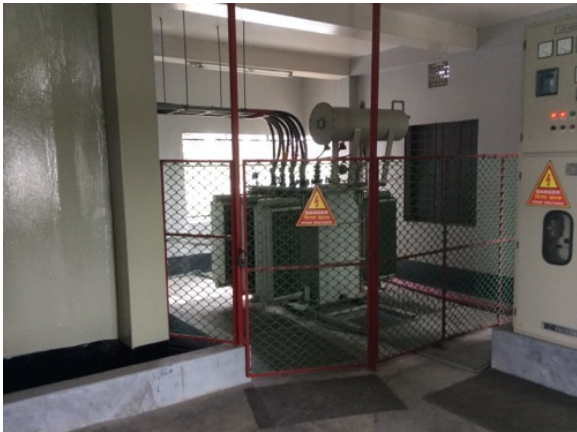
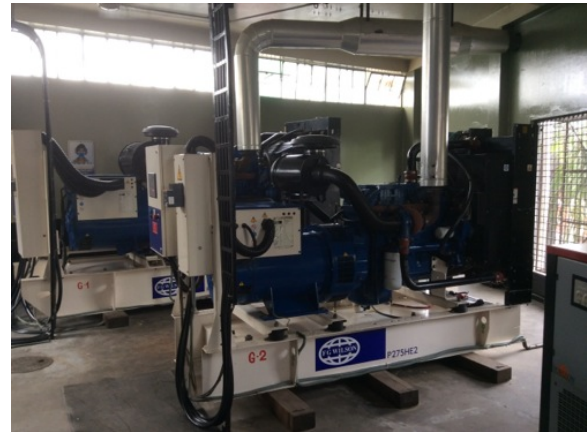
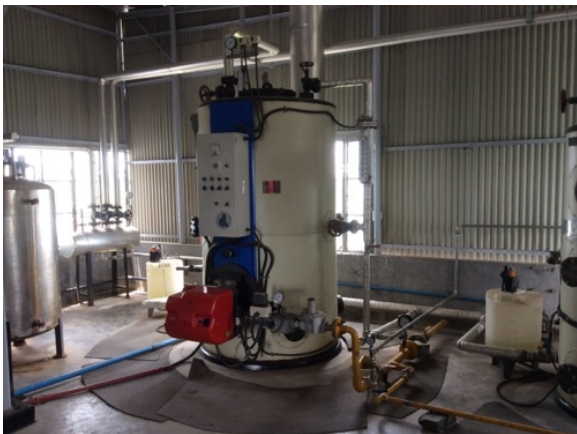
F-3	Fire Rated Construction	The boiler, generator, and transformer room located on the ground floor, is not separated by fire-rated construction, openings, non-rated doors, and penetrations.	Separate the boiler, generator, and transformer room by a minimum 2-hr fire-rated construction. Seal and/or protected all openings to maintain the required fire separations	Within 3 months
-----	-------------------------	--	--	-----------------

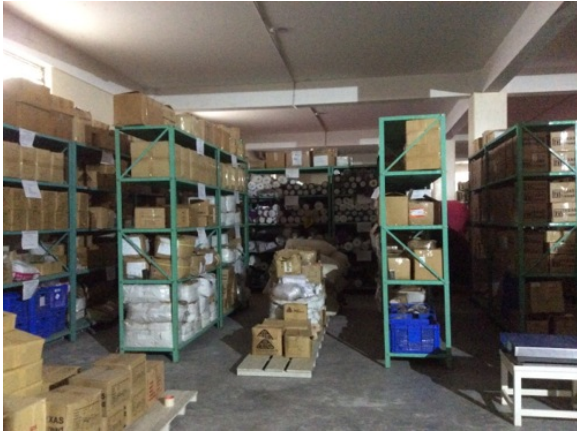
F-4	Fire Rated Construction	Storage rooms used for combustible storage on the basement, ground and first floors are not separated by fire-rated construction.	Provide dedicated storage rooms separated by minimum 1-hr fire-rated construction.	Within 3 months
-----	-------------------------	---	--	-----------------

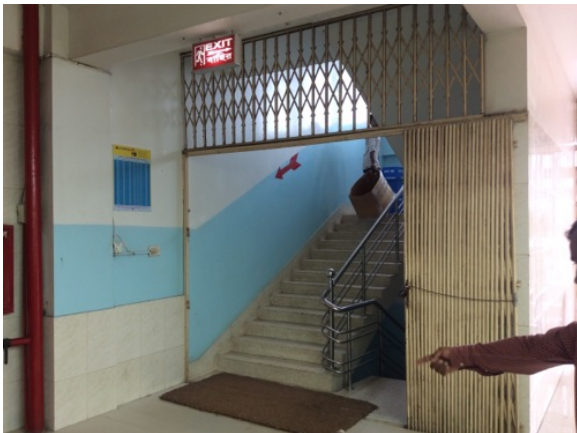
F-5	Egress	Egress doors / gates with locking features are provided at building exits, exit stairs, along egress routes, and exit discharge. This was reflected throughout the building on all floors.	Remove locking features from all egress doors / gates. If locks are required for security reasons, utilize special door locking features complying with NFPA 101.	Immediate
-----	--------	--	--	-----------

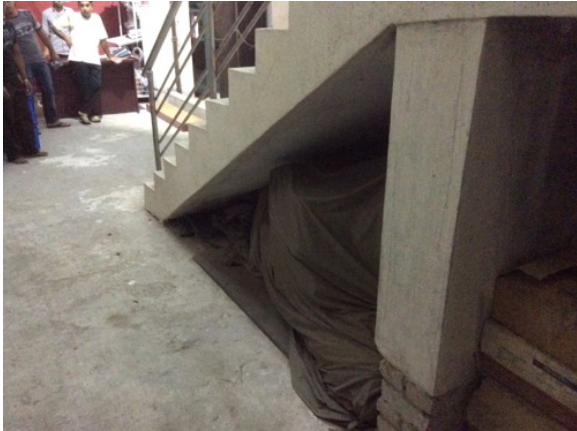
F-6	Egress	Storage areas were located in all exit stairwells on the ground floor, underneath the stairs.	Remove all storage from exit stairs and egress paths.	Immediate
-----	--------	---	---	-----------

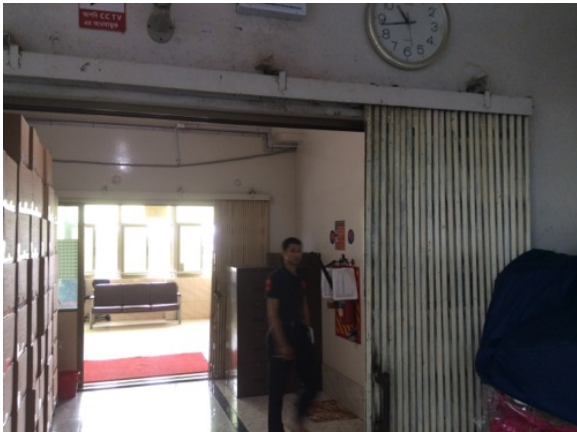
F-7	Egress	Collapsible gates / sliding doors are provided at building exits, exit stairs, along egress routes, and exit discharge. This was reflected throughout the building on all floors.	Replace all gates / sliding doors along the means of egress with side-hinged, swinging egress doors. If locks are required for security reasons, utilize special door locking features complying with NFPA 101.	Within 1 month
-----	--------	---	--	----------------

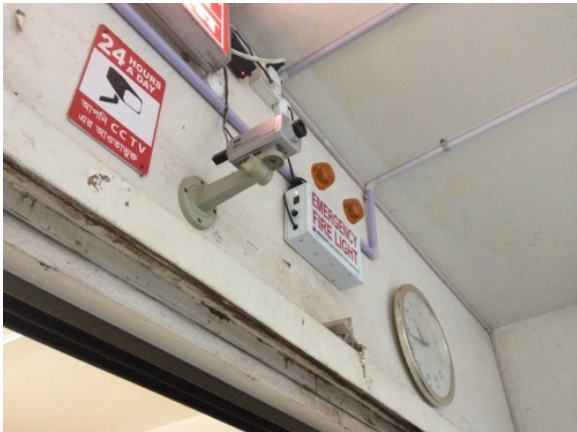
F-8	Fire Protection	The high-rise building has an occupied floor greater than 23m (75 ft) and is not provided with automatic sprinkler protection. The large occupant loads, heavy fuel loading, and anticipated extended egress times warrant sprinkler protection.	Provide automatic sprinkler protection throughout the building in accordance with NFPA 13.	Design within 6 months, install within 12 months
F-9	Fire Protection	Inspection, testing, and maintenance records for the fire alarm system was not in accordance with NFPA 72.	Inspect, test and maintain the fire alarm system, and keep written records on-site, in accordance with NFPA 72.	Within 3 months
F-10	Egress Lighting	Manual on-off switch is provided for emergency lighting units. This was reflected throughout the building in various locations.	Remove manual on/off switches from emergency lighting units to prevent them from being switched off.	Within 1 month
