# **FIRE SAFETY INSPECTION REPORT**

**L' USINE FASHION LTD. (UNIT-2)**  
**36, GAZIPURA SANTAISH ROAD, TONGI, GAZIPURA**  
**-1712, BANGLADESH**

**ACCORD**  
on Fire and Building Safety in Bangladesh

March 15, 2014

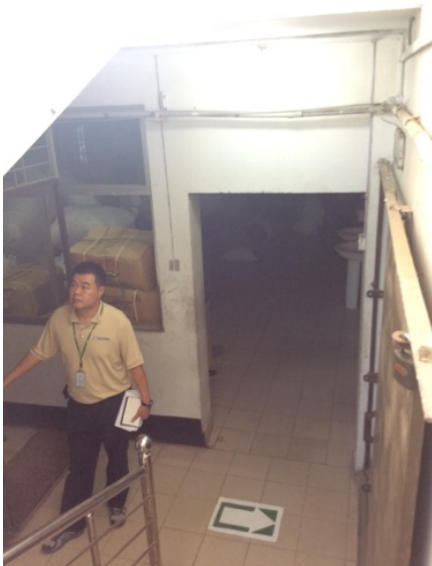
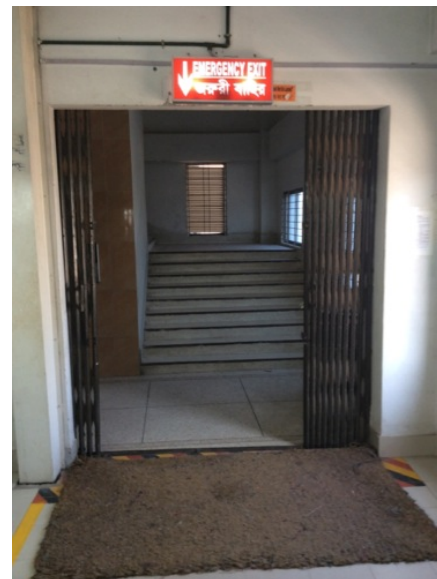
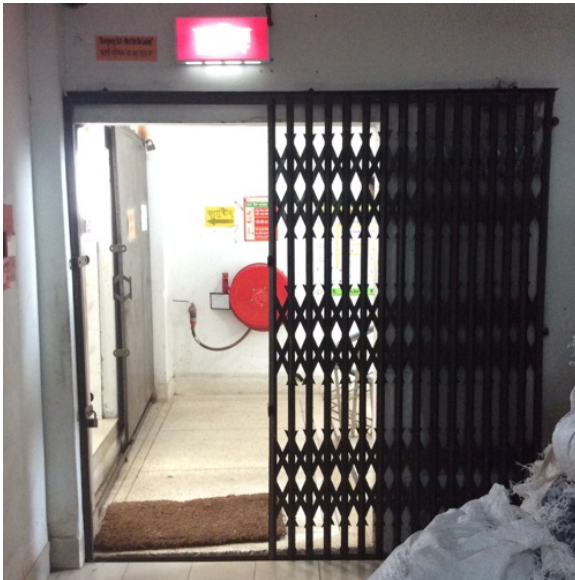
| No. | Category | Finding | Recommendation | Remediation Timeframe |
|---|---|---|---|---|
| F-1 | Fire Rated Construction | The exit stairs are not separated from work areas, the elevator shaft, and other spaces on each floor by fire-rated construction. | <p>Provide minimum 1.5-hr fire rated doors and seal all unprotected openings to separate the exit stairs from work areas, the elevator shaft, and other building spaces on all floor levels. Ensure that the fire doors are self-closing and positive latching and that they are provided with fire exit (panic) hardware where serving production floors.</p> <p>If fire doors are required to be held open for functional reasons, provide automatic-closing devices tied to the fire alarm system.</p> | Within 3 months |

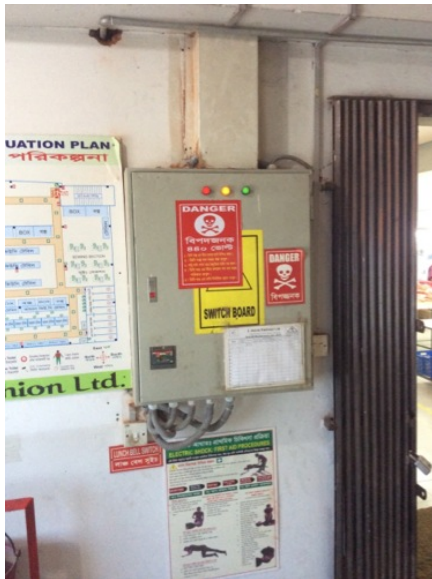
| F-2 | Fire Rated Construction | Unsealed penetrations and openings with electrical panel are located in NW exit stair enclosures. | Seal all penetrations and openings in exit stair enclosure walls to maintain the fire separation. | Within 3 months |

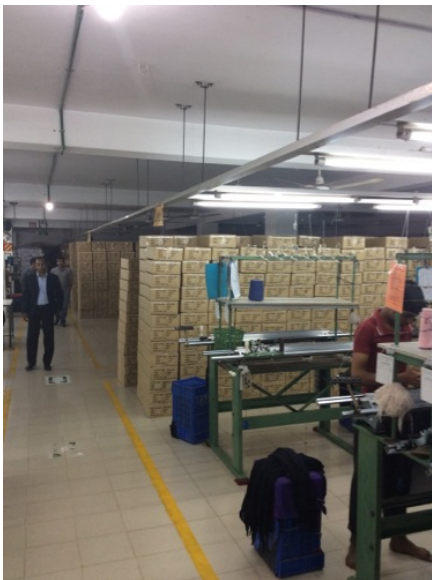
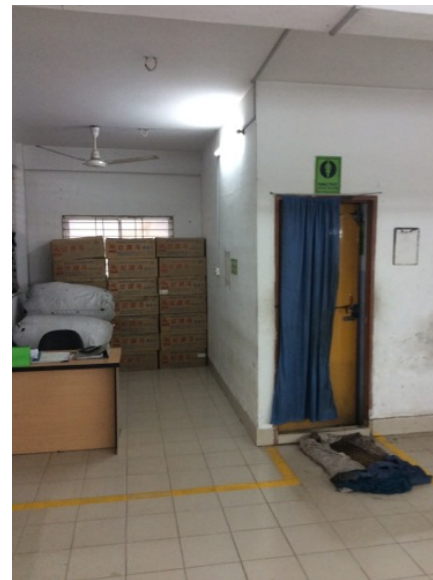
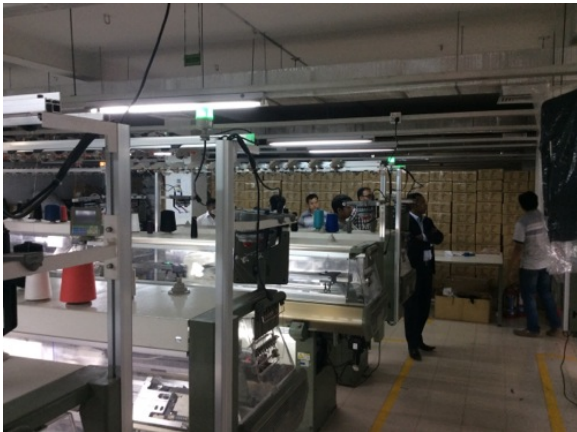
| F-3 | Fire Rated Construction | Areas used for combustible storage are not separated by fire-rated construction at adjacent to NW stair on 4th floor, work area on 3rd floor, adjacent to female toilet on 2nd floor and work area on ground floor. | <p>Provide dedicated storage rooms separated by minimum 1-hr fire-rated construction.</p> <p>Where separate storage rooms are not feasible, provide defined storage areas and limit the storage arrangement as follows:</p> <ul style="list-style-type: none"><li>- Maximum height of 2.4m and maximum area of 23m<sup>2</sup></li><li>- If sprinkler protected: maximum height of 3.66m and maximum area of 93m<sup>2</sup></li></ul> <p>Separate areas of unenclosed combustible storage by a minimum clear distance of 3m.</p> | Within 3 months |

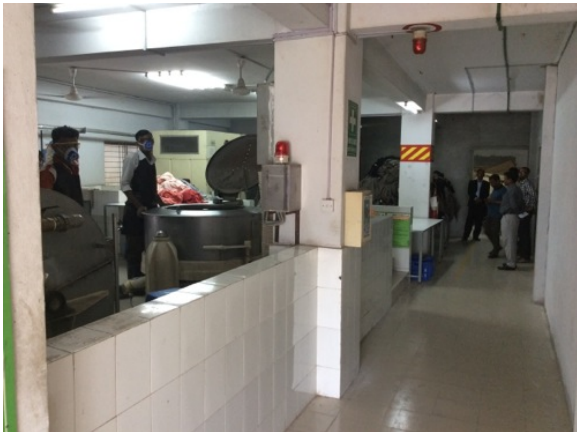
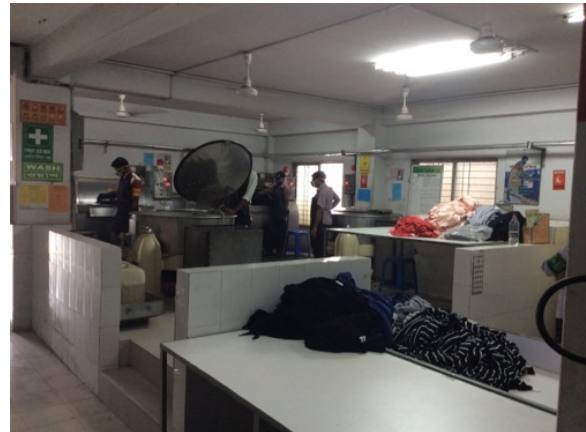
| F-4 | Fire Rated Construction | The washer and dryers on 1st floor are not separated by fire-rated construction. | Separate the washer and dryer room by a minimum 2-hr fire-rated construction. Seal and/or protected all openings to maintain the required fire separations | Within 3 months |

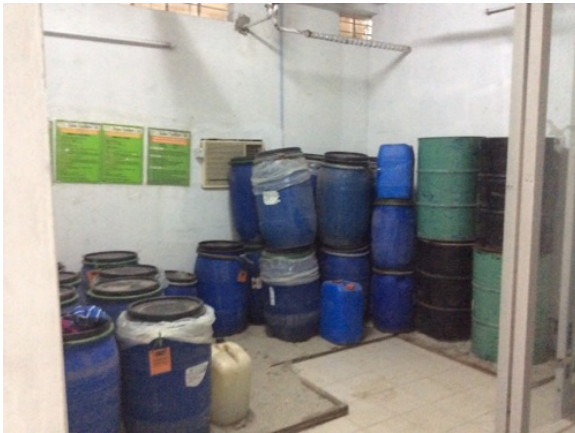
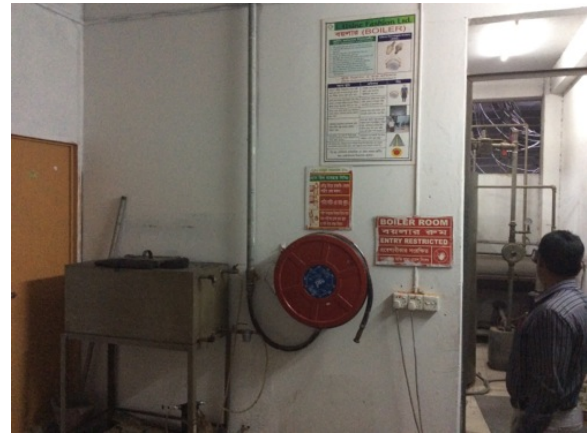
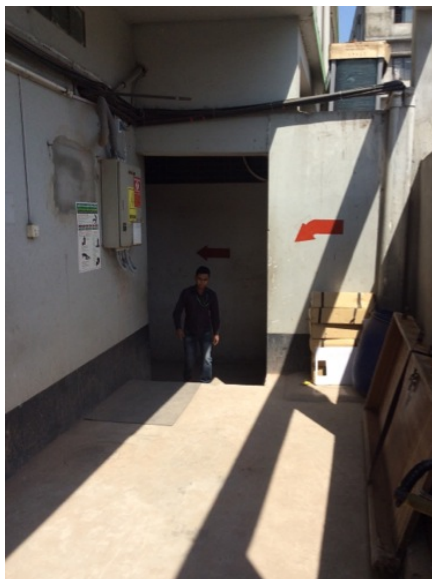
| F-5 | Fire Rated Construction | Hazardous materials / flammable liquid storage in the corridor in front of boiler room, loading dock and exterior egress route from SE exit stair is not separated by fire-rated construction. | Separate the hazardous materials / flammable liquid storage room by a minimum 2-hr fire-rated construction. Seal and/or protected all openings to maintain the required fire separations. | Within 3 months |

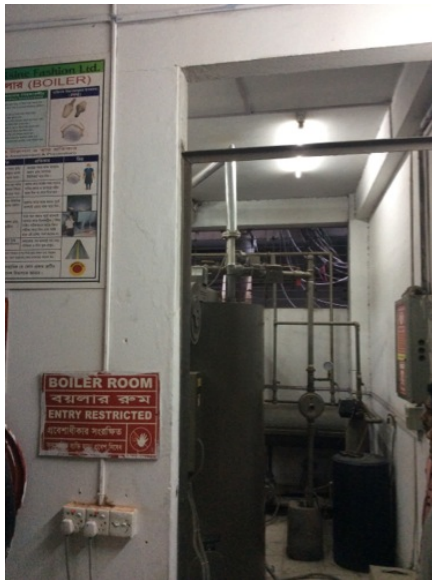
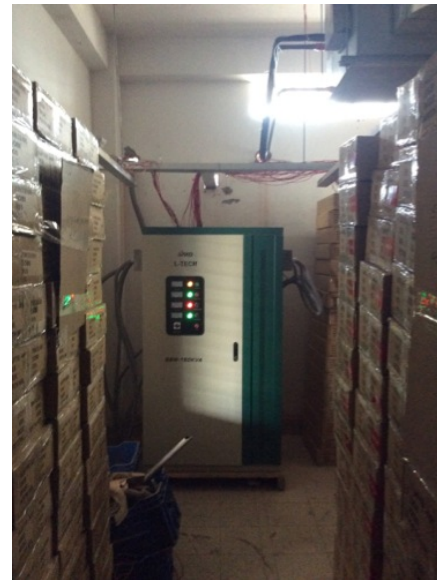
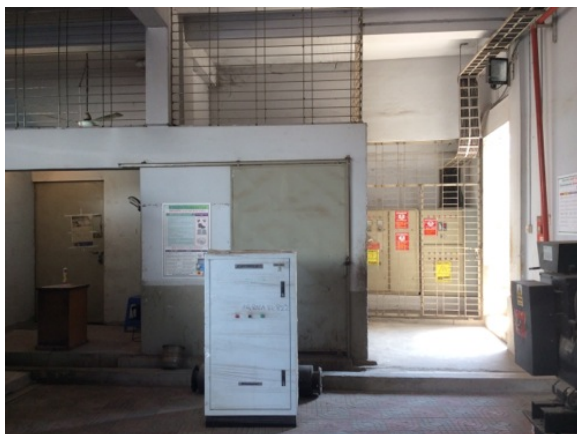
| F-6 | Fire Rated Construction | The boiler / generator / transformer rooms are not separated by fire-rated construction. | Separate the boiler / generator / transformer rooms by a minimum 2-hr fire-rated construction. Seal and/or protected all openings to maintain the required fire separations | Within 3 months |

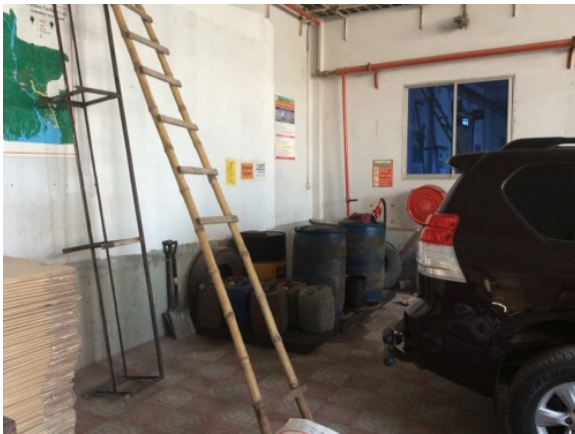
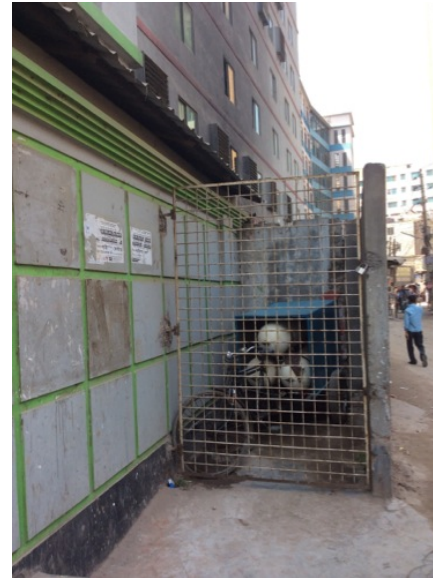
| F-7 | Fire Rated Construction | Flammable liquid storage near the loading dock and LPG storage near the main entrance on ground floor are not separated by fire-rated construction. | Relocate the hazardous materials / flammable liquid storage to a dedicated room separated by minimum 2-hr fire-rated construction. | Within 3 months |

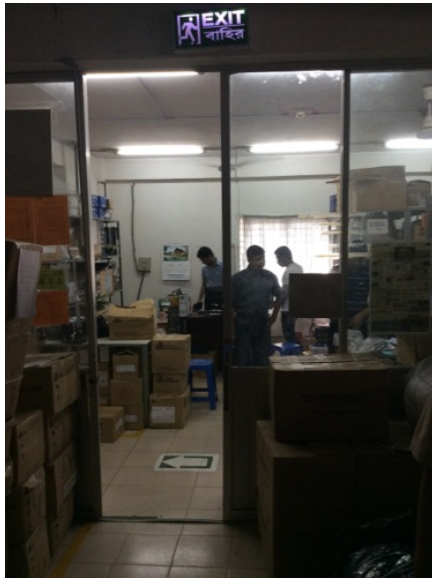
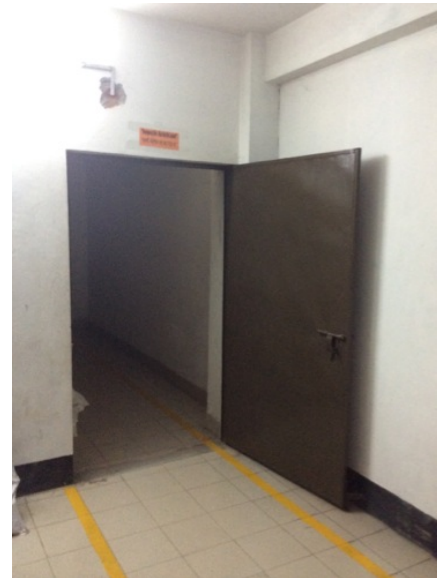
| F-8 | Egress | Egress doors with locking features are provided at storage room on 6th floor. | <p>Remove locking features from all egress doors / gates.</p> <p>If locks are required for security reasons, utilize special door locking features complying with NFPA 101.</p> | Immediate |

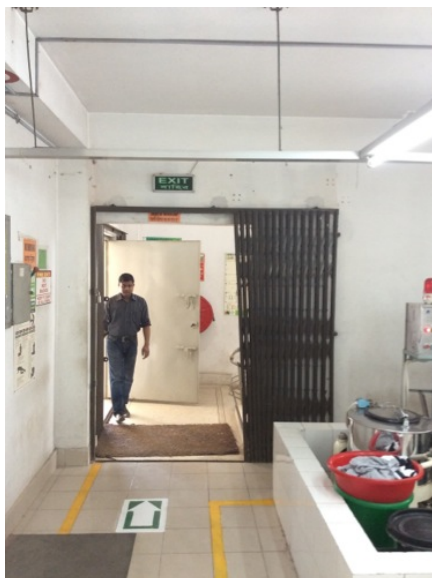
| F-9 | Egress | Locking features are provided at egress door leading to SE exit stair on 6th floor. | Remove locking features from all egress doors / gates.<br><br>If locks are required for security reasons, utilize special door locking features complying with NFPA 101. | Immediate |

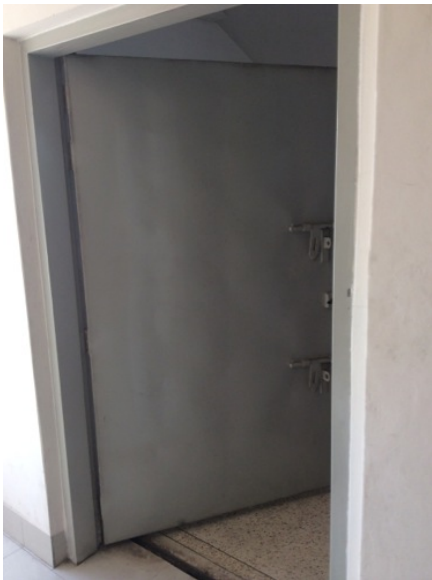
| F-10 | Egress | Egress door with locking features is provided at secondary exit door at office leading to 5th floor SE exit stair. | Remove locking features from all egress doors / gates.<br><br>If locks are required for security reasons, utilize special door locking features complying with NFPA 101. | Immediate |

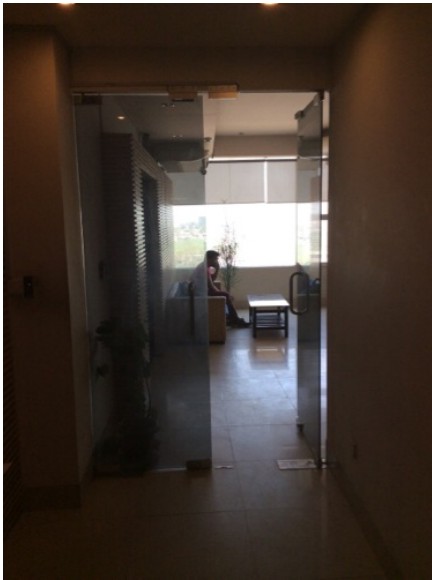
| F-11 | Egress | Access control with locking features is provided at door along egress routes from the office leading to NW exit stair. | Remove locking features from all egress doors / gates.<br><br>If locks are required for security reasons, utilize special door locking features complying with NFPA 101. | Immediate |

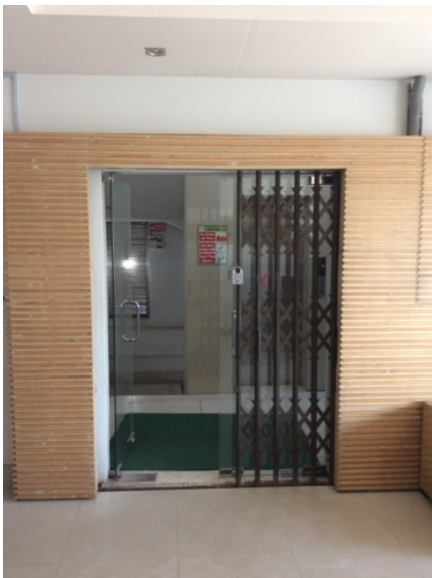
| F-12 | Egress | Egress door with locking features is provided at main office lobby door on 5th floor. | <p>Remove locking features from all egress doors / gates.</p> <p>If locks are required for security reasons, utilize special door locking features complying with NFPA 101.</p> | Immediate |

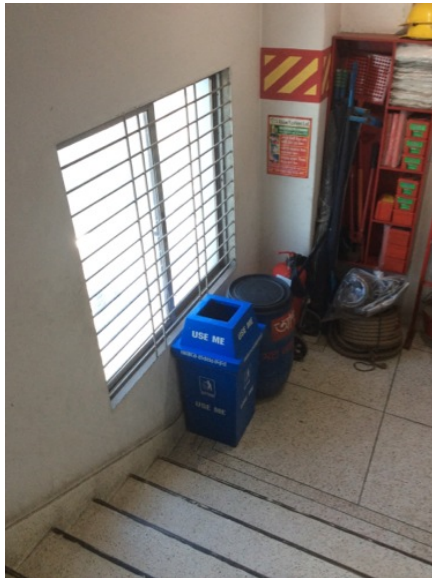
| F-13 | Egress | Trash can with combustibile materials was located in the NW exit stair. | Remove all storage from exit stairs and egress paths. | Immediate |

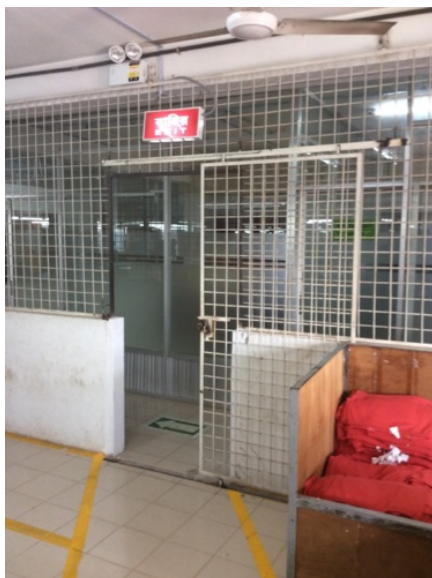
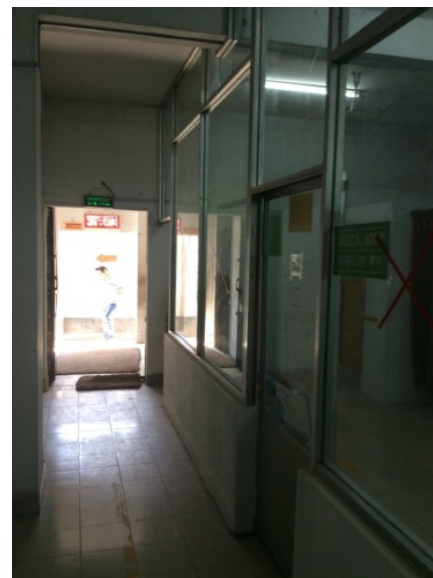
| F-14 | Egress | Egress doors / gates with locking features are provided at exit discharge door from SE stair on Ground floor and door from work area on 4th floor. | Remove locking features from all egress doors / gates.<br><br>If locks are required for security reasons, utilize special door locking features complying with NFPA 101. | Immediate |

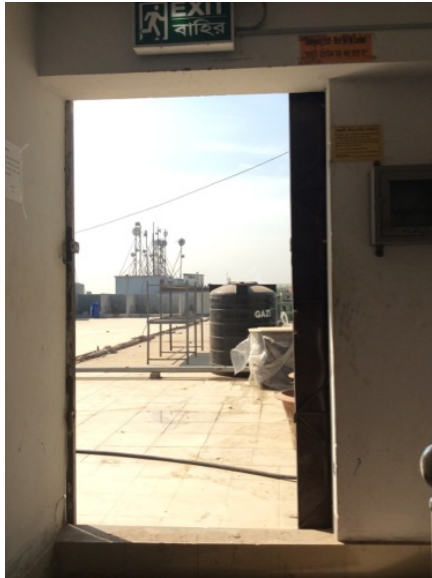
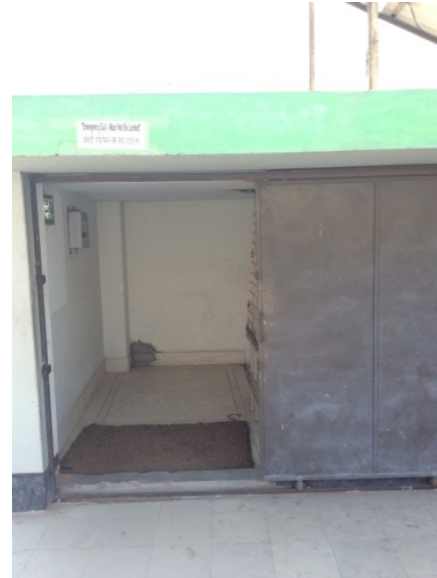
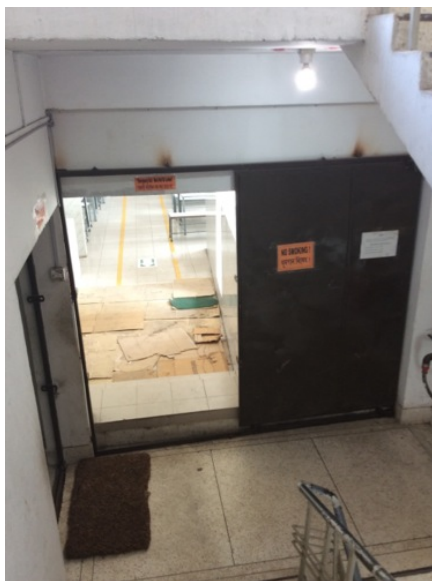
| F-15 | Egress | Sliding doors are provided at exit stairs on roof top. | Replace all gates / sliding doors along the means of egress with side-hinged, swinging egress doors. | Within 1 month |

If locks are required for security reasons, utilize special door locking features complying with NFPA 101.

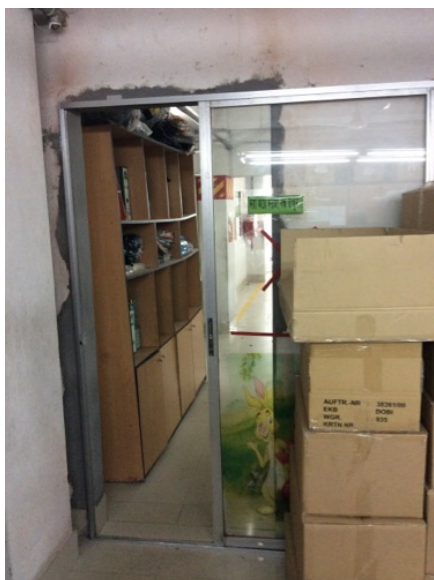
| F-16 | Egress | Sliding door is provided at along egress routes on 6th floor between 2 spaces. | Replace all gates / sliding doors along the means of egress with side-hinged, swinging egress doors. | Within 1 month |

If locks are required for security reasons, utilize special door locking features complying with NFPA 101.

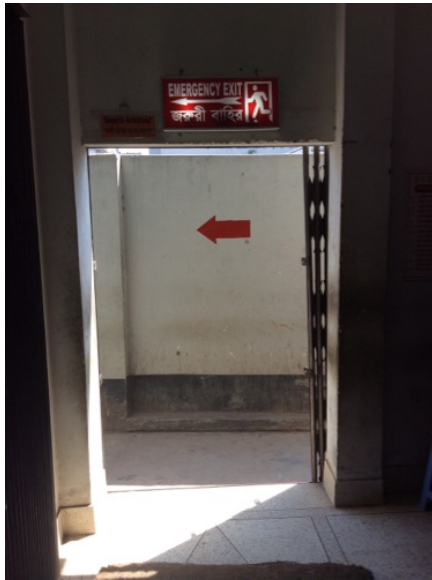
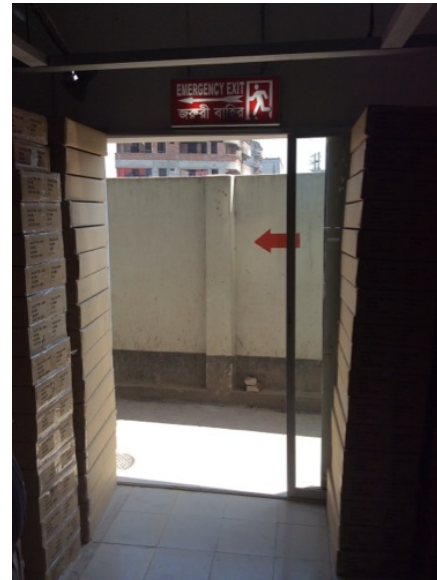
| F-17 | Egress | Sliding doors are provided at exit discharge doors on ground floor. | Replace all gates / sliding doors along the means of egress with side-hinged, swinging egress doors. | Within 1 month |

If locks are required for security reasons, utilize special door locking features complying with NFPA 101.

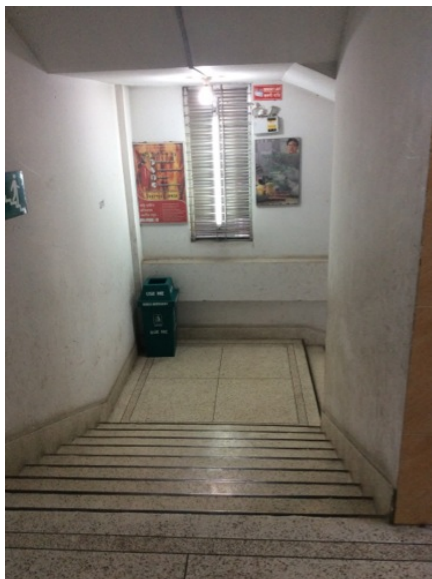
| F-18 | Egress | Handrails are not provided in the NW exit stair . | Provide handrails on at least one side of exit stair. | Within 3 months |

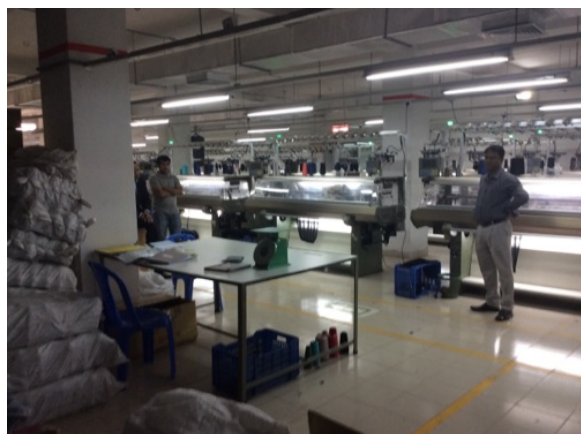
| F-19 | Egress | The exits in the work area on ground floor are not remotely located from each other (less than one-half maximum diagonal distance of space) such that a single fire event could compromise both exits. | Modify exit arrangement to provide remote exits.<br><br>Alternatively, provide sprinkler protection for ground floor in accordance with NFPA 13. | Within 6 months |

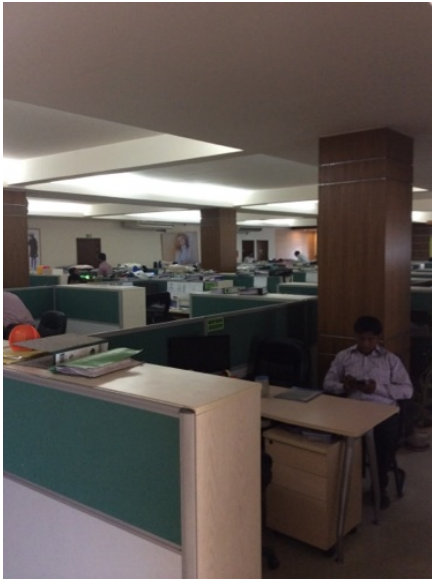
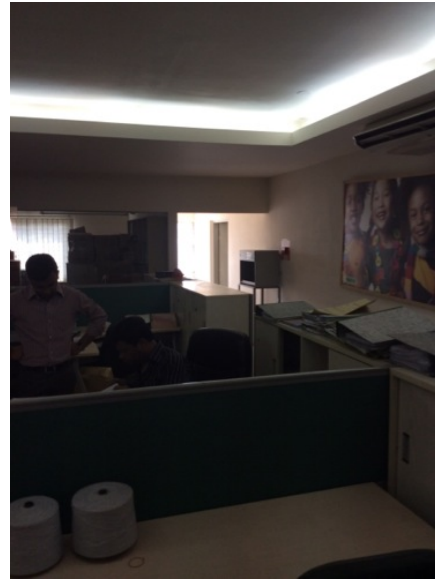
| F-22 | Egress Lighting | Exit sign is not provided at office secondary exit door on 5th floor. | Provide exit signs above all exits to the exterior and all doors to the exit stairs. | Within 1 month |
