# **FIRE SAFETY INSPECTION REPORT**

**KNIT CONCERN LTD.**

**62 WATER WORKS ROAD**

**ACCORD**  
on Fire and Building Safety in Bangladesh

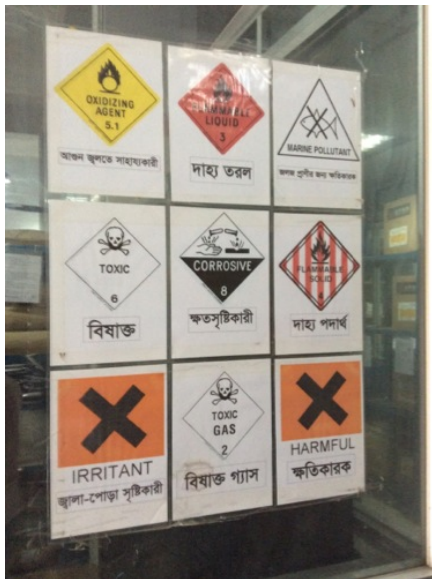
| No. | Category | Finding | Recommendation | Remediation Timeframe |
|---|---|---|---|---|
| F-1 | Fire Rated Construction | <p>Hazardous materials / flammable liquid storage area is not separated by fire-rated construction (openings, non-rated doors, penetrations).</p> <p>It was located on the ground floor.</p> | Separate the hazardous materials / flammable liquid storage room by a minimum 2-hr fire-rated construction. Seal and/or protected all openings to maintain the required fire separations. | Within 3 months |

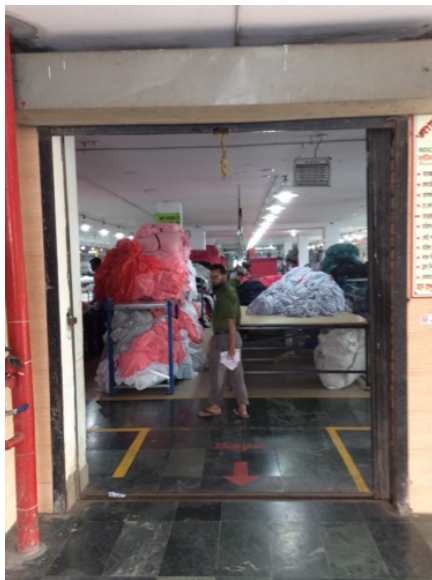
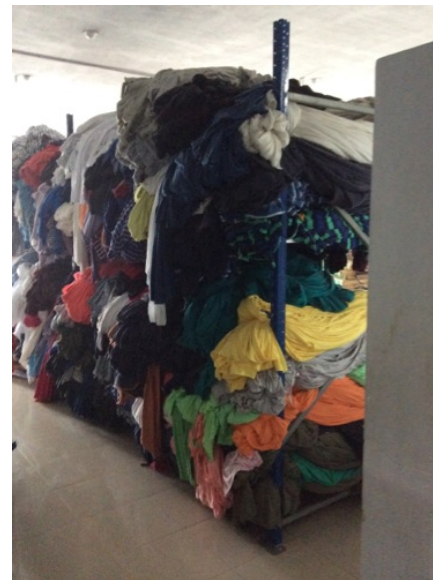
| F-2 | Fire Rated Construction | <p>Areas used for combustible storage are not separated by fire-rated construction.</p> <p>All Floors except roof.</p> | <p>Provide dedicated storage rooms separated by minimum 1-hr fire-rated construction.</p> <p>Where separate storage rooms are not feasible, provide defined storage areas and limit the storage arrangement as follows:</p> <ul style="list-style-type: none"><li>- Maximum height of 2.4m and maximum area of 23m<sup>2</sup></li><li>- If sprinkler protected: maximum height of 3.66m and maximum area of 93m<sup>2</sup></li></ul> <p>Separate areas of unenclosed combustible storage by a minimum clear distance of 3m.</p> | Within 3 months |

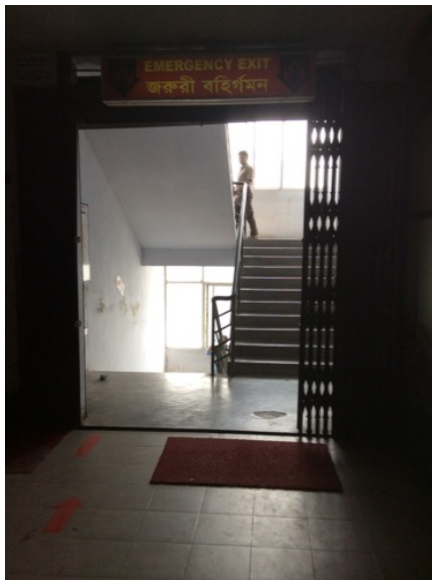
| F-3 | Fire Rated Construction | The exit stairs are not separated from work areas, other spaces on each floor by fire-rated construction. | Provide minimum 1.5-hr fire rated doors and seal all unprotected openings to separate the exit stairs from work areas and other building spaces on all floor levels. Ensure that the fire doors are self-closing and positive latching and that they are provided with fire exit (panic) hardware where serving production floors.<br><br>If fire doors are required to be held open for functional reasons, provide automatic-closing devices tied to the fire alarm system. | Within 3 months |

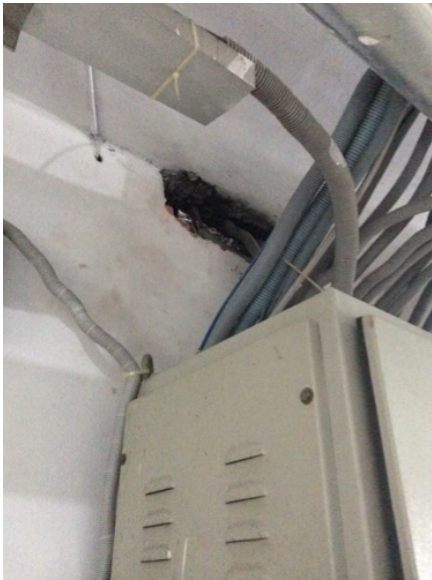
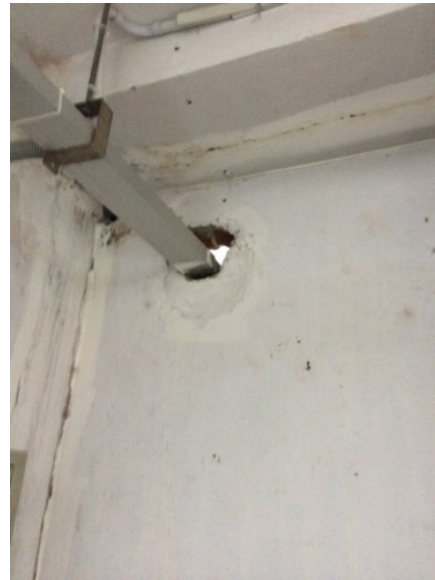
| F-4 | Fire Rated Construction | Unsealed penetrations and openings are located in the fire-rated floor/ceiling assemblies. | Provide a minimum 2-hr fire-rated shaft to separate the utility risers from each floor level.<br><br>Seal all penetrations and openings in floor/ceiling assemblies to maintain the fire separation. | Within 3 months |

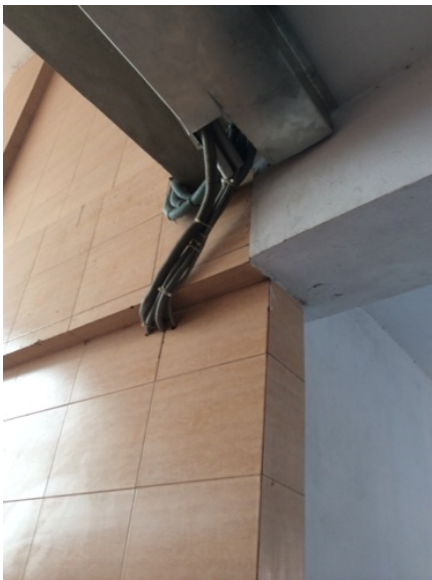
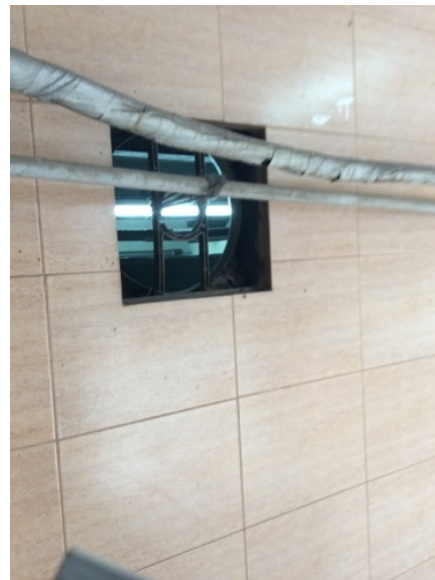
| F-5 | Fire Rated Construction | Unsealed penetrations and openings are located in exit stair enclosures. | Seal all penetrations and openings in exit stair enclosure walls to maintain the fire separation. | Within 3 months |

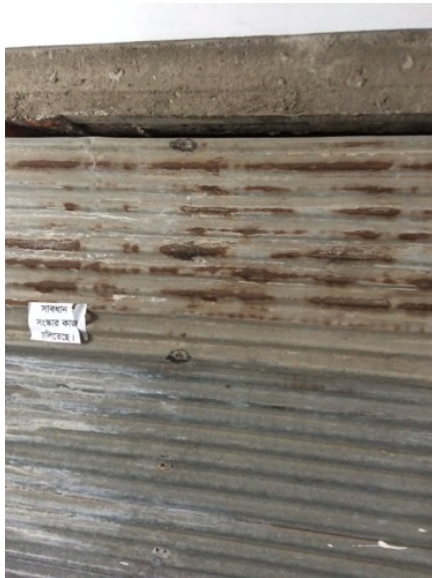
| F-6 | Fire Rated Construction | Unsealed penetrations and openings are located in open vertical shaft. | Seal all penetrations and openings in open vertical shaft walls to maintain the fire separation. | Within 3 months |

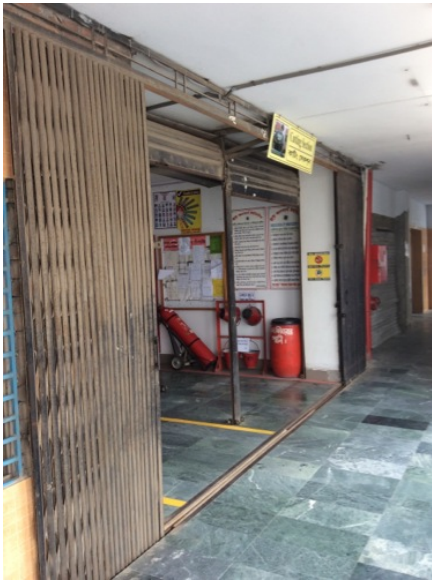
| F-8 | Egress | Egress doors / gates with locking features are provided at building exits, exit stairs, along egress routes, and exit discharge. | Remove locking features from all egress doors / gates.<br><br>If locks are required for security reasons, utilize special door locking features complying with NFPA 101. | Immediate |
| | | All gates/doors were open and unlocked during the inspection. | | |

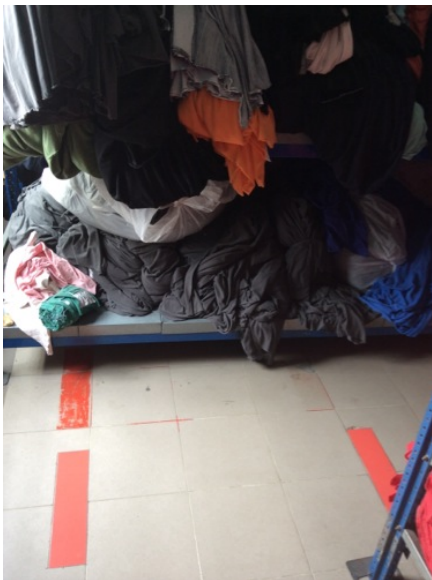
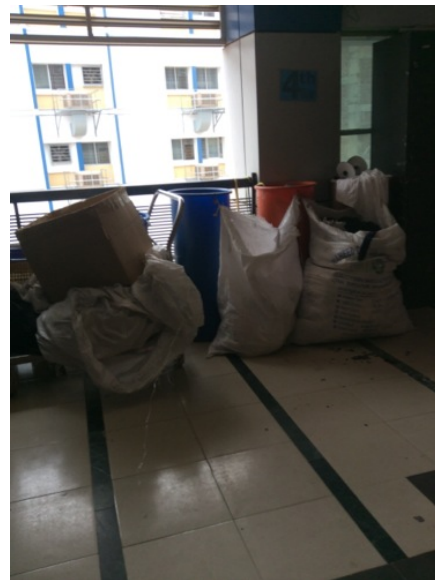
| F-9 | Egress | Storage was located in the egress path. | Keep egress paths and stairs clear of storage. | Immediate |
| All Floors except roof. | | | | |

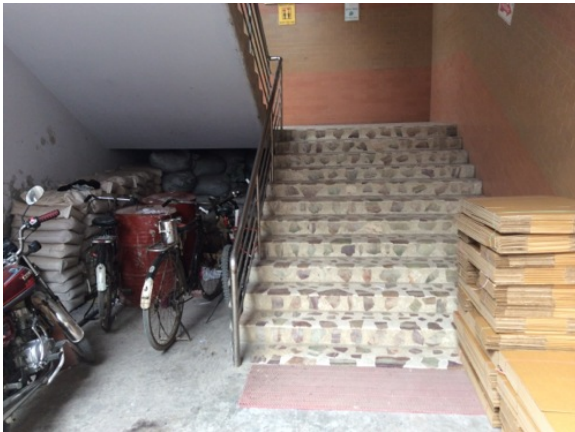
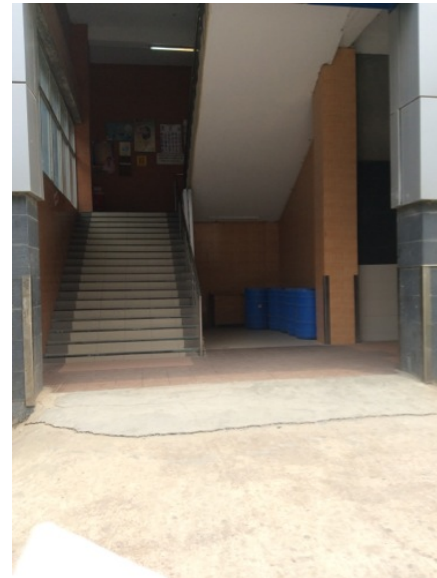
| F-10 | Egress | Storage was located in the exit stair. | Remove all storage from exit stairs and egress paths. | Immediate |

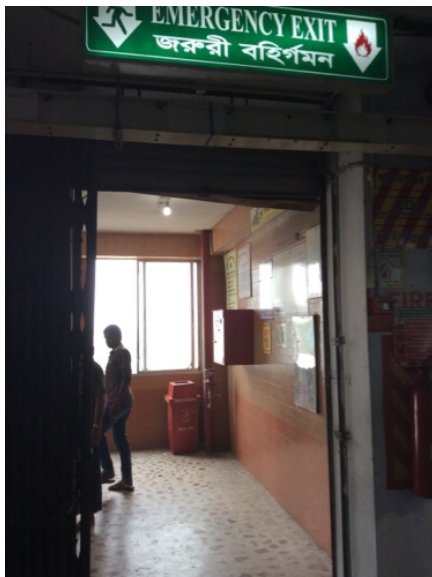
| F-11 | Egress | <p>Collapsible gates / sliding doors are provided at building exits, exit stairs, along egress routes, and exit discharge.</p> <p>Locations:<br/>All Floors.</p> | <p>Replace all gates / sliding doors along the means of egress with side-hinged, swinging egress doors.</p> <p>If locks are required for security reasons, utilize special door locking features complying with NFPA 101.</p> | <p>Within 1 month</p> |

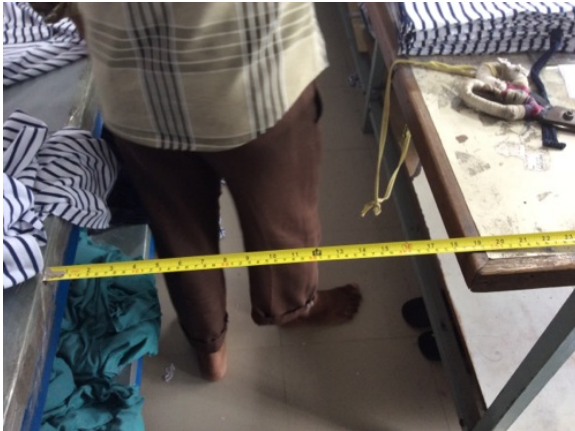
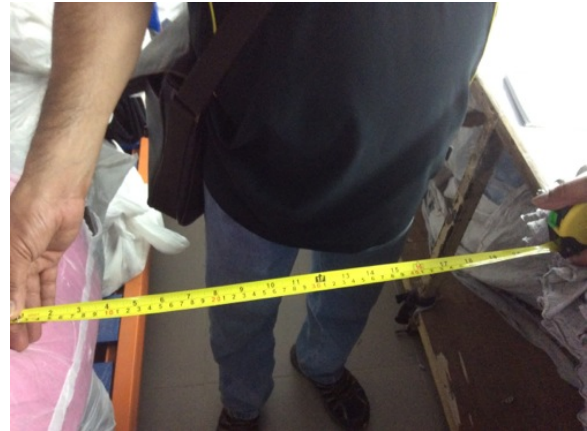
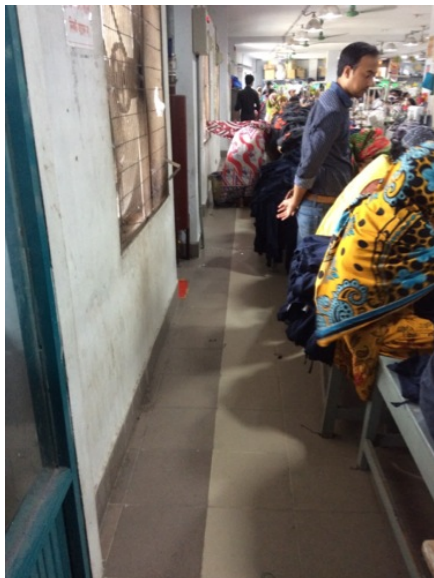
| F-12 | Egress | The width of egress aisles is less than 36-in. | Provide minimum aisle widths of 36-in. | Within 3 months |

Locations:

2nd through 4th floor  
(Sewing)

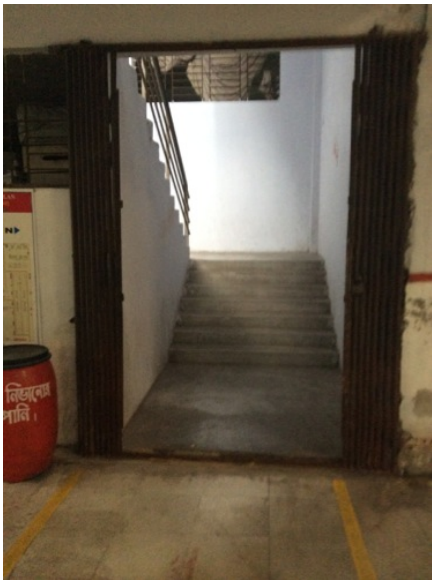
| F-13 | Egress | <p>Exit stairs discharge inside the building.</p> <p>The Northwest stair discharges on the ground floor into the Dying shed. It is approximately a 75ft path to get to the nearest exit.</p> | <p>- Provide sprinkler protection for discharge floor in accordance with NFPA 13.</p> | <p>Within 6 months</p> |

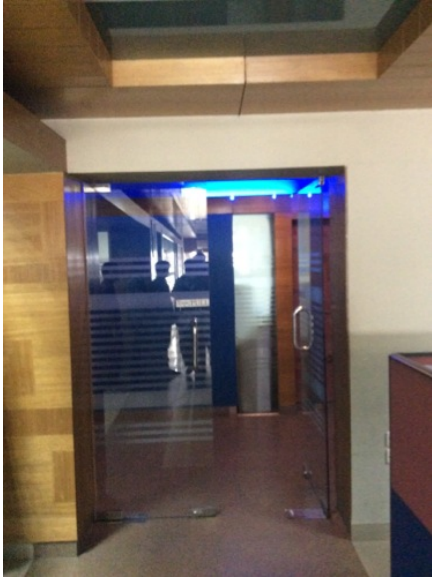
| F-18 | Egress Lighting | Exit sign not provided at exit.<br><br>Along exits paths and exit stairs on multiple floors. | Provide exit signs above all exits to the exterior and all doors to the exit stairs. | Within 3 months |
