# FIRE SAFETY INSPECTION REPORT

**Jericho Imex Limited.**

**ACCORD ID: 12495**

**Date:** 20-September-2016

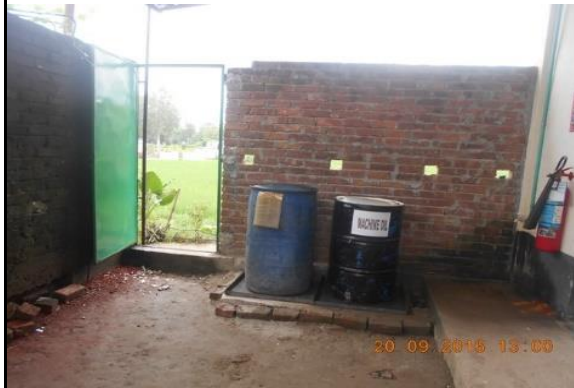
| Serial No. | Category | Findings | Required Action | Remediation Time Frame | Pictorial Evidence |
|---|---|---|---|---|---|
| 1 | Fire Rated Construction | Diesel fuel storage was located near the exit discharge path. | Remove all diesel fuel storage from the generator room and relocate to the exterior such that the diesel fuel storage is at least 10 ft. from the egress paths. If located along egress paths or in a utility building, separate the diesel fuel storage with 2-hr. fire rated construction. There shall be no diesel fuel storage in a factory production building | Immediately | |

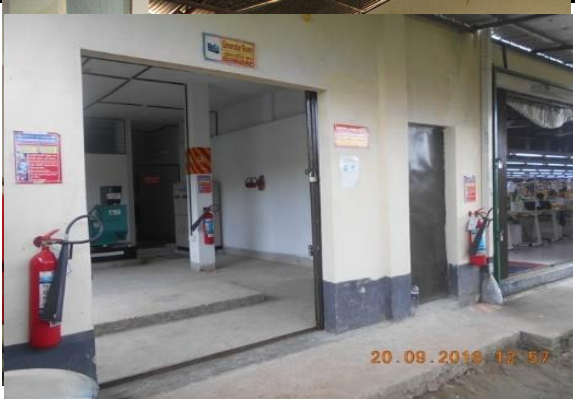
| Serial No. | Category | Findings | Required Action | Remediation Time Frame | Pictorial Evidence |
|---|---|---|---|---|---|
| 2 | Fire Rated Construction | The generator room is not separated by fire rated construction (openings, non-rated doors, penetrations) | Separate the generator room by a minimum 2-hr fire rated construction. Seal and/or protected all openings to maintain fire separations. | Within 3 months | |

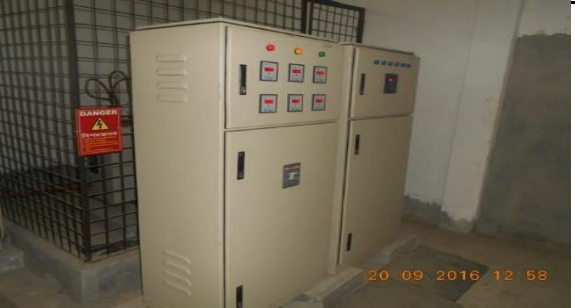
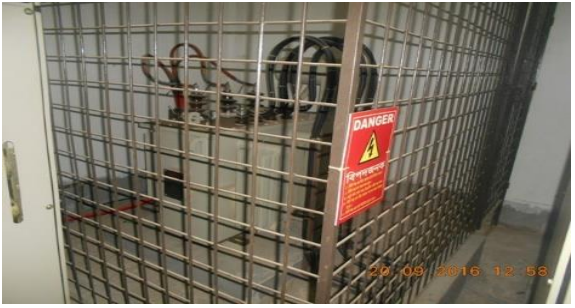
| Serial No. | Category | Findings | Required Action | Remediation Time Frame | Pictorial Evidence |
|---|---|---|---|---|---|
| 3 | Fire Rated Construction | Transformer & HT/LT panel are not properly separated from each other by fire rated construction. | Separate the transformer & LT/HT panel from each other by a minimum 2-hr fire rated construction. | Within 3 months | |

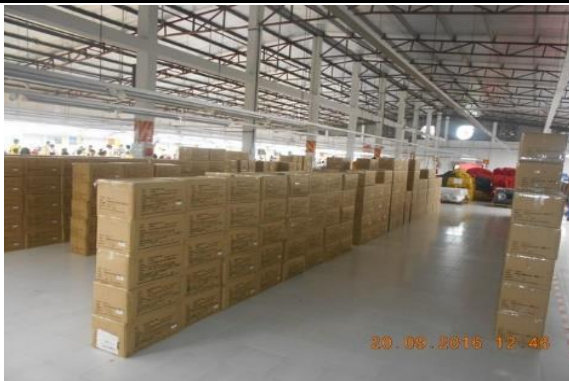
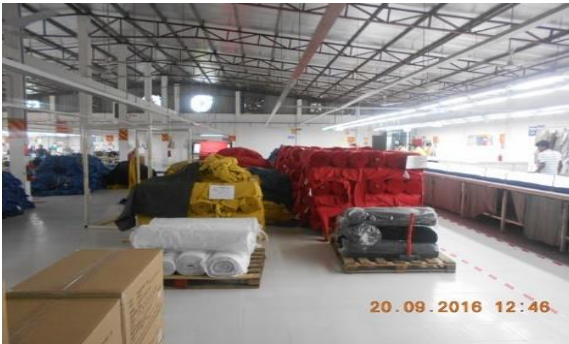
| Serial No. | Category | Findings | Required Action | Remediation Time Frame | Pictorial Evidence |
|---|---|---|---|---|---|
| 4 | Fire Rated Construction | Areas used for combustible storage are not separated by fire rated construction nor properly defined/within limits. | <p>Provide dedicated storage rooms separated by minimum 1-hr fire-rated construction. Where separate storage rooms are not feasible, provide defined storage areas and limit the storage arrangement as follows:</p> <ul style="list-style-type: none"> <li>- Maximum height of 2.4m and maximum area of 23m<sup>2</sup> - If sprinkler protected: maximum height of 3.66m and maximum area of 93m<sup>2</sup>. Separate areas of unenclosed combustible storage by a minimum clear distance of 3m.</li> </ul> | Within 3 months | |

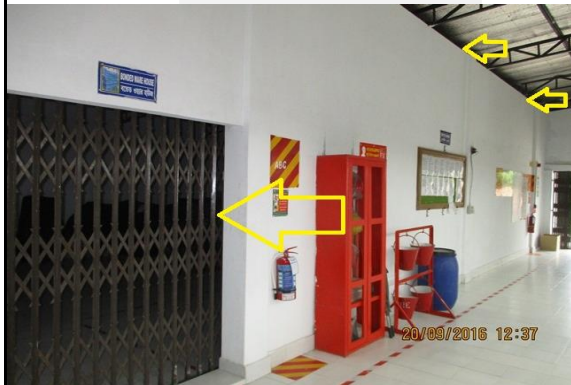
| Serial No. | Category | Findings | Required Action | Remediation Time Frame | Pictorial Evidence |
|---|---|---|---|---|---|
| 5 | Fire Rated Construction | Rooms used for combustible storage on the ground floor are not separated by fire-rated construction. Location: Bonded warehouse. | Provide dedicated storage rooms separated by minimum 1-hr fire-rated construction. | Within 3 months | |

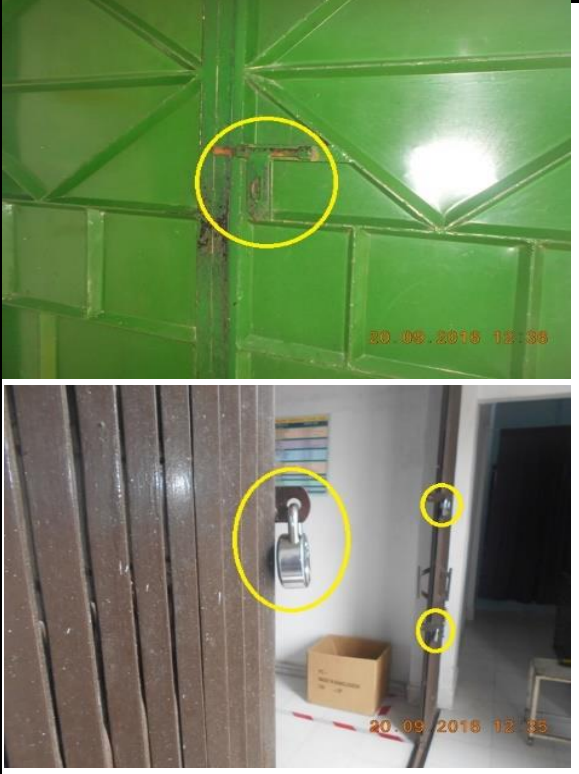
| Serial No. | Category | Findings | Required Action | Remediation Time Frame | Pictorial Evidence |
|---|---|---|---|---|---|
| 6 | Egress | Egress doors/gates with locking features not complying with NFPA101 are provided at all building exits. | Remove locking features from all egress doors/gates.<br>If locks are required for security reasons, utilize specialized door locking features complying with NFPA101. | Immediate | |

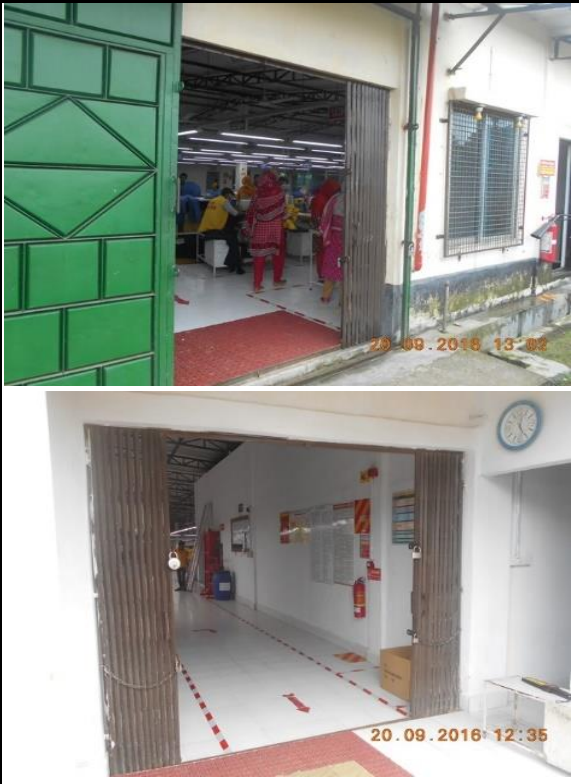
| Serial No. | Category | Findings | Required Action | Remediation Time Frame | Pictorial Evidence |
|---|---|---|---|---|---|
| 7 | Egress | Collapsible gates/sliding doors are provided at building exits & exit discharge. | Replace all collapsible gates/sliding doors along the means of egress with side-hinged, swinging egress doors. | Within 1 month | |

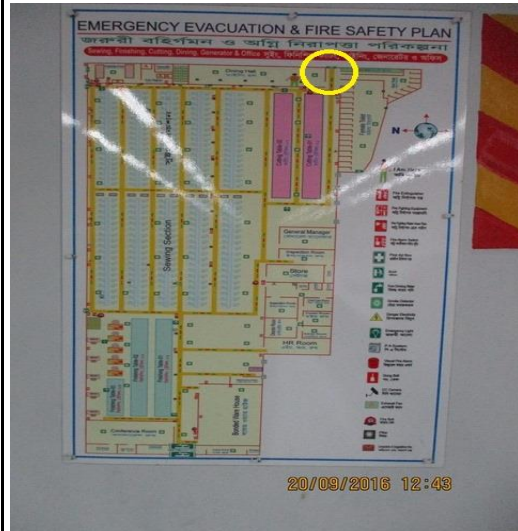
| Serial No. | Category | Findings | Required Action | Remediation Time Frame | Pictorial Evidence |
|---|---|---|---|---|---|
| 8 | Egress | A single means of egress is provided from dining area where the occupant load exceeds 49 person. | Specify appropriate upgrade based on conditions:<br>-Reduce occupant load to not more than 49 persons.<br>-Provide additional means of egress. | Within 3 months | |

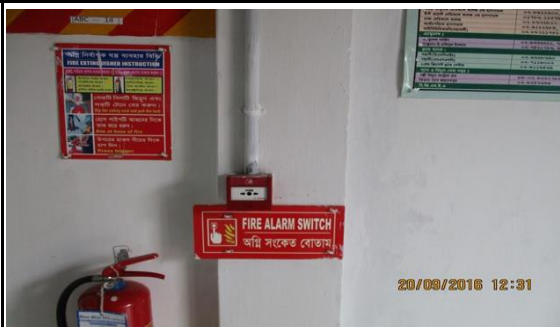
| Serial No. | Category | Findings | Required Action | Remediation Time Frame | Pictorial Evidence |
|---|---|---|---|---|---|
| 9 | Fire Detection & Alarm | Fire detection & alarm system installation requires detailed review to confirm compliance with NFPA 72 and ACCORD standards | Submit as-built drawings, testing records, equipment (cable, FACP, detectors) certification and other relevant documentation to the ACCORD for review and approval | Within 1 month | |
