FIRE SAFETY INSPECTION REPORT

**LOGOS APPARELS LTD.
TELIRCHALA, MOUCHAK, KALIAKOIR, GAZIPUR**

ACCORD
on Fire and Building Safety in Bangladesh

April 6, 2014

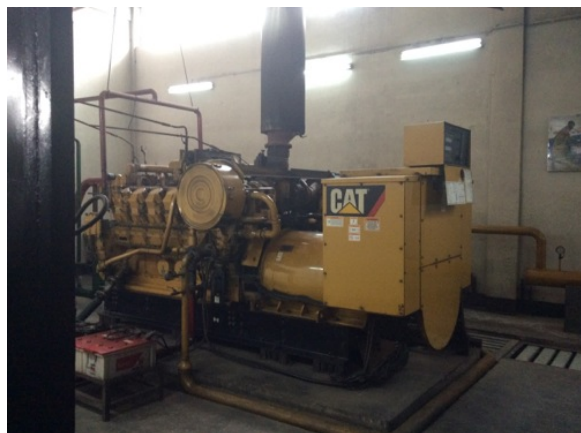
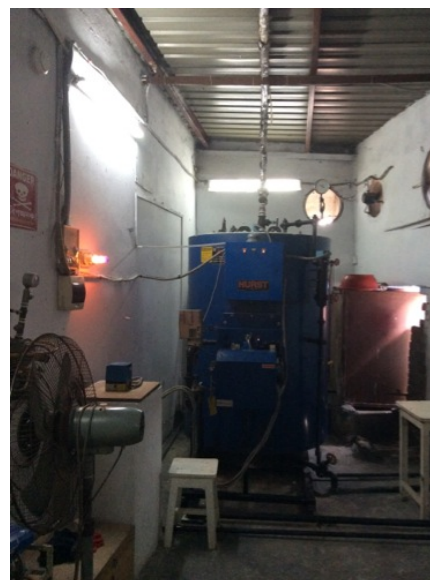
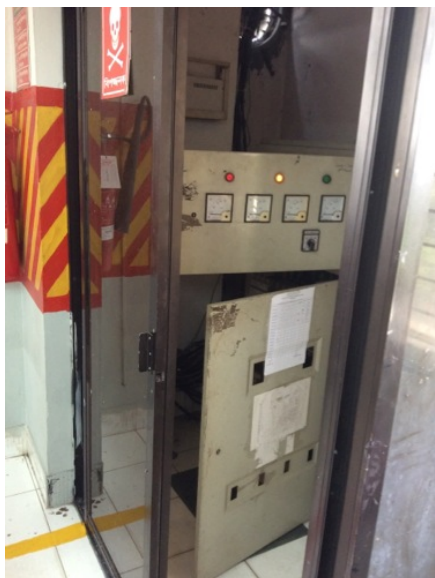
No.	Category	Finding	Recommendation	Remediation Timeframe
F-1	Fire Rated Construction	The boiler, generator and EMR rooms are not separated by fire-rated construction (openings, non-rated doors, penetrations).	Separate the boiler, generator and EMR rooms by a minimum 2-hr fire-rated construction. Seal and or protected all openings to maintain the required fire separations	Within 3 months

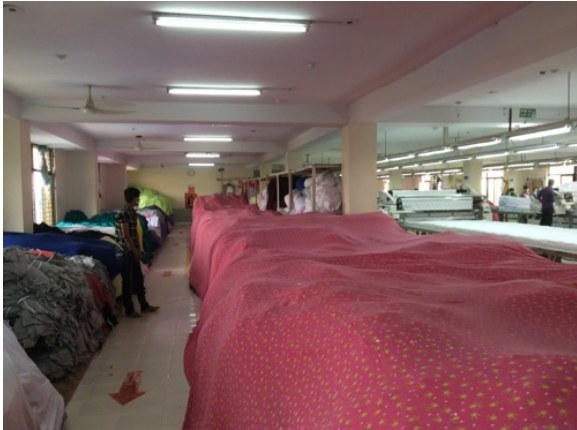
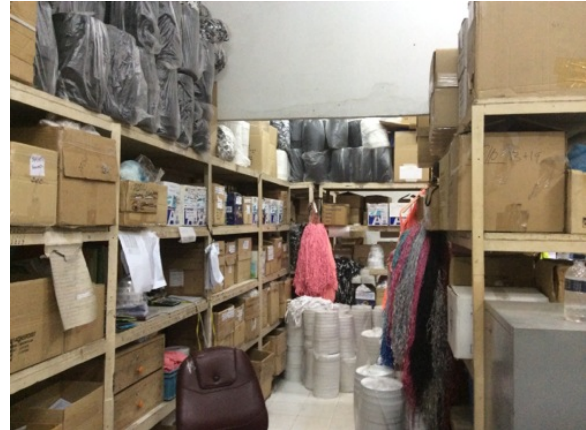
F-2	Fire Rated Construction	Areas used for combustible storage in several floors are not separated by fire-rated construction.	Provide dedicated storage rooms separated by minimum 1-hr fire-rated construction. Where separate storage rooms are not feasible, provide defined storage areas and limit the storage arrangement as follows: - Maximum height of 2.4m and maximum area of 23m ² - If sprinkler protected: maximum height of 3.66m and maximum area of 93m ² Separate areas of unenclosed combustible storage by a minimum clear distance of 3m.	Within 3 months
-----	-------------------------	--	--	-----------------

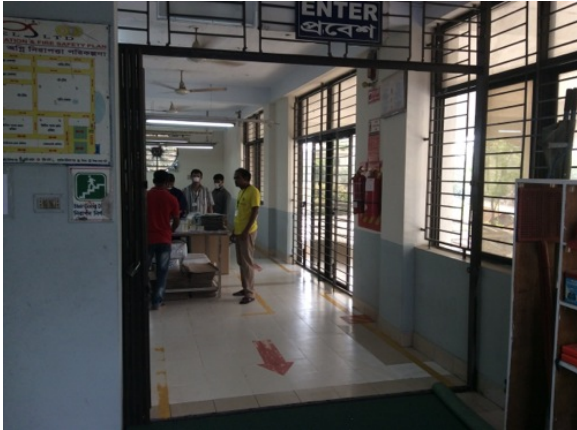
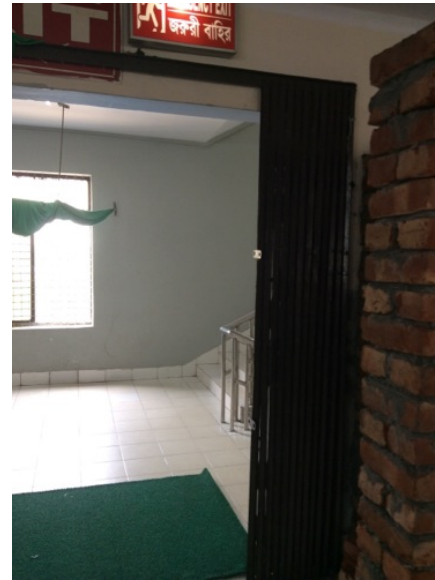
F-3	Fire Rated Construction	The exit stairs are not separated from work areas or other spaces on each floor by fire-rated construction.	Provide minimum 1.5-hr fire rated doors and seal all unprotected openings to separate the exit stairs from work areas and other building spaces on all floor levels. Ensure that the fire doors are self-closing and positive latching and that they are provided with fire exit (panic) hardware where serving production floors. If fire doors are required to be held open for functional reasons, provide automatic-closing devices tied to the fire alarm system.	Within 3 months
-----	-------------------------	---	---	-----------------

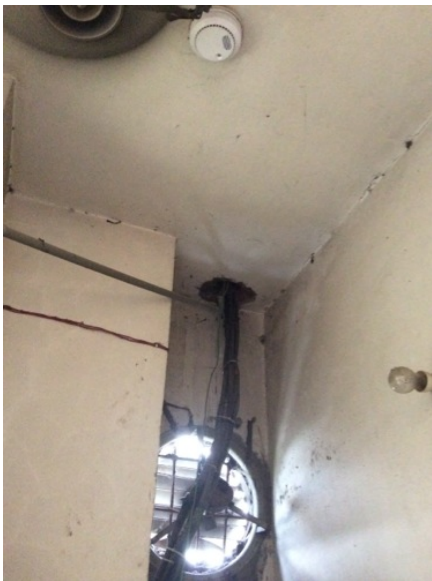
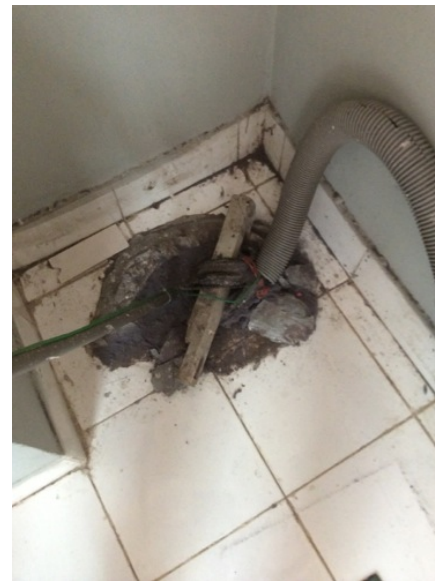
F-4	Fire Rated Construction	Unsealed penetrations and openings are located in the fire-rated floor/ceiling assemblies at the SE corner of 3,4 and 5th floors.	Provide a minimum 2-hr fire-rated shaft to separate the utility risers from each floor level. Seal all penetrations and openings in floor/ceiling assemblies to maintain the fire separation.	Within 3 months
-----	-------------------------	---	--	-----------------

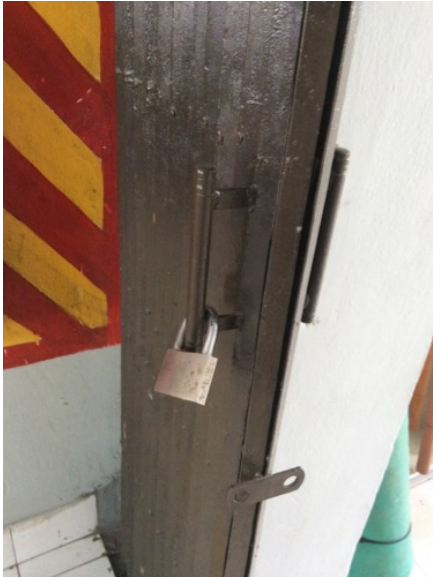
F-5	Egress	<p>Egress doors / gates with locking features are provided at building exits and exit stairs.</p> <p>All gates/doors were open and unlocked during the inspection.</p>	<p>Remove locking features from all egress doors / gates.</p> <p>If locks are required for security reasons, utilize special door locking features complying with NFPA 101.</p>	Immediate
-----	--------	--	---	-----------

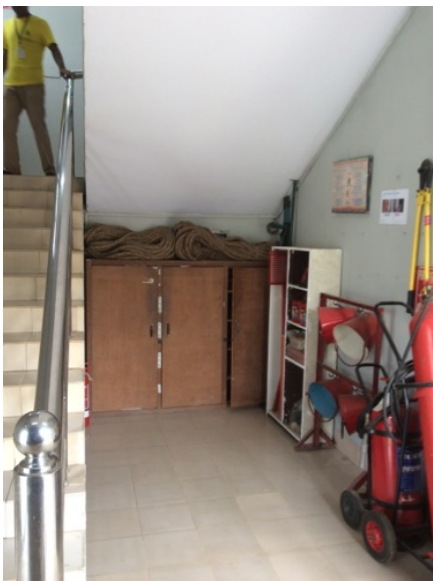
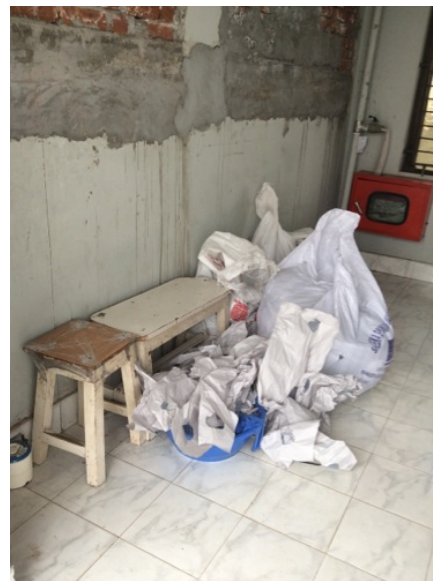
F-6	Egress	<p>Storage was located in the exit stair.</p>	<p>Remove all storage from exit stairs and egress paths.</p>	Immediate
-----	--------	---	--	-----------

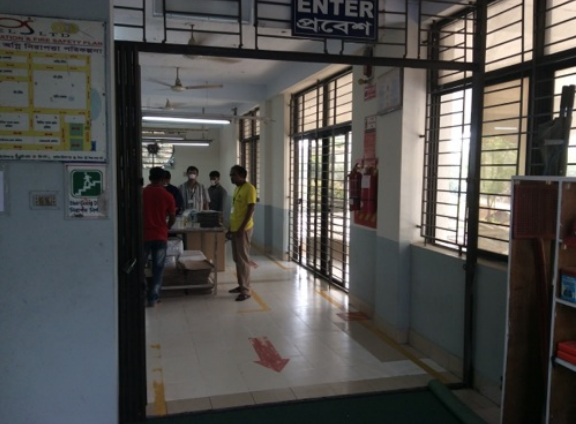
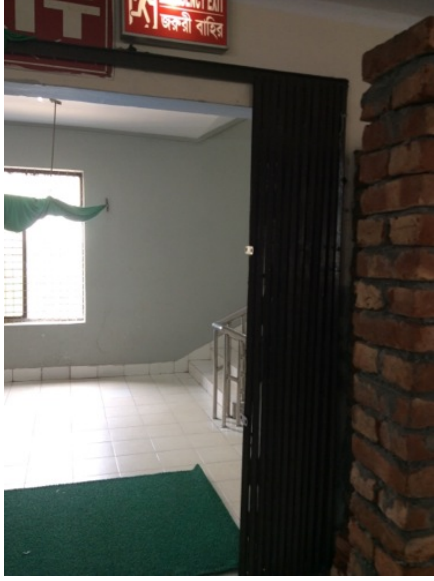
F-7	Egress	Collapsible gates / sliding doors are provided at most of exits and exit stairs	Replace all gates / sliding doors along the means of egress with side-hinged, swinging egress doors. If locks are required for security reasons, utilize special door locking features complying with NFPA 101.	Within 1 month

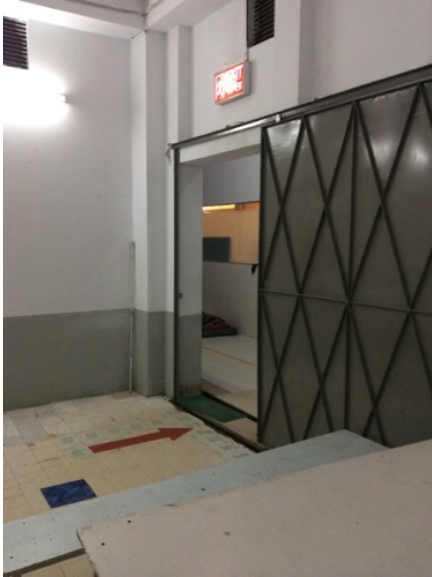
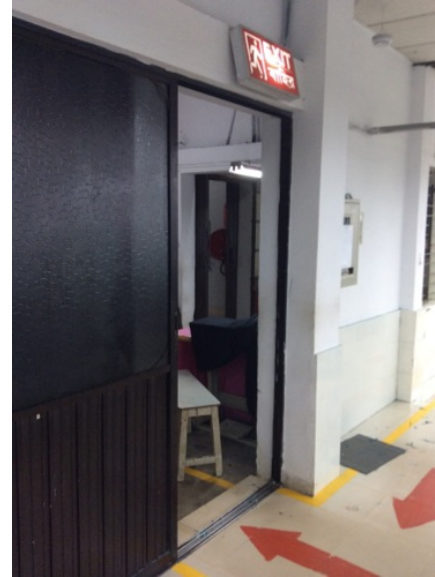
F-8	Egress	Exit stair door / egress door serving 50 or more occupants does not swing in the direction of egress travel at dining and sewing section in the ground floor	Modify the egress door to swing in the direction of egress travel.	Within 3 months
-----	--------	--	--	-----------------

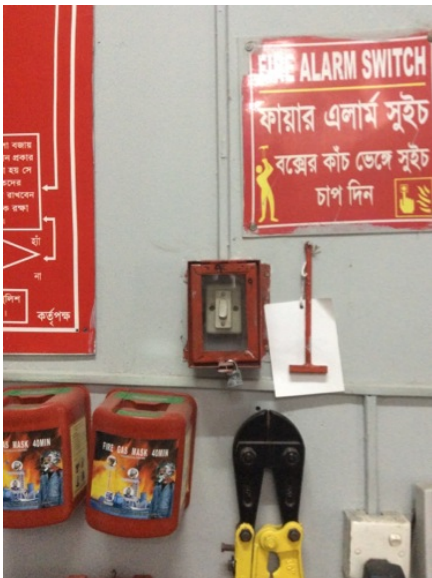
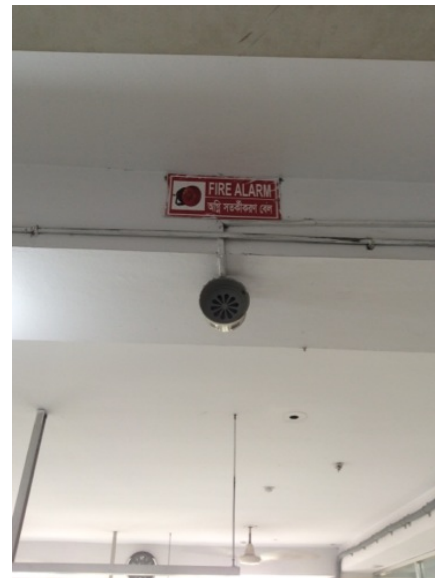
F-9	Fire Protection	The fire alarm system is antiquated, not a listed system, and does not provide alarm and notification features consistent with acceptable standards.	Replace the fire alarm system with a new, listed addressable fire alarm system in accordance with NFPA 72.	Design within 4 months, install within 9 months
-----	-----------------	--	--	---

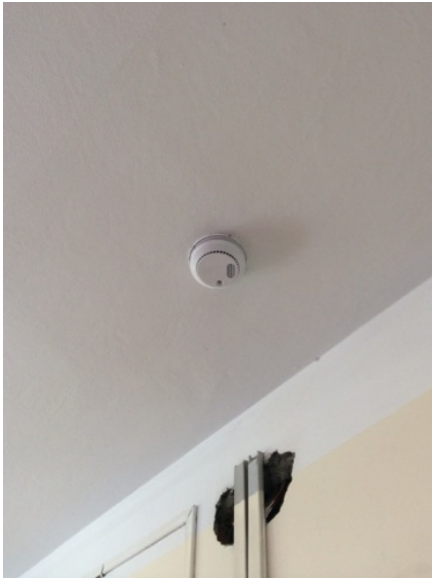
F-11	Fire Protection	The building is equipped with single-station smoke alarms. Smoke alarm activation sounds only a local alarm and does not provide automatic fire alarm notification of occupants.	Replace the single-station smoke alarms with automatic smoke detectors tied into the fire alarm system. Configure the fire alarm system to initiate occupant notification upon activation of any two smoke detectors in addition to the manual fire alarm stations.	Within 6 months
------	-----------------	--	---	-----------------

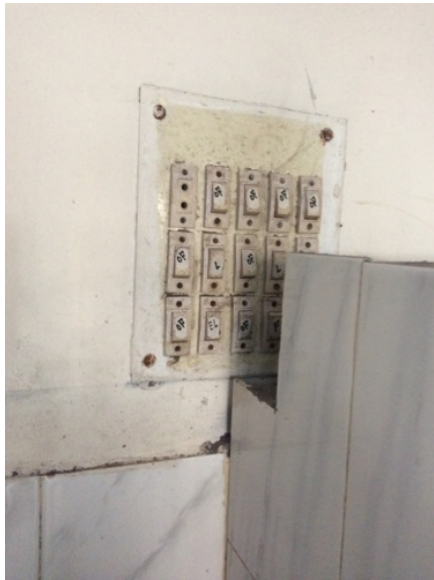
F-12	Egress Lighting	Manual on-off switches in several locations are provided for emergency lighting / exit signage units.	Remove manual on/off switches from emergency lighting / exit signage units to prevent them from being switched off.	Within 1 month
------	-----------------	---	---	----------------

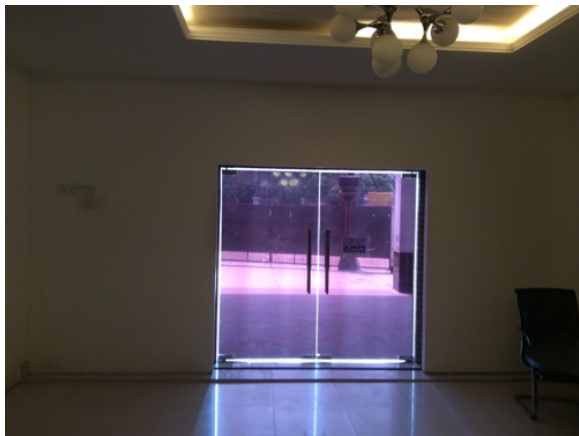
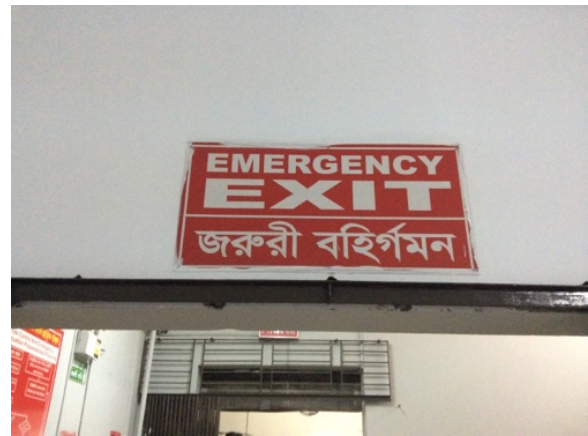
F-13	Egress Lighting	Exit sign in the ground floor not provided at exit	Provide exit signs above all exits to the exterior and all doors to the exit stairs.	Within 3 months
------	-----------------	--	--	-----------------
