# **FIRE SAFETY INSPECTION REPORT**

## **NRN Knitting & Garments Limited**

**ACCORD ID: 12441**

**ADDRESS: 181, Jamgara, Ashulia, Dhaka, Bangladesh**

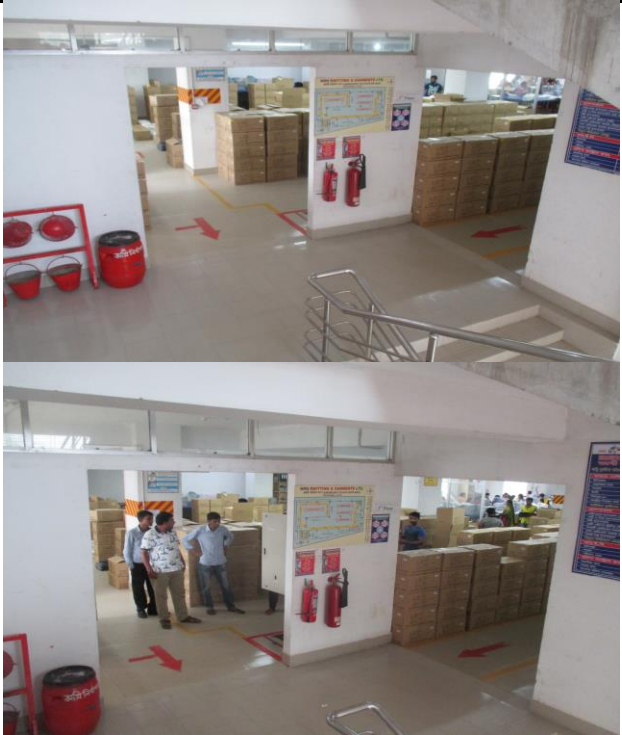
| SI No. | Category | Findings | Required Action | Remediation Time Frame | Pictorial Evidence |
|---|---|---|---|---|---|
| 1 | Fire Rated Construction | The exit stairs are not separated from factory floor on each floor by fire-rated construction. | Provide minimum 1.5-hr fire rated doors and seal all unprotected openings to separate the exit stairs from work areas and other building spaces on all floor levels. Ensure that the fire doors are self-closing and positive latching and that they are provided with fire exit (panic) hardware where serving production floors. If fire doors are required to be held open for functional reasons, provide automatic closing devices tied to the fire alarm system. | Within 2 months | |

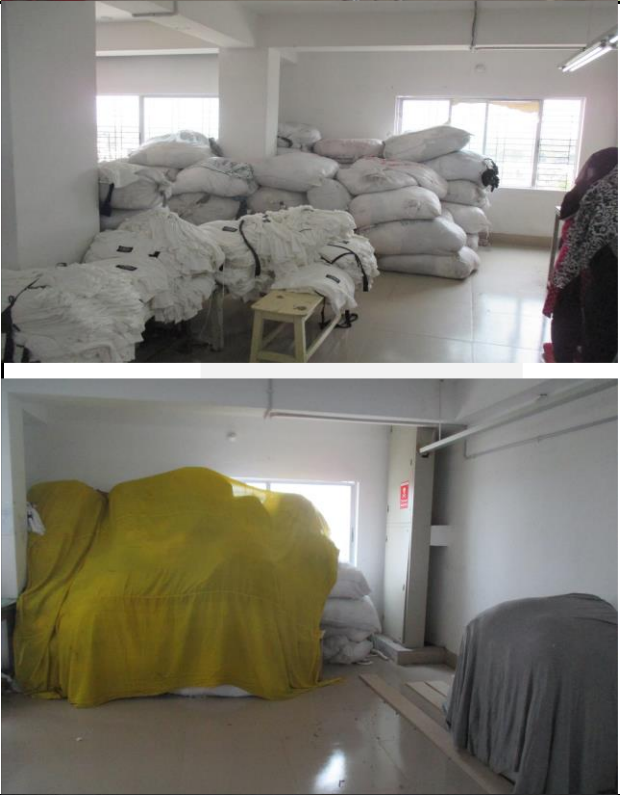
| Sl No. | Category | Findings | Required Action | Remediation Time Frame | Pictorial Evidence |
|---|---|---|---|---|---|
| 2 | Fire Rated Construction | Areas used for combustible storage are not separated by fire rated construction. Store room on seventh floor. | Provide dedicated storage rooms separated by minimum 1-hr fire-rated construction. Where separate storage rooms are not feasible, provide defined storage areas and limit the storage arrangement as follows: - Maximum height of 2.4m and maximum area of 23m <sup>2</sup> - If sprinkler protected: maximum height of 3.66m and maximum area of 93m <sup>2</sup> . Separate areas of unenclosed combustible storage by a minimum clear distance of 3m. | Within 3 months | |

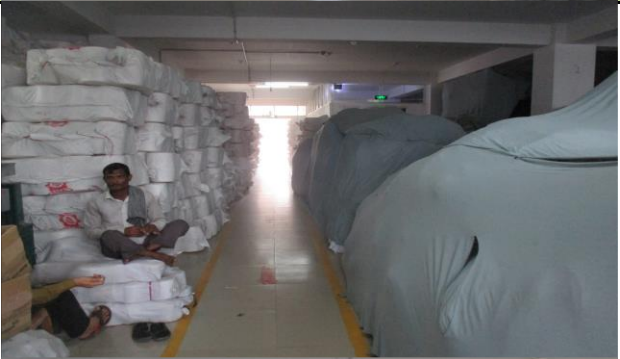
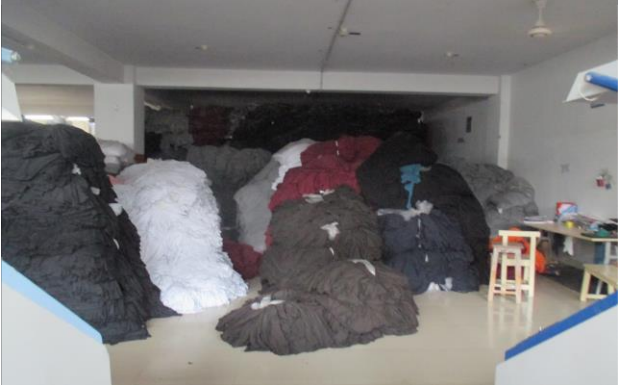
| Sl No. | Category | Findings | Required Action | Remediation Time Frame | Pictorial Evidence |
|---|---|---|---|---|---|
| 3 | Fire Rated Construction | Rooms used for combustible storage on the ground floor are not separated by fire-rated construction. Location: 1st and 4th floor. | Provide dedicated storage rooms separated by minimum 1-hr fire-rated construction. | Within 2 months | |

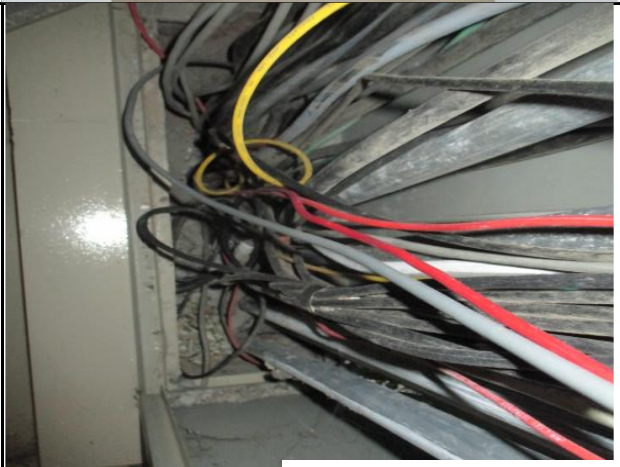
| Sl No. | Category | Findings | Required Action | Remediation Time Frame | Pictorial Evidence |
|---|---|---|---|---|---|
| 4 | Fire Rated Construction | Penetrations through floor/ceiling assemblies are found unsealed. | <p>Seal all penetrations and openings in floor/ceiling (full thickness of the floor/ceiling) assemblies by fire rated materials to maintain the fire resistance rating.</p> <p>Provide a minimum 2-hr fire rated shaft to separate the utility risers from each floor if required.</p> | Within 3 months | |

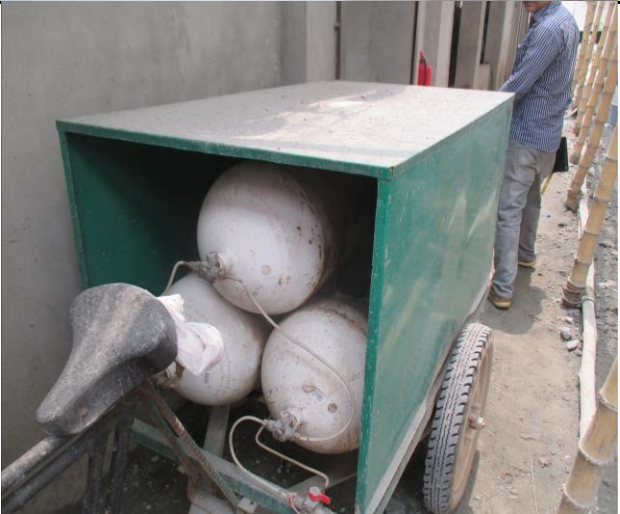
| Sl No. | Category | Findings | Required Action | Remediation Time Frame | Pictorial Evidence |
|---|---|---|---|---|---|
| 5 | Fire Rated Construction | Flammable gas storage area is not separated by fire-rated construction | Separate the flammable gas cylinder storage area by a minimum 2-hr fire-rated construction | Within 3 months | |

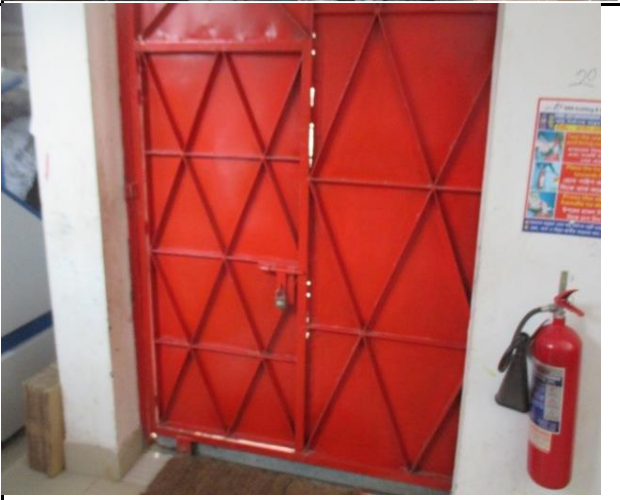
| Sl No. | Category | Findings | Required Action | Remediation Time Frame | Pictorial Evidence |
|---|---|---|---|---|---|
| 6 | Lockage Egress Doors | Egress doors/gates with locking features not complying with NFPA101 are provided at [ building exits, exit stairs, along egress routes, exit discharge] | Remove locking features from all egress doors/gates. If locks are required for security reasons, utilize specialized door locking features complying with NFPA101. | Immediate | |

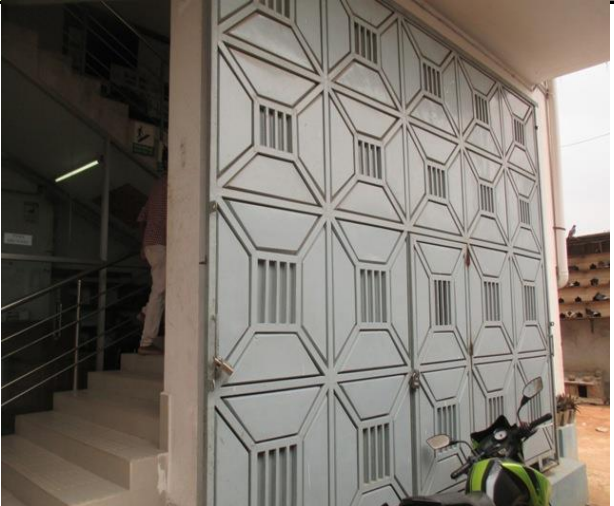
| Sl No. | Category | Findings | Required Action | Remediation Time Frame | Pictorial Evidence |
|---|---|---|---|---|---|
| 7 | Sliding Door & Gates | Collapsible gates/sliding doors/rolling shutter doors are provided at [building exits, exit stairs, along egress routes, exit discharge] | Replace all collapsible gates/ sliding doors/ rolling shutter doors along the means of egress with side-hinged, swinging egress doors. | Within 1 month | |

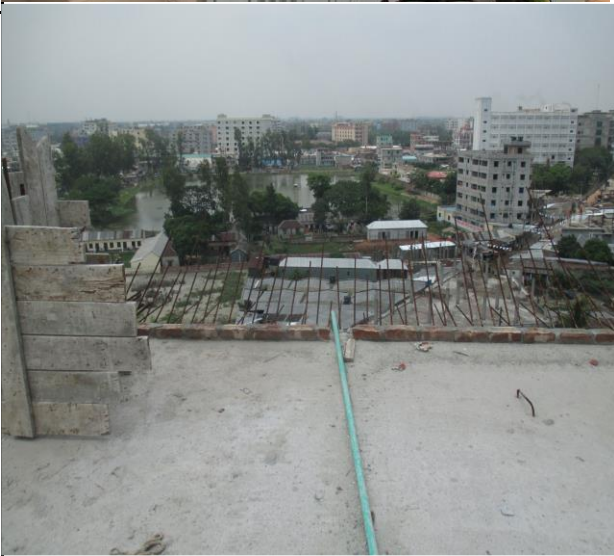
| Sl No. | Category | Findings | Required Action | Remediation Time Frame | Pictorial Evidence |
|---|---|---|---|---|---|
| 8 | Egress | Parapets or guards are not provided in occupied roof.<br>OR<br>Parapets or guards are provided in occupied roof which is less than 1067mm (42 inch.). | Provide parapets or guards with a minimum height of 1067mm (42 inch.). | Within 3 months | |

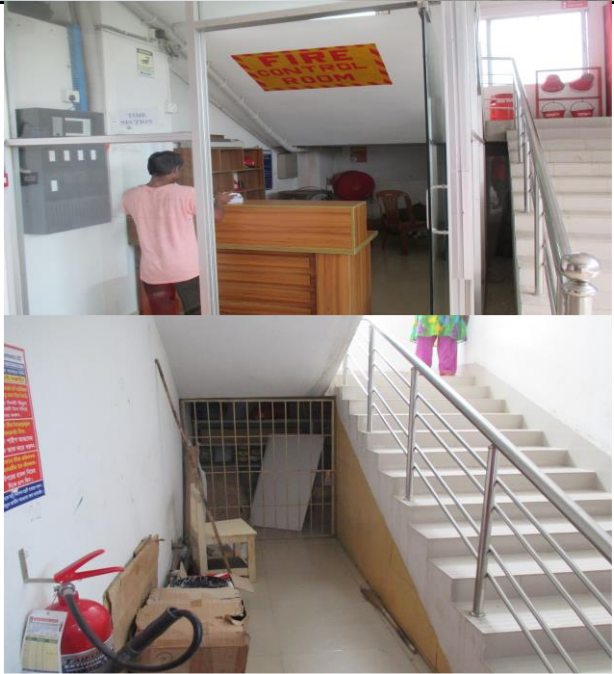
| Sl No. | Category | Findings | Required Action | Remediation Time Frame | Pictorial Evidence |
|---|---|---|---|---|---|
| 9 | Egress | Storage and office was located in both exit stair. | Remove storage and office area from the exit stairs and egress path | Immediate | |

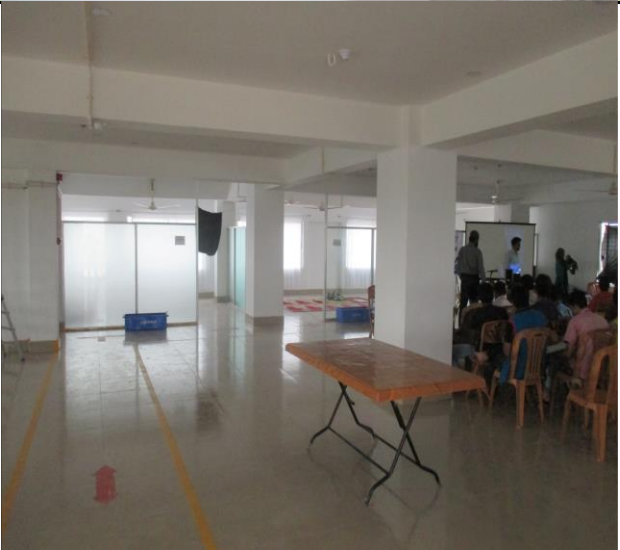
| Sl No. | Category | Findings | Required Action | Remediation Time Frame | Pictorial Evidence |
|---|---|---|---|---|---|
| 11 | Egress Lighting | Based on the number and location of emergency lights observed, adequate illumination levels are not anticipated along egress routes. Location: Dining area. | Test the emergency lighting system on each floor and provide additional emergency fixtures to provide adequate illumination along the means of egress. Provide a minimum illumination of 10 lux at the floor level within exit stairs and exit discharge paths and minimum 2.5 lux along exit access aisles. | Within 2 months | |

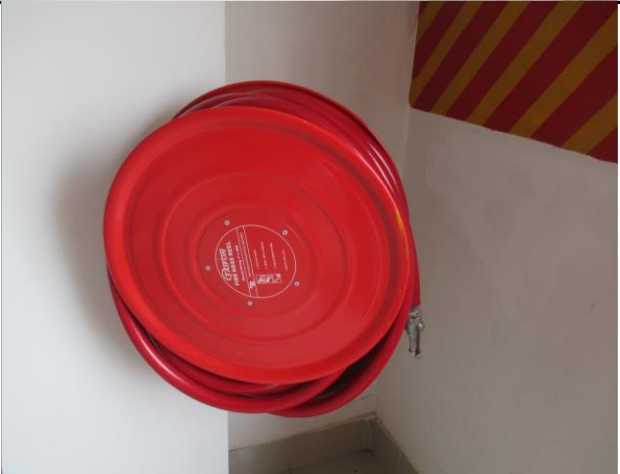
| Sl No. | Category | Findings | Required Action | Remediation Time Frame | Pictorial Evidence |
|---|---|---|---|---|---|
| 15 | Fire Protection System | The existing building has an occupied floor greater than 10 meter (33 feet) and is not provided with standpipe protection. | Install a new class III standpipe system & fire department connection in accordance with NFPA 14. A class I system shall be permitted in buildings protected throughout by an automatic sprinkler system. | Design within 2 months, Install within 6 months | |

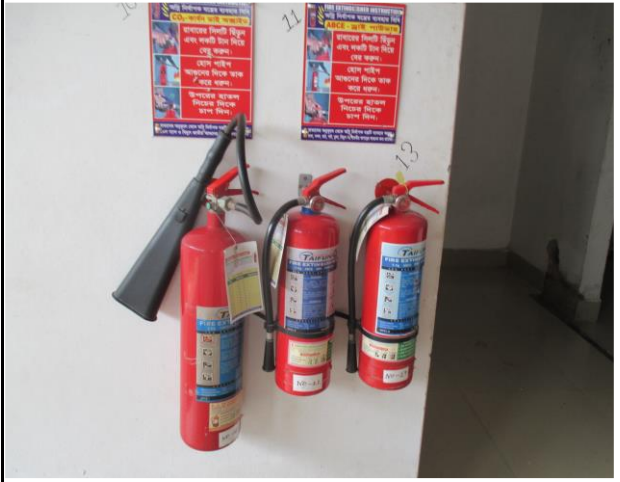
| Sl No. | Category | Findings | Required Action | Remediation Time Frame | Pictorial Evidence |
|---|---|---|---|---|---|
| 16 | Fire Protection System | Fire Protection : Inspection, testing and maintenance of the standpipe system is not in accordance with NFPA 14. | Inspect, test and maintain the standpipe system and keep written records on-site, in accordance with NFPA 14. | Within 2 months | |

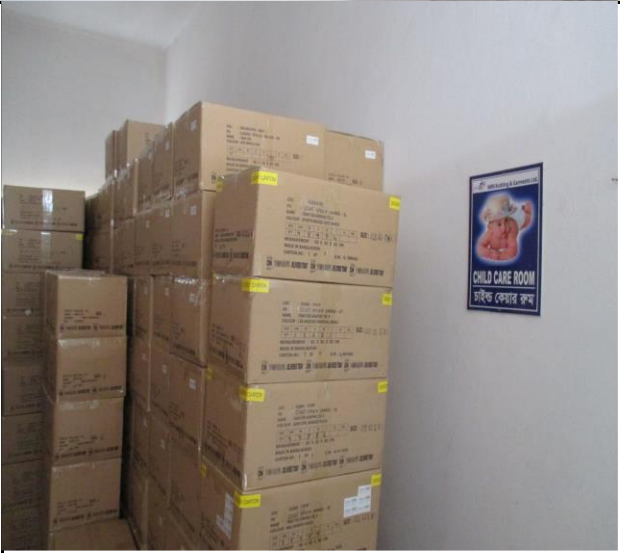
| Sl No. | Category | Findings | Required Action | Remediation Time Frame | Pictorial Evidence |
|---|---|---|---|---|---|
| 18 | Day care | Storage was located inside the child care room. | Remove all storage from child care room. | Immediately | |
