# **FIRE SAFETY INSPECTION REPORT**

**PARKSTAR APPAREL LTD**  
**KUNIA, K.B. BAZAR GAZIOUR SADAR**

April 28, 2014

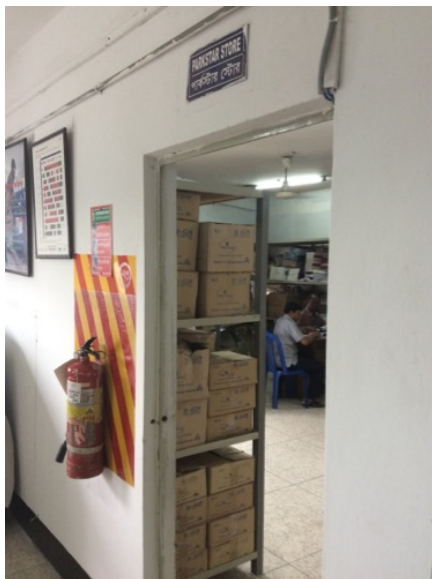
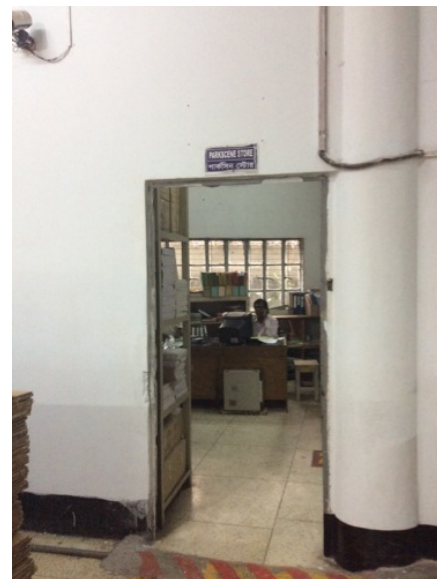
| No. | Category | Finding | Recommendation | Remediation Timeframe |
|---|---|---|---|---|
| F-1 | Fire Rated Construction | Areas used for combustible storage are not separated by fire-rated construction on every floor except 2nd floor. | <p>Provide dedicated storage rooms separated by minimum 1-hr fire-rated construction.</p> <p>Where separate storage rooms are not feasible, provide defined storage areas and limit the storage arrangement as follows:</p> <ul style="list-style-type: none"> <li>- Maximum height of 2.4m and maximum area of 23m<sup>2</sup></li> <li>- If sprinkler protected: maximum height of 3.66m and maximum area of 93m<sup>2</sup></li> </ul> <p>Separate areas of unenclosed combustible storage by a minimum clear distance of 3m.</p> | Within 3 months |

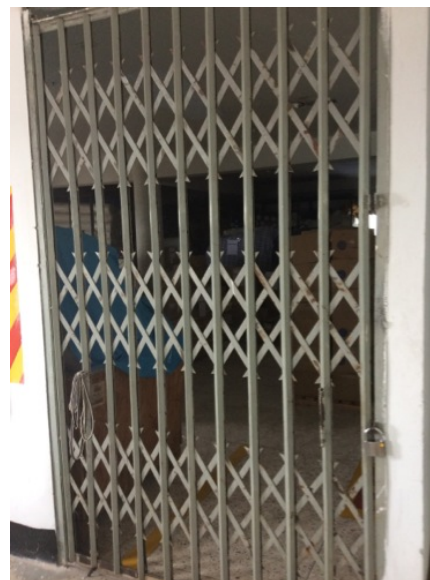
| F-2 | Fire Rated Construction | The exit stairs are not separated from other spaces on each floor by fire-rated construction. | Provide minimum 1.5-hr fire rated doors and seal all unprotected openings to separate the exit stairs from work areas and other building spaces on all floor levels. Ensure that the fire doors are self-closing and positive latching and that they are provided with fire exit (panic) hardware where serving production floors. | Within 3 months |

If fire doors are required to be held open for functional reasons, provide automatic-closing devices tied to the fire alarm system.

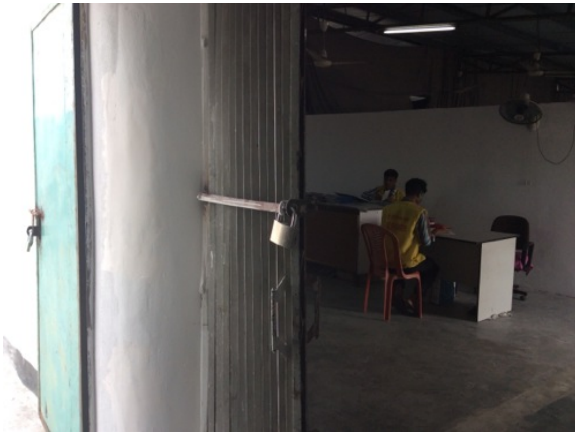
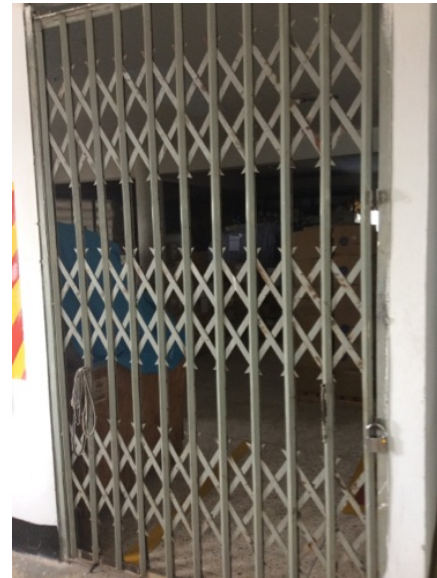
| F-3 | Egress | Egress doors / gates with locking features are provided at building exits, exit stairs on every floor. | Remove locking features from all egress doors / gates.<br><br>If locks are required for security reasons, utilize special door locking features complying with NFPA 101. | Immediate |

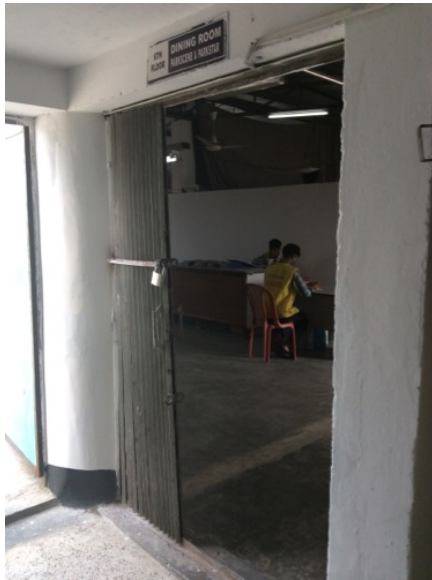
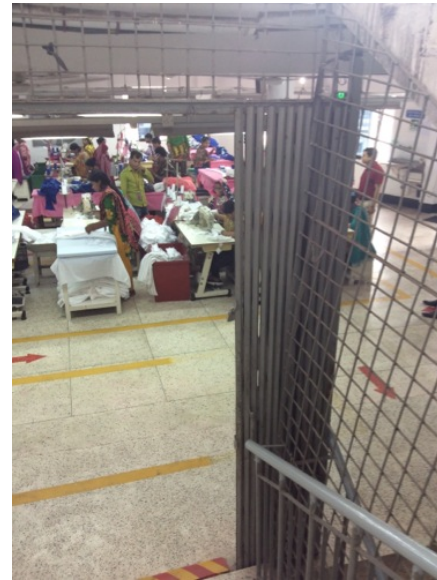
| F-5 | Egress | Collapsible gates / sliding doors are provided at building exit and exit stairs on every floor. | Replace all gates / sliding doors along the means of egress with side-hinged, swinging egress doors.<br><br>If locks are required for security reasons, utilize special door locking features complying with NFPA 101. | Within 1 month |

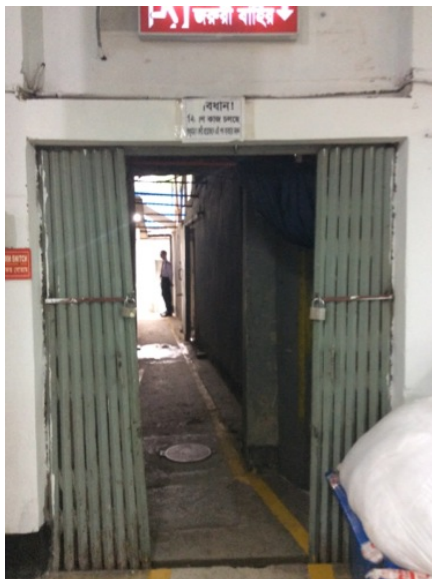
| F-6 | Egress | Exit stairs discharge inside the building at the SE exit stair. | Modify stair to discharge directly outside. | Within 6 months |

or

Provide 2-hr fire-rated exit passageway leading directly outside (vestibules to separate any storage areas).

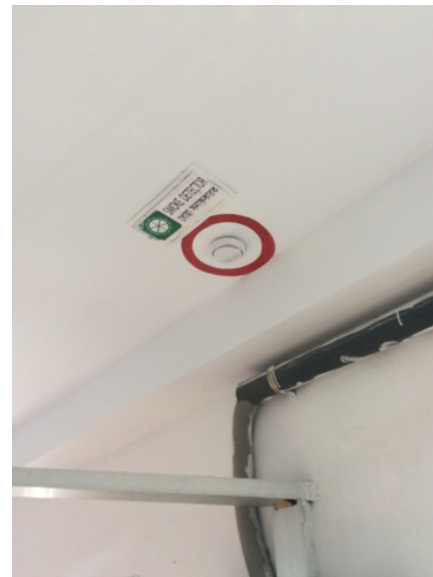
| F-9 | Fire Protection | The building is equipped with single-station smoke alarms. Smoke alarm activation sounds only a local alarm and does not provide automatic fire alarm notification of occupants. | Replace the single-station smoke alarms. Provide automatic smoke detectors throughout the building in accordance with NFPA72 | Within 6 months |
